**REPORT ON PHASE 2 GROUND  
INVESTIGATION  
Proposed Replacement Residence  
Elmsdale house, Ratcliffe Lane  
Sheepy Magna  
Leicestershire**

**Date : August 2022**

**Job No : 22 2430-2**

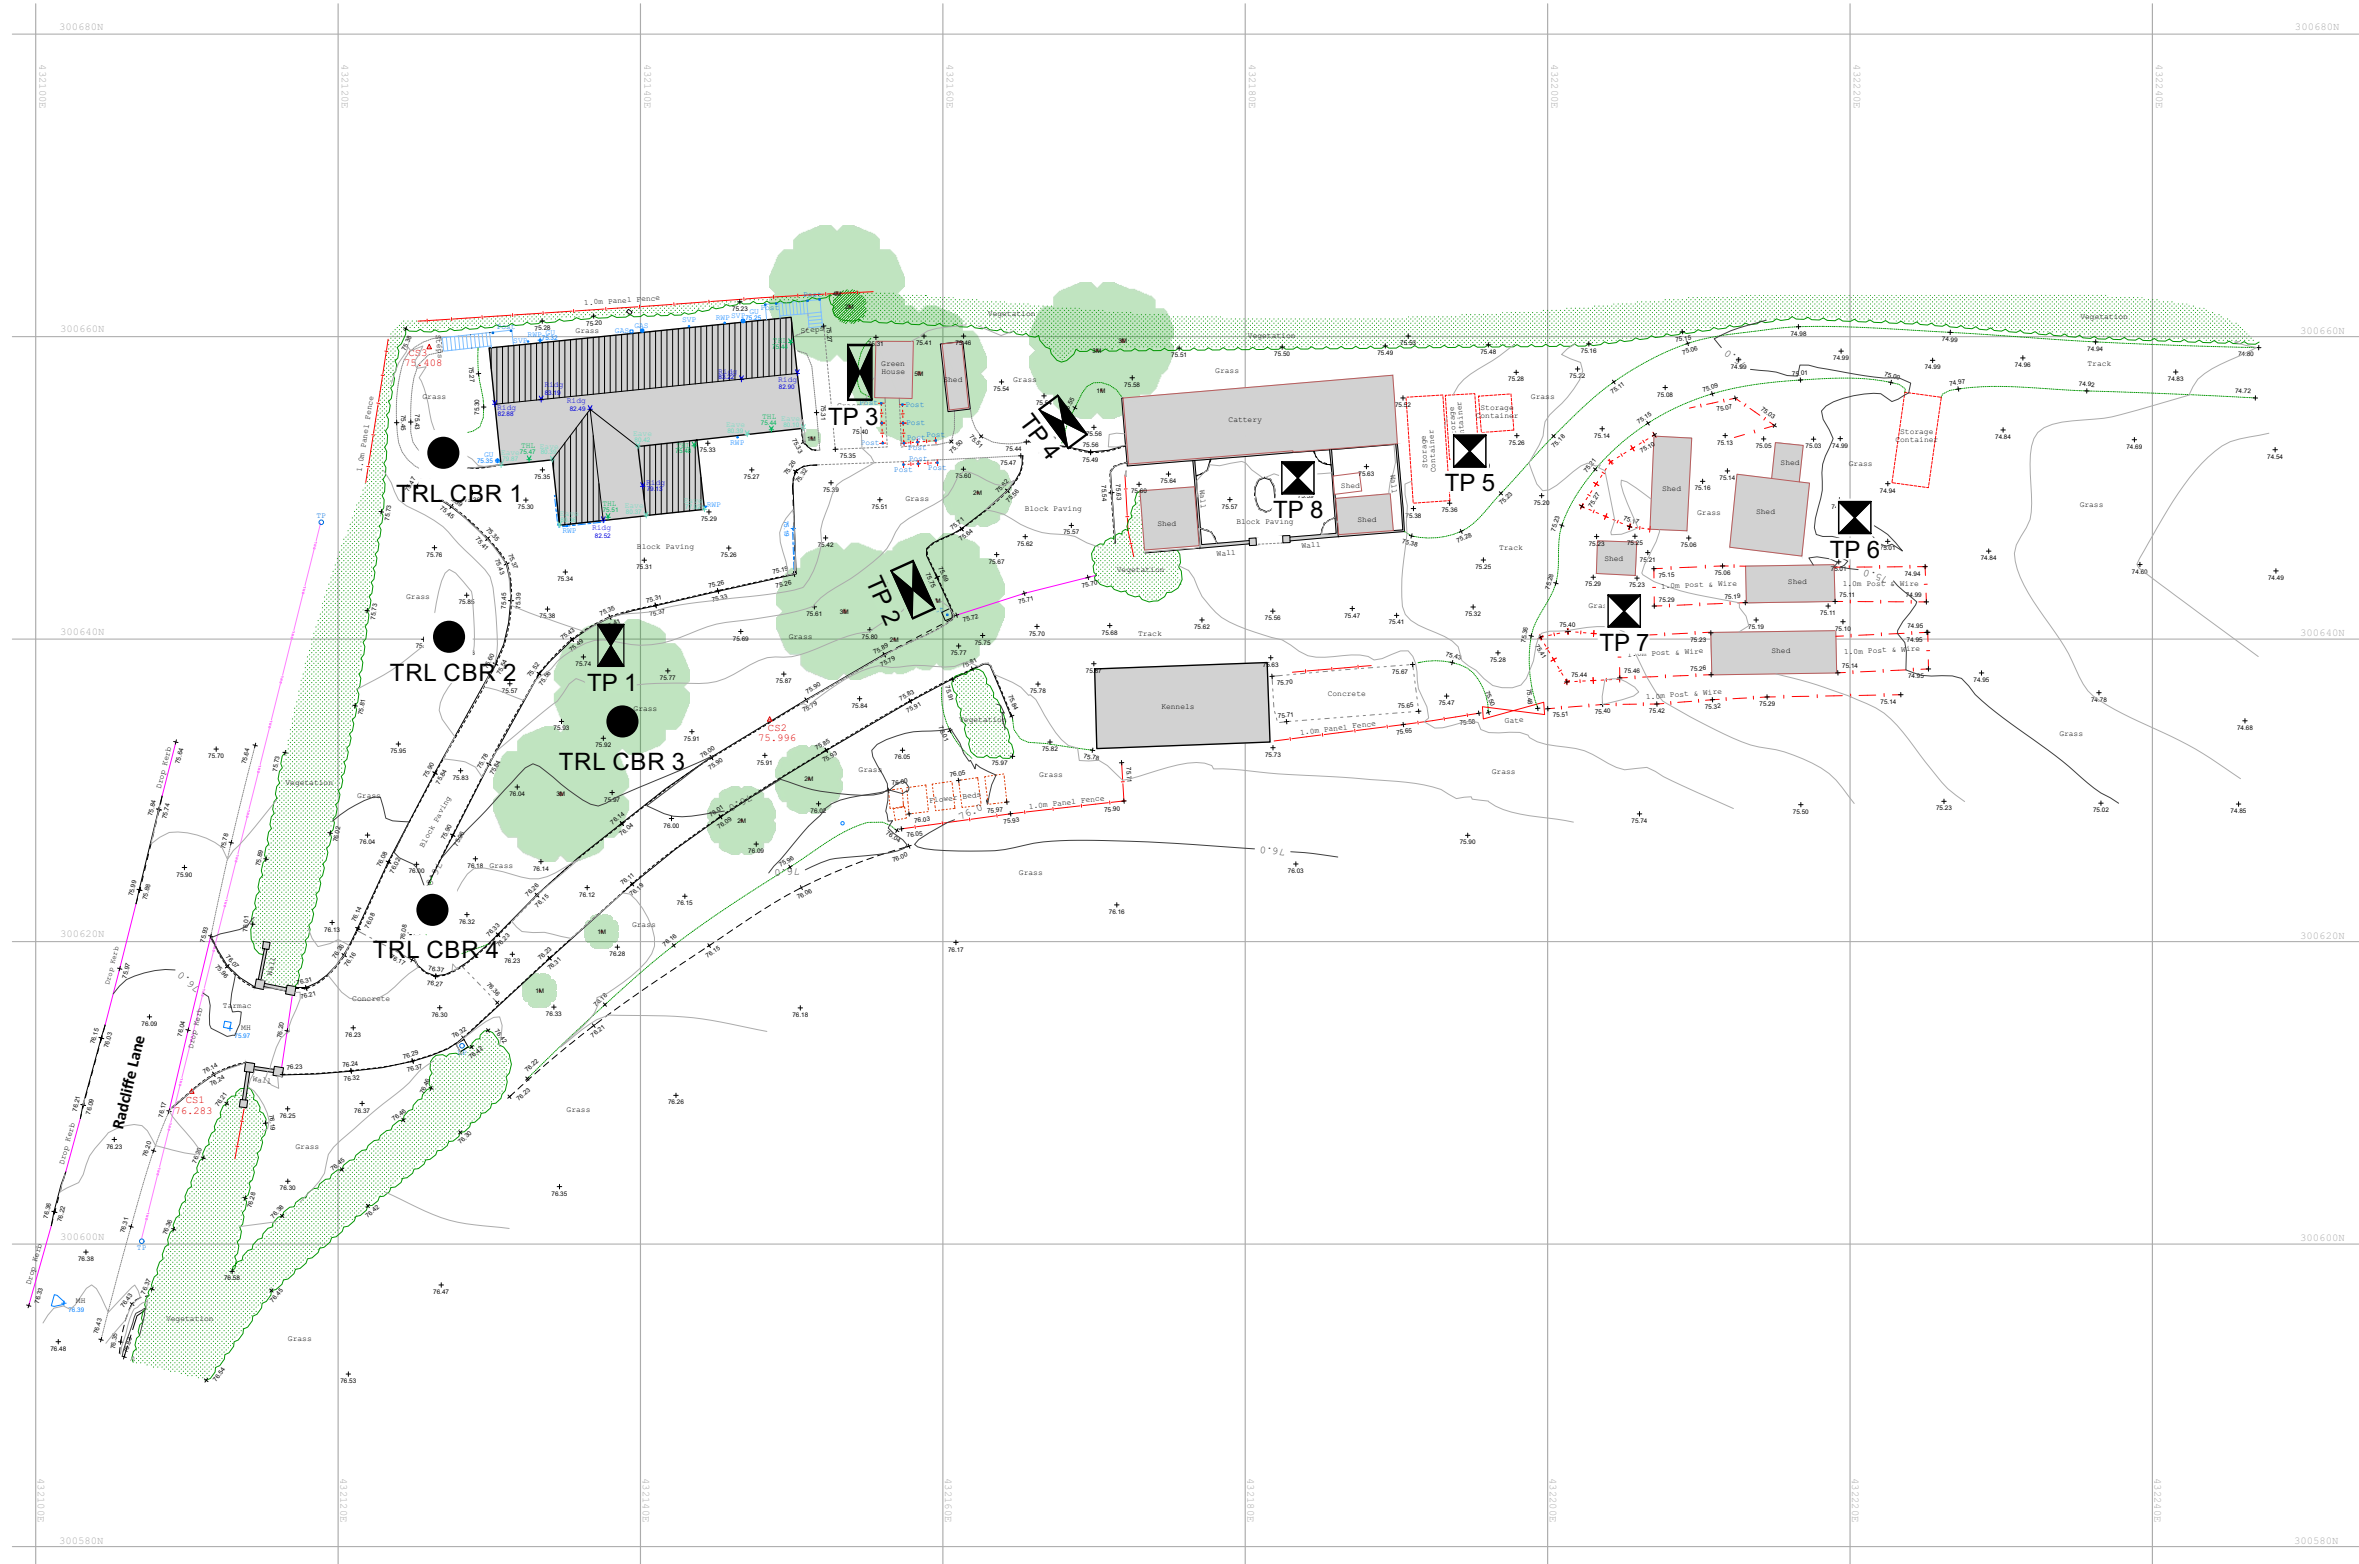
SITE LAYOUT PLAN WITH BOREHOLE LOCATIONS

The recent fieldwork comprised seven mechanically excavated trial pits (TP1 to TP7) and four TRL CBR Probes. The exploration hole locations are shown on the site layout plan, Figure 2. A soakaway test was undertaken in one of the trial pits prior to backfilling.

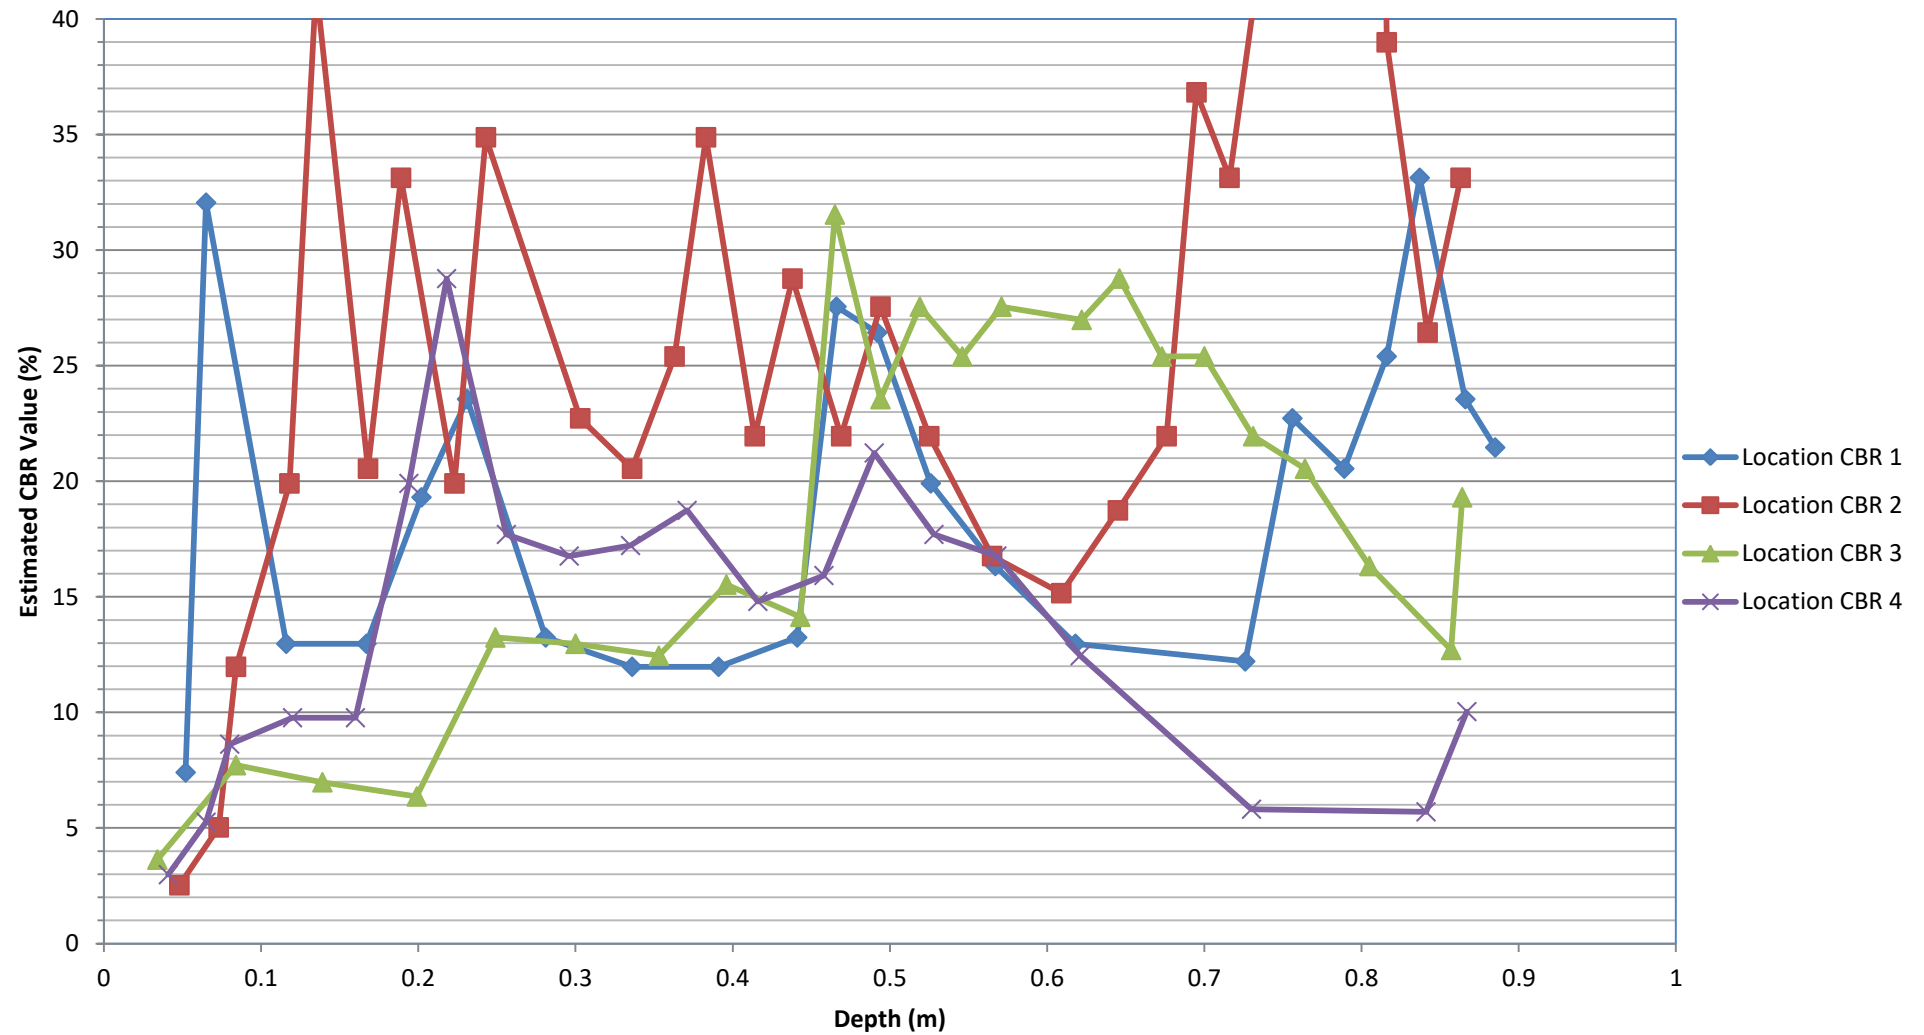
## CBR vs Depth

### TRL DCP Method

In situ TRL probe testing has been used to estimate California Bearing Ratio (CBR) values and profiles of inferred CBR are included in Appendix B.

Generally a sensible lower bound CBR value would be of the order of 5 %, which could be adopted for pavement design. The base course layer should be placed as soon as practicable after excavation. Although predominantly granular soils are anticipated near surface, if clay is present at subgrade, the profile of the subgrade should be designed such as to prevent accumulation of water in the base course and connected to suitable gravity drainage. Consideration could be given to incorporating a geotextile fabric between the base course and any clay subgrade areas to reduce the risk that softened clay contaminates the granular base course.

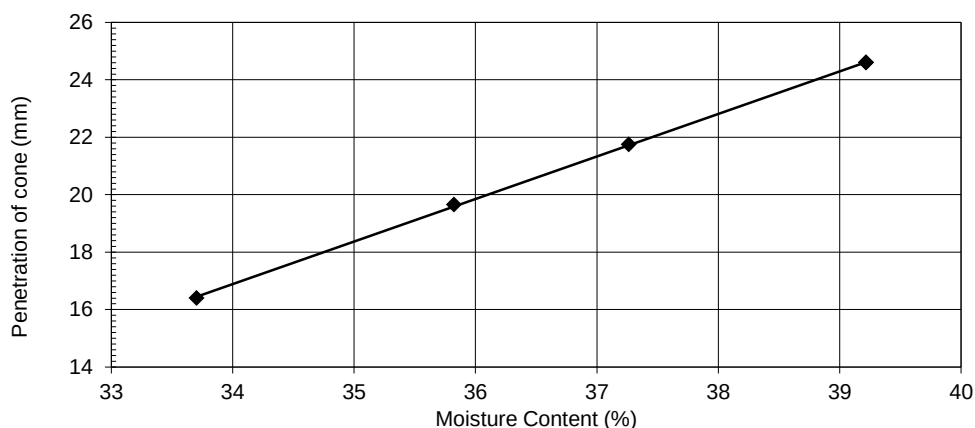
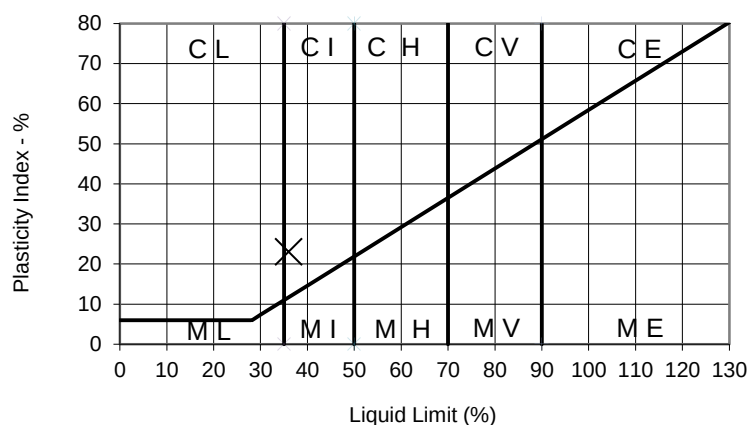
Water Content : (BS EN ISO 17892-1:2014) 14.0 %  
Estimated percentage passing 425µm sieve : 95 %  
Liquid Limit - Fall Cone 4 point Method (cone angle 30°) with increasing water content : 36 %  
Plastic Limit : 13 %  
Plasticity Index : 23 %

Equivalent Water Content of material passing 425µm sieve : 14.7 %  
Liquidity Index : 0.07

proximity to the structure and depth of foundations as well as ground conditions. Guidance on this issue can be obtained from NHBC Standards. Visual classification and testing to determine index properties suggest that the cohesive units would exhibit 'low' to 'medium' shrinkability according to the classification proposed by NHBC. However the soils are partly granular and no thick clay units were encountered. Accordingly it is considered that 'low' shrinkability may be assumed for foundation design.

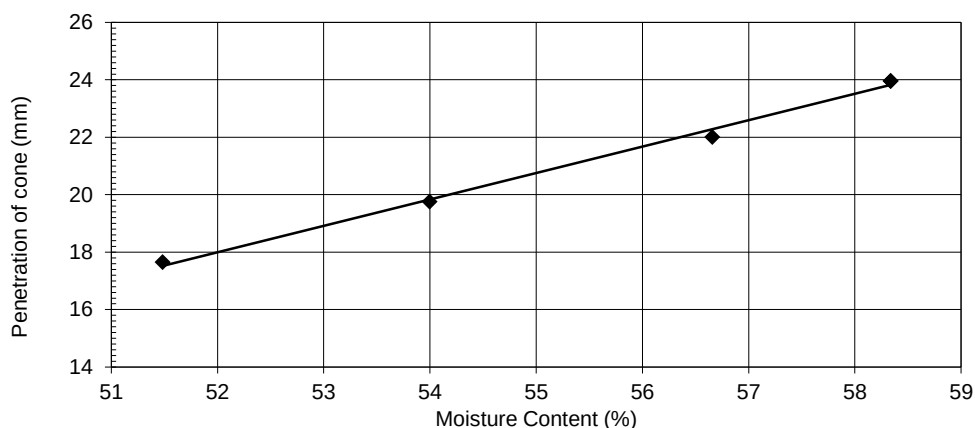
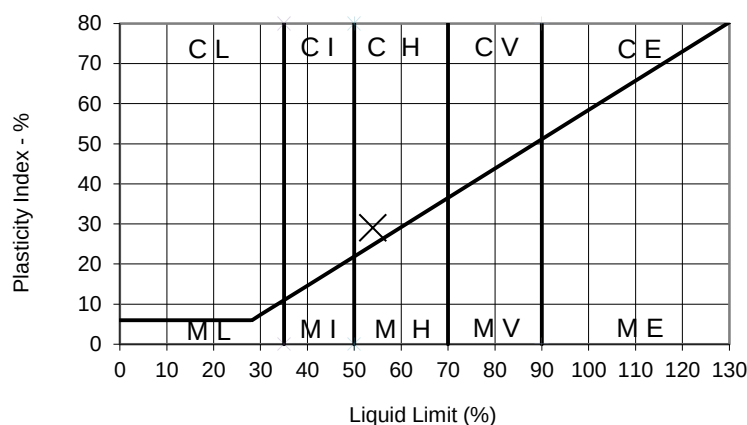
Water Content : (BS EN ISO 17892-1:2014) 16.1 %  
Estimated percentage passing 425µm sieve : 95 %  
Liquid Limit - Fall Cone 4 point Method (cone angle 30°) with increasing water content : 54 %  
Plastic Limit : 25 %  
Plasticity Index : 29 %

Equivalent Water Content of material passing 425µm sieve : 16.9 %  
Liquidity Index : -0.28

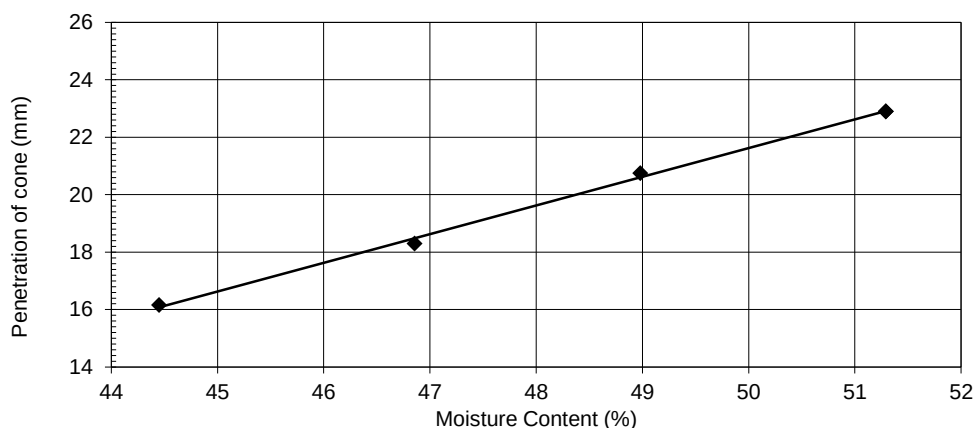
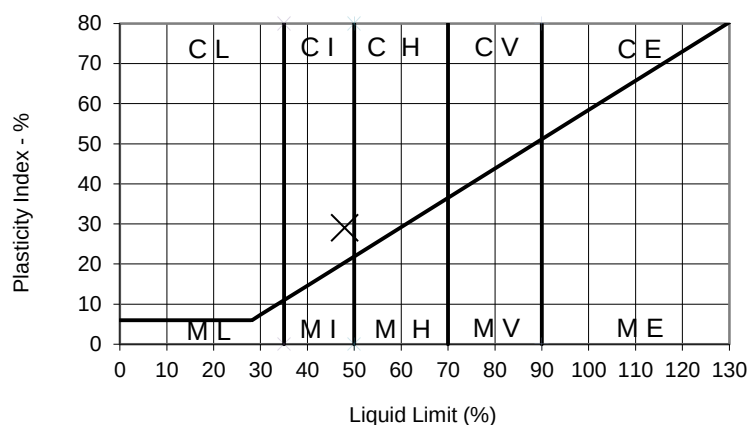
Equivalent Water Content of material passing 425µm sieve : 31.0 %

Liquidity Index : 0.41
