This Arboricultural Method Statement has been produced following a review of a fixed approved development layout for the site, based on data provided by the client. The methods of work described herein will be a requirement of all relevant contractors associated with the development proposals.

An Arboricultural Impact Assessment (AIA) was subsequently undertaken to identify the potential impact of the development on the existing trees surveyed during the PAA in accordance with British Standard 5837:2012 '*Trees in Relation to Design, Demolition and Construction - Recommendations*' (hereafter referred to as BS5837).

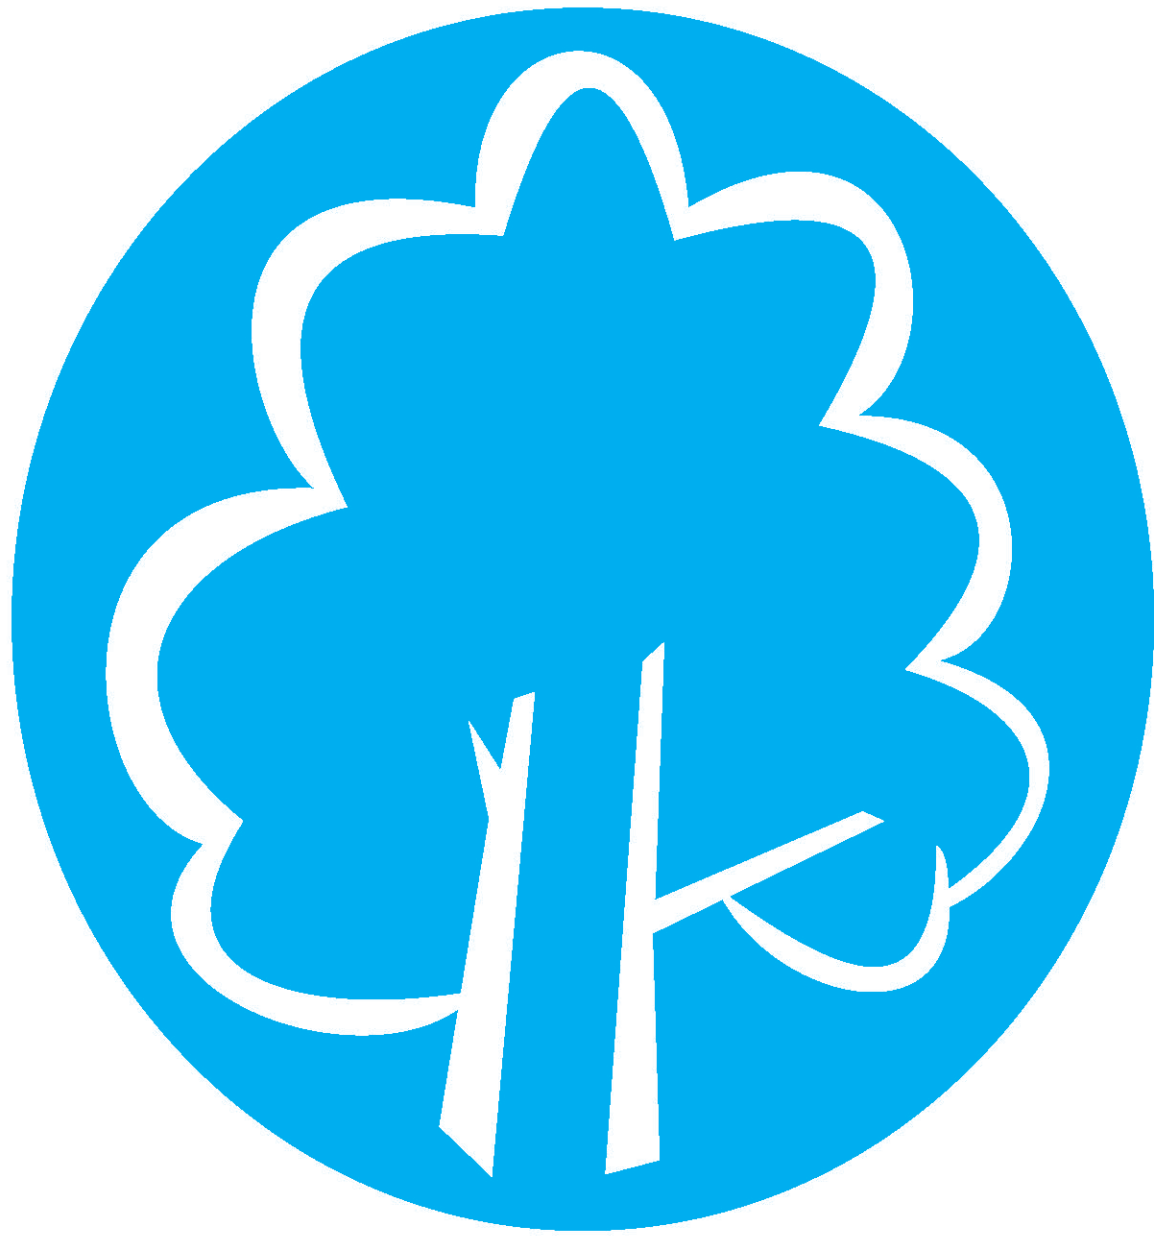
**PROTECTIVE FENCING. THIS  
FENCING MUST BE  
MAINTAINED IN ACCORDANCE  
WITH THE APPROVED PLANS  
AND DRAWINGS FOR THIS  
DEVELOPMENT.**

Protective barriers will define the Demolition Exclusion Zone (DEZ) and will be erected prior to site occupation. Signs will be installed on the barriers to inform site contractors of the importance of the tree protection measures and no works that cause physical damage to retained trees, compaction of the soil or severance of tree roots will occur within any exclusion zone. The extent of the DEZ encompasses the Root Protection Area (RPA) and / or tree canopy, whichever is the greatest.

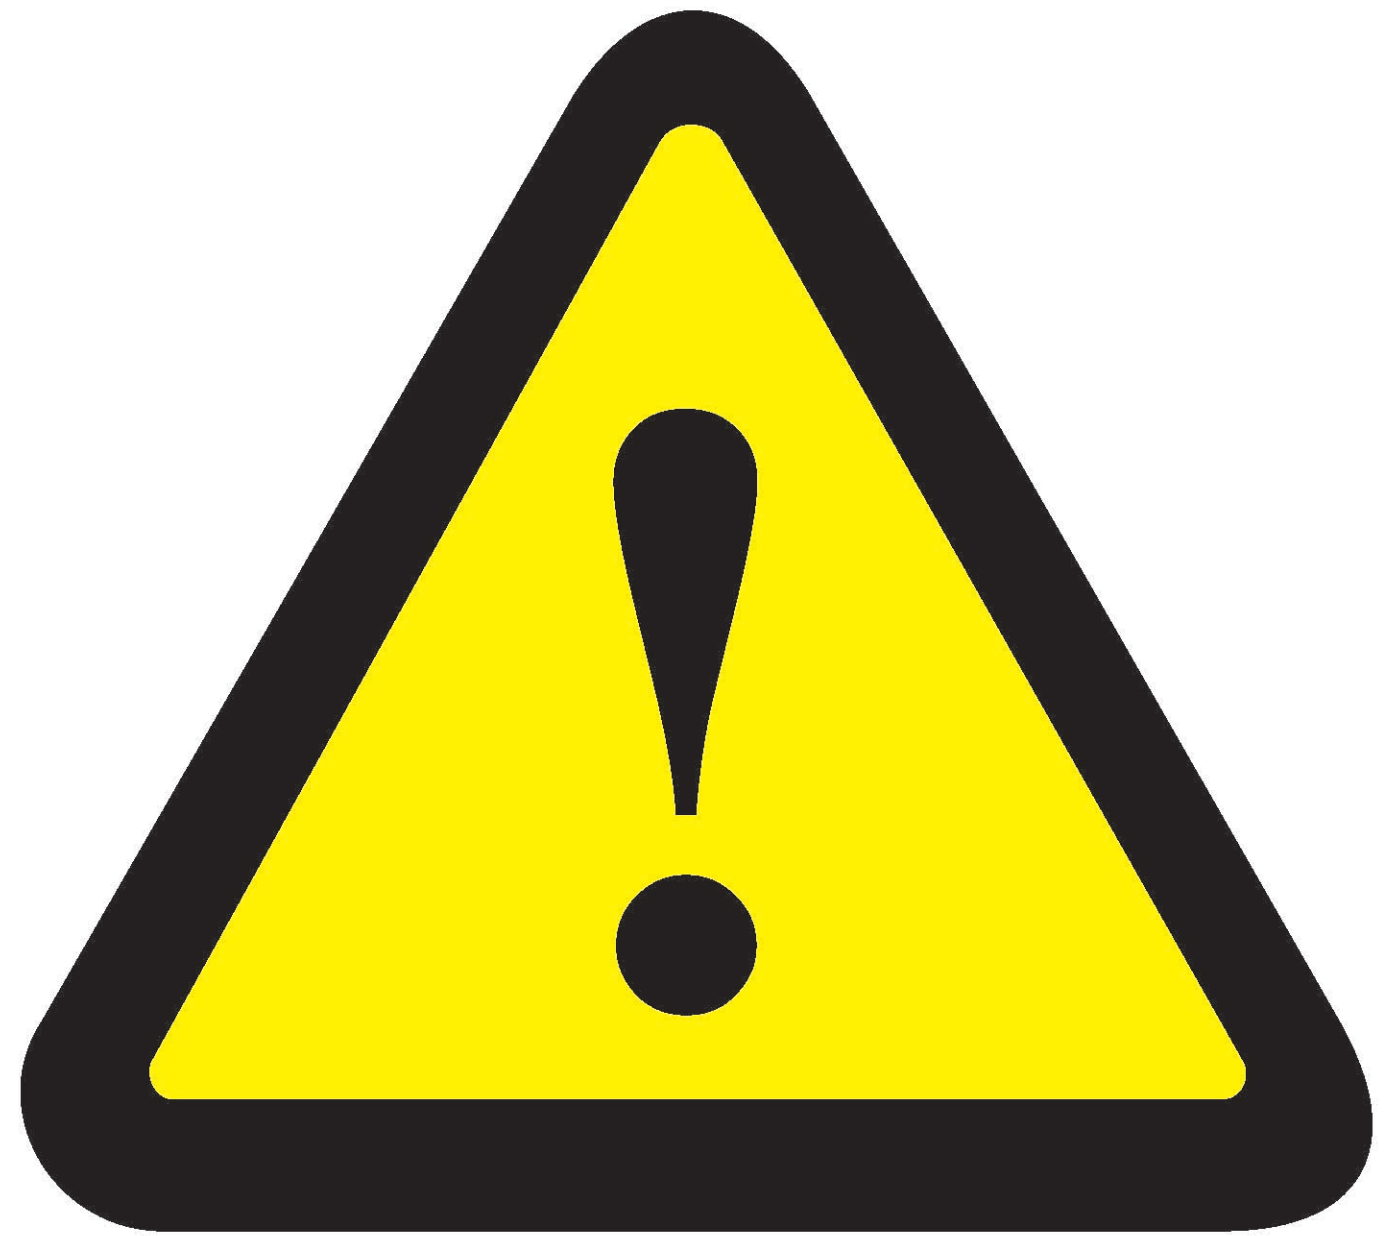
**TREE PROTECTION AREA  
KEEP OUT !**

**(TOWN & COUNTRY PLANNING ACT 1990)  
TREES ENCLOSED BY THIS FENCE ARE PROTECTED BY  
PLANNING CONDITIONS AND/OR ARE THE SUBJECTS OF A  
TREE PRESERVATION ORDER.  
CONTRAVENTION OF A TREE PRESERVATION ORDER MAY  
LEAD TO CRIMINAL PROSECUTION**
