# LAND SOUTH OF WATLING STREET, HINCKLEY

## Site Investigation & Ground Assessment

Report Ref: BEK-23005-1 (Rev C)

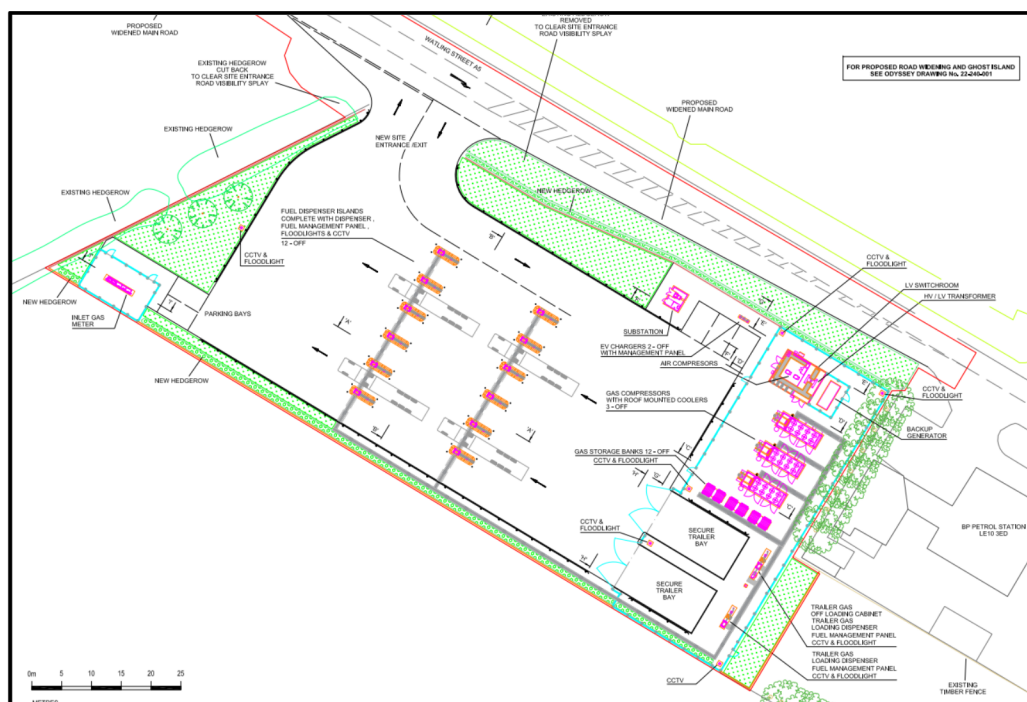
Figure 1: Site Layout Plan

1.2.2 A sketch of the proposed site plan is provided on CNG Fuels drawing 'Proposed CNG Station Site Layout Plan', a copy of which is presented in Appendix D. An extract from that drawing is presented in Figure 1:

1.2.1 The report has been prepared to support a planning application for the construction of a biomethane gas vehicle fuelling facility comprising 12 fuelling islands. Infrastructure including gas storage banks, compressors and backup generator are proposed to be located on the eastern boundary. The site will be predominantly hard surfaced, however, landscaping will be added on raised islands between the site and the A5 and on the northern boundary.

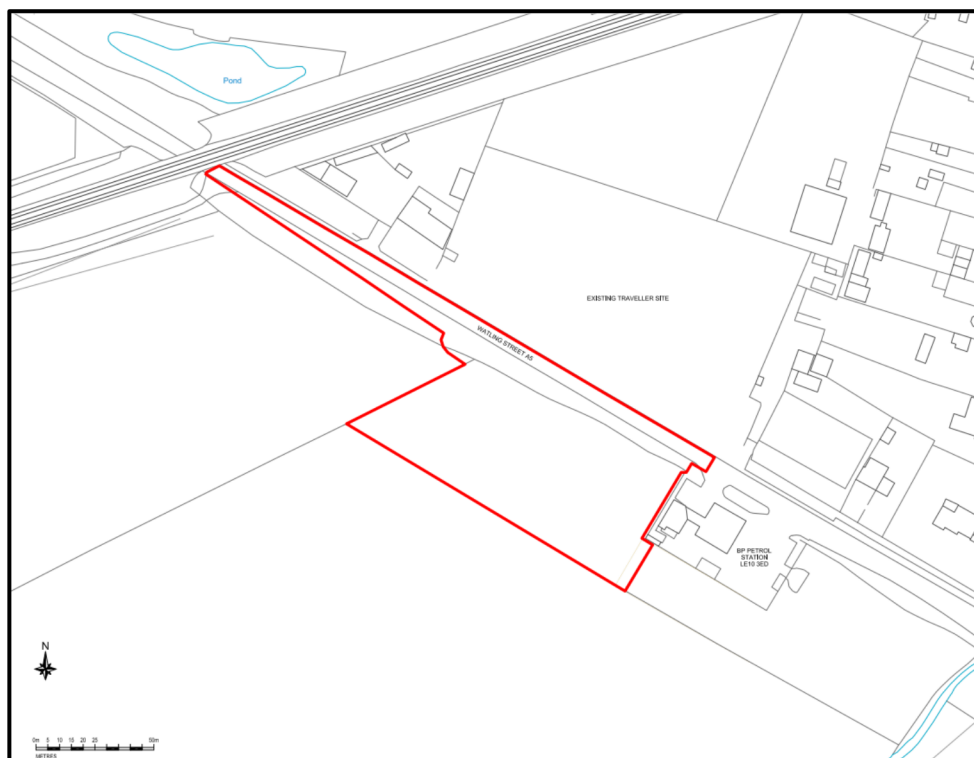
**Figure 2: Site Boundary (Red) and Surrounding Area**

2.1.1 The site is located on the A5 approximately 2.6 km south-west of Hinckley and 760 m south-west of the A5/A47 junction. The grid reference is 440080 292977. Surrounding the site is predominantly agricultural fields to the south and industrial/warehouses to the north. Immediately to the east is a petrol filling station, served by separate access from the A5. An industrial estate containing an electrical substation and infrastructure for the National Grid is located further east of the petrol station.

2.1.3 The site is shown within Figure 2 below.

2.1.2 The site currently forms part of a wider greenfield plot currently comprising flat grassland that is understood to be used for grazing.

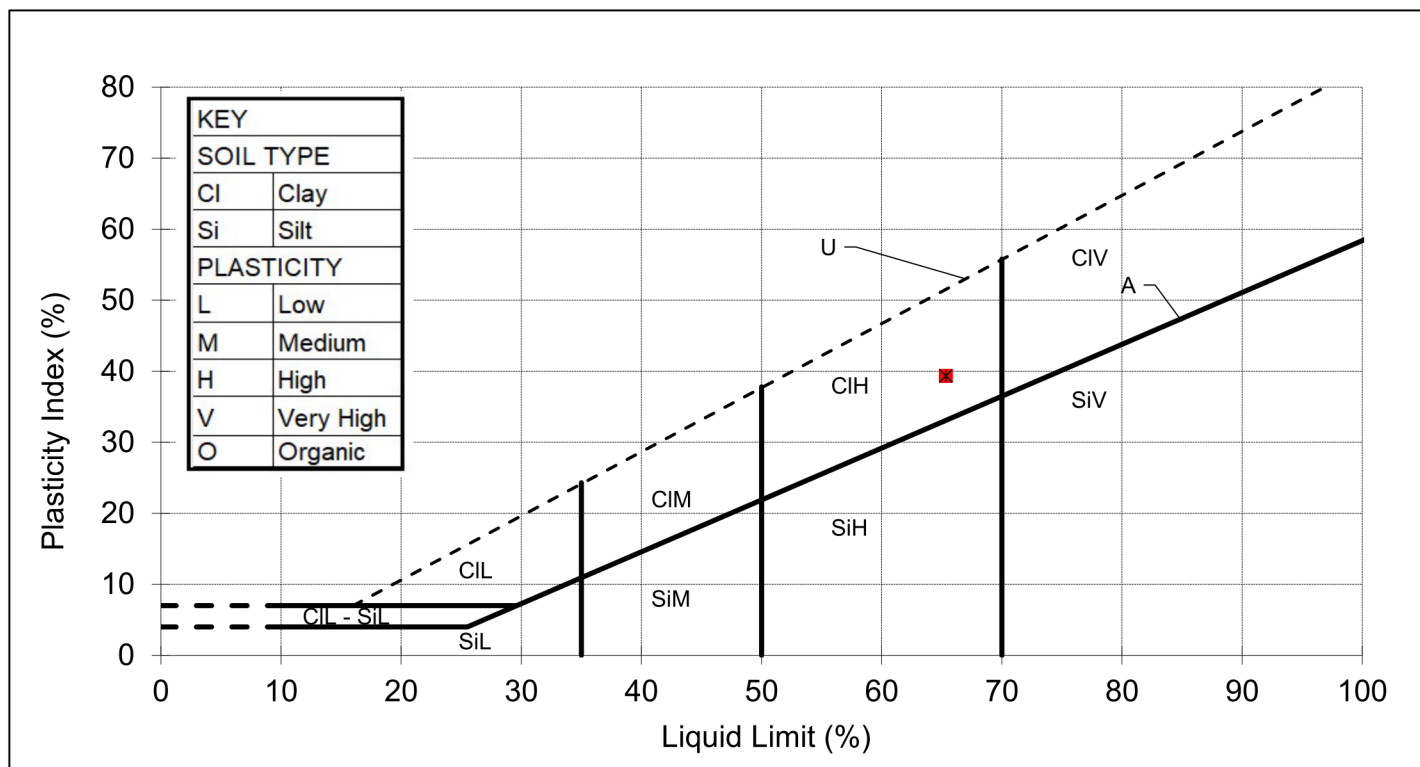
| Natural Moisture Content (%) | Liquid Limit (%) | Plastic Limit (%) | Plasticity Index (%) | Passing 425 micron (%) |
|---|---|---|---|---|
| 28.9 | 65 | 26 | 39 | 100 |

- 5.5 Clay samples were taken from borehole WS1, WS3 & WS7. Atterberg testing was undertaken in the laboratory conditions to determine the plasticity index of the clay. The result is presented in Appendix C. The modified plasticity index for the sample was calculated in accordance with NHBC guidance and summarised in Table 5 below.

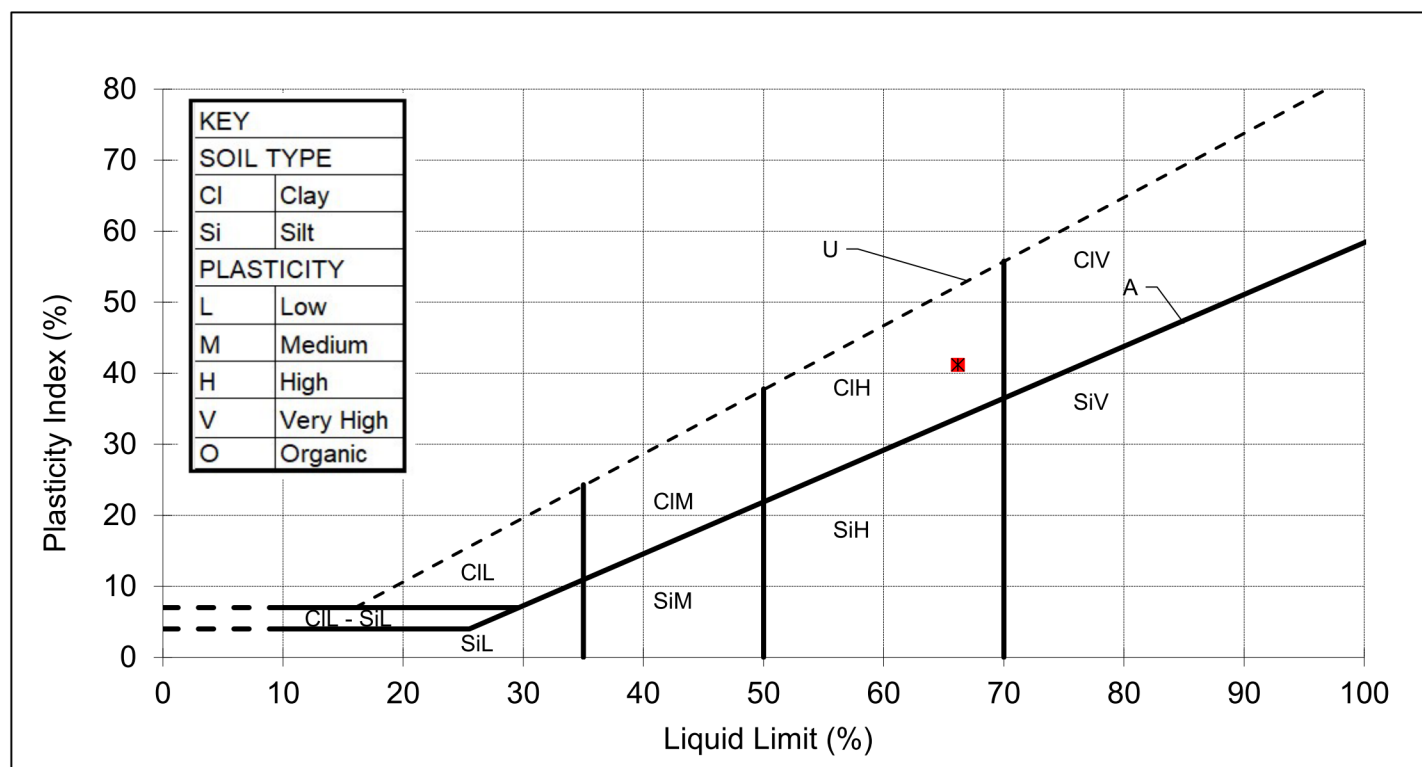
| Natural Moisture Content (%) | Liquid Limit (%) | Plastic Limit (%) | Plasticity Index (%) | Passing 425 micron (%) |
|---|---|---|---|---|
| 29.8 | 66 | 25 | 41 | 100 |

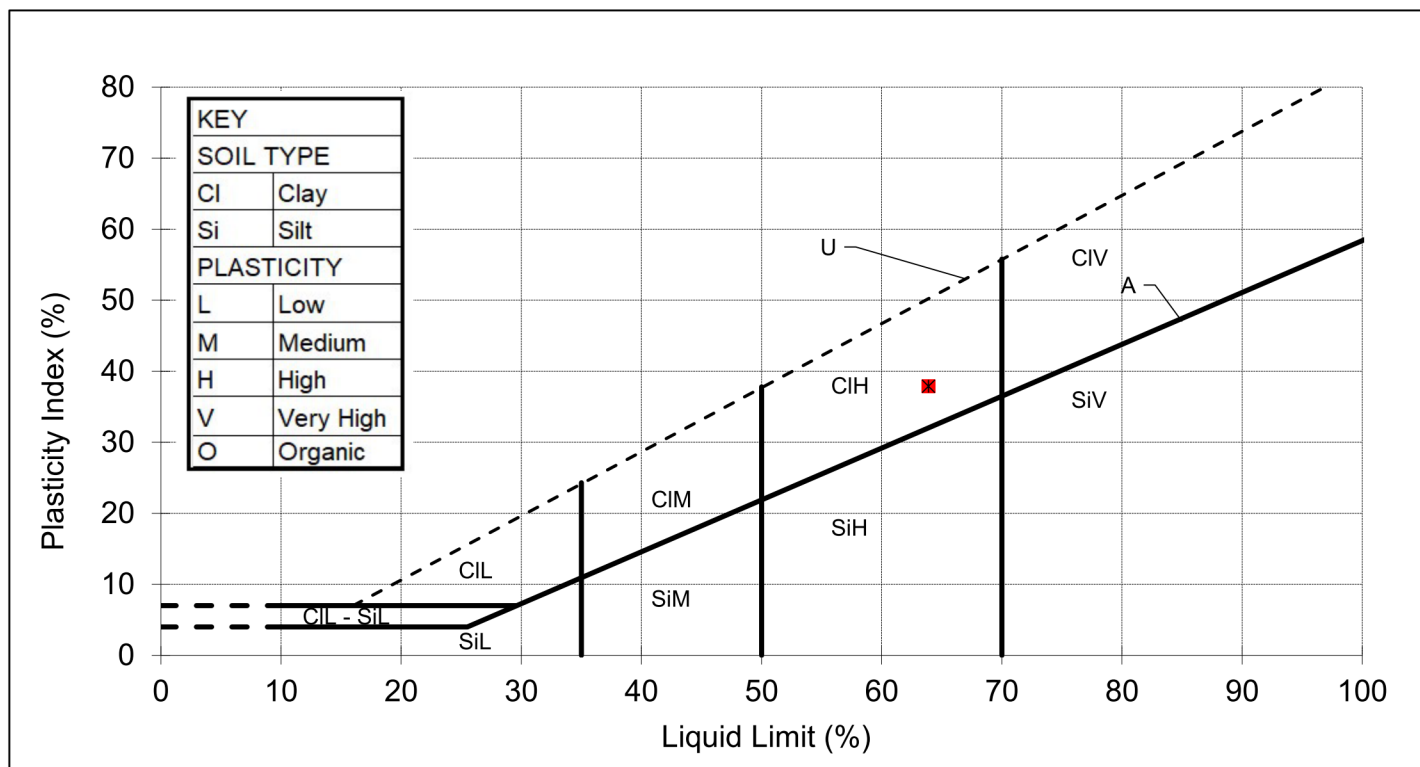
| Natural Moisture Content (%) | Liquid Limit (%) | Plastic Limit (%) | Plasticity Index (%) | Passing 425 micron (%) |
|---|---|---|---|---|
| 29.8 | 64 | 26 | 38 | 100 |

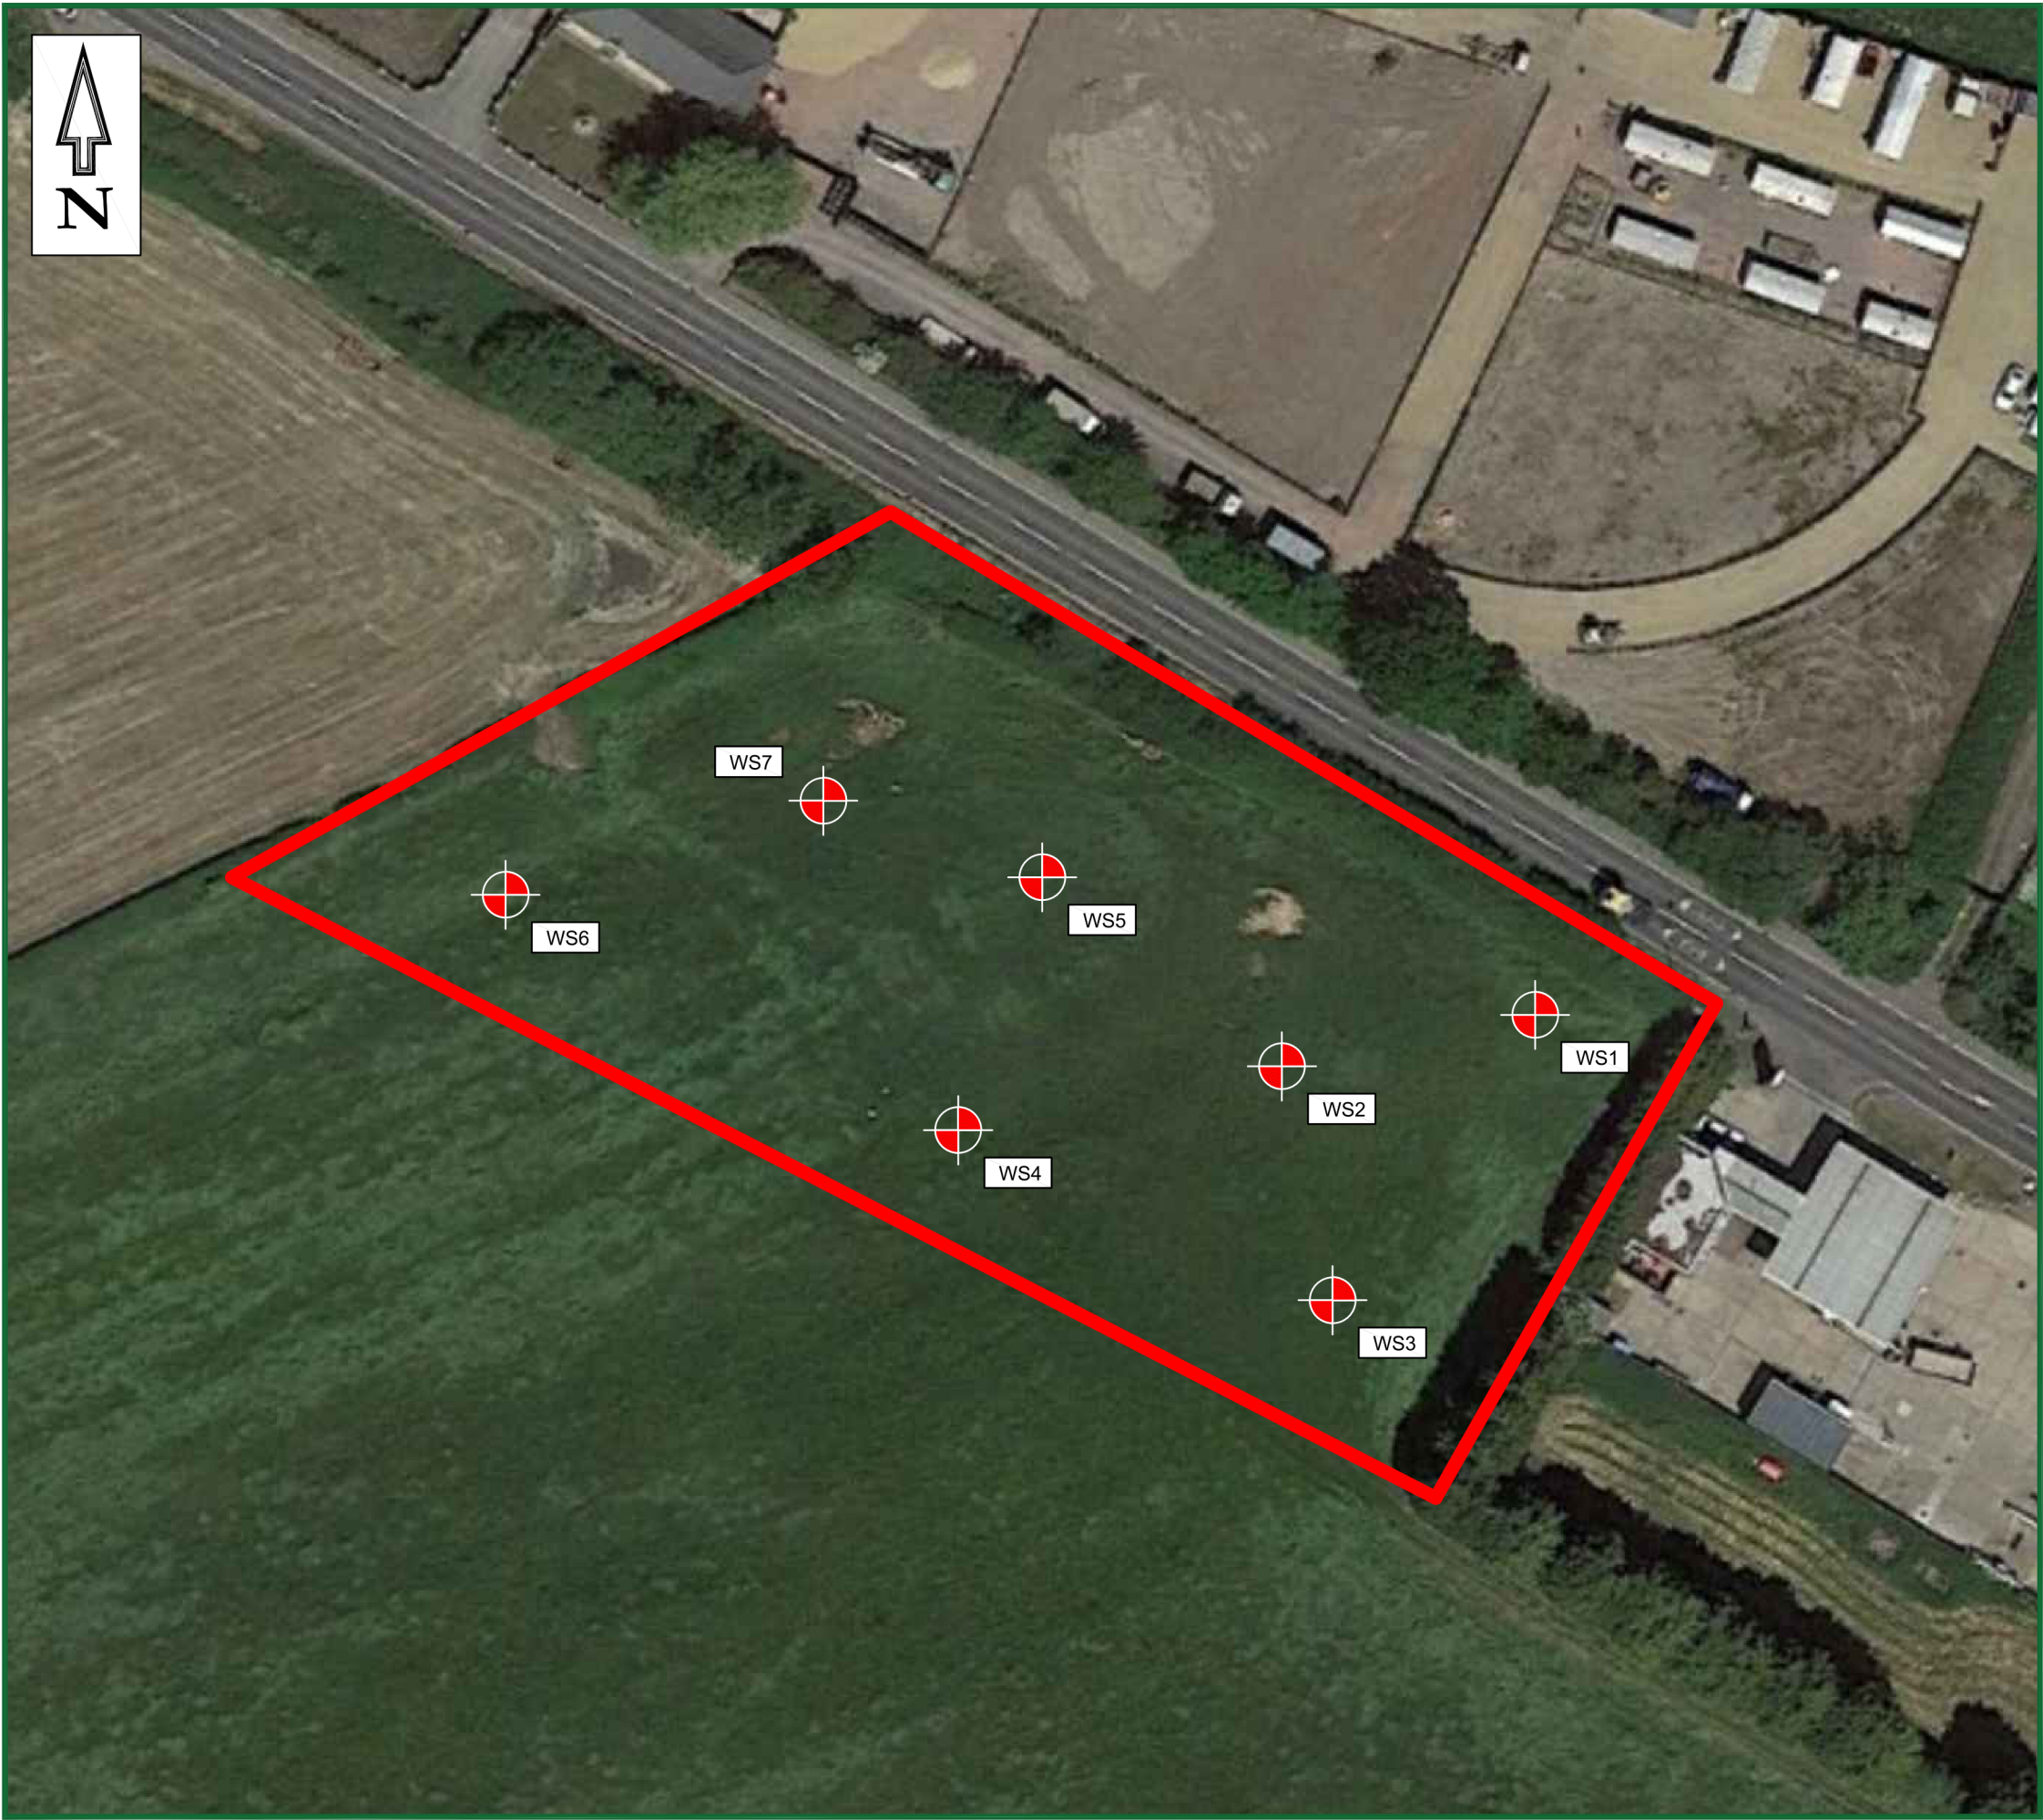
| DRAWING No.<br>23005-3 | REV.<br>- | | |

3.1.3 All exploration locations were set out by the site engineer and the exploratory locations are illustrated on BEK Drawing No 23005-3 presented in Appendix D.

INFILTRATION TEST LOCATION

3.2.1 Seven window sample boreholes were drilled using a window sample borehole rig to a maximum depth of 5.45 m. Borehole locations were set out by the site engineer in order to establish representative conditions at the site. In-situ testing (SPTs) were carried out in each of the boreholes.

3.3.1 Soakaway testing (to BRE365) was carried out at 2 locations to determine percolation rate and the possible use of soakaways for surface water drainage.
