GRM Development Solutions Ltd  
Laurus House  
First Avenue  
Centrum 100  
Burton upon Trent  
Staffordshire  
DE14 2WH

**RE: Markfield Road, Ratby – Interim Remediation Completion Report**

| | TITLE: | REMEDIATION PLAN | | | | | | | | |

**Supporting Photographs – Soil  
Management**

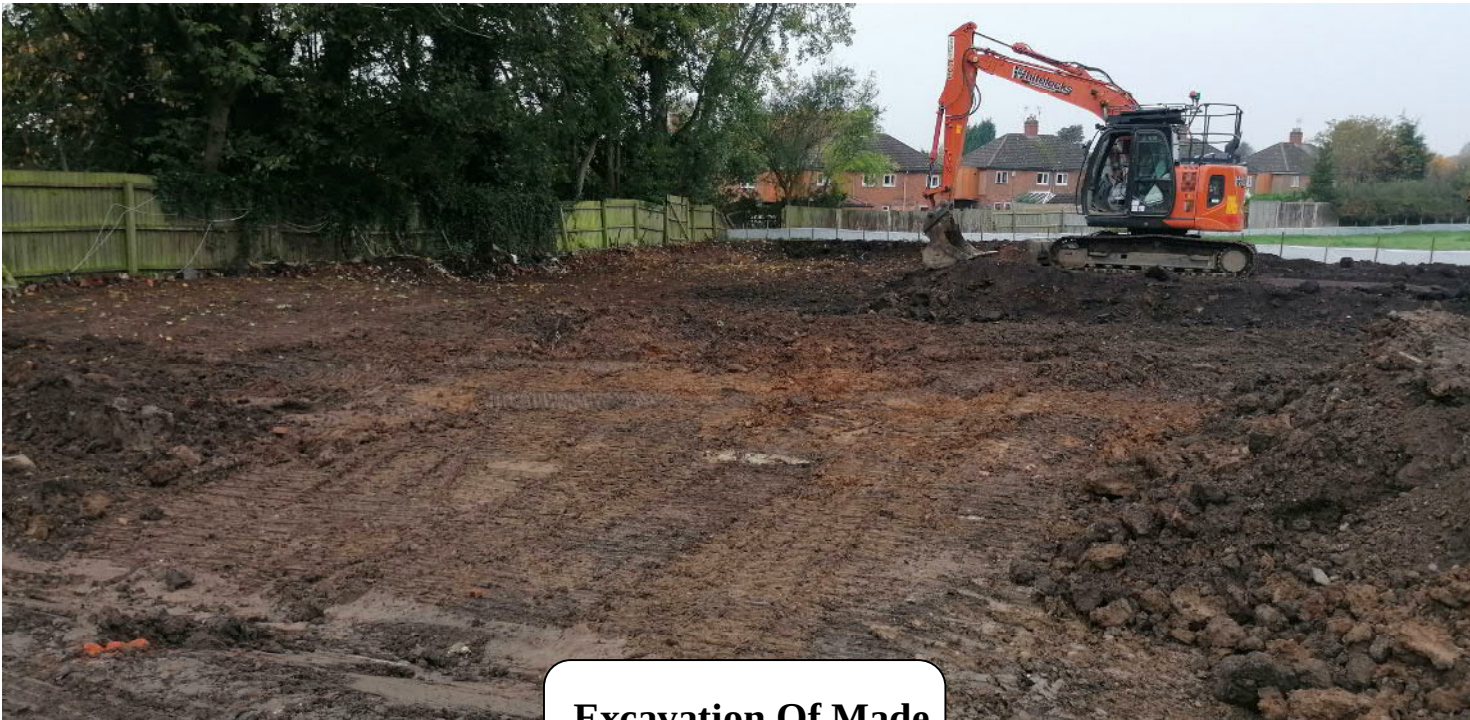
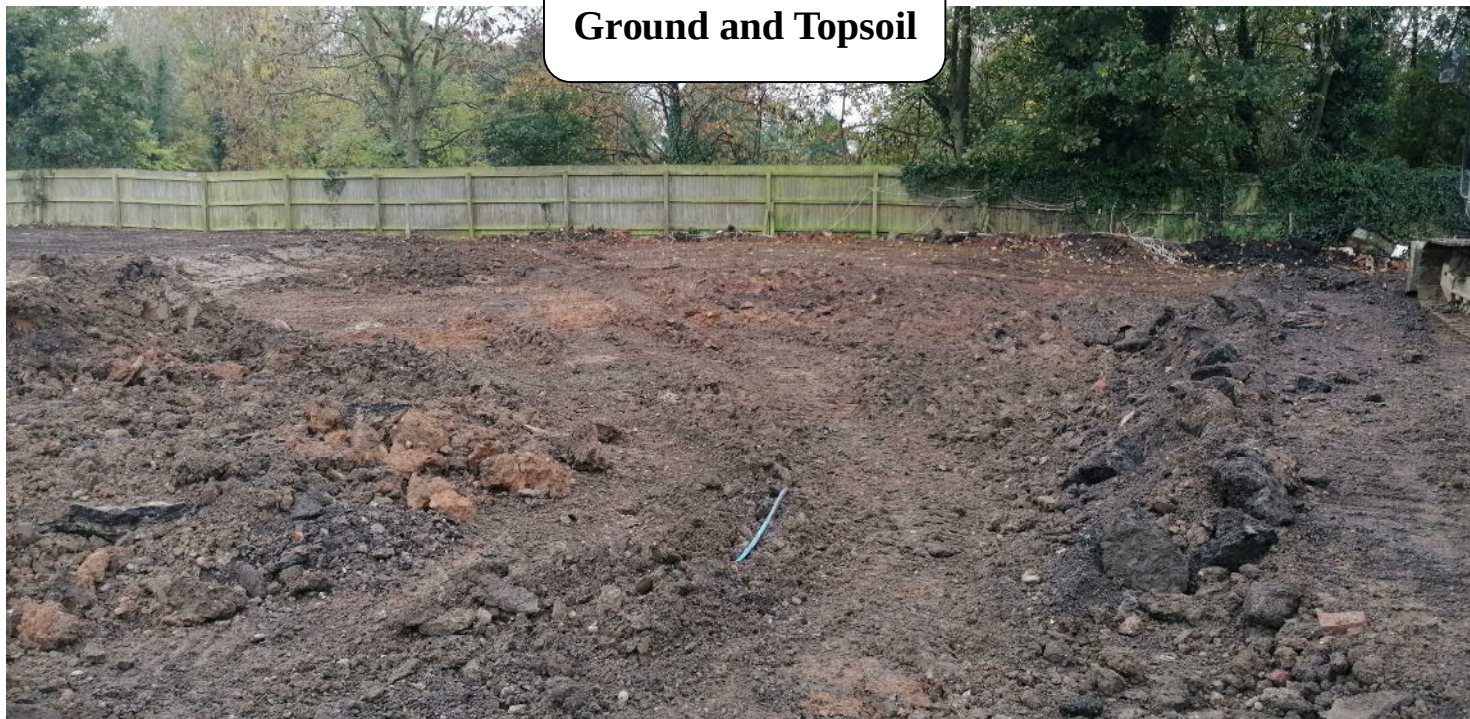
1

**Excavation Of Made  
Ground and Topsoil**

The excavation of the made ground and buried topsoil, and the introduction of the made ground into the main designated area, was undertaken in October 2020, GRM undertaking part time monitoring of the works to inspect the base of the excavation, ensure that all materials had been removed and relocated as necessary. Supporting photographs are presented in Appendix B.

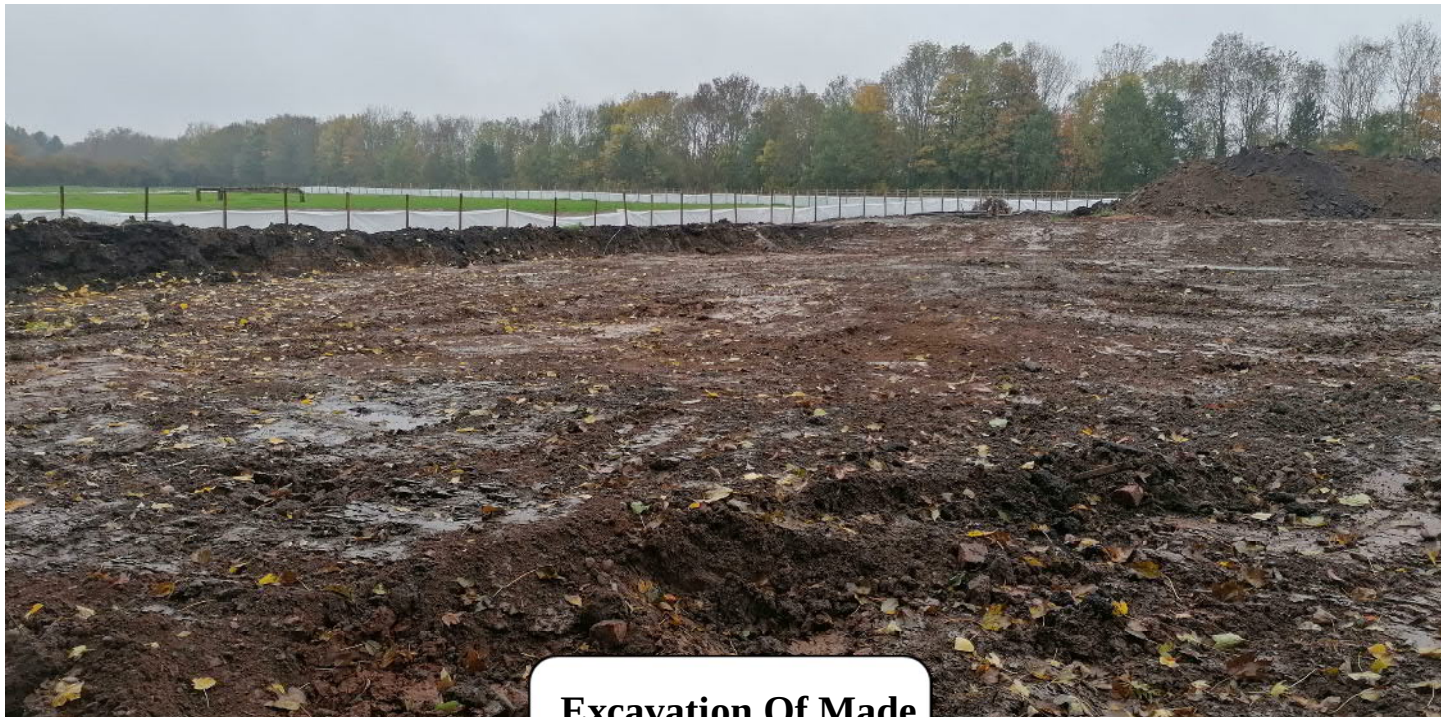
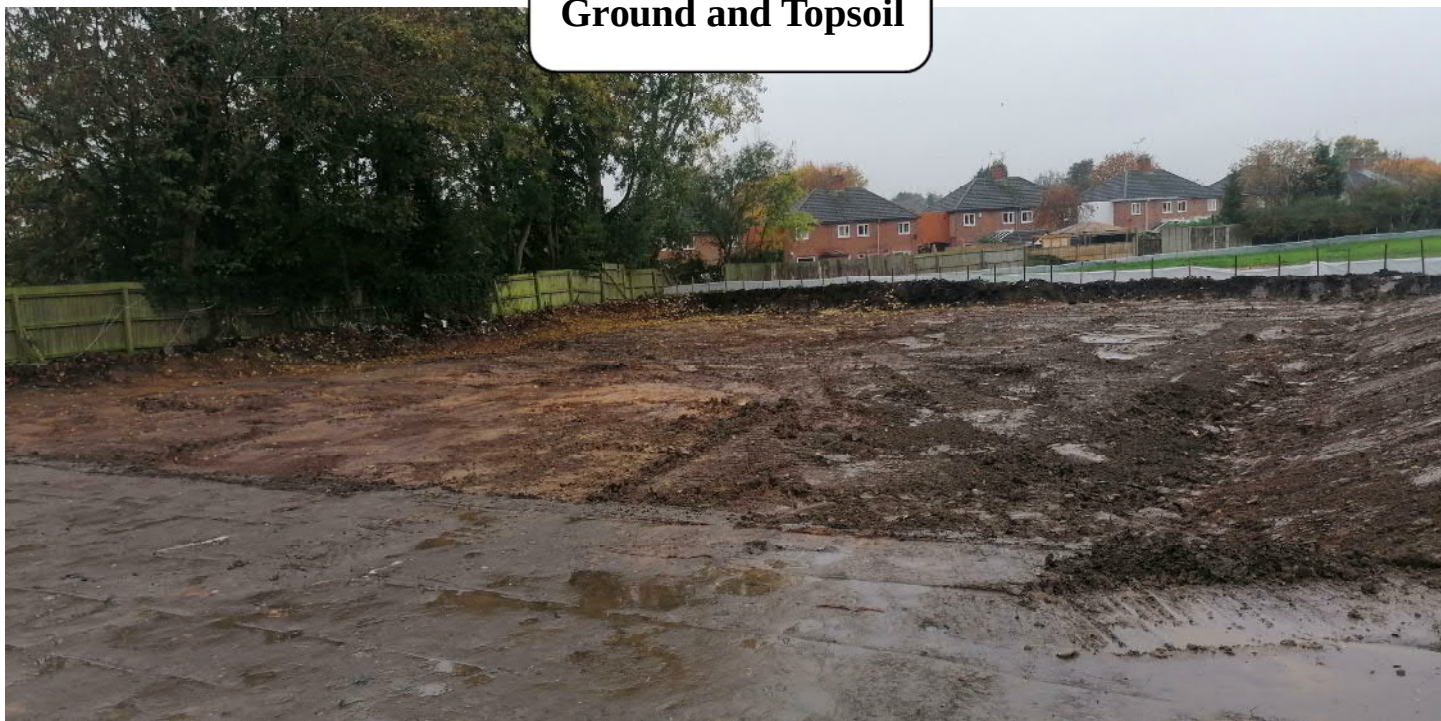
2

**Excavation Of Made  
Ground and Topsoil**

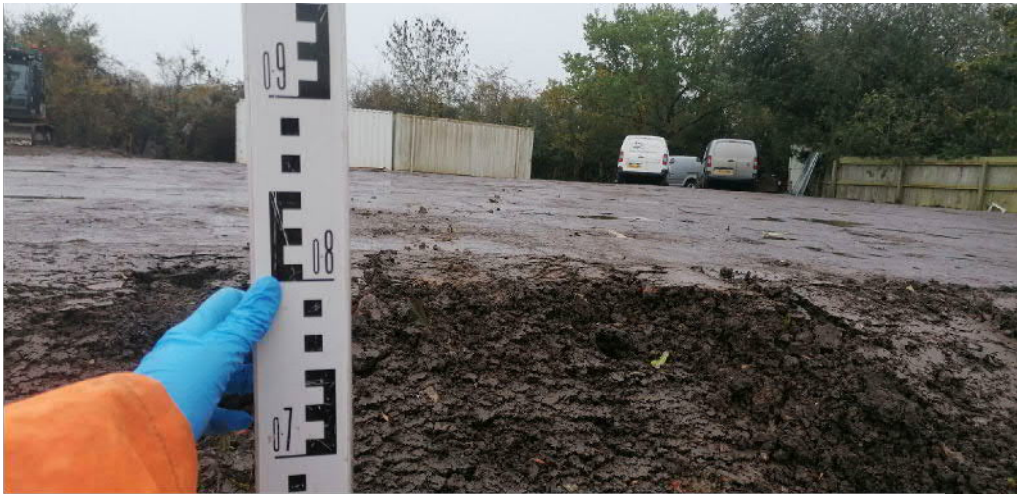
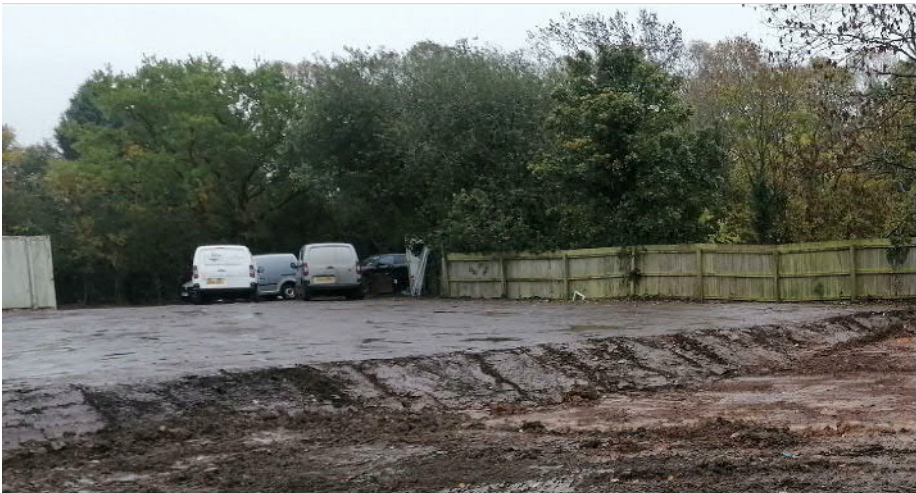
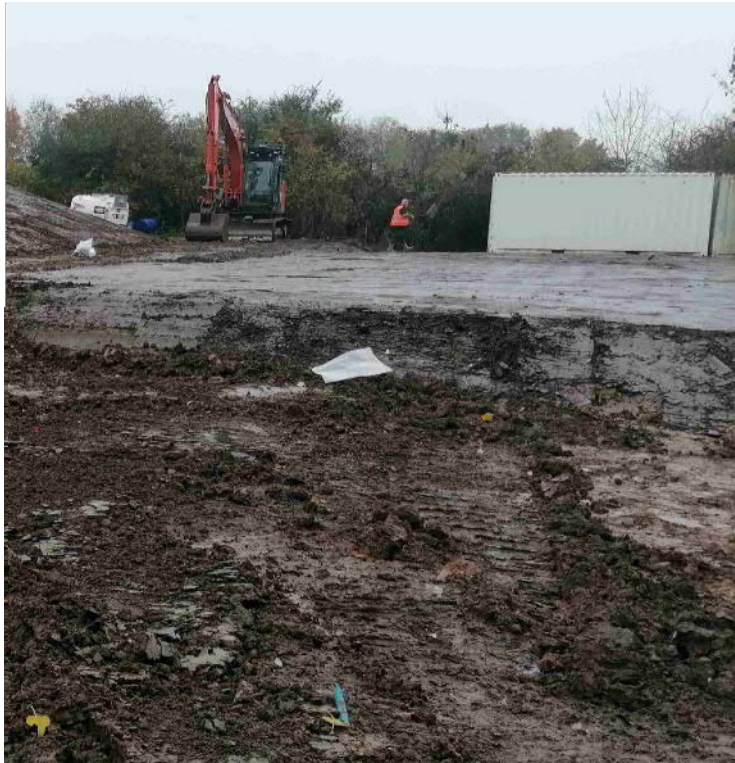
| P9347 | 3 |

# Re-Introduction Of Made Ground

Once the made ground and topsoil had been removed, as much of the made ground as possible was re-introduced into the part of the excavation that was to be covered with POS; the remainder of the excavation was filled with clean site won arisings from roads and sewers excavations. Due to the volume of the made ground, and proposed finished levels, not all of it could be re-introduced into the designated part of the excavation, and so the surplus was placed in the other designated area of POS to the north, this being completed by January 2021.

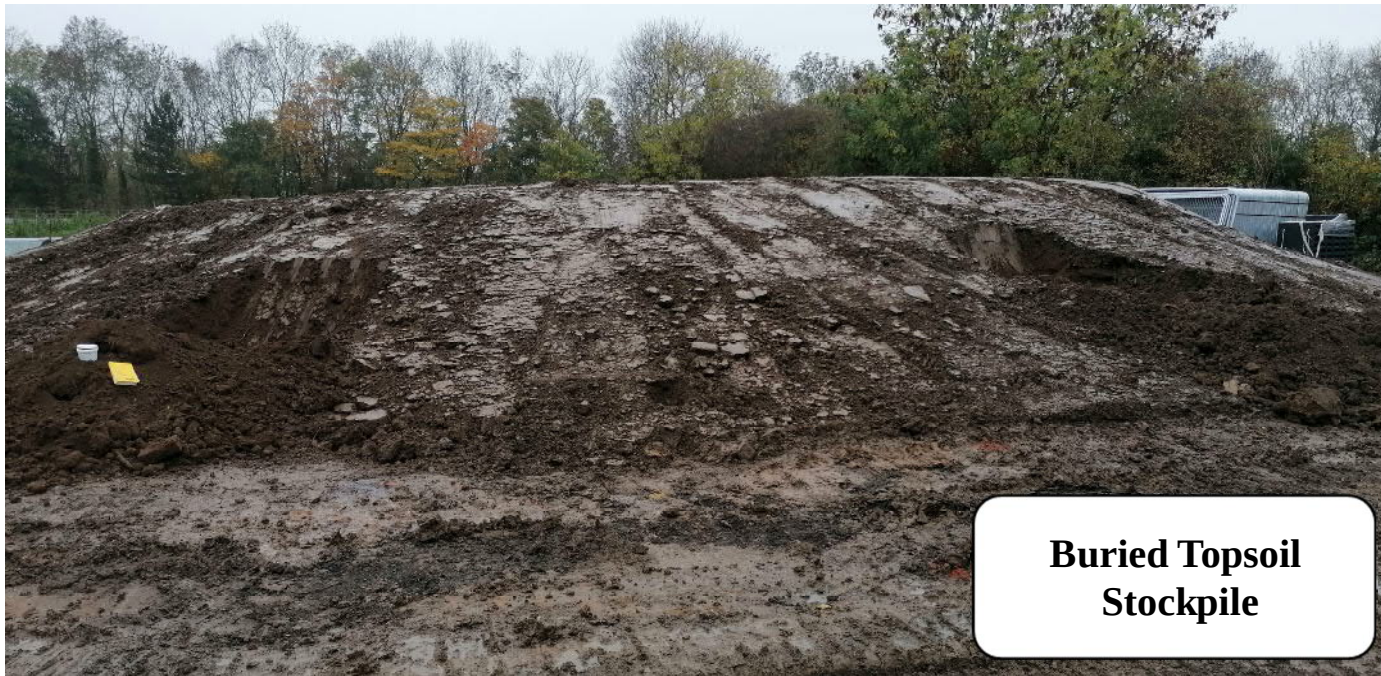
**Buried Topsoil  
Stockpile**

The made ground and buried topsoil were stockpiled separately in an area to the north of the main works area.

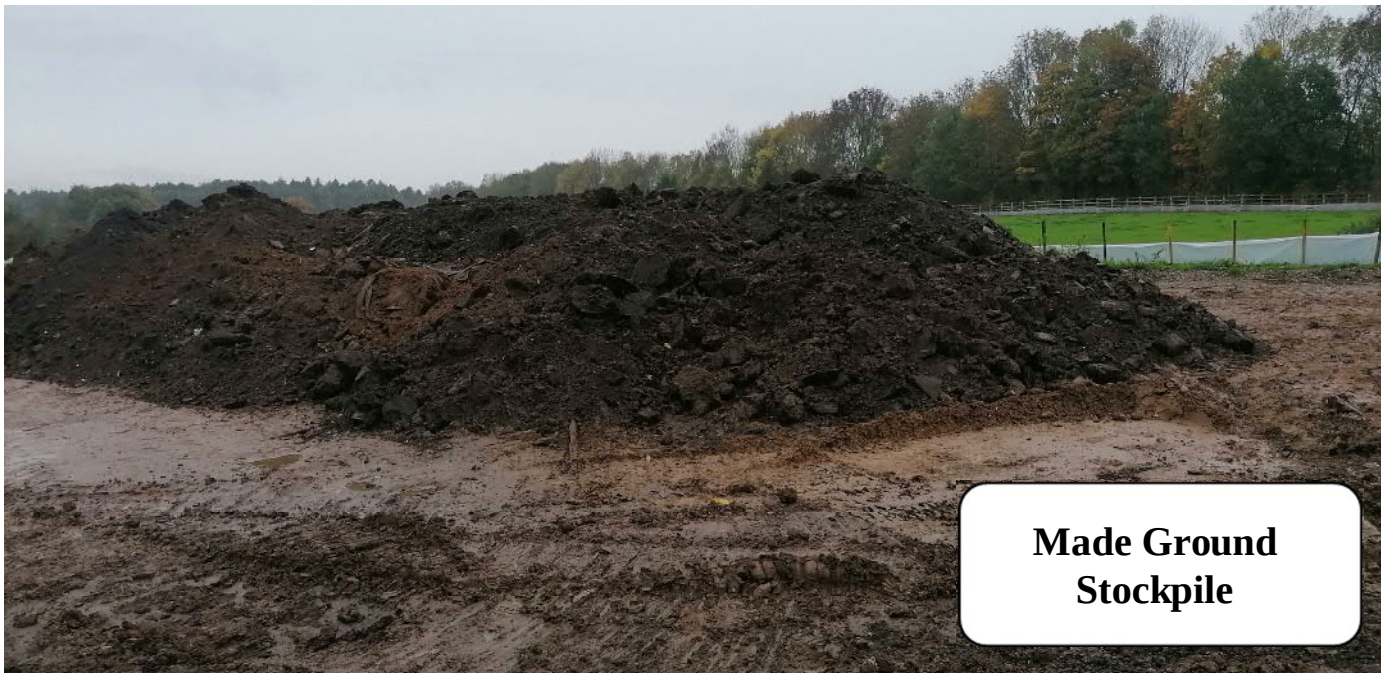
**Made Ground  
Stockpile**

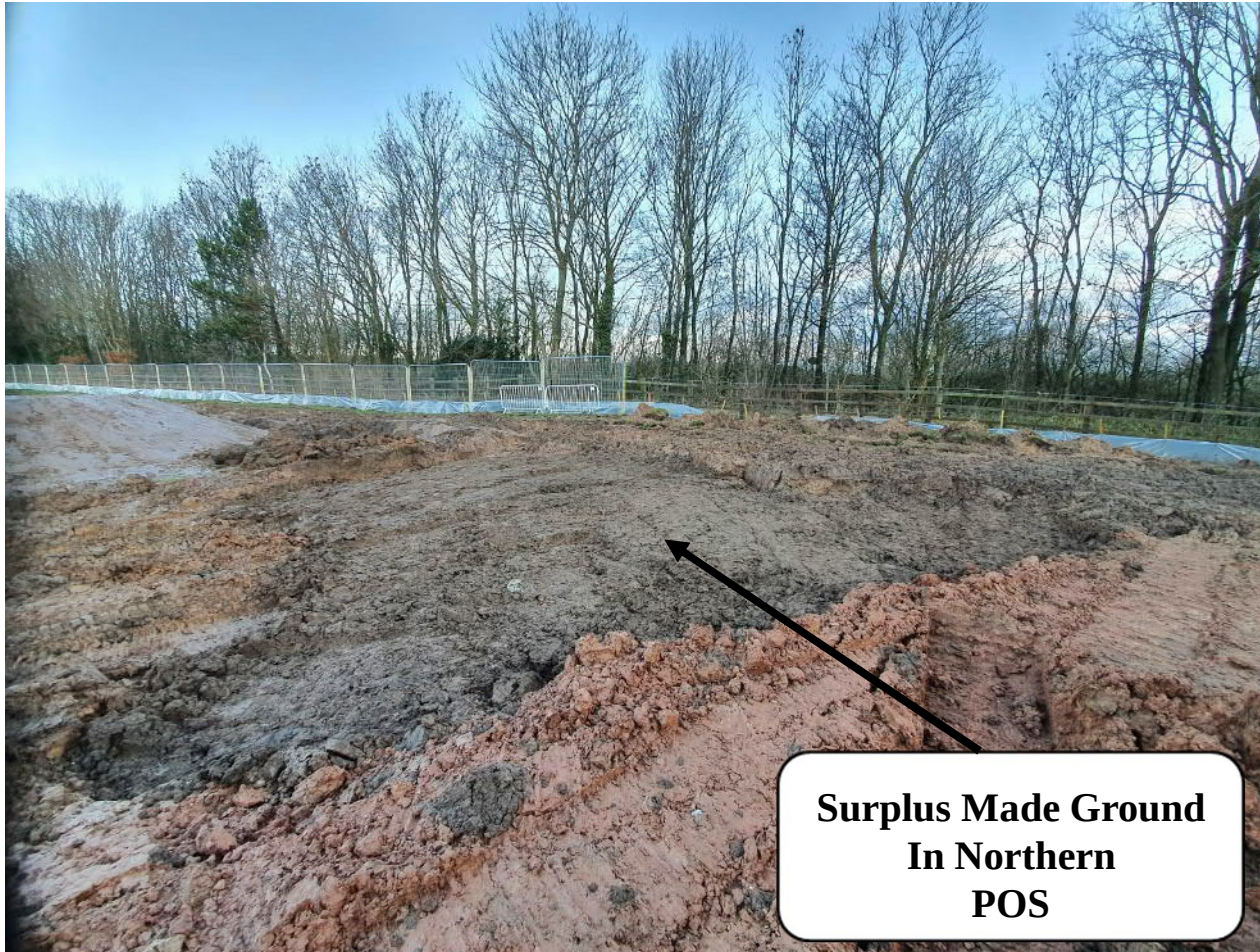
5

**Surplus Made Ground  
In Northern  
POS**

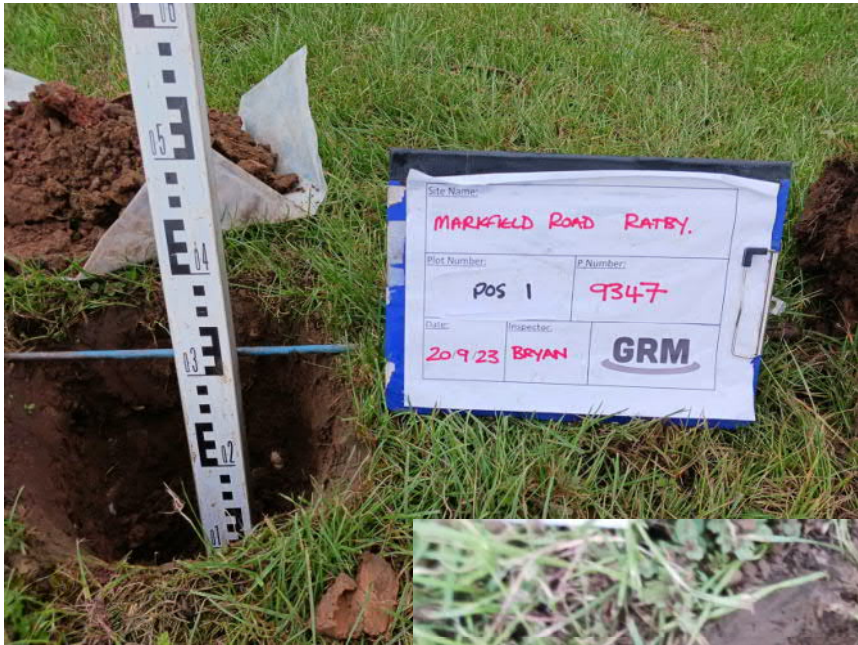
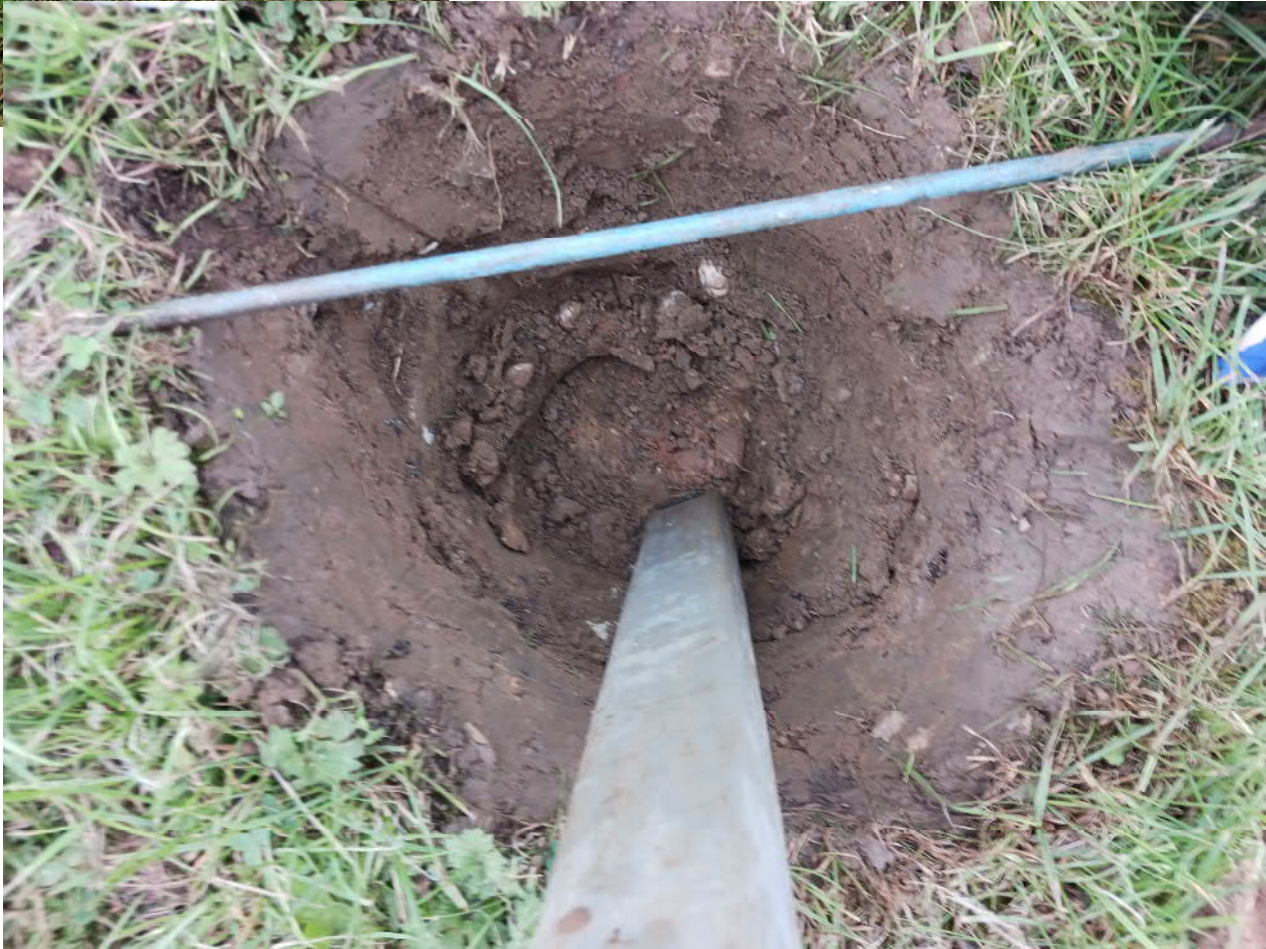
| Supporting Photographs –<br>Capping Verification POS 1 | |

Three hand dug trial pits (POS1 to POS3) were excavated in the northern area of POS to confirm the thickness of capping present. The excavations confirmed that at least 300mm of capping was present in every location.
