## **Phase 1 Desktop Study**

**Hinckley and District Hospital – Proposed Daycase and CDC Units**

**Waterman Infrastructure & Environment Ltd**

**Client Name:** WT Partnerships, on behalf of NHS Property Services  
**Document Reference:** WIE19831  
**Project Number:** WIE19831-100-R-1-2-1

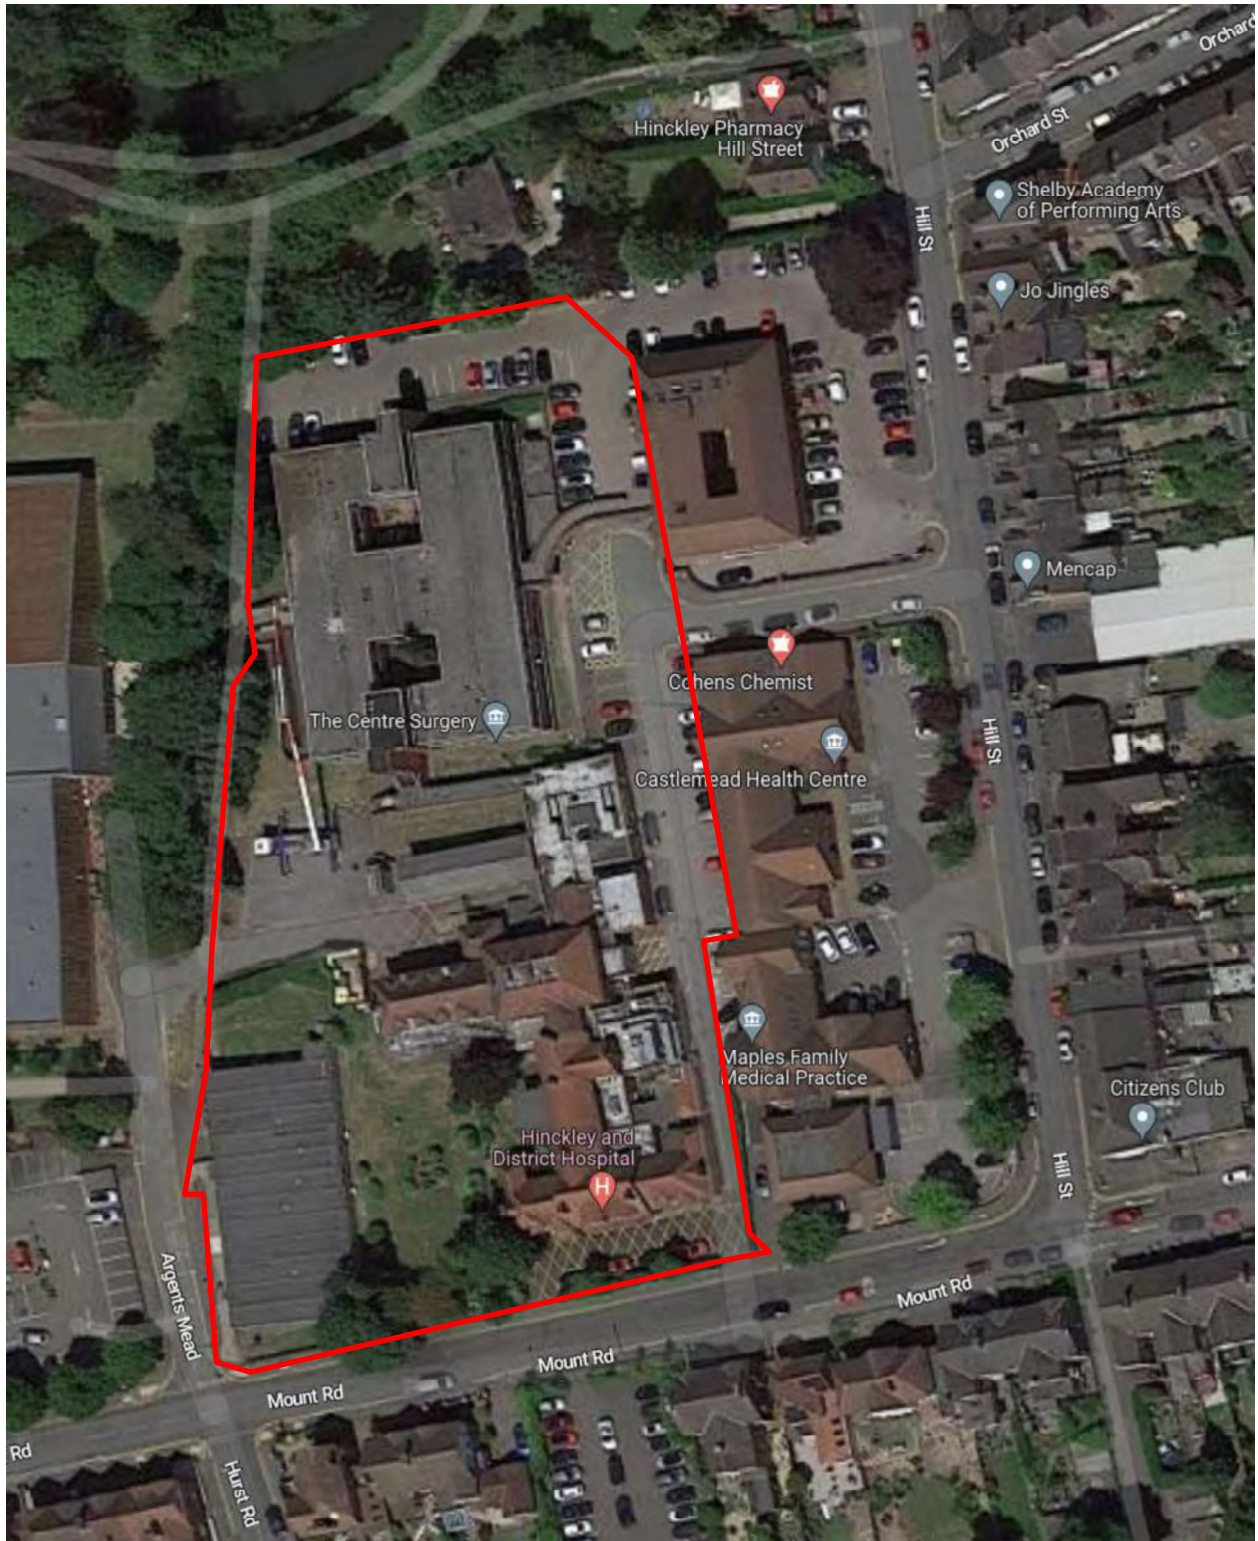
Figure 1: Current Site Layout

The Site is located at National Grid Reference 442942, 293741 off Mount Road, in Hinckley City Centre. The site is roughly rectangular in shape and forms the western section of Hinckley and District Hospital, comprised of 3No. separate buildings.

Externally the site is predominantly covered in macadam surfacing with small grassed areas between the southern buildings and around the surgeries building in the north. It is noted that the macadam surfaces were generally all in good condition with no obvious signs of cracking or spalding.

The levels on site were recorded to drop in the region of 5m from the east to the west of the site.

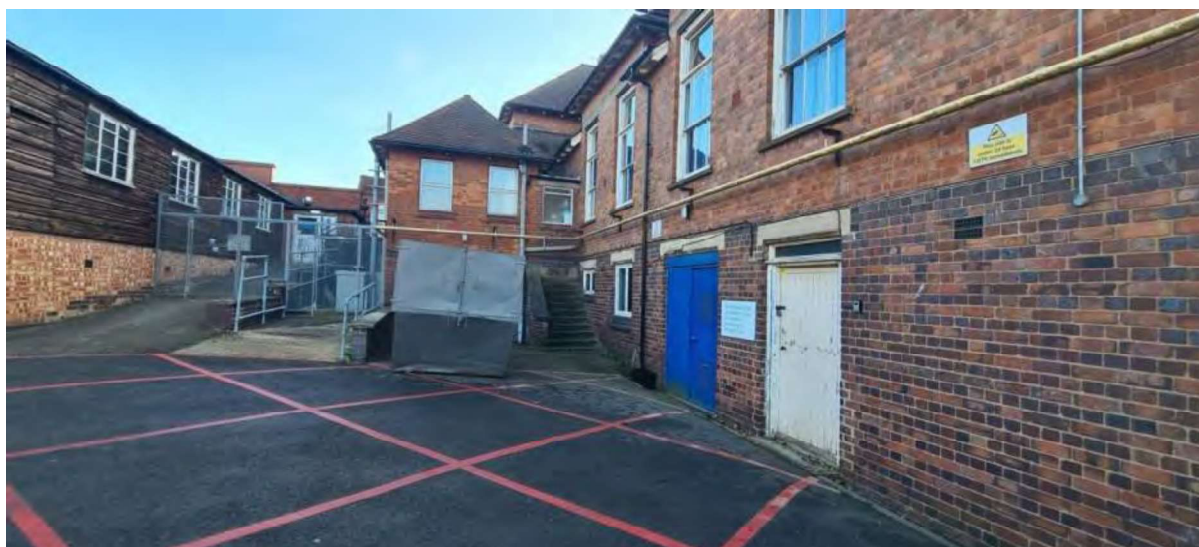
Photo 13: Basement entrance at ground floor level on the northern / western elevation of the x-ray and ultrasound building.

| Potential Issue | Description | Condition |
|---|---|---|
| Basement Areas | Old boiler rooms – potential for hydrocarbons and coal/combustible materials. | Numerous vents externally around SE building. |

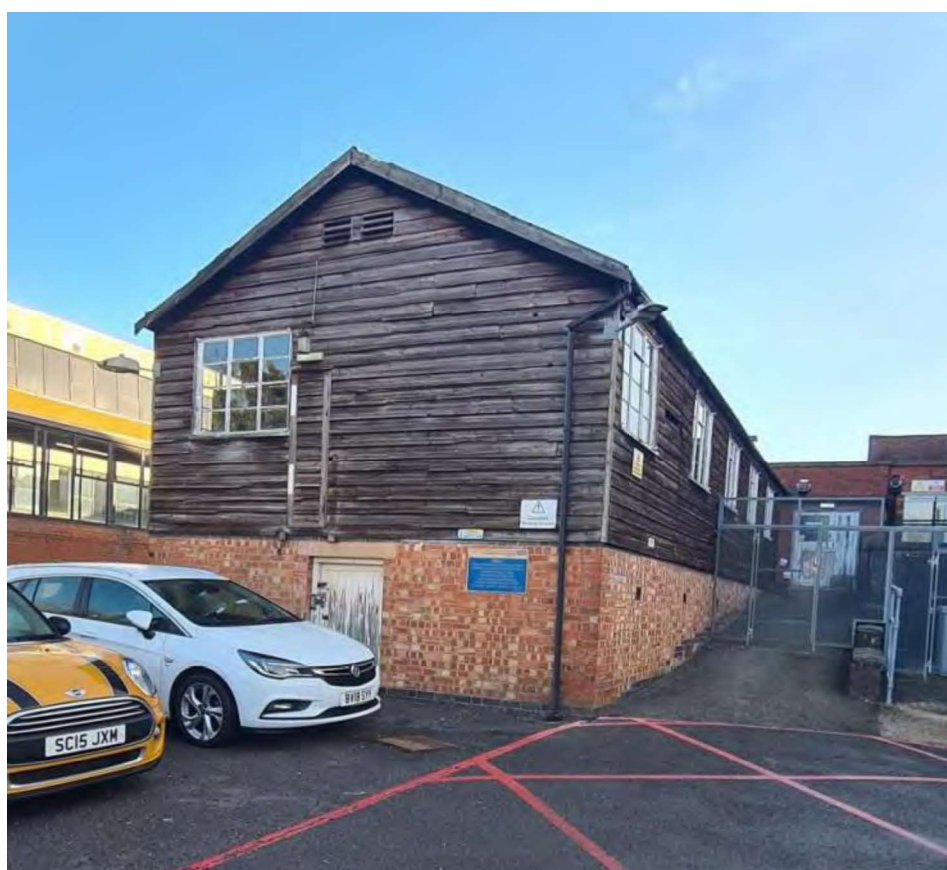
Photo 14: Wooden cladded building with basement access on the western elevation.
