LAND AT BARTON ROAD, BARLESTONE
PHASE II GEO-ENVIRONMENTAL ASSESSMENT
FOR
MYPAD 2020 LIMITED

Project Ref:
EAL.288.22

Date:
July 2023

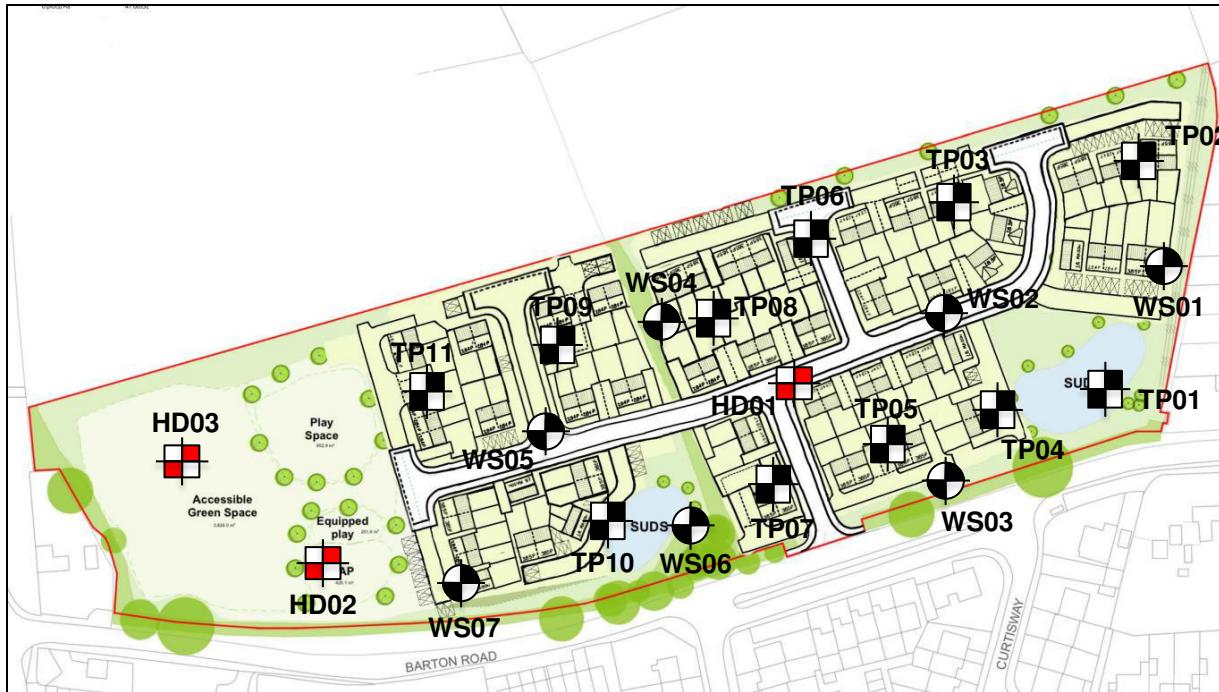
Exploratory Hole Location Plan

WS Borehole

An exploratory hole plan along with all exploratory hole records are included in **Appendix B**.

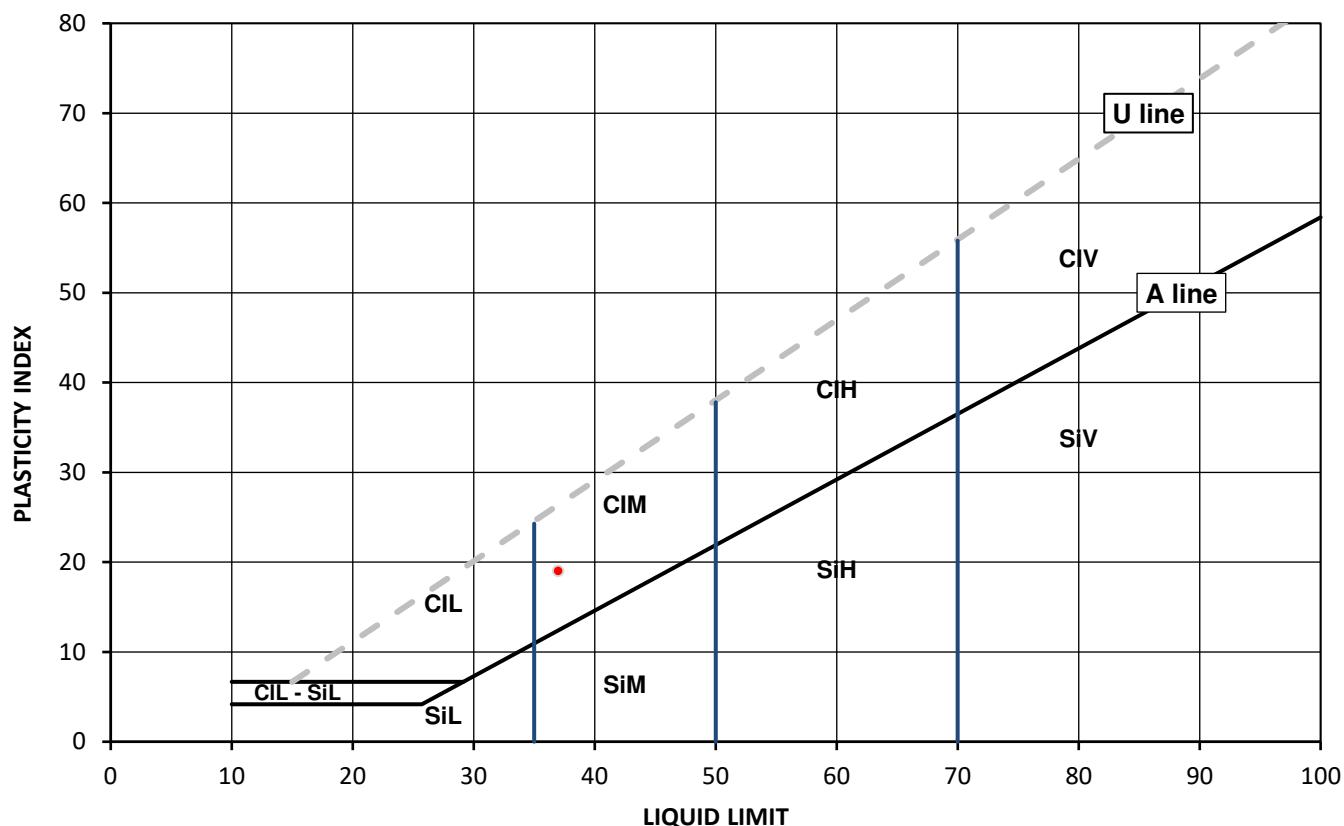
As Received Water Content [W] %	Liquid Limit [WL] %	Plastic Limit [Wp] %	Plasticity Index [Ip] %	% Passing 425µm BS Test Sieve
18	37	18	19	82

The results contained in **Appendix C** illustrate PI values of between 15% and 26% indicating that the shallow natural cohesive deposits should be classified as medium plasticity as a maximum classification to be used across the site. Moisture contents of between 12% and 18%, have also been recorded in the natural cohesive strata.

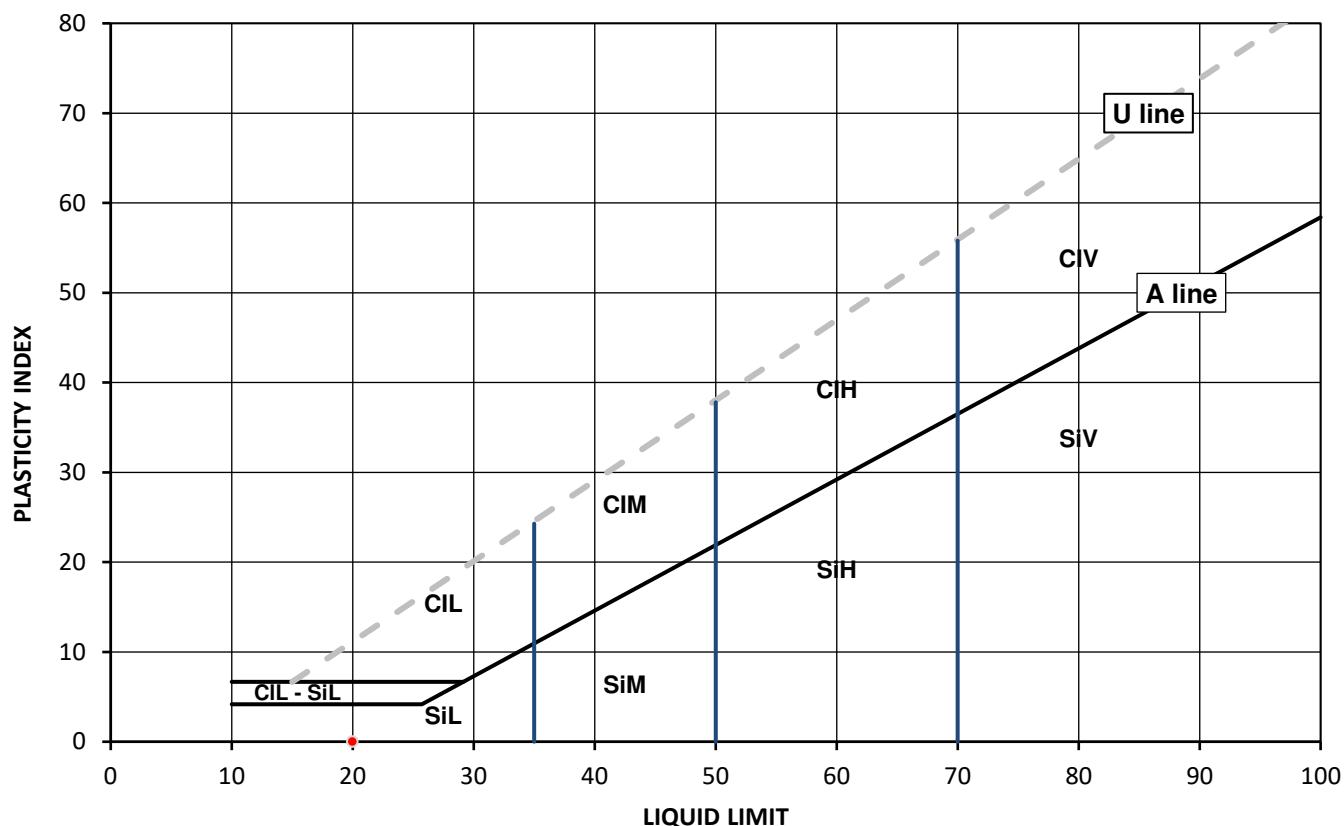
As Received Water Content [W] %	Liquid Limit [WL] %	Plastic Limit [Wp] %	Plasticity Index [Ip] %	% Passing 425µm BS Test Sieve
18	20	NP	NP	99

Plasticity index testing of one selected sample of the granular soils has confirmed that these are non-plastic.

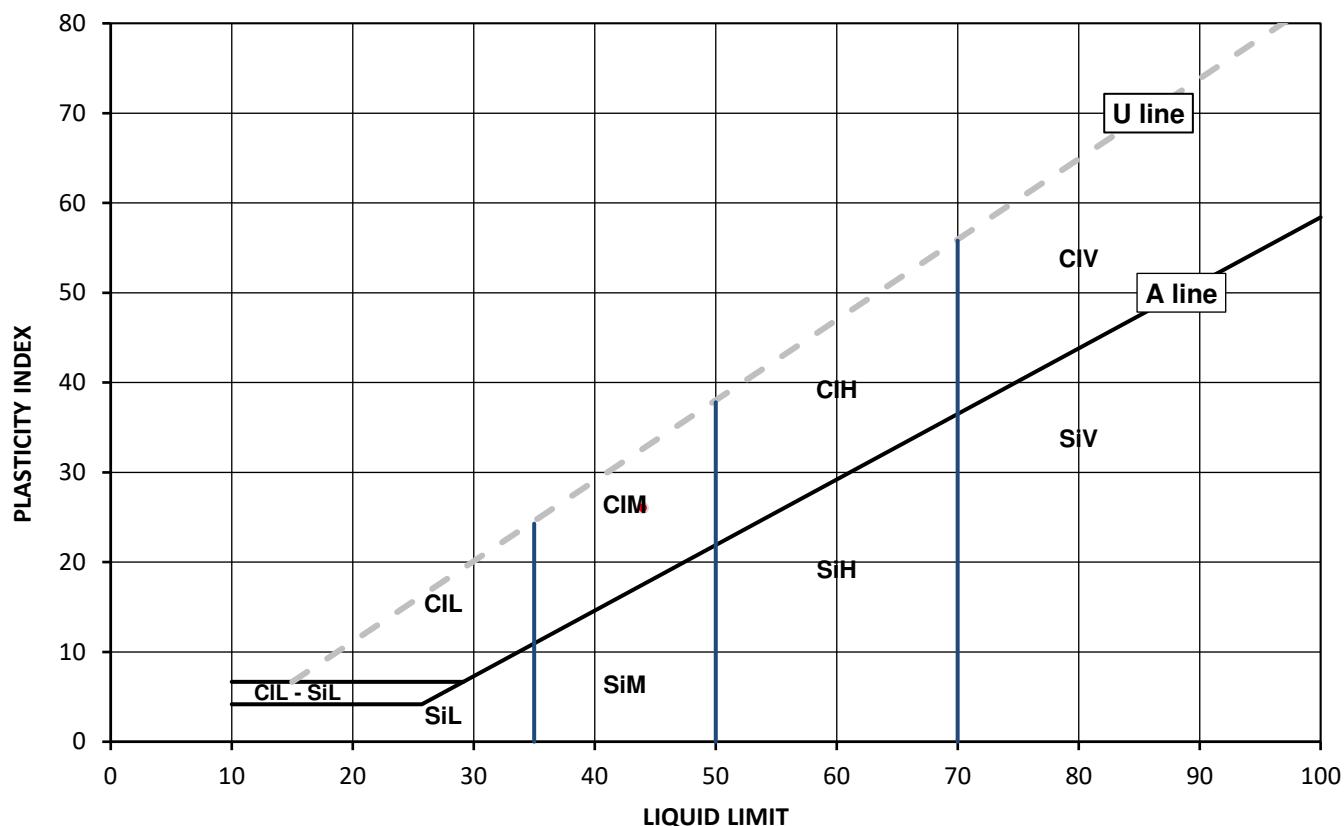
As Received Water Content [W] %	Liquid Limit [WL] %	Plastic Limit [Wp] %	Plasticity Index [Ip] %	% Passing 425µm BS Test Sieve
15	44	18	26	99

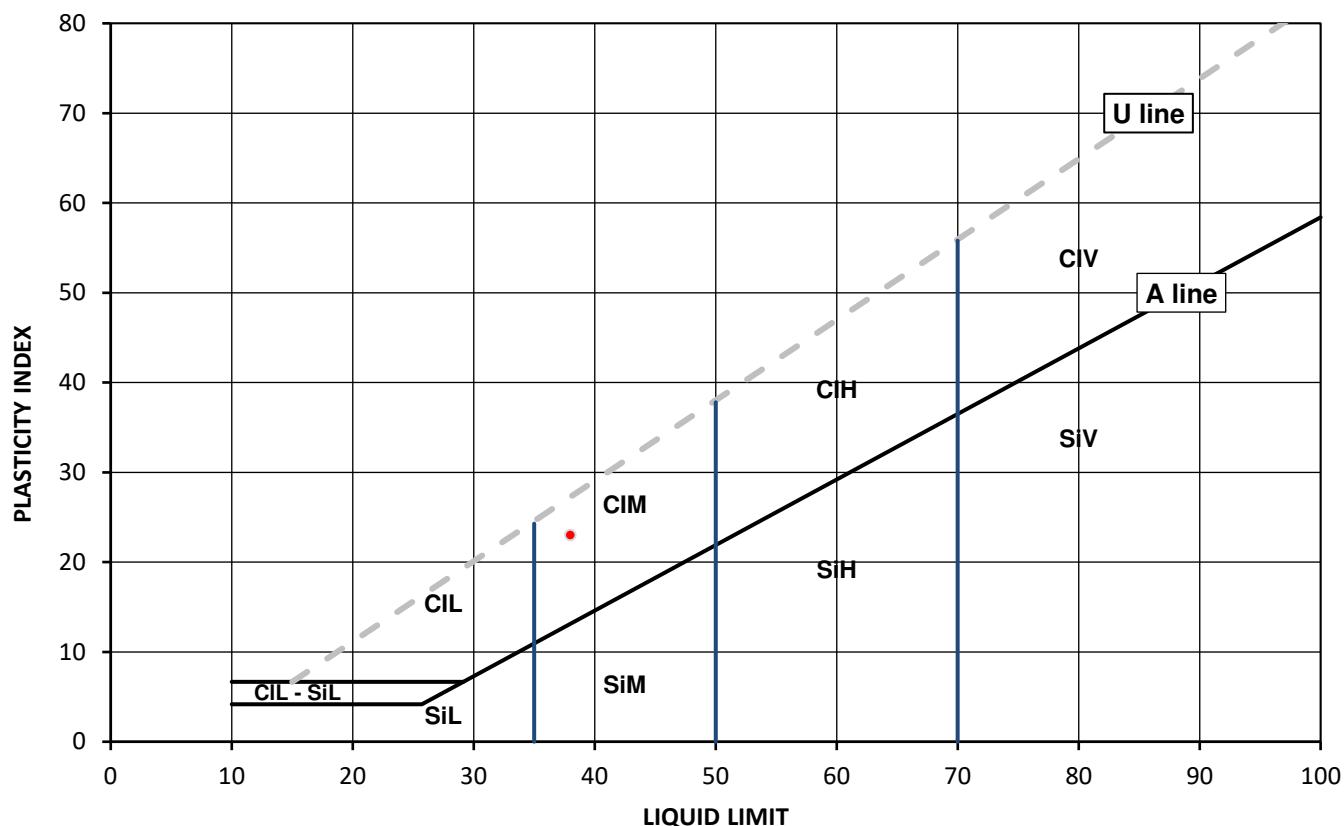
As Received Water Content [W] %	Liquid Limit [WL] %	Plastic Limit [Wp] %	Plasticity Index [Ip] %	% Passing 425µm BS Test Sieve
12	38	15	23	99

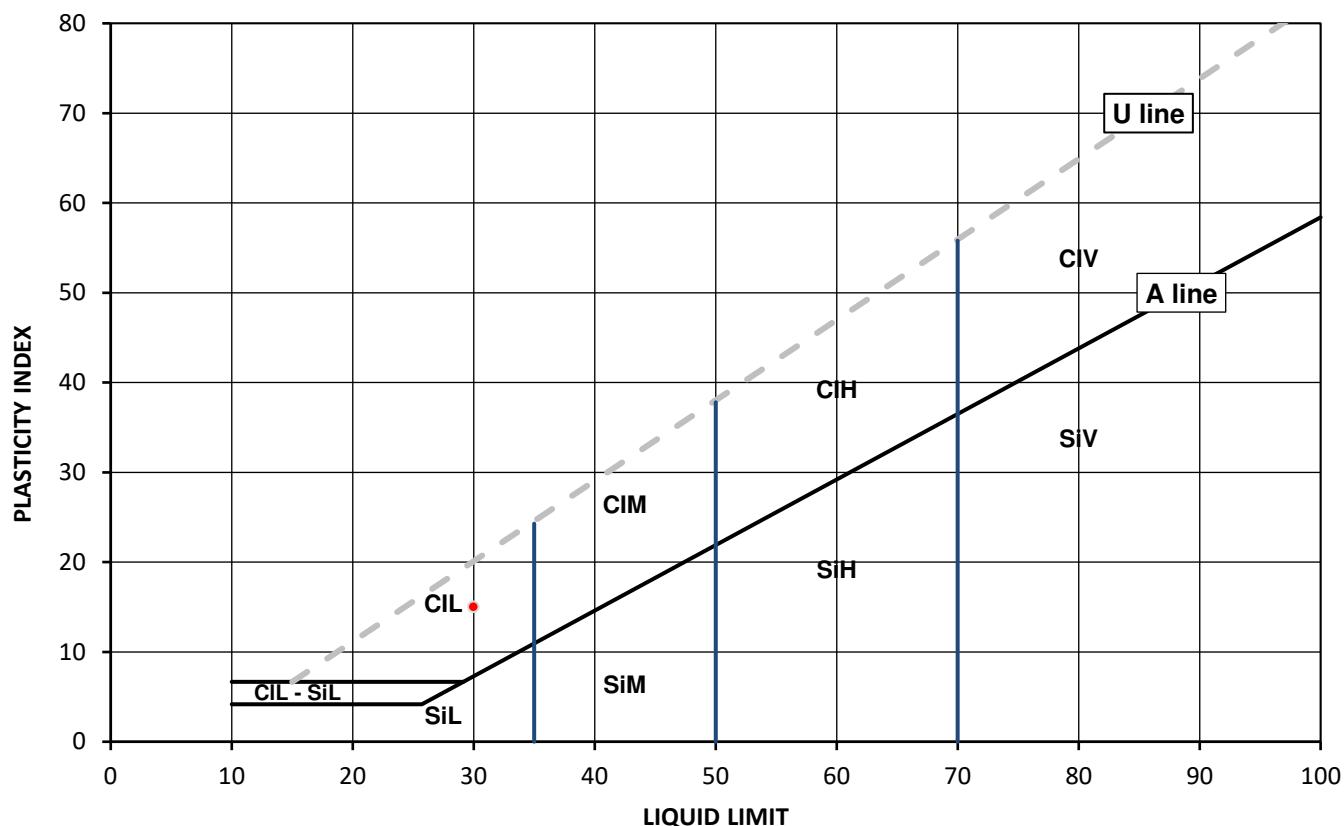
As Received Water Content [W] %	Liquid Limit [WL] %	Plastic Limit [Wp] %	Plasticity Index [Ip] %	% Passing 425µm BS Test Sieve
18	30	15	15	99

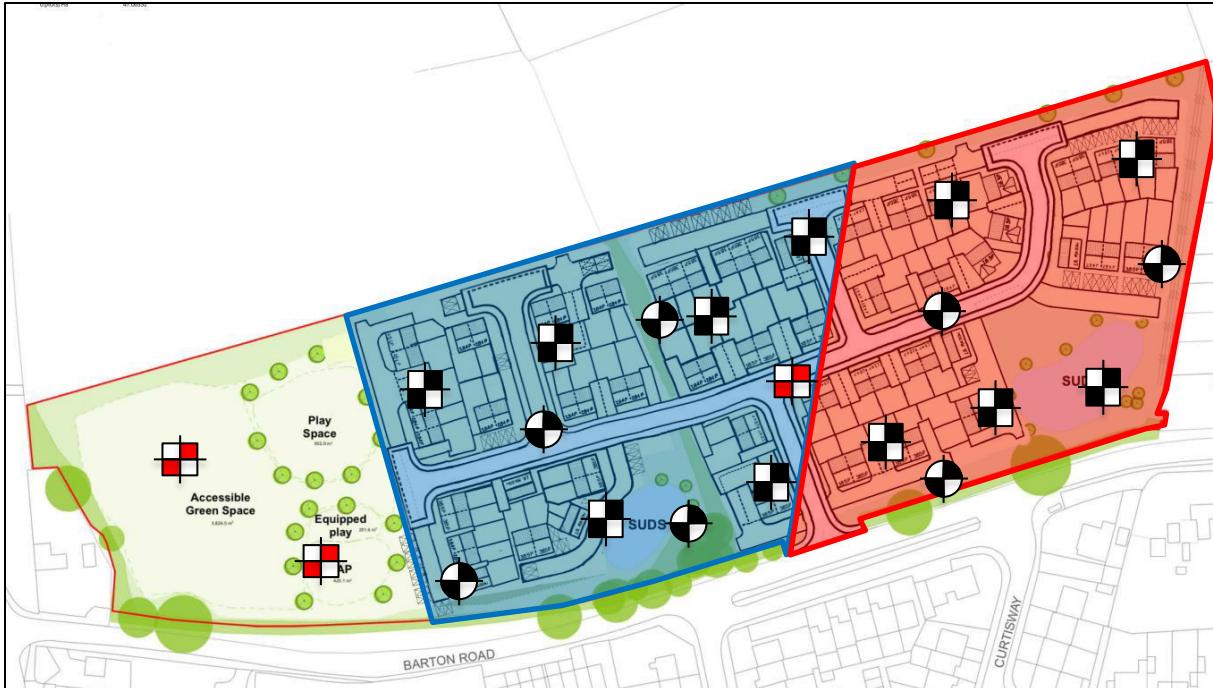
Foundation Zoning Plan

Area requiring piled/vibro foundations

Area where traditional foundations may be suitable subject to structural engineer assessment.

Any foundations that require deepening (due to tree influence or in the area of the former pond) should be piled or vibro.

Consideration should be given to presence of loose granular deposits at depth and plot specific investigation may be required.

Due to the variability between granular and cohesive deposits and poor composition of the granular deposits in conjunction with groundwater, traditional foundations are considered to be potentially unsuitable. At this stage it is recommended that piled foundations/vibro stone columns are budgeted for across the entire site. A piling/vibro specialist will need to be approached to provide pile/stone column dimensions and safe pile/vibro capacities. Consideration should be given to nearby structure when selecting foundation type. Consideration should also be given to the effects of shrink/heave within cohesive deposits on pile/vibro foundations.

It is noted that the cohesive soils generally increased with thickness to the western portion of the site. There may be a sufficient thickness of clay above the deeper granular deposits in the western area to utilise traditional foundations. However, this assessment would need to be confirmed with your appointed structural engineer. It is likely that plot specific investigation will be required to assist with foundation design/confirm the cohesive soils are sufficient. Where foundations require deepening due to tree influence (in accordance with NHBC Chapter 4.2 – Building Near Trees) in the western field, it is likely that a piled or vibro foundation will be required. Piled/vibro foundations will also be required in the area of the former pond in the central northern area of the site.

A foundation zoning plan illustrating the above is included in **Appendix E**, for reference.
