**Archaeological Watching Brief**

**Land at Mulberry Farm**

**Stoke Golding**

**Report No. 303**

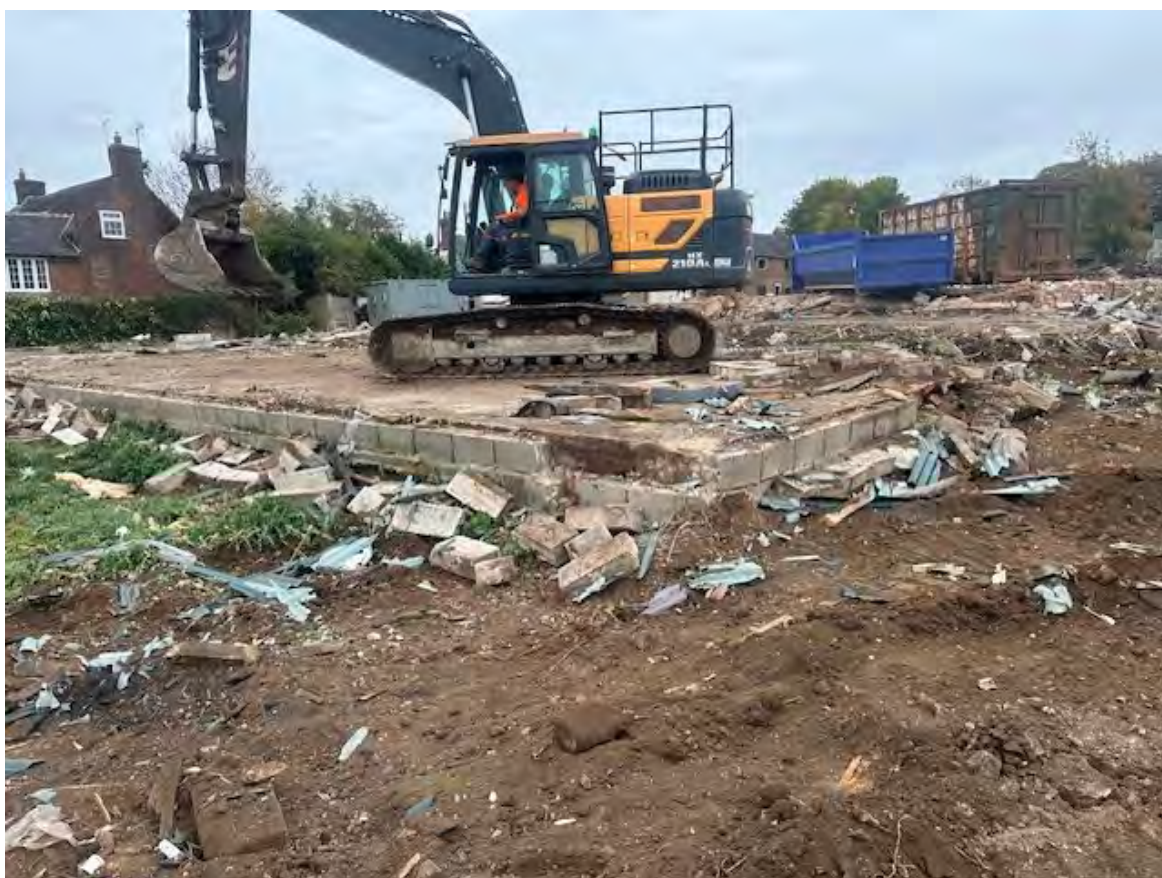
*Plate 2: Example of raised concrete raft*

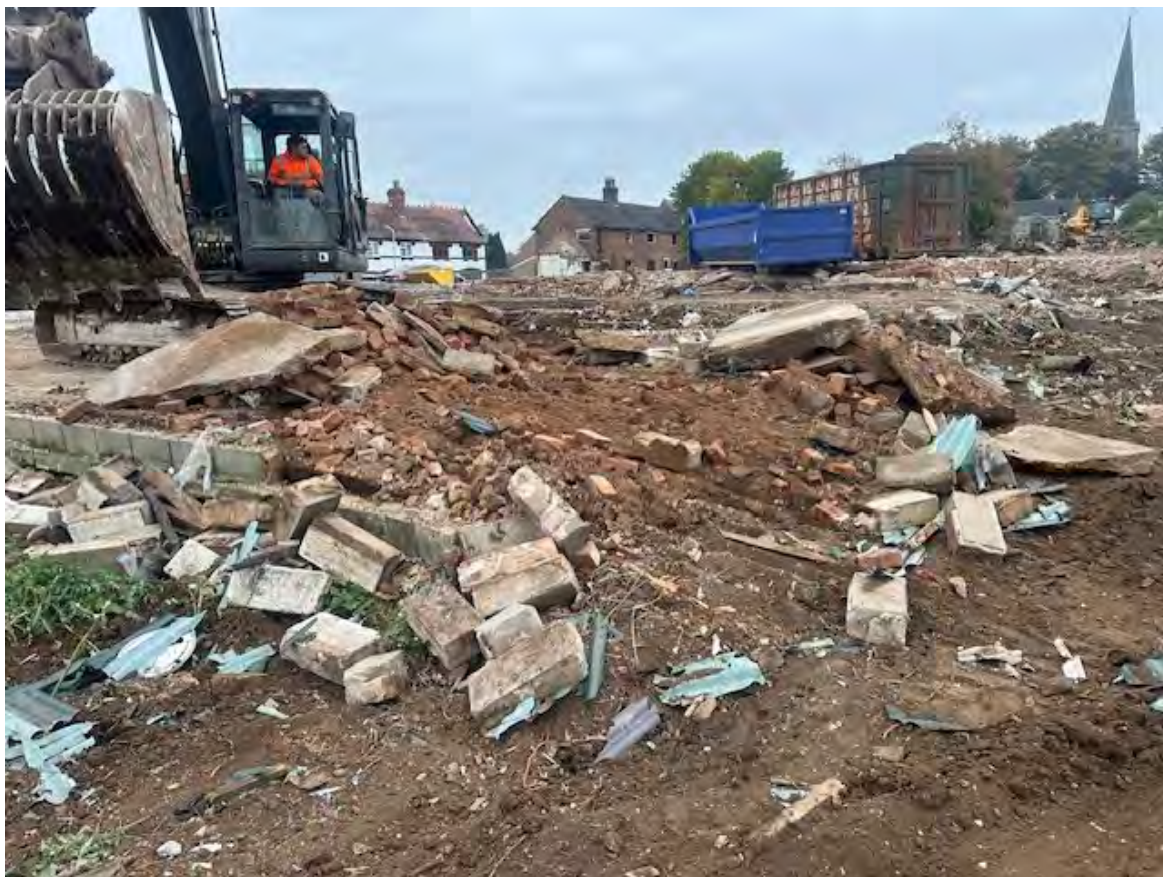
- 5.2 The removal of the concrete floors revealed large areas of made ground, generally comprising of rubble which had been laid directly onto the topsoil. The demolition activity did not penetrate below the buried topsoil.

*Plate 3: Rubble exposed below raft*

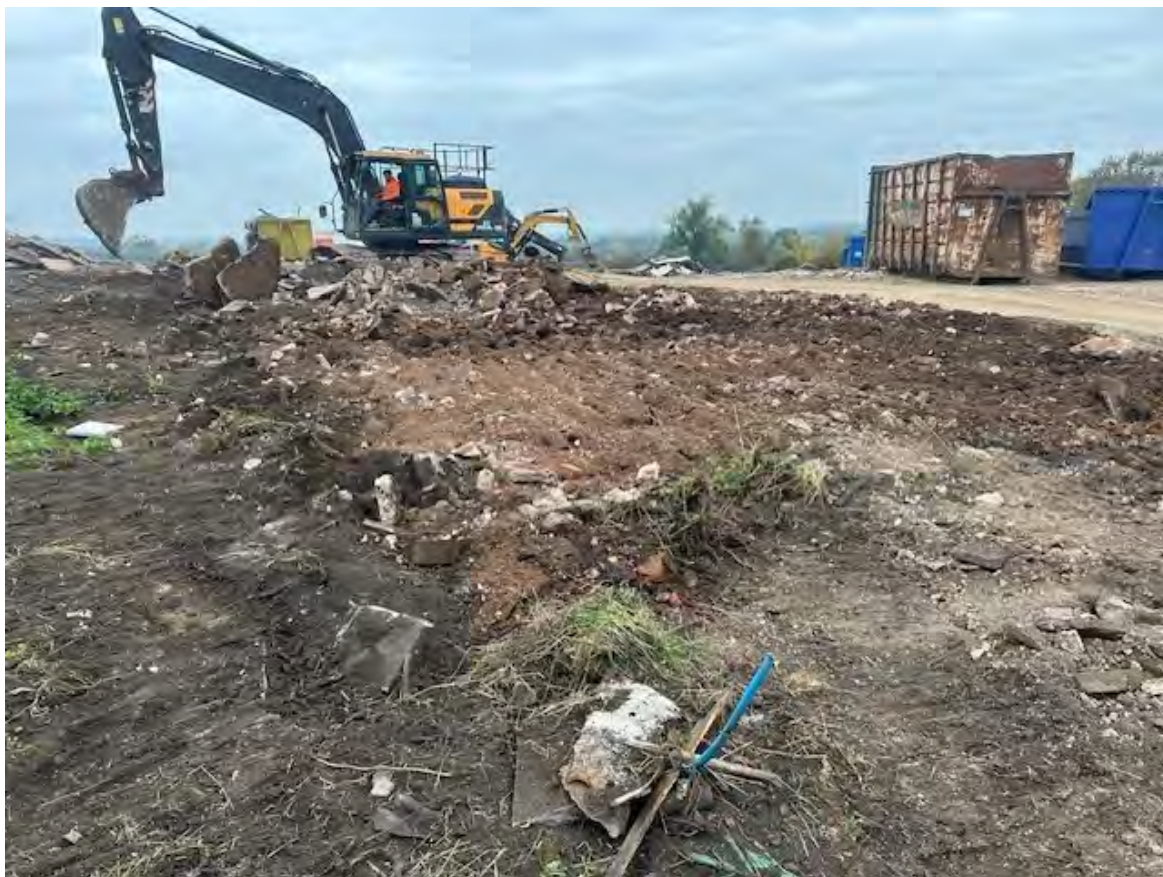
- 5.1 The agricultural buildings present within the site were all of light weight construction generally built on concrete rafts. The site slopes down to the north and west, this resulted in the majority of the structures being constructed on built up platforms of rubble. Where foundations were present they were no more than two courses of brick deep. The demolition was limited to removal of the superstructure, concrete slabs and hard standing. The made ground was left in situ.

*Plate 4: Extent of demolition work*
