**LAGOS COTTAGE
18 BURTON ROAD
TWYCROSS
LEICESTERSHIRE
CV9 3PR**

ARBORICULTURAL ASSESSMENT

Ref: WCL/LE/AA/12825

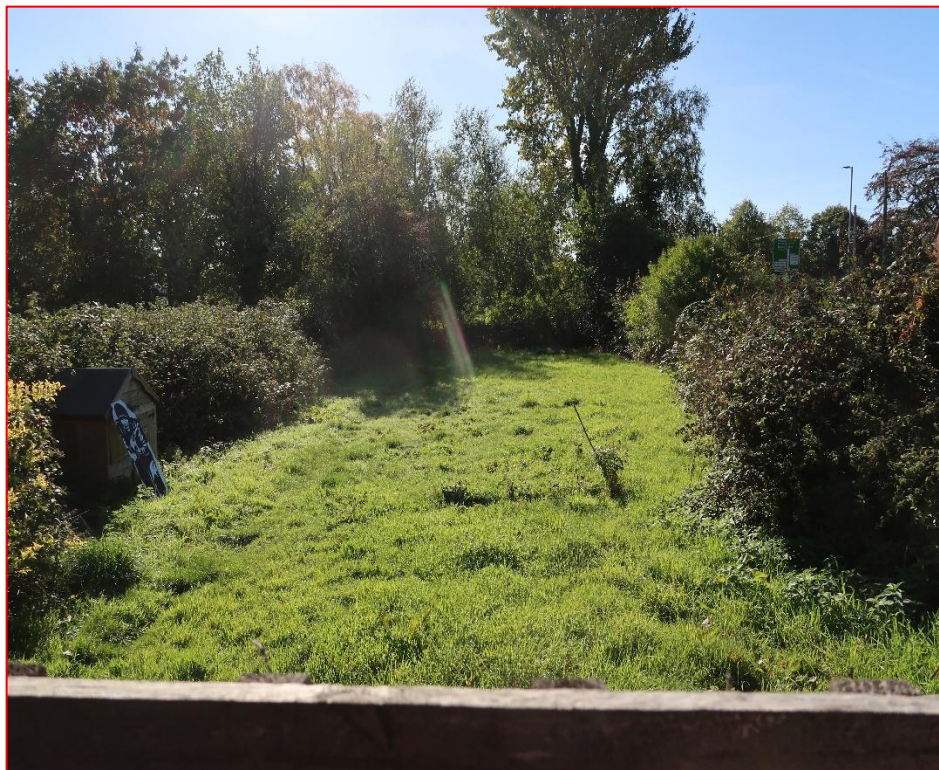
Fig.1: View of site and Existing Habitat

The proposed development site has a western boundary roadside hedge (A444) and a eastern boundary garden hedge (adjacent property garden) with 2 mature trees to the southern boundary.

Goat willow trees are present to the southern boundary of the adjacent property.

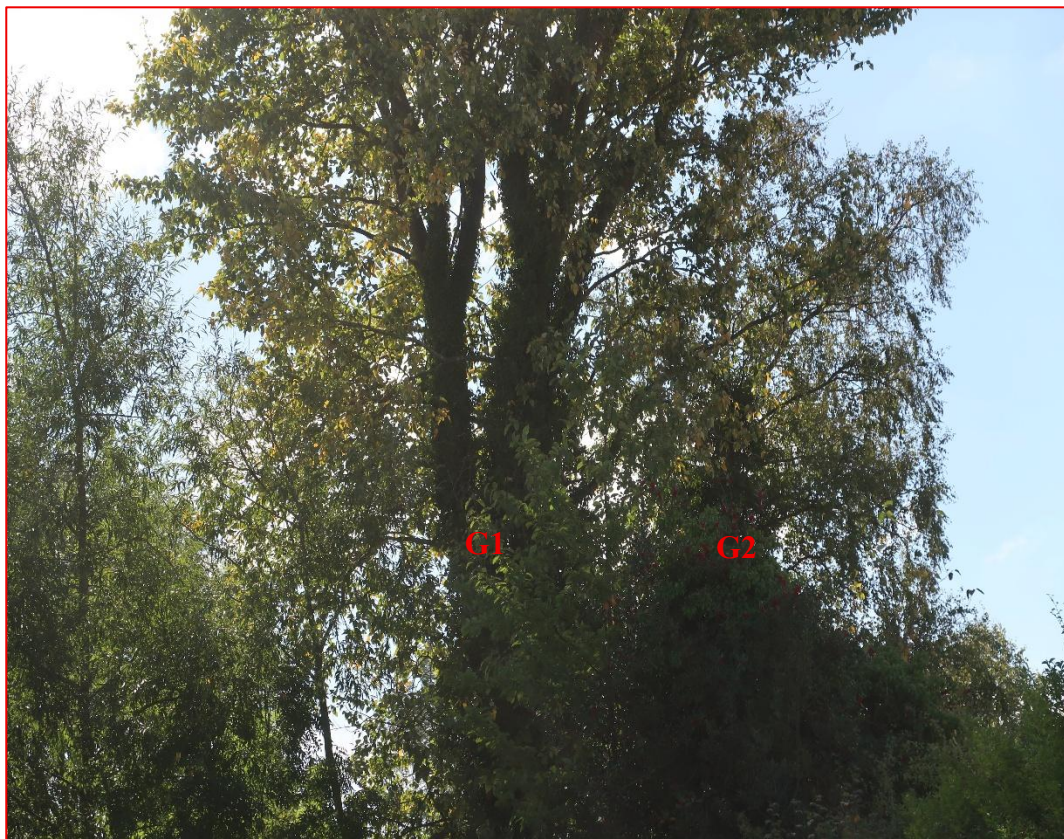
Tree Constraints Data – Root Protection Areas (RPA) & Crown Spread													
Tree Number	Species	Measurements				RPA (M)	Retention	Life Stage	Other				Comment
		Trunk (mm)	Height (M)	Crown (M)	Spread N,E,S,W (M)				Structure	Amenity	Landscape	Pyshic	
G1	POPLAR <i>Populus nigra</i>	800	16	4	3, 3, 2, 4	9.6	A2	M	A	High	High	A	
G2	BIRCH <i>Betula pendula</i>	430	10	4	3, 3, 4, 2	5.2	A2	M	A	Medium	Medium	A	Suppressed in proximity to Poplar

Fig. 1: View of trees to the southern boundary of proposed plot.

The trees are advised as to be retained during and post development.

The proposed 2.2m high facing brickwork boundaries to be discussed / reviewed where present within the RPA.
