**51 Desford Road, Newbold, Verdon, Leicester, LE9 9LG**

**Bat & Bird Survey - Preliminary Roost Assessment**

21<sup>st</sup> November 2023

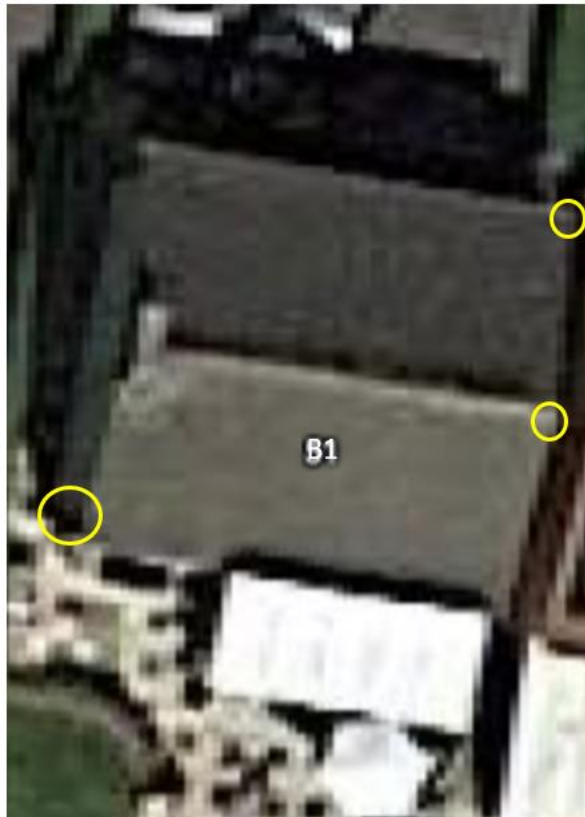
## Appendix 1: Survey Plan

The building within the survey area comprised a relatively modern, two-storey, brick house (B1). Potential roosting features (PRF) described below are illustrated on the map in Appendix 1. B2 was a garage at the rear of the property.

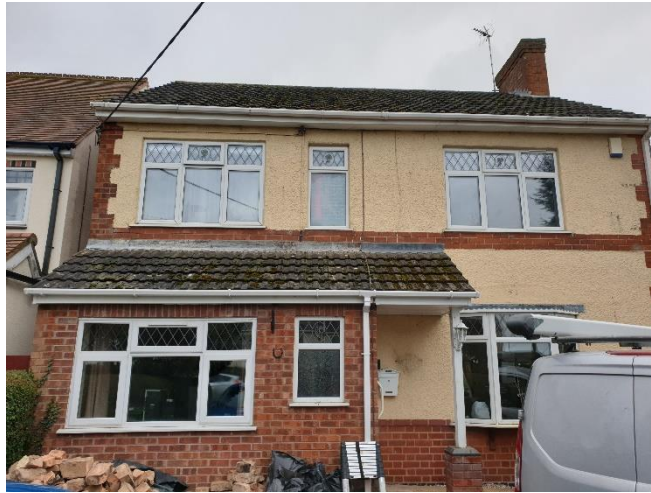
Image 1: View of the front of B1

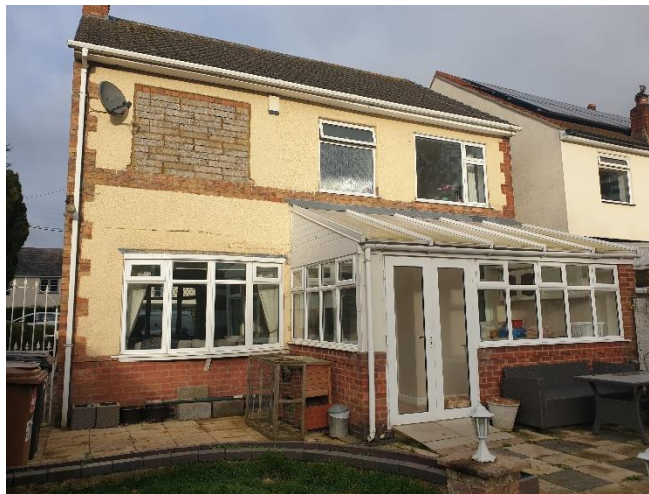
Image 2: View of rear of the property

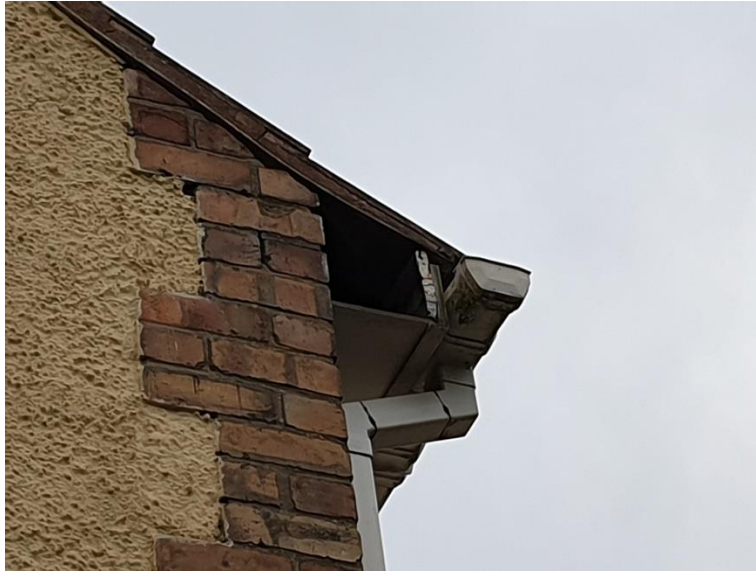
- There was a small number of lifted tiles/slightly raised on the main roof, notably at the south-western corner and north-eastern corner.
- There was an area of missing mortar below the tile board on the eastern gable end.
- At the roof's southeast corner, the soffit box was uncapped at its end; leaving a large gap which could be used by bats to access the roof.

Image 3: View of missing soffit box cap

| Building Ref | Value for / Likelihood of supporting roosting bats | Recommendations |
|---|---|---|
| B1 | Low | One bat presence/likely-absence survey (dusk or dawn), conducted during the optimal survey period for bats (May to August inclusive). |

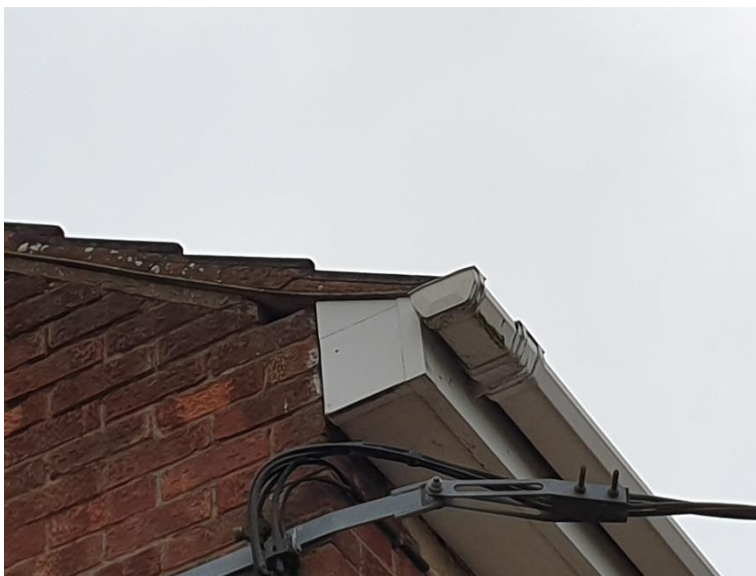
Image 4: Missing mortar at the north-eastern corner

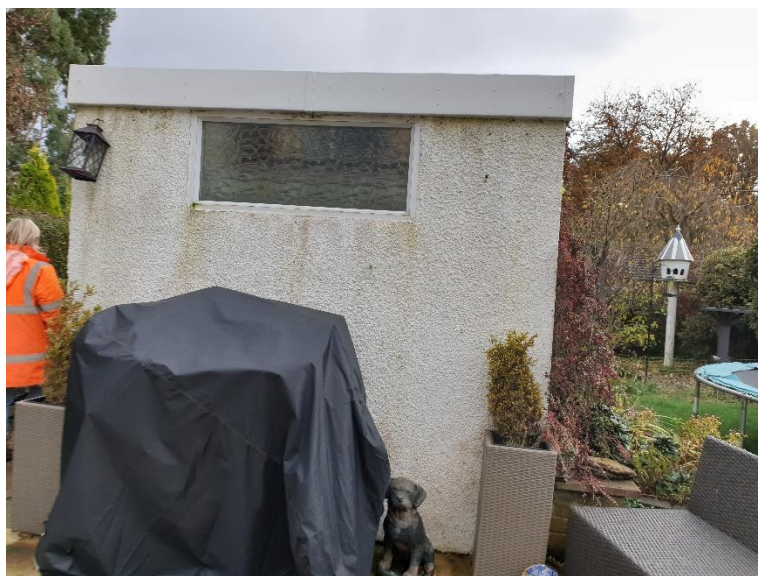
The garage was single-storey, made of concrete and covered in rendering. The roof shape was flat and covered in metal sheeting. The internal also had metal and concrete supports. The internal was every cobwebbed, with no suitable roosting locations for bats due to the type of material the building was made from. The building was assessed as having negligible potential to support roosting bats.

Image 6: View of B2

| Building Ref | Value for / Likelihood of supporting roosting bats | Recommendations |
|---|---|---|
| B2 | Negligible | No further surveys required. |
