**Archaeological Evaluation at  
Land off Hill Lane, Markfield,  
Leicestershire,  
LE67 9UB**

**NGR: SK 48706 10548**

ULAS Report No 2026-066

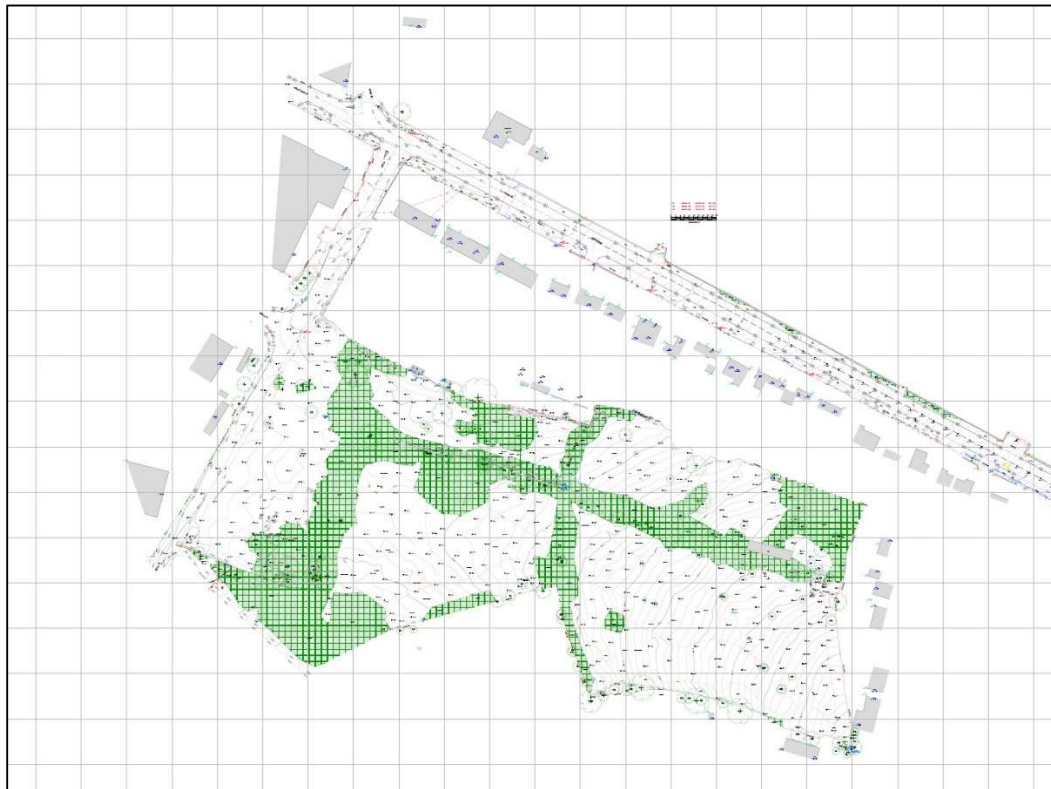
The ground within the PDA rises from c.195m aOD in the south-eastern corner to c.200m aOD in the north-eastern corner and to c.205m AOD along the western site boundary (Figure 3).

Figure 3: Topographic survey (provided by client).

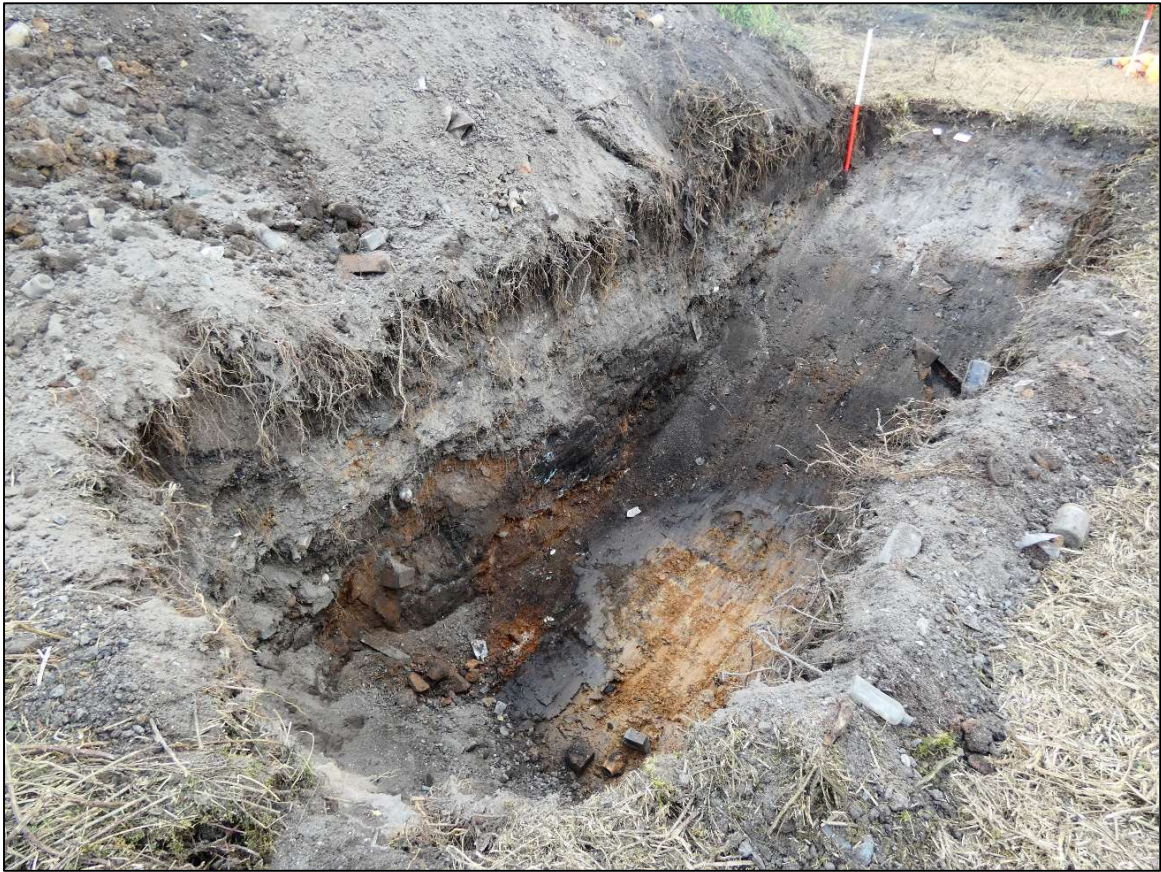
Trenches 1, 2 and 3 all contained a topsoil consisting of a dark greyish brown loamy sandy silt. No subsoil was present in this area, however a 1.2-1.7m thick layer of mid greyish brown ashy silt containing discarded 20<sup>th</sup> century waste was present beneath the topsoil (contexts (104), (204) and (304)).

Figure 8: The modern landfill and natural substratum in Trench 1.

The waste material was mainly glass and ceramic vessels with fragments of metal, however the first trench to be excavated in this area (Trench 2) contained fragments of asbestos cement sheets at the southern end. Because of this none of the trenches in this area were entered by the archaeologist and the remaining trenches were excavated at a reduced length (8-10m) with the aim of not disturbing any more of the material.

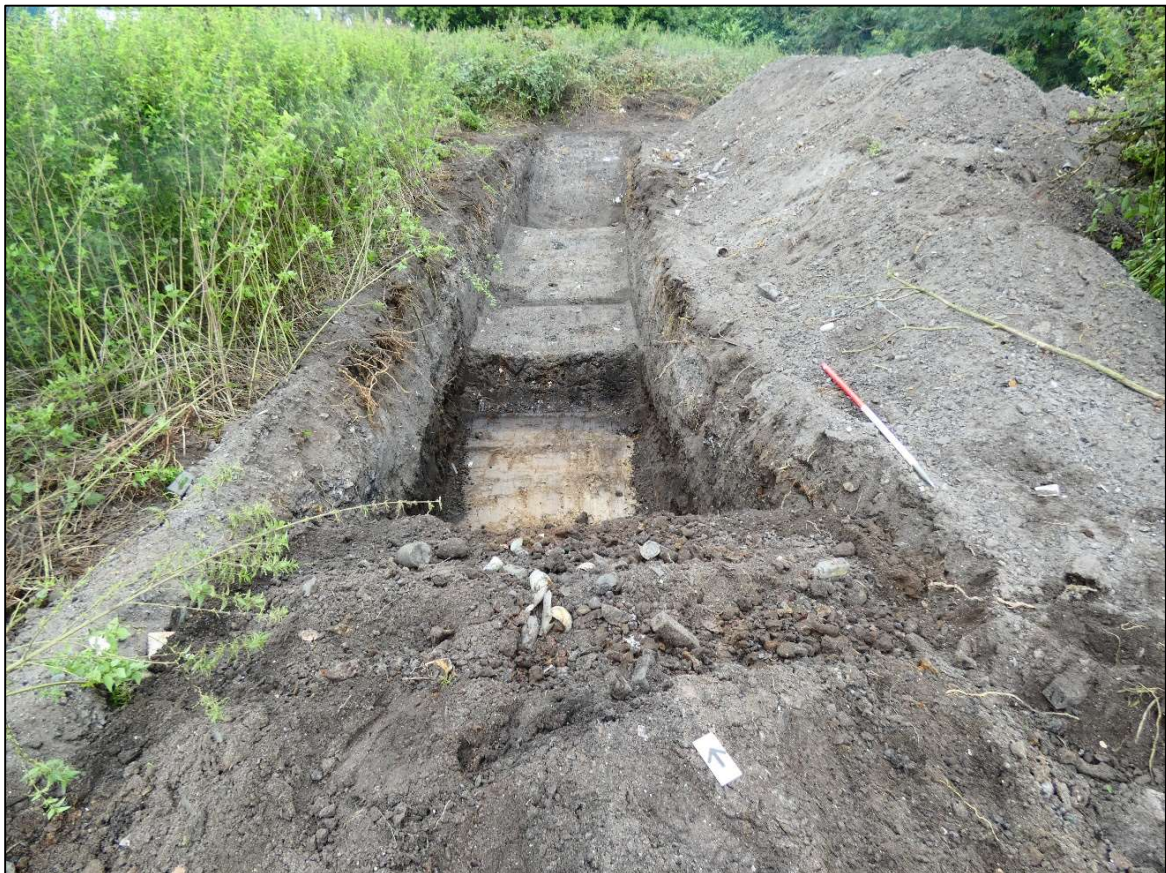
Figure 9: The modern landfill and natural substratum in Trench 2.

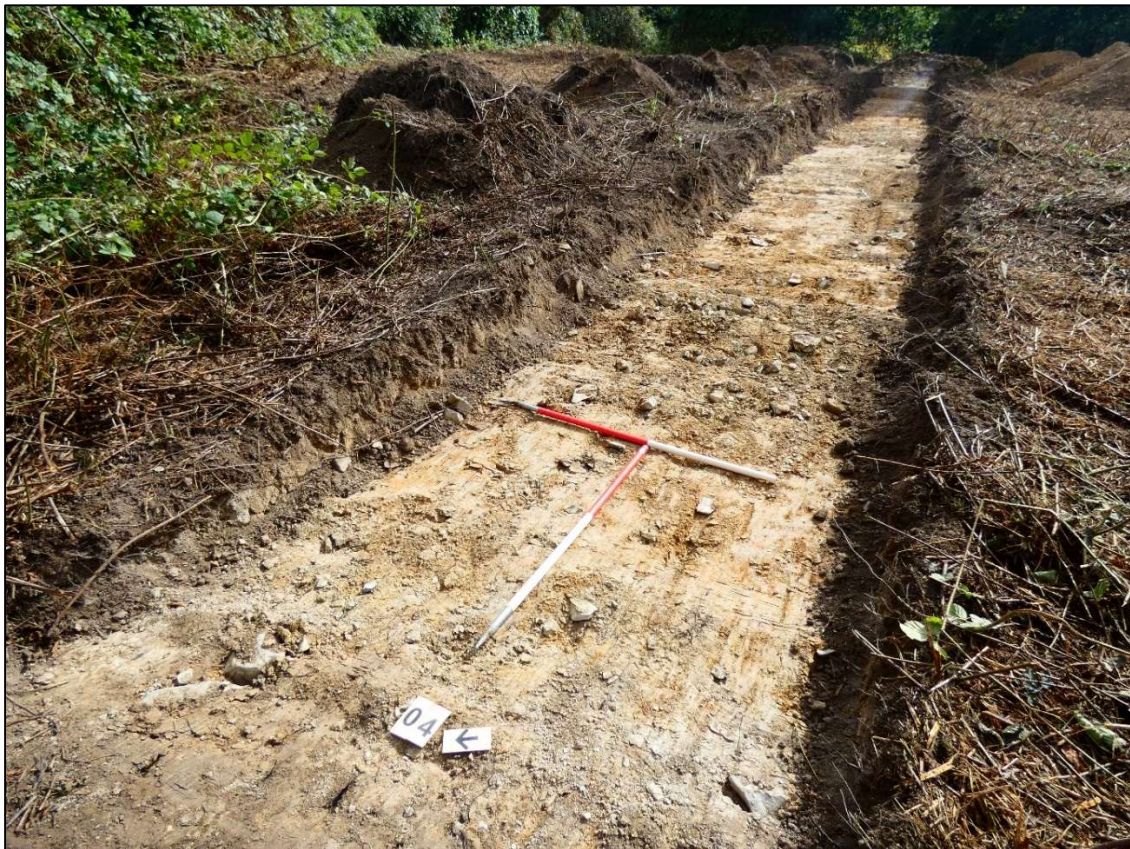
Trench 4 measured 0.2-0.54m deep and contained a topsoil consisting of mid greyish brown sandy silt. A mid-yellowish brown sandy silt subsoil was found beneath it. The natural substratum consisted of light yellowish grey clayey sand which occasionally contained patches of stones. Larger stones were occasionally present at the eastern end of the trench.

Figure 12: Trench 4 with patches of stone visible in the natural substratum.

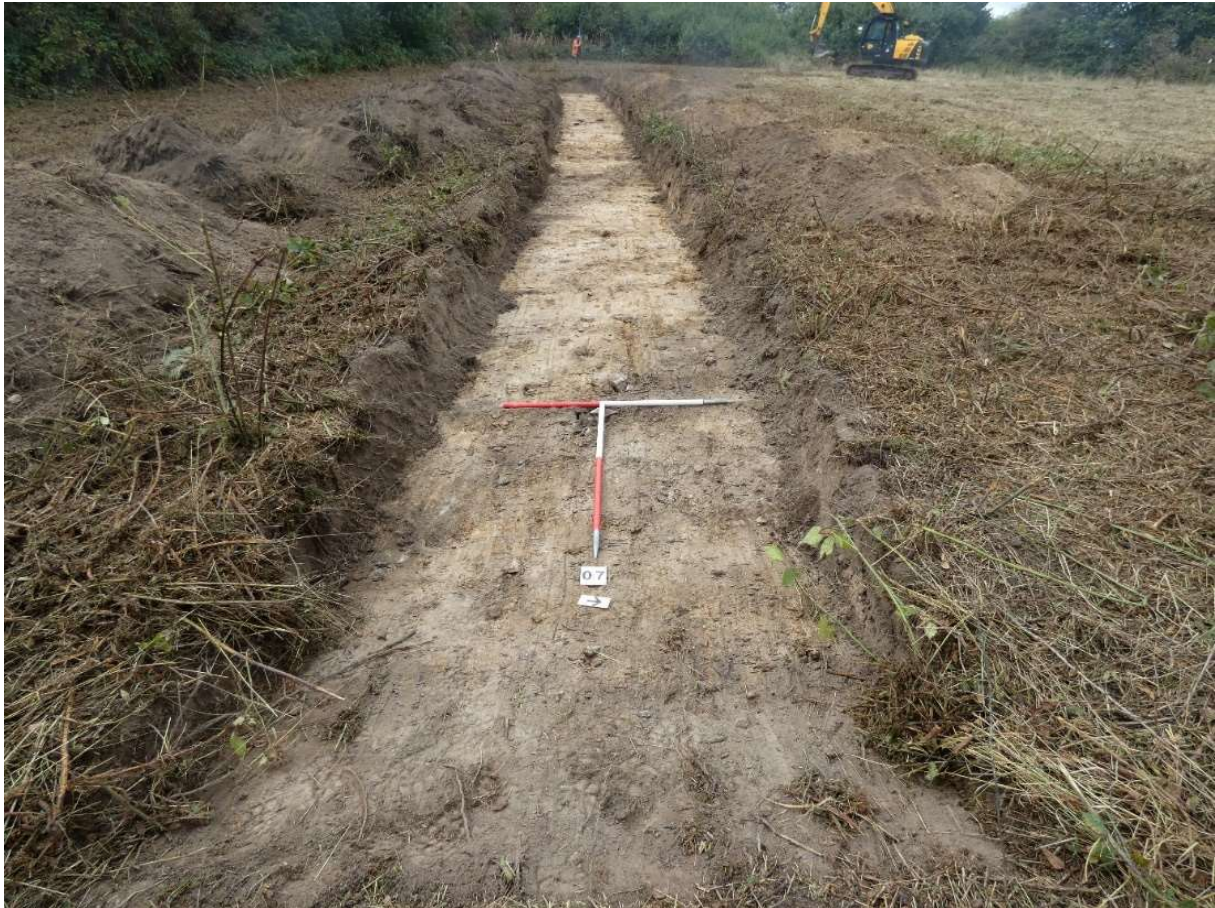
An east to west orientated furrow was found at the southern end of Trench 6 and another was found near the centre of Trench 7. At the southern end of Trench 5 a depression, which may have been caused by a furrow, was found and this coincided with where there was a change of geology. East to west orientated drains were regularly found and occasionally others orientated north-west to south-east were present.

Figure 14: Trench 7 with the regularly spaced drains and furrows.

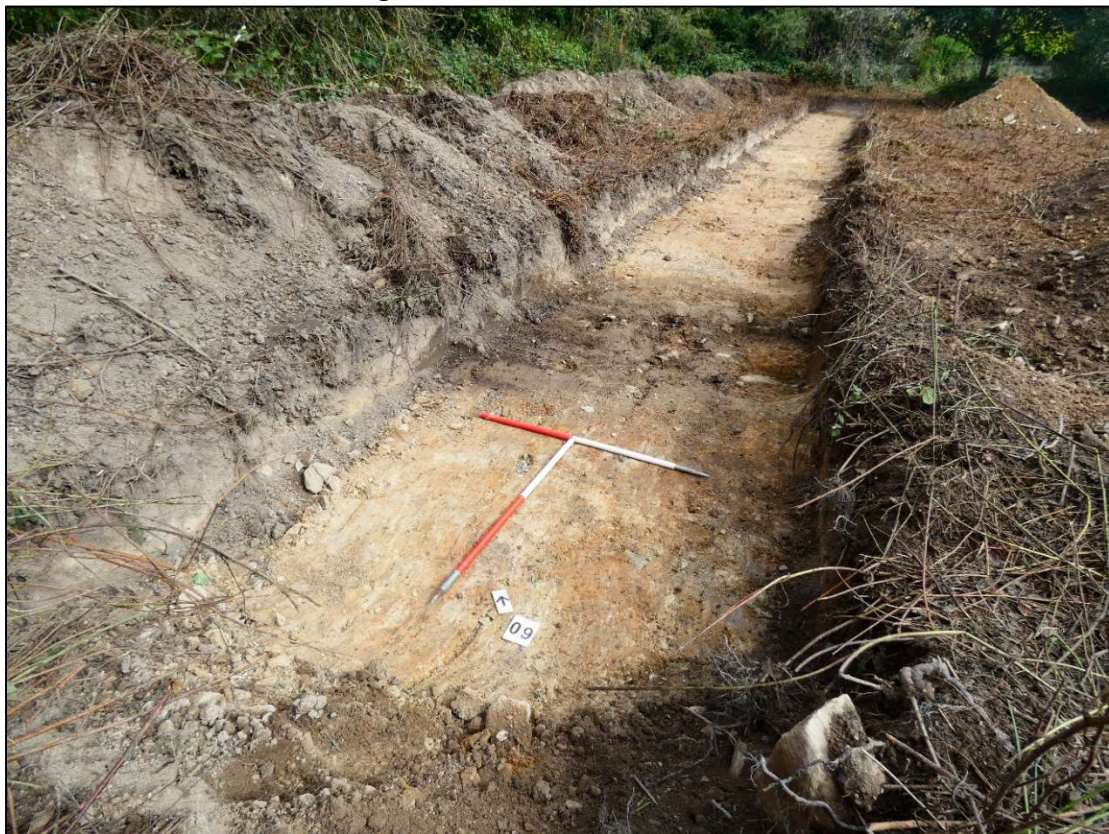
An east to west orientated furrow containing two land drains was found in the southern end of Trench 9. Drains were also found in in the northern end and in Trench 14.

Figure 16: Trench 09 with the east to west orientated furrow.

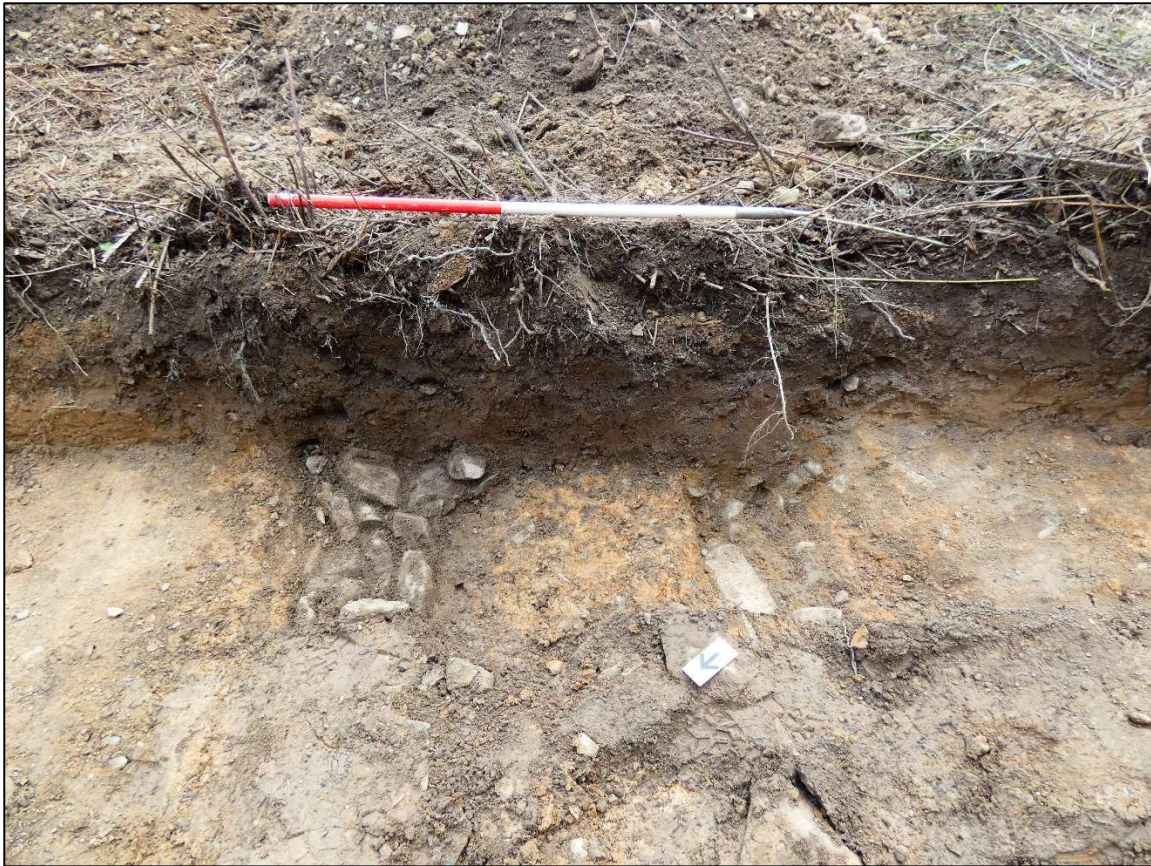
Figure 17: The drains in the furrow in Trench 09.

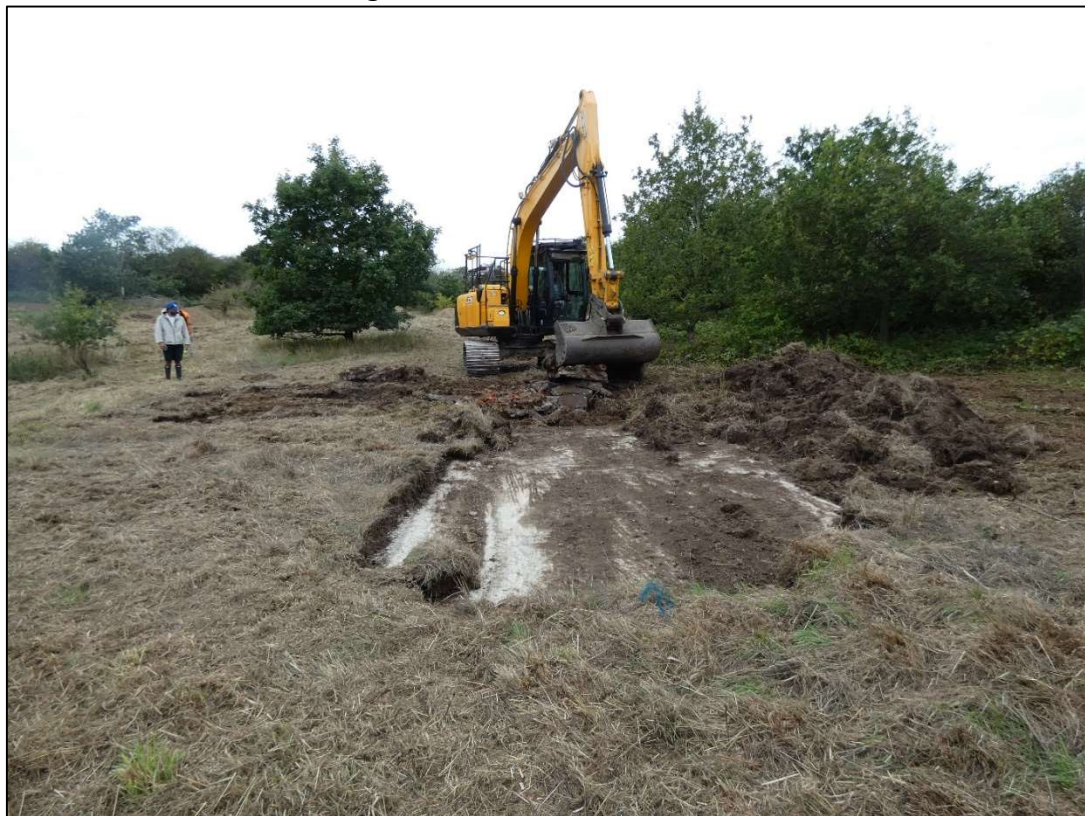
Figure 19: The concrete surface in the original location of Trench 15.

The geophysical survey identified areas of magnetic disturbance and ferrous spread in Field 5 which was thought to be due to the demolition of a former structure (Clements 2021 *ibid*). This was confirmed with the proposed excavation of Trench 15 which found a concrete slab at the eastern end of the trench, in the ferrous spread. Demolition rubble was found more than 30m to the west indicating that the adjacent magnetic disturbance also contains demolished building remains. Both anomalies were found to contain fragments of asbestos cement sheets and Trench 15 was moved further west to avoid disturbing it (Figure 23).

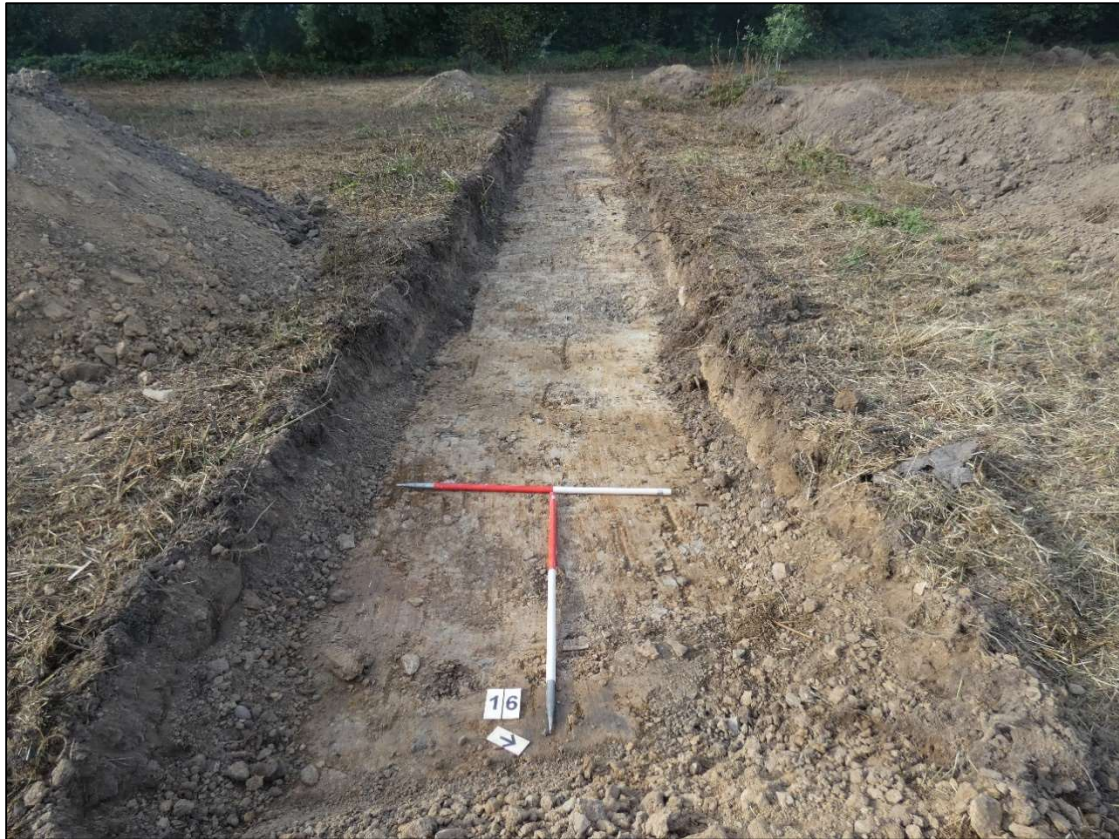
Land drains on various orientations were found in most trenches in this area although many were orientated north-west to south-east. Two furrows were also found on this alignment in the centre of Trench 16.

Figure 20: Trench 16 in Field 5.

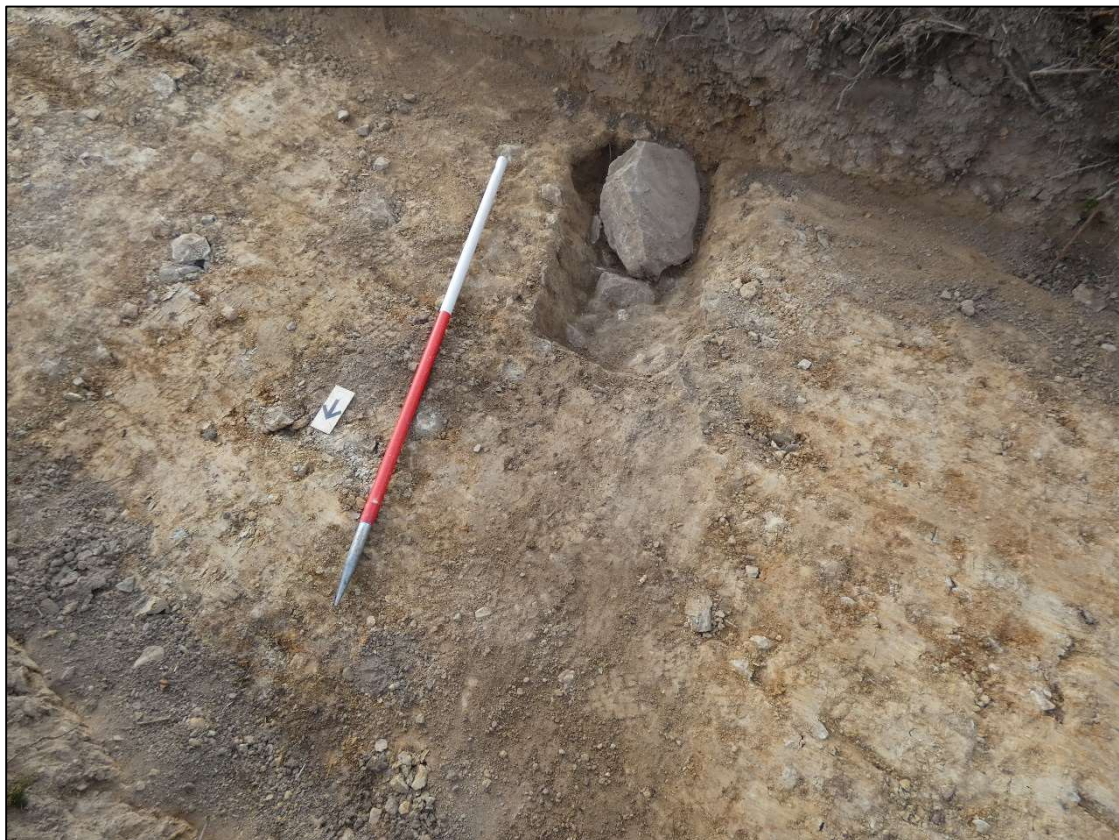
Figure 21: A land drain filled with stone in Trench 10.

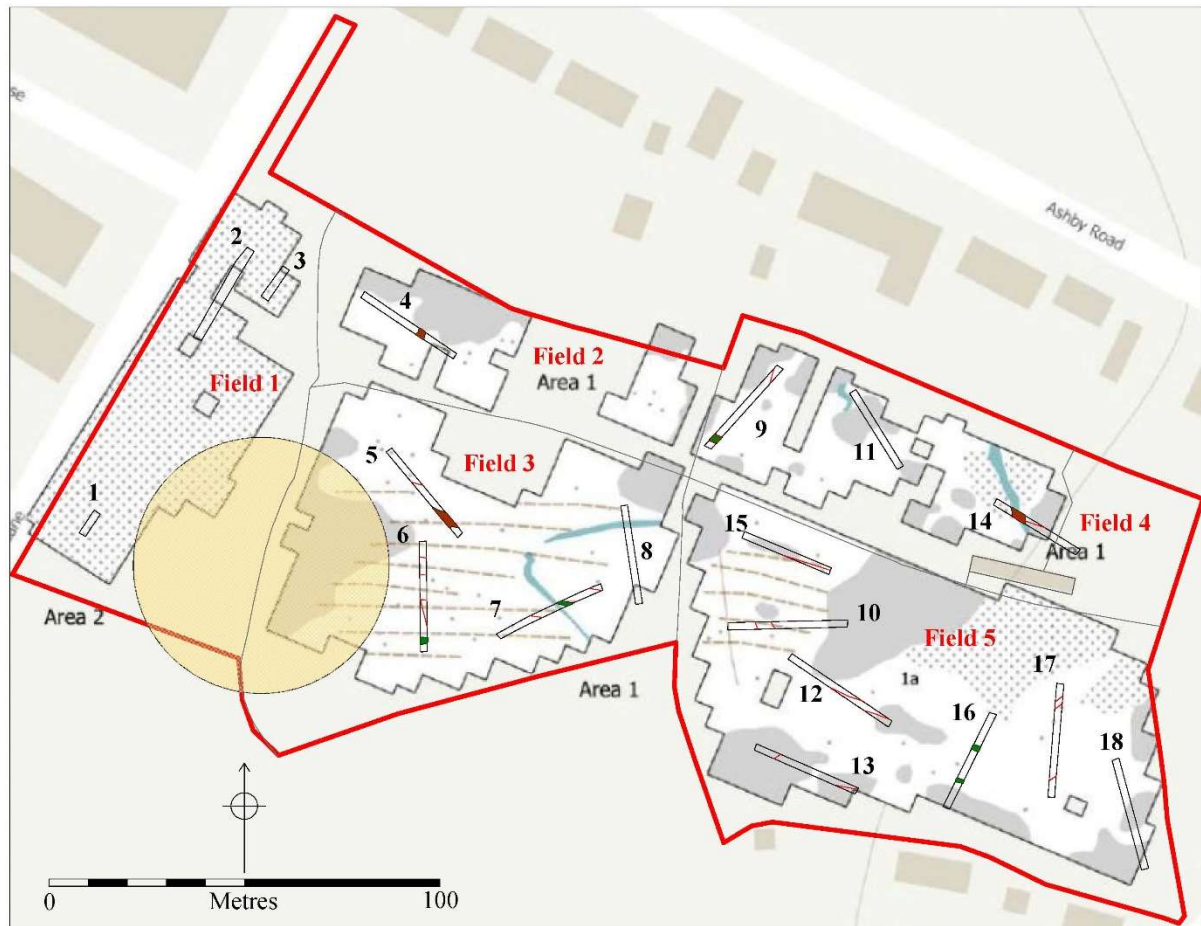
A programme of archaeological trenching was undertaken by ULAS at Hill Lane, Markfield, Leicestershire. Previous geophysical survey identified no anomalies that strongly suggest archaeological activity. Anomalies from ridge and furrow cultivation along with modern demolition debris were identified. Several weak anomalies of an uncertain nature were also identified (Clements 2021, p11).

Figure 22: The site plan overlaid with the geophysical plan (Clements 2021, p18).

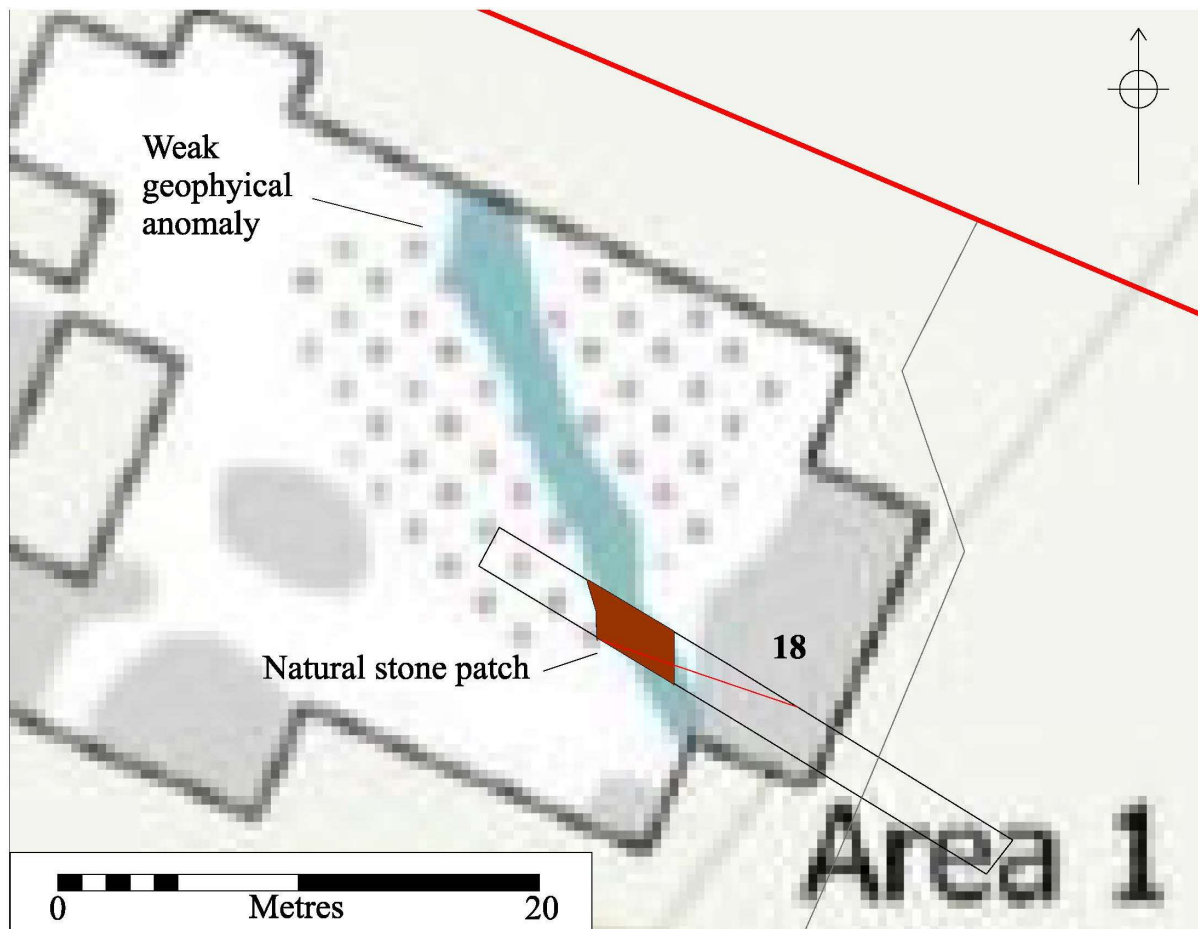
The results of the archaeological trial trenching show that no archaeological remains were present in the area investigated. A spread of ferrous debris was identified through geophysical survey in Field 1, and this is likely to be the result of a 20<sup>th</sup> century landfill. Several weak geophysical anomalies were identified (blue lines in Figure 22) however none of these were archaeological. The large curvilinear anomaly in Trenches 7 and 8 could not be identified, however it is possible this is the result of changes in geology, which occasionally had patches of stones within it. In Trench 14 a band of stones was found at the western end of the trench, and this corresponds to the location as another weak geophysical anomaly (Figure 23).

Figure 23: Trench 14 overlaid with the geophysical survey.

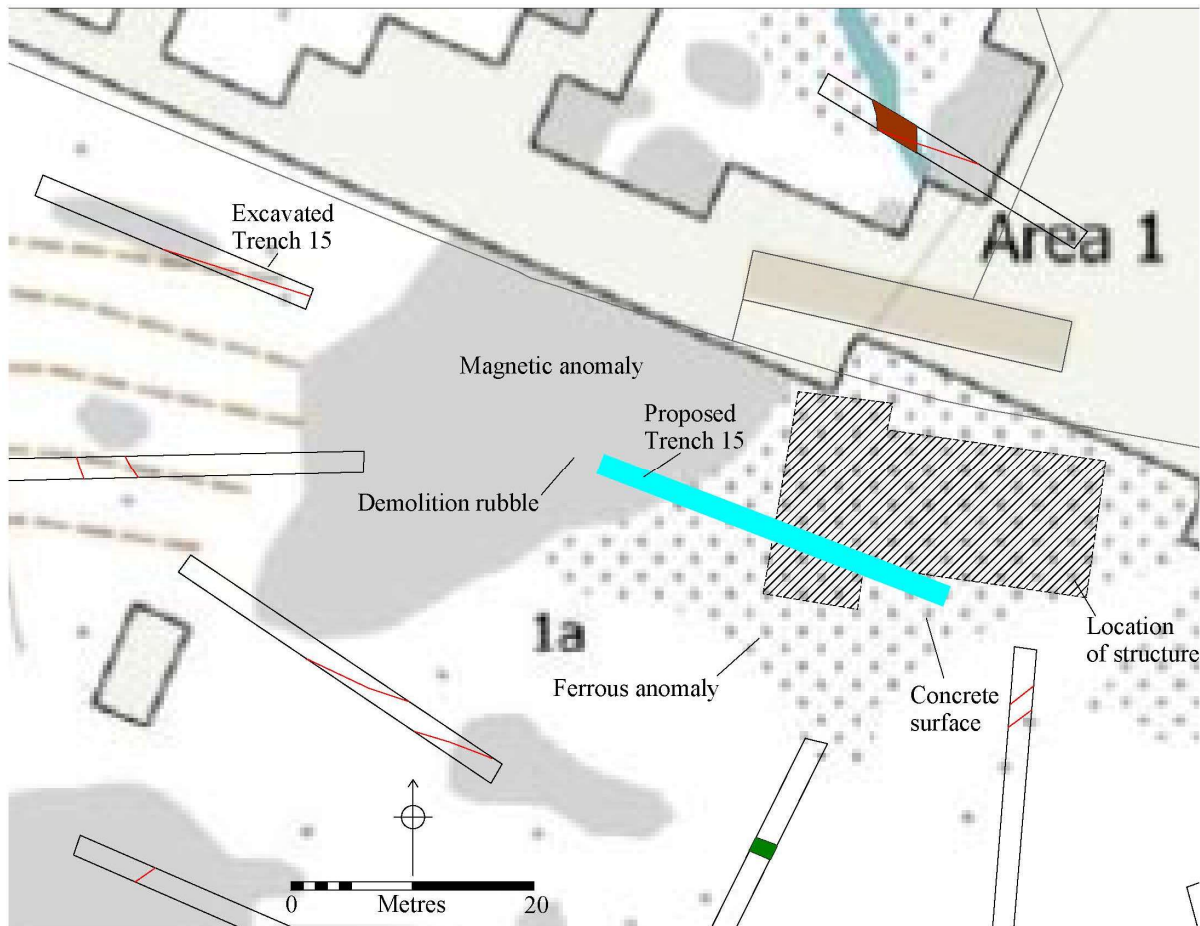
Figure 24: The proposed location of Trench 15 with the geophysical overlay and location of former building highlighted.

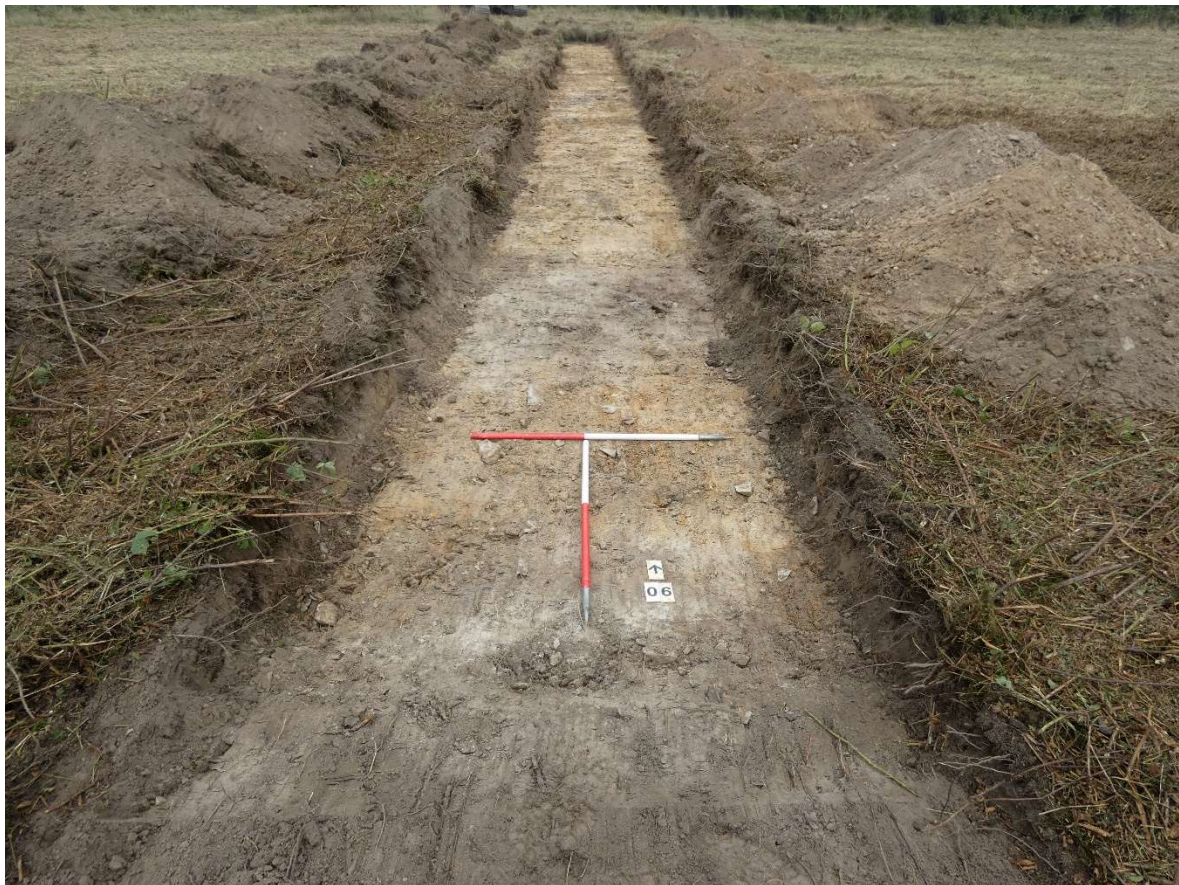
Photo 10. Furrow in the southern end of Trench 6.
