# Cadeby Hall, Cadeby

## Non-Licensed Method Statement for Bats

Report No. 260710.2.NLMS.v1.1

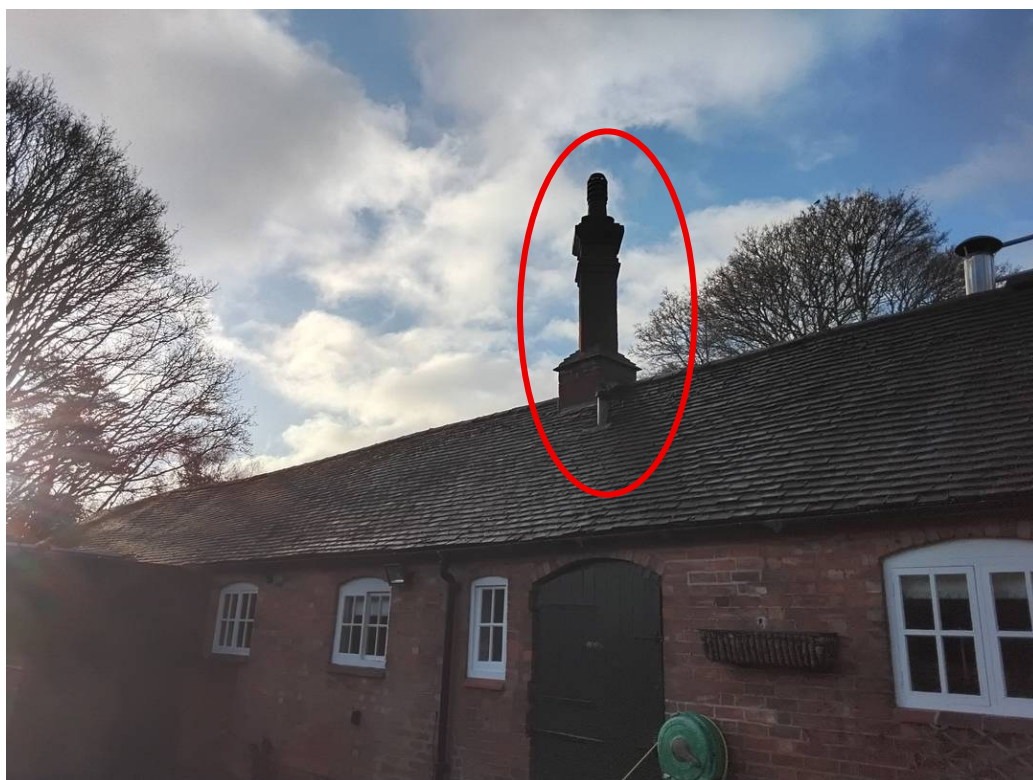
*Figure 1 B1, with the chimney affected by the works circled in red*

The purpose of this Method Statement is to provide a precautionary method of working for the proposed removal of the chimney from Building B1 and associated disturbance to immediately adjacent roof tiles, in order to minimise the risk of injury or disturbance to bats.

Taken together, the survey findings indicate that, if bats do occasionally use B1, such use is likely to be limited and was not associated with the chimney or immediately adjacent roof covering. The chimney itself is not considered to contain a bat access point or suitable roosting feature, and its removal is not anticipated to alter the thermal characteristics of the adjacent roof void.

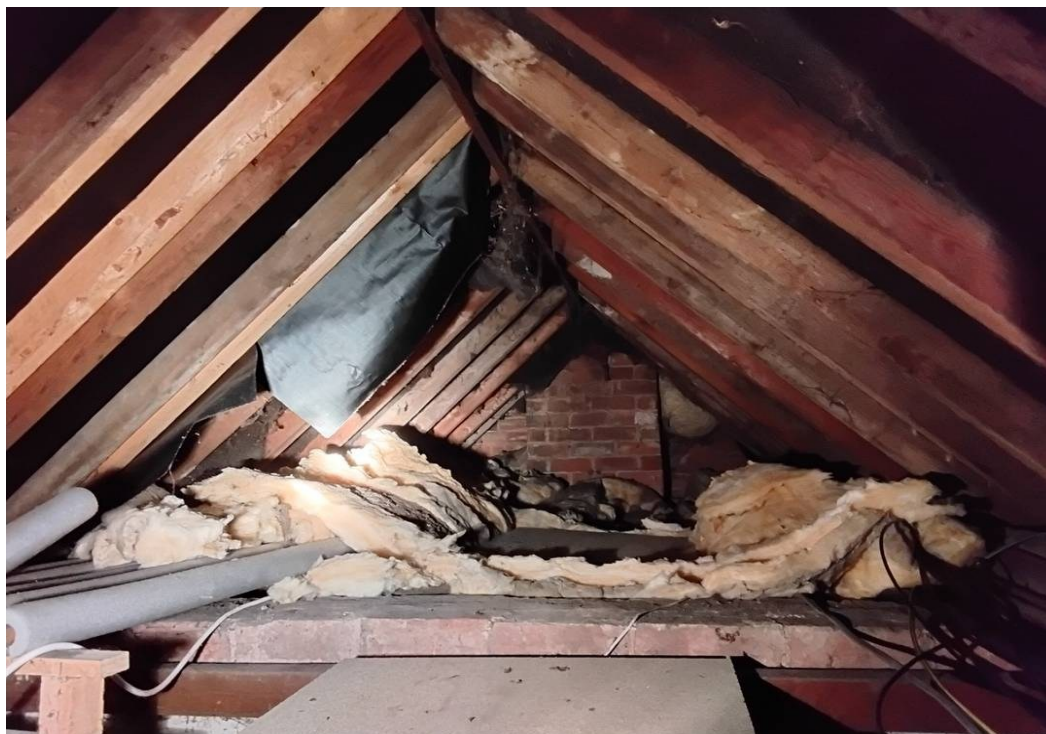
*Figure 2 Crawl space of B1, with chimney at the rear*

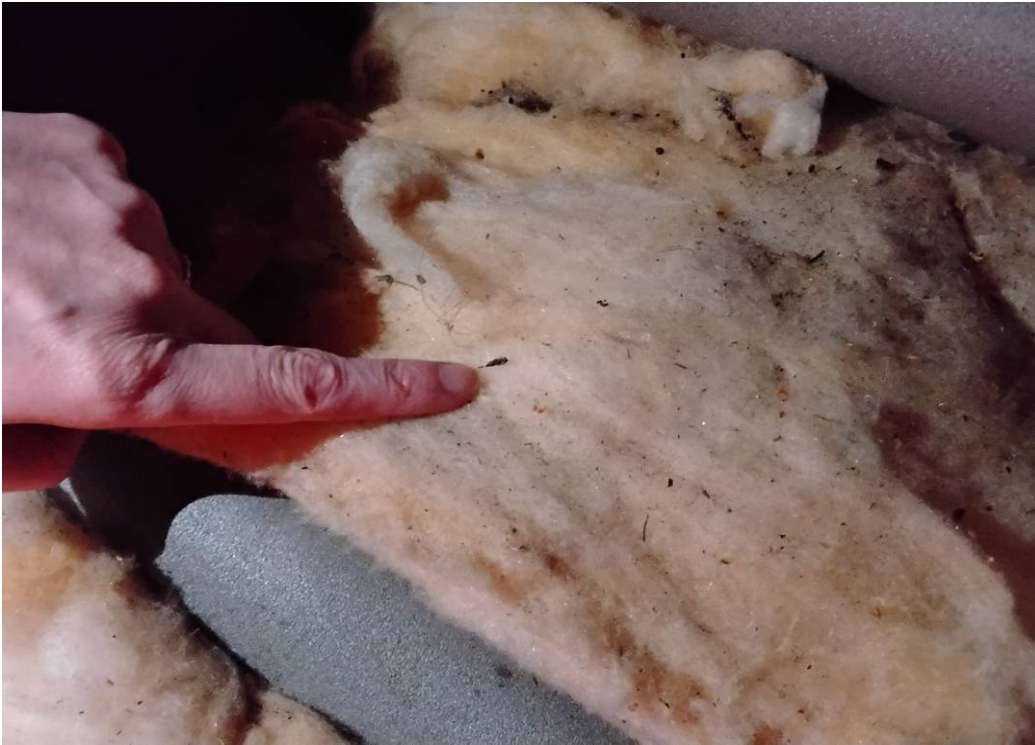
*Figure 3 Bat dropping located within the void of B1*

A Preliminary Roost Assessment undertaken by Croft Ecology on 03 March 2026 identified Building B1 as having moderate potential for roosting bats due to several potential access points around the ridge tiles, roof tiles and lead flashing. A small number of pipistrelle-type droppings were also recorded within the roof void. These indicated that bats may occasionally

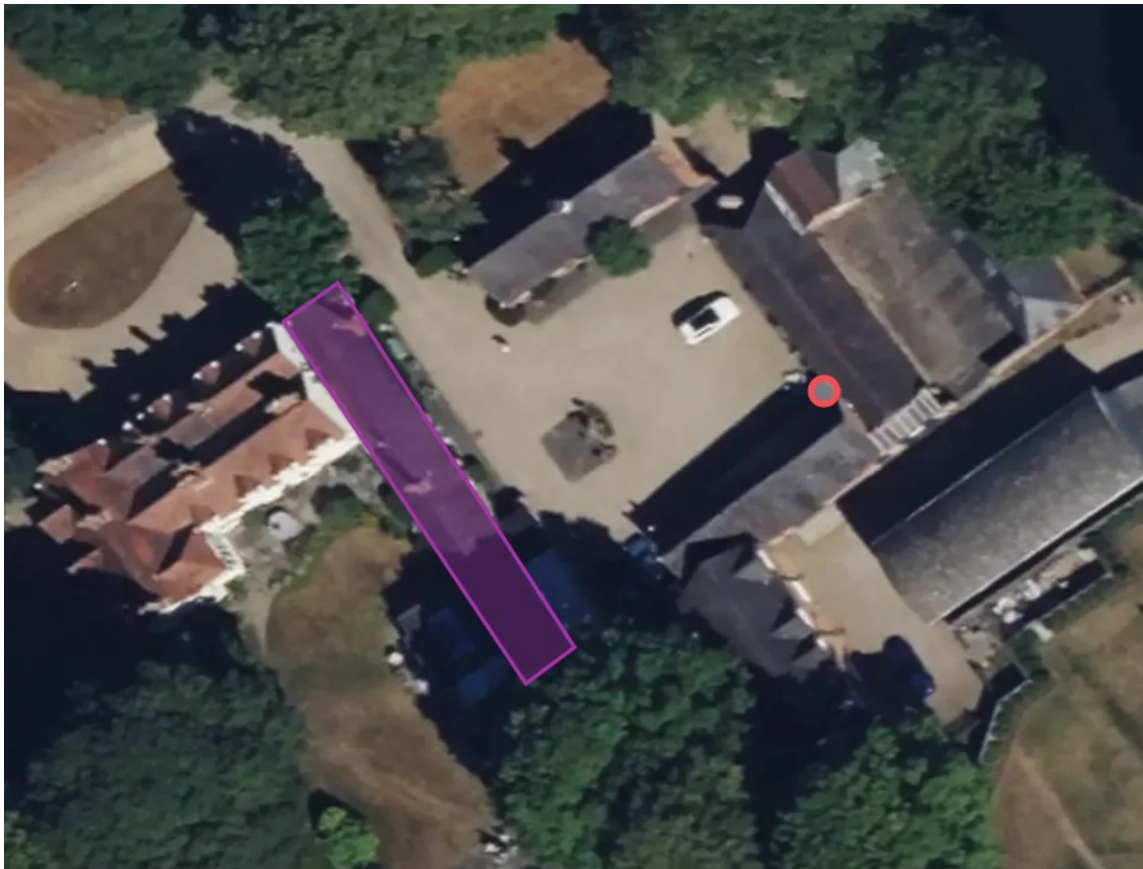
*Figure 4, Red dot showing the emergence location of the Myotis bat, adjacent to the Site*

External lighting associated with the development will be designed and positioned to avoid unnecessary illumination of retained trees, garden habitats and surrounding buildings, including the nearby courtyard building from which a *Myotis* sp. bat was recorded emerging during the bat surveys. Figure 4 below shows the building in which the bat was seen emerging from.

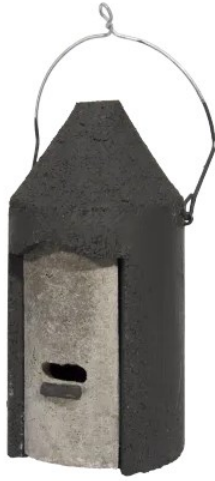
*Figure 5 2F Schwegler Bat Box, available from various sources*

The inclusion of two 2F Schwegler bat boxes, or similar (Figure 5), on the retained mature trees within the southeast of the garden is recommended to provide enhanced roosting opportunities for bats. The boxes should be installed prior to works commencing, at a height of at least 3m, on southwest and southeast-facing aspects, and away from artificial light sources.

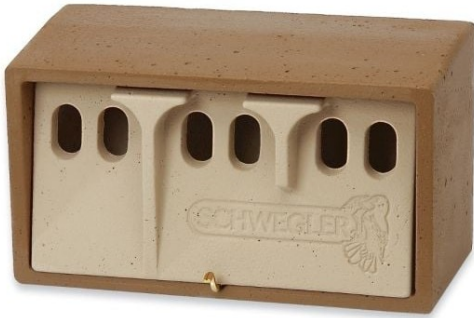
*Figure 6 Schwegler house sparrow terrace, available from various sources*

The inclusion of one Schwegler House Sparrow Terrace, or similar (Figure 6), attached to B1 is also recommended to provide enhanced nesting opportunities for house sparrow. The box should be installed on the northeast elevation, at least 2m above ground level and directly below the eaves, where it will be suitably sheltered.

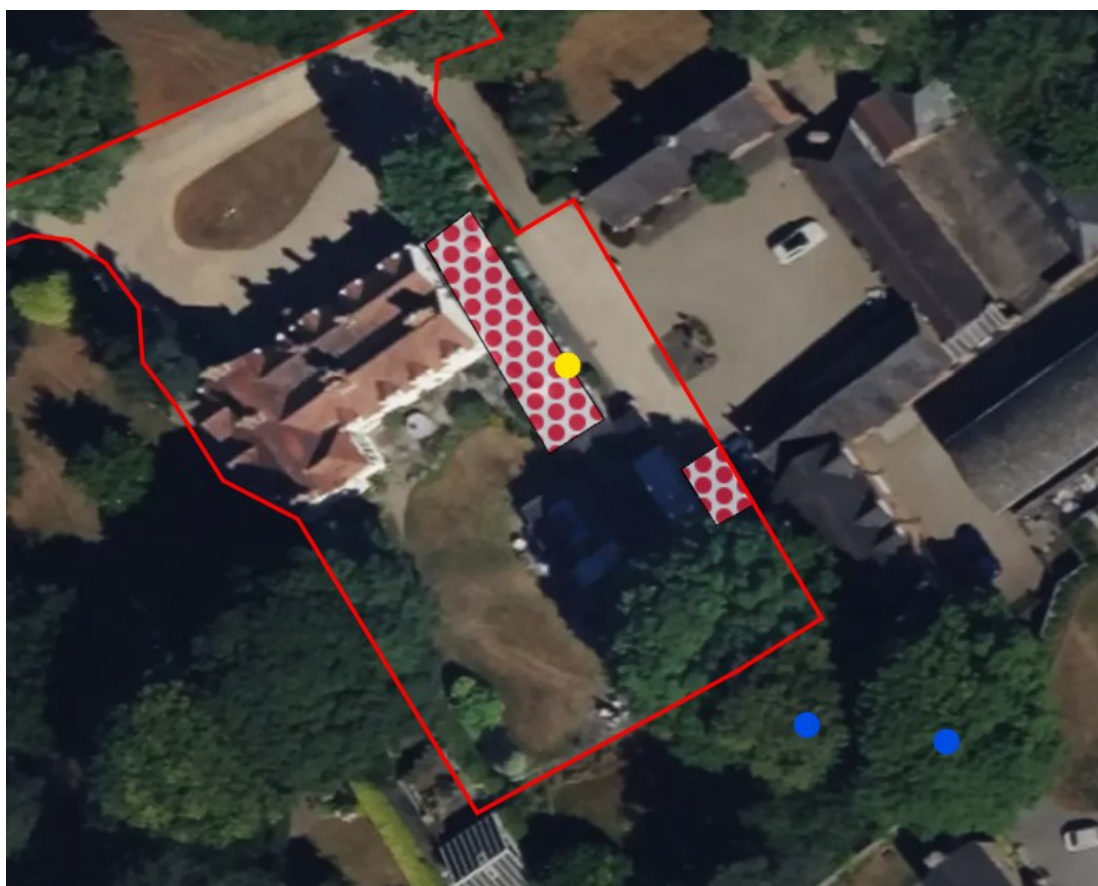
*Figure 7 Position of bat boxes (blue dots), and bird box (yellow dot)*

Figure 7 below shows an annotated image showing the position of the bat and bird boxes.
