# Heritage Statement

Land off York Close, Market Bosworth

On behalf of Gladman

Date: 28th June 2024 | Pegasus Ref: P21-2986

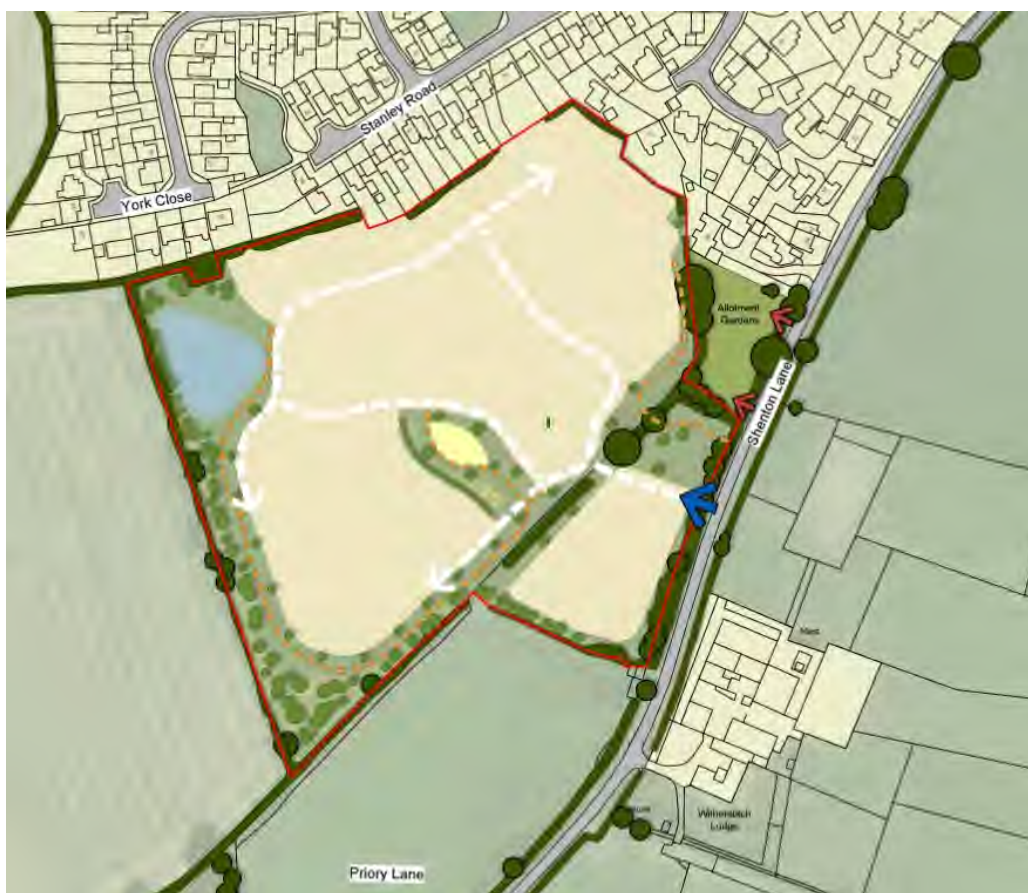
*Plate 1 Development framework for Application 22/00167/OUT*

- 1.7. An application was previously made for the residential development of land North of Shenton Lane, Market Bosworth in February 2022 (LPA reference 22/00167/OUT). This was notably different in that built form was proposed in the smaller south-eastern field of the site, and that off-site highway works were proposed on Shenton Lane, from which access was proposed.

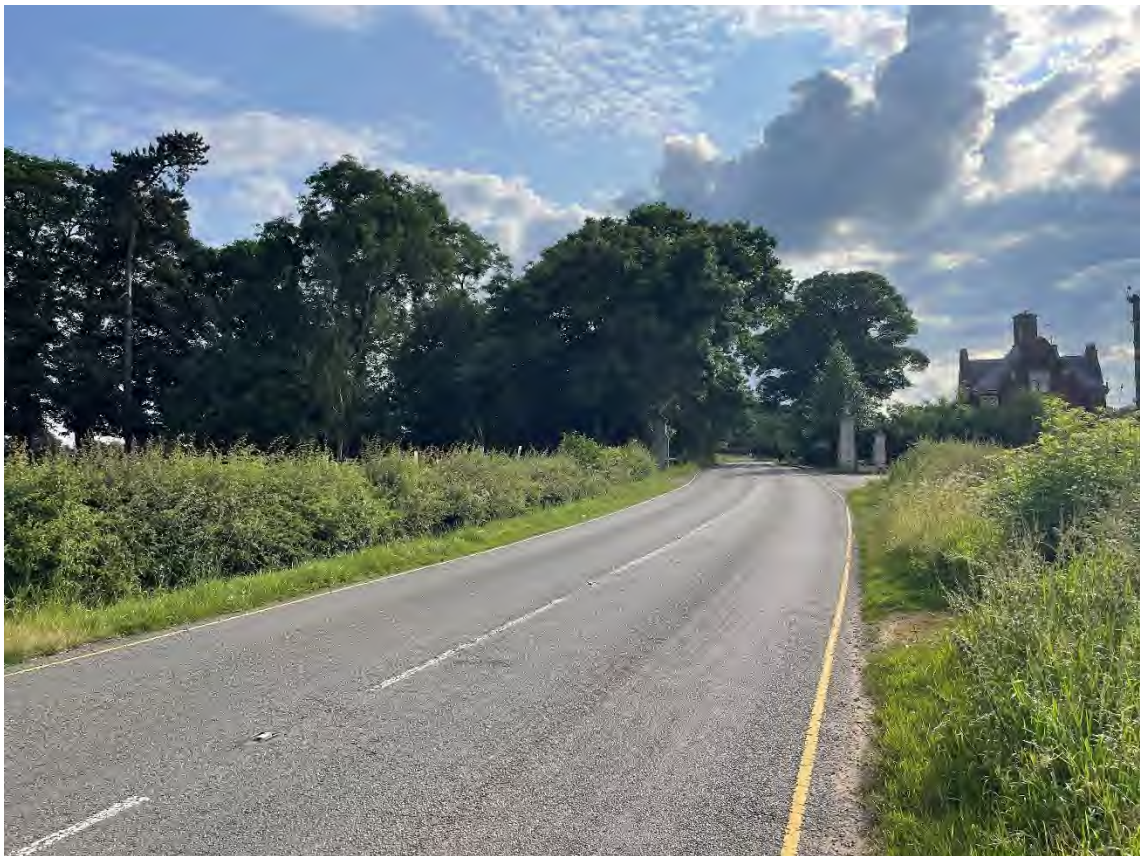
*Plate 2 Looking west along The Park/Bosworth Road*

2.8. The section on gateways first notes the approach from the east, along The Park, with the entrance to the village alongside the Listed Gate House and Gate Piers, with the parkland within the Conservation Area beyond, and flanked by open countryside. Clearly, this is the approach to Market Bosworth that contributes the most to its heritage significance through setting (Plate 2).

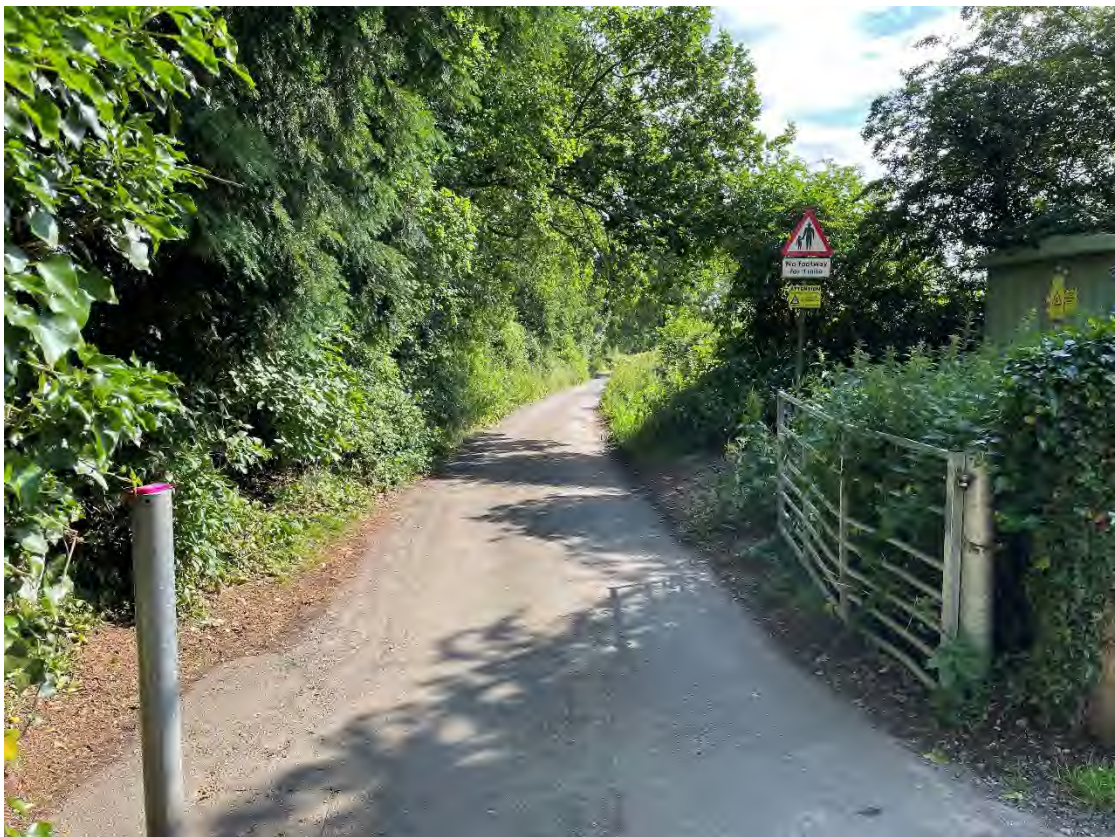
Plate 3 Looking south down Sutton Lane

2.11. With regards to Sutton Lane, the approach is highly rural in character, with the lane approaching through a field with the routeway unenclosed, hence the need for the gate at the southern edge of the Conservation Area (Plates 3-5).

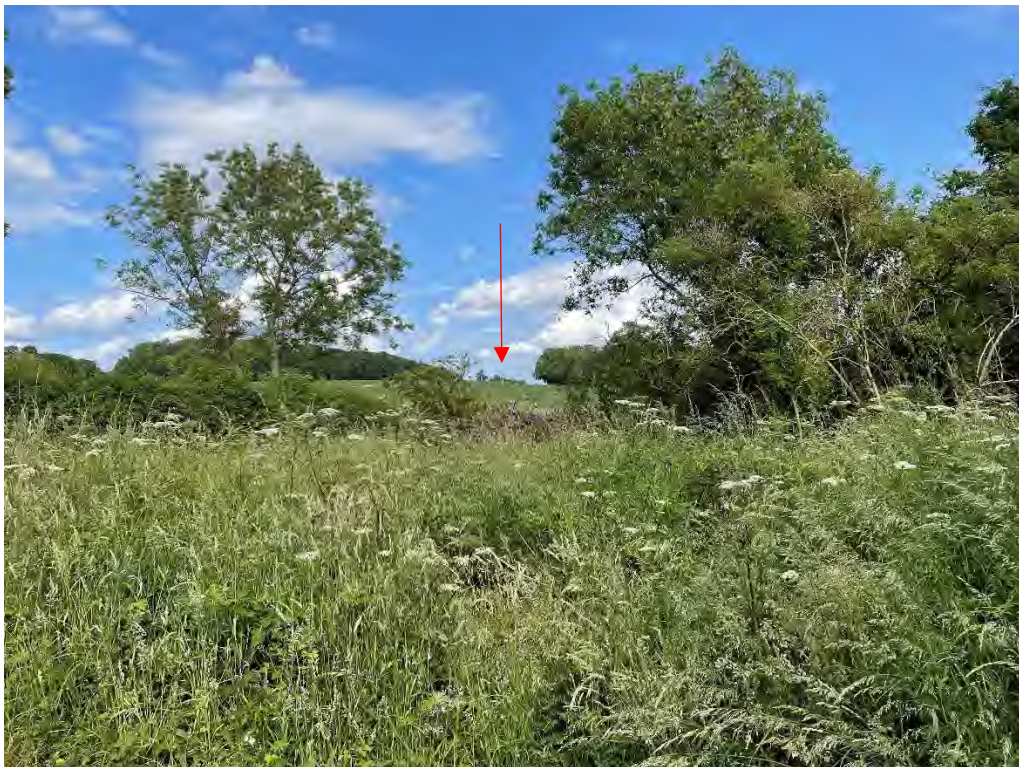
*Plate 4 Looking north-east to the Hercules Monument from Sutton Lane*

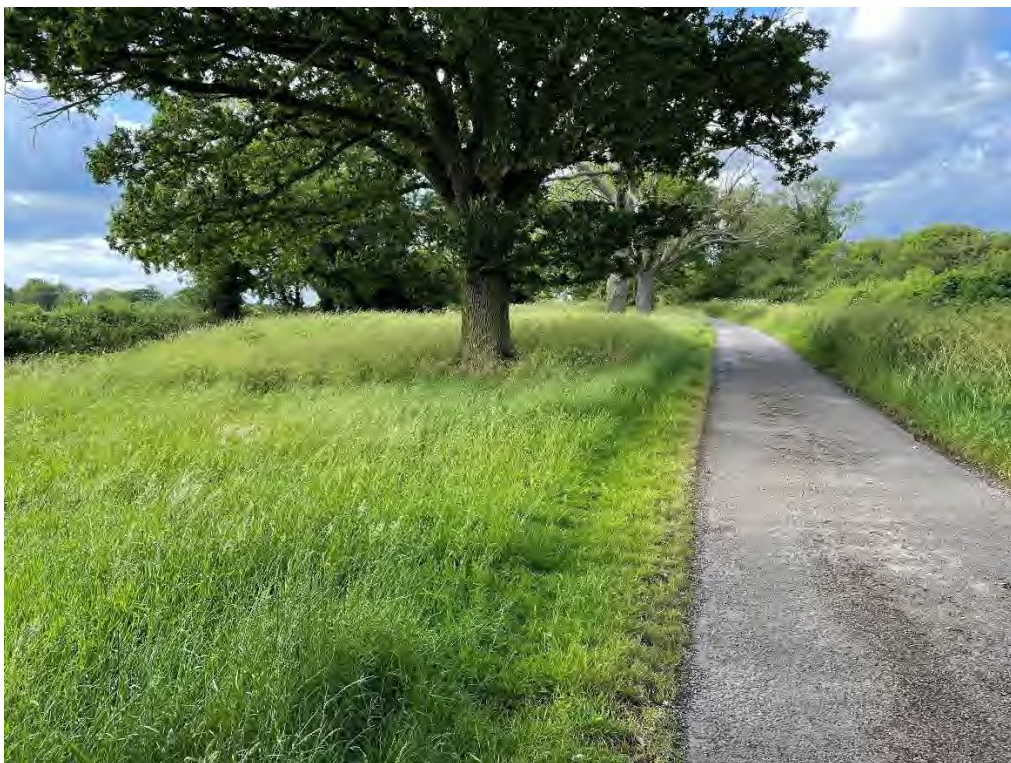
*Plate 5 The highly rural character of Sutton Lane, passing through a field, south of the Conservation Area*

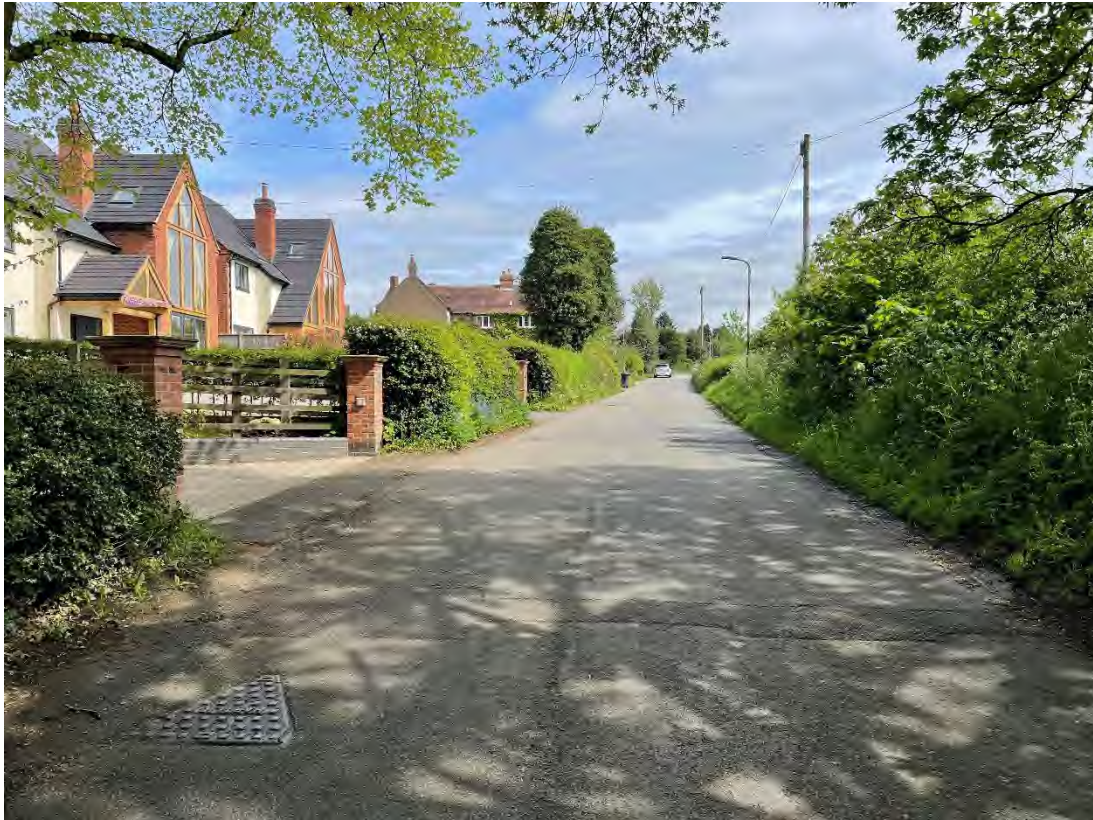
*Plate 6 Looking north along Shenton Lane*

- 2.12. With regards to Shenton Lane, this is predominantly rural in character south of the Conservation Area, although with some settlement south of the boundary of the area, west of the lane (Plate 6). It should also be noted that the dip under the railway mentioned in the appraisal lies over 2km south-west of the Conservation Area (Plate 7).

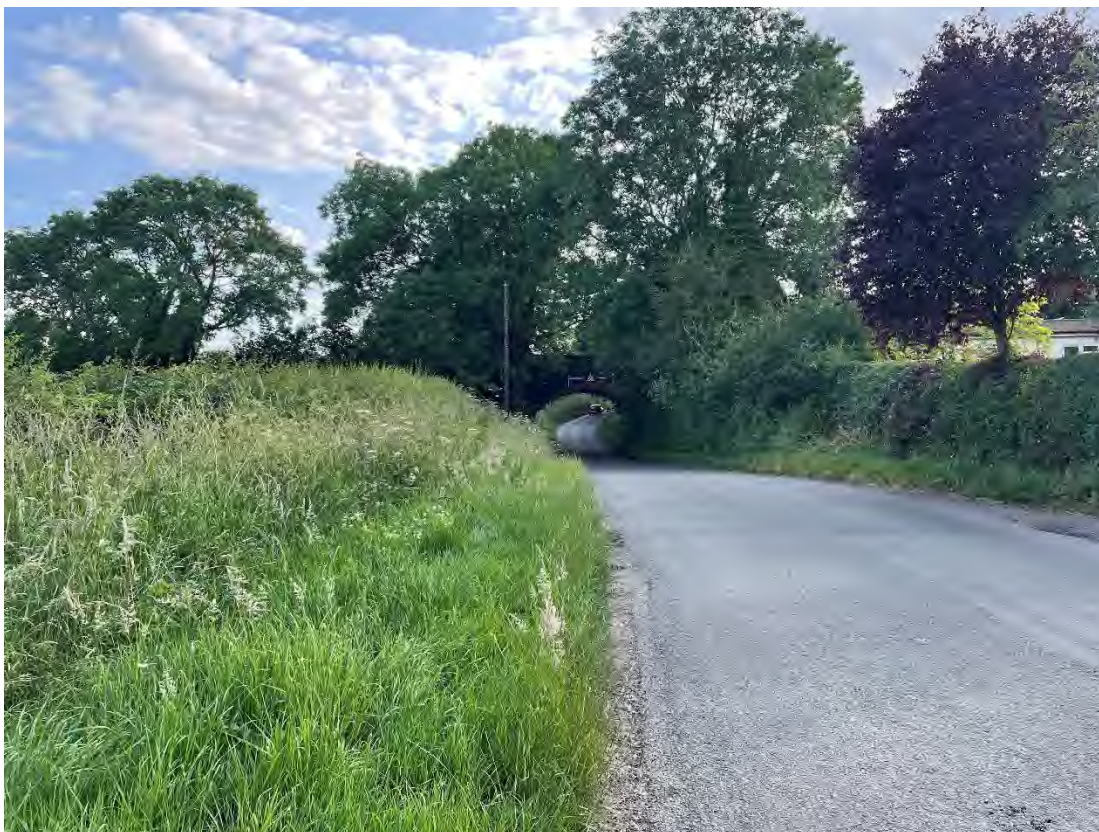
Plate 7 The 'dip' of Shenton Lane beneath the Railway Bridge, over 2km south-west of the Conservation Area

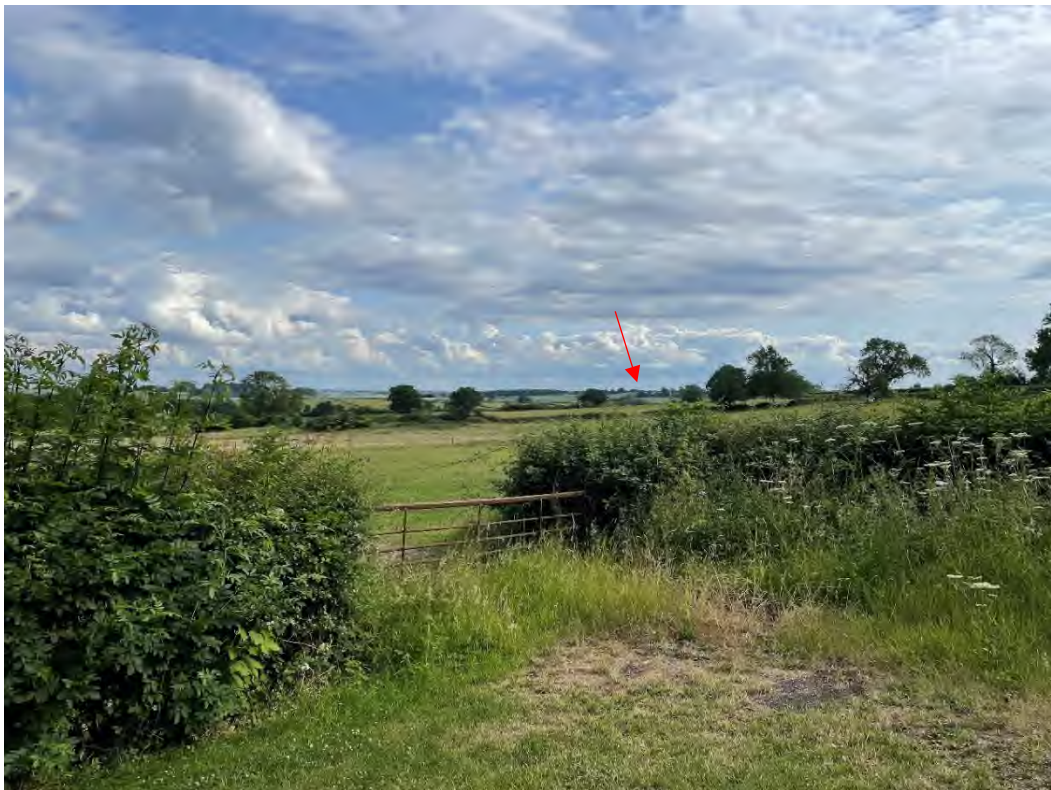
*Plate 8 Looking south from Shenton Lane (flags at Battlefield Centre arrowed)*

*Shenton Lane to the west leads out into open farmland with views southeast towards Bosworth Battlefield. Sutton Lane is narrow and gated again presenting an important vista into the countryside beyond. [Plate 8, below]*

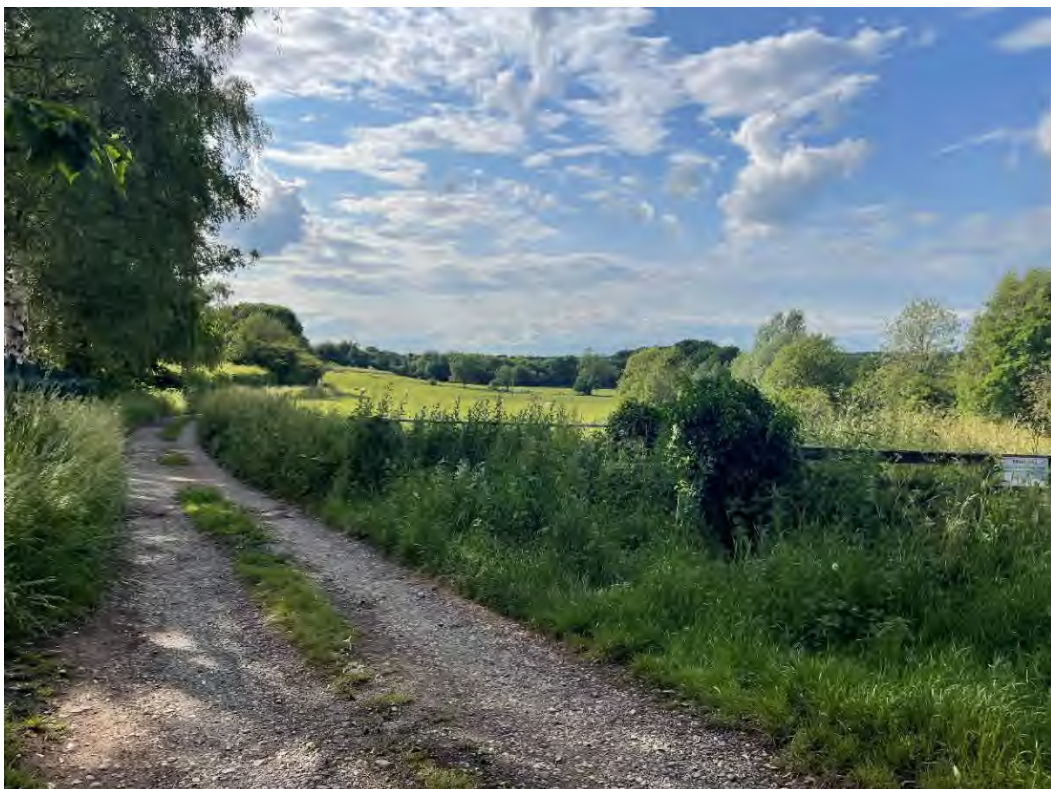
*Plate 9 Looking north-west from Back Lane*

*There are also fine views from Back Lane [Plate 9, below] and down Barton Road [Plate 10, below] northwards across woodland and open countryside.*

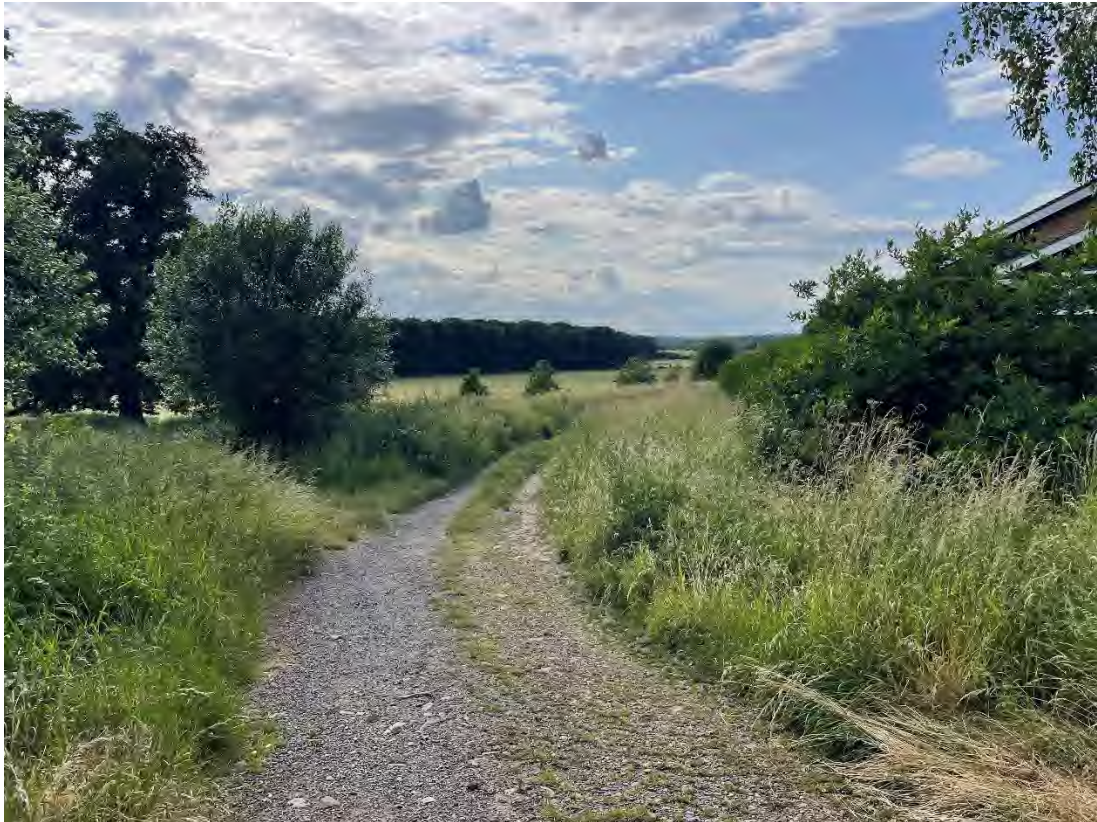
*Plate 10 View looking north-east from Barton Lane*

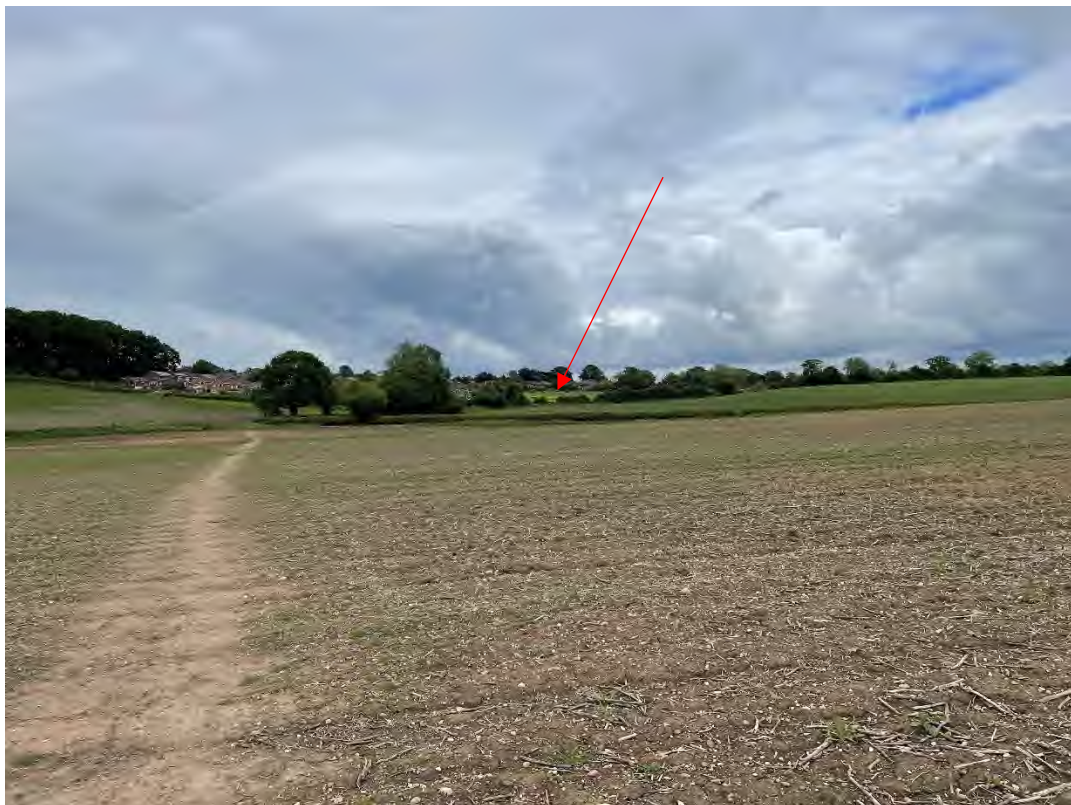
*Plate 11 Looking west towards Market Bosworth (site arrowed red)*

- 2.21. The larger field of the site is set some distance away from the historic core of the settlement and the Conservation Area and is separated from it by modern built form. It is not readily experienced in views from key approaches to the settlement. There are glimpsed views of it from footpaths to the west, but in the context of modern development.

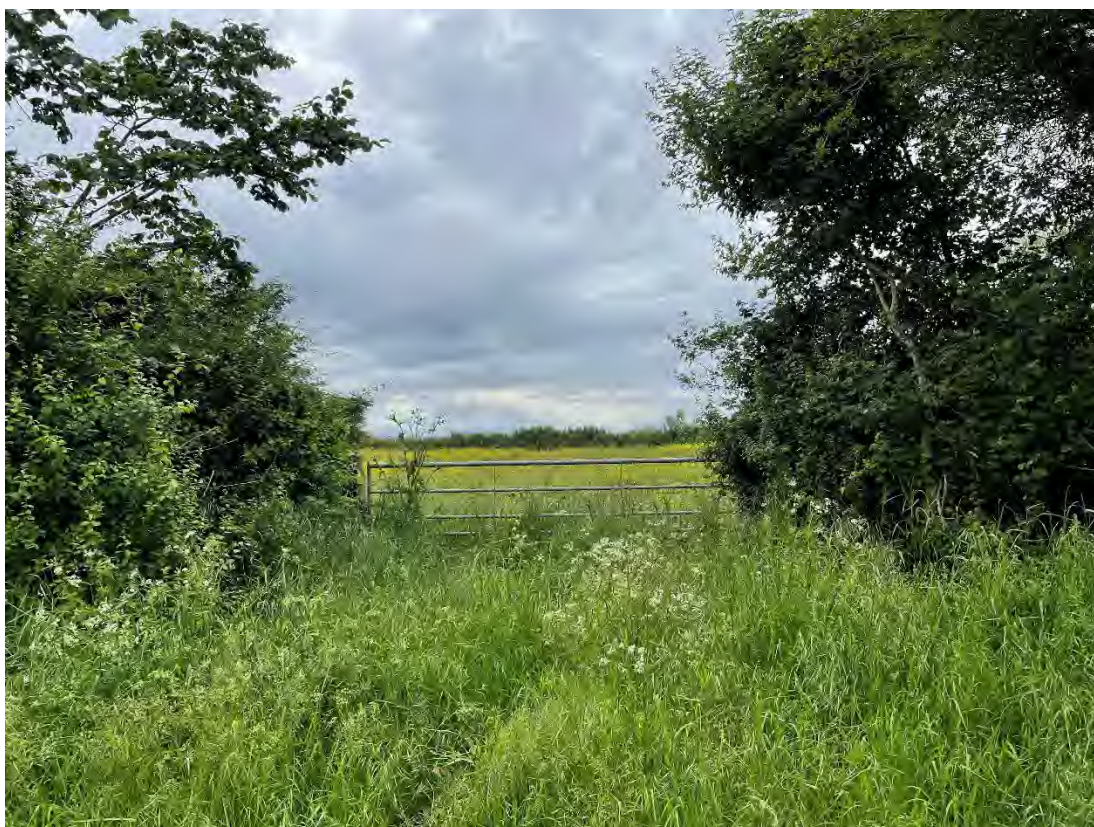
*Plate 12 Looking west into the site from Shenton Lane*

- 2.22. This field is not considered to contribute to the Conservation Area through setting.
- 2.23. The smaller area of the site which lies adjacent to Shenton Lane has limited visibility from Shenton Lane, including from the field gateway (Plate 12).

- 2.24. Whilst not contiguous with the Conservation Area, the undeveloped nature of the site as appreciable from Shenton Lane makes a very small contribution to the significance of the Conservation Area through setting, through illustrating the rural surrounds.
- 2.25. No views which take in the site are identified as a 'View to be Protected' in the Conservation Area Appraisal.

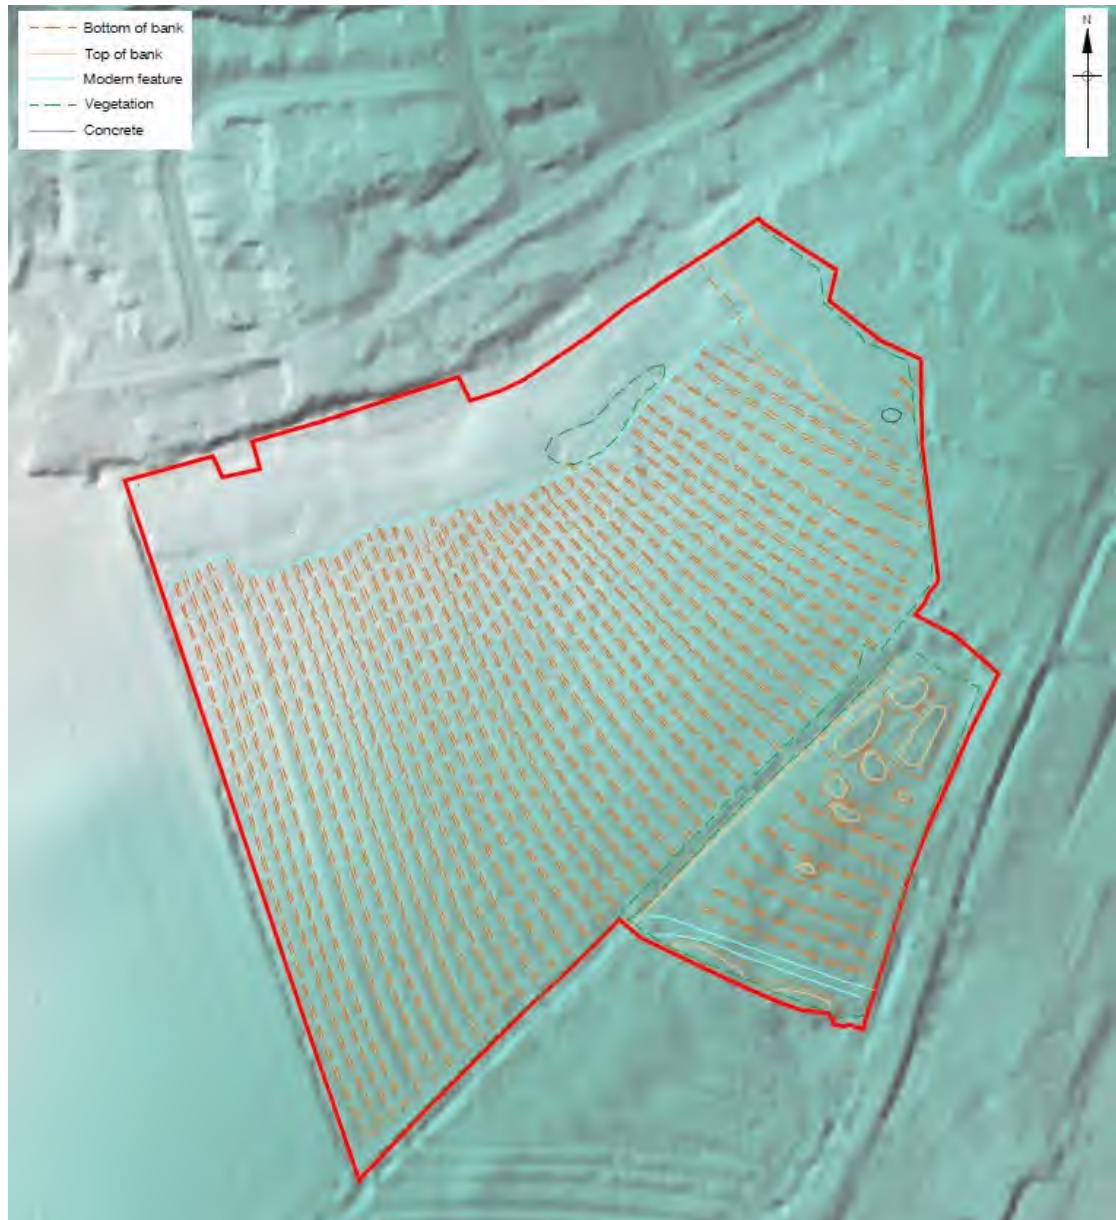
- 3.1. Ridge and furrow earthworks are present within the site, which have been subject to an earthwork survey, completed by PCA in 2022. This included topographic survey and photographic survey, the results of the former were presented in plan form (Plate 13) and as profiles.

*Plate 13 Results of the earthwork survey*

- 3.2. Legible earthworks are observable across the majority of the western field running on a broadly north-west to south-east alignment and measuring c.5.3m across (from mid-furrow to mid-furrow; Plate 14). The earthworks have an extremely slight reverse-S shape in plan.

- 3.4. The earthworks within the south-eastern area of the site run on a roughly east to west alignment and measure c.7m across (from mid-furrow to mid-furrow; Plate 13). These are noted as being slightly degraded.

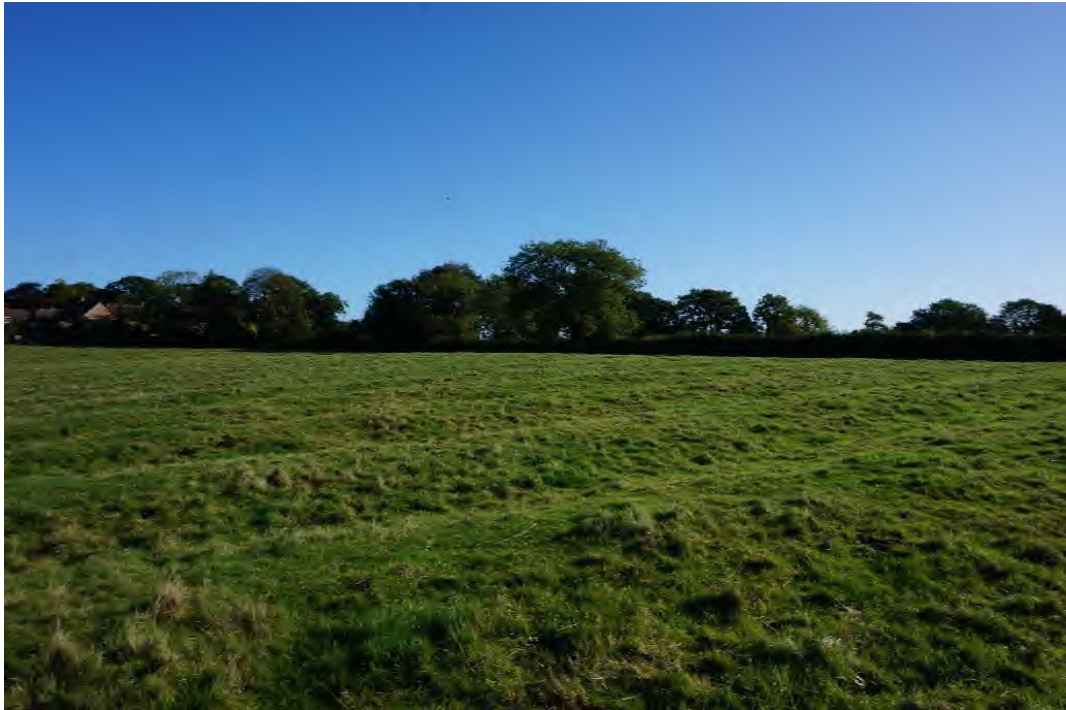
*Plate 14 Photograph from within western field, facing eastwards, showing legible ridge and furrow earthworks*

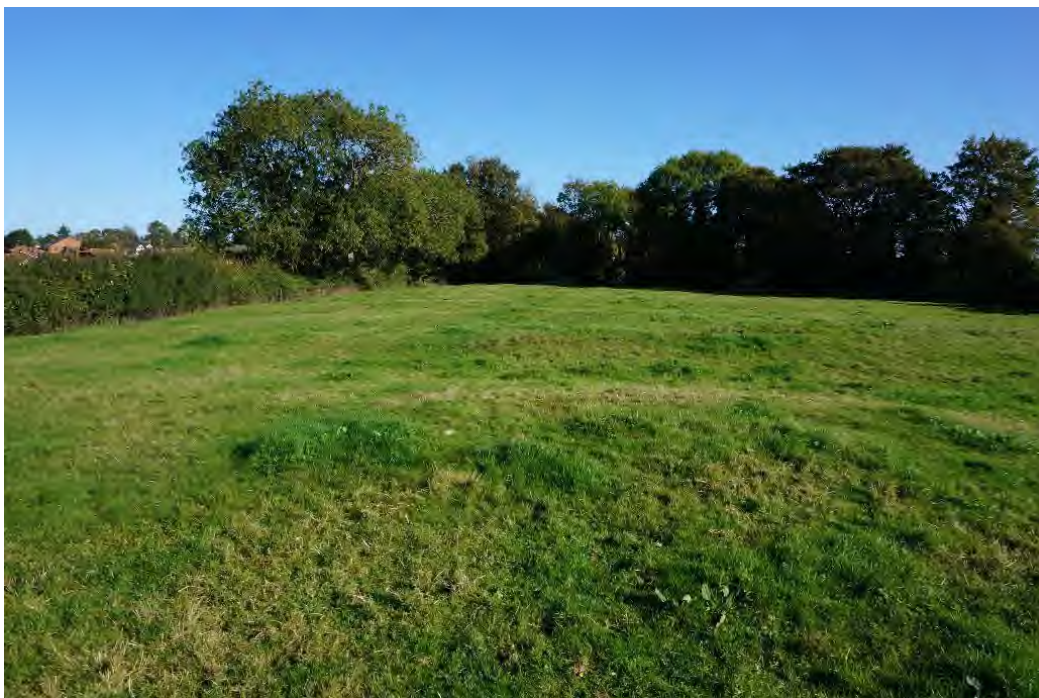
*Plate 15 Photograph taken from within south-eastern field, facing north-north-east, showing legible ridge and furrow earthworks*

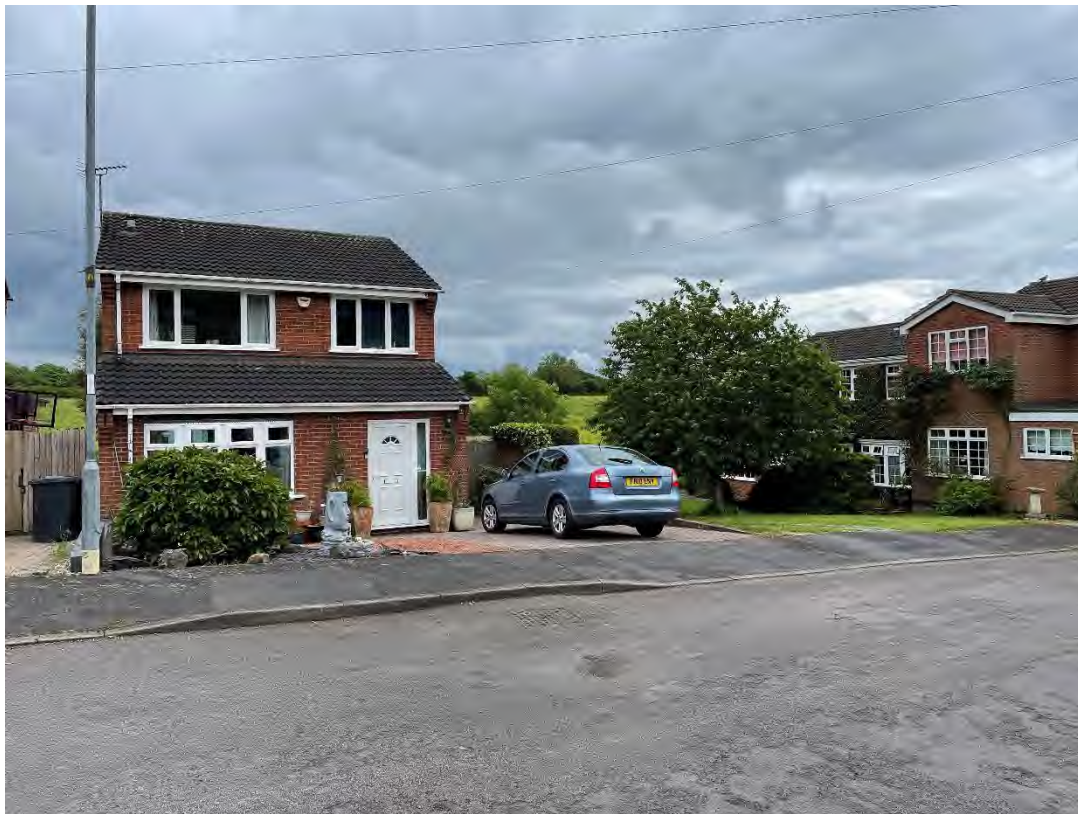
*Plate 16 Looking south to the site from Stanley Road*

- 3.7. Historic satellite imagery indicates some ridge and furrow was previously present in this area, running on a broadly north-south alignment. Again, this would have formed part of a larger block of ridge and furrow which continued northwards.
- 3.8. There are only limited, publicly accessible views of the ridge and furrow within the site. Occasional glimpsed views of the ridge and furrow within the east of the site are possible from Shenton Lane, and occasional distant, glimpsed views are possible from York Close, and Stanley Road (Plate 16) to the north of the site, between some of the residential properties which abut the site's northern edge.

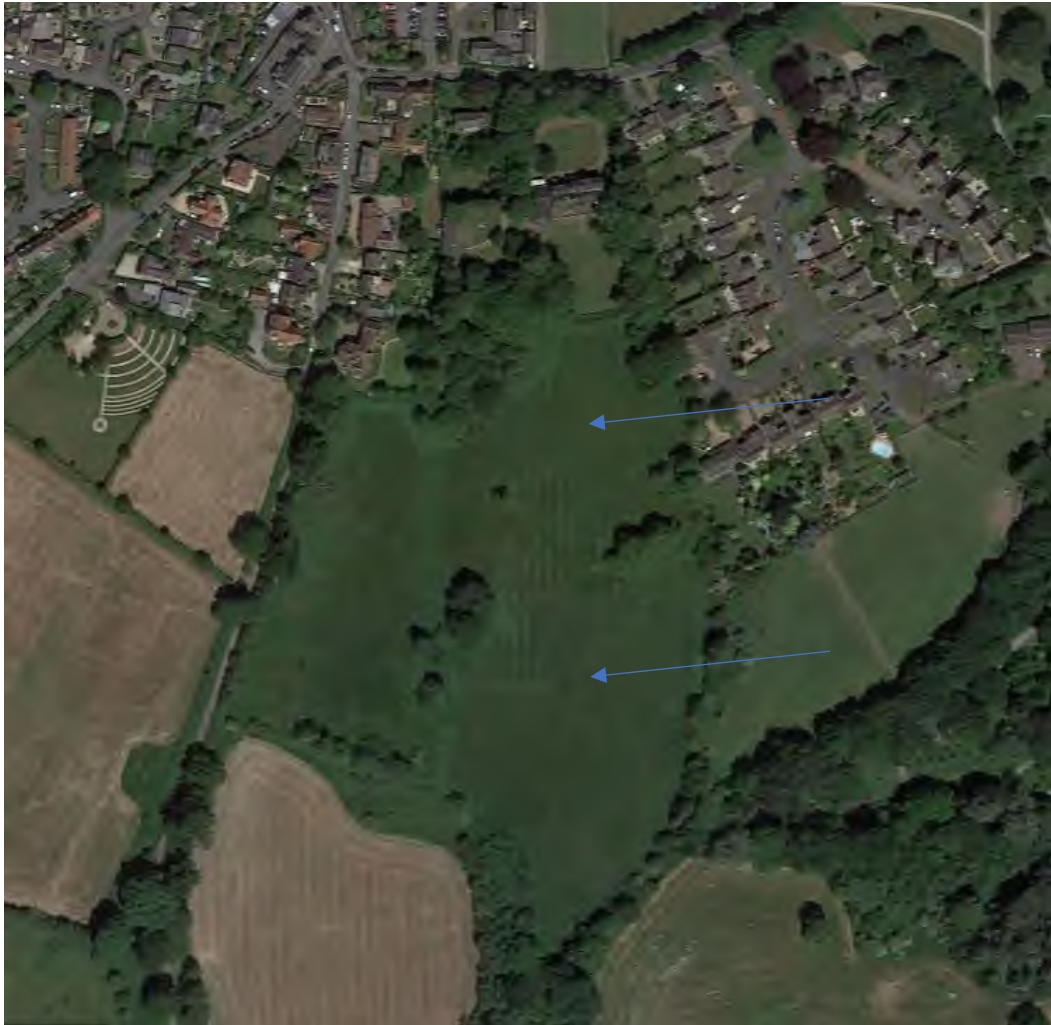
- 3.11. Interestingly, other areas of ridge and furrow within the parish have not been included in this list. This includes the earthworks within fields to the south of the Old Rectory (Plate 18).

These earthworks lie within a corridor of open land directly to south of the historic settlement core and give a far better appreciation of past land use, providing a more legible link between the historic settlement and its agricultural hinterland.

*Plate 18 Ridge and furrow south of The Old Rectory*

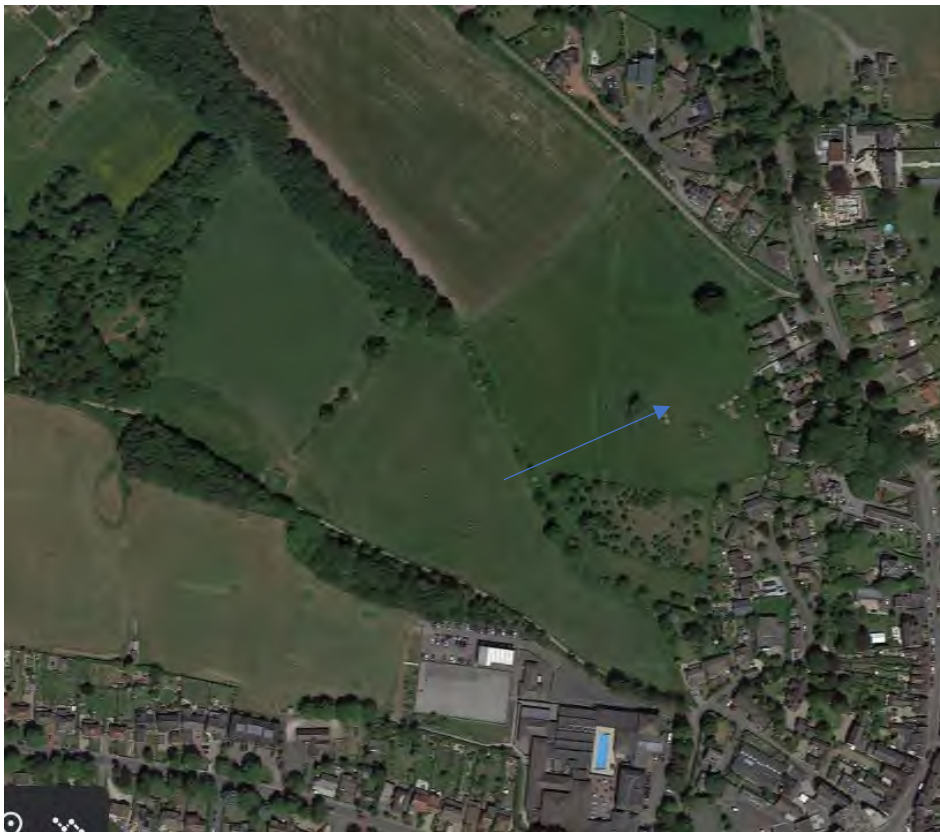
- 3.12. Ridge and furrow earthworks also lie to the north-west of the settlement, where they are crossed and flanked by public rights of way (Plates 19 and 20), again providing public legibility on the egress from the settlement.

*Plate 19 Ridge and furrow north-west of Market Bosworth*

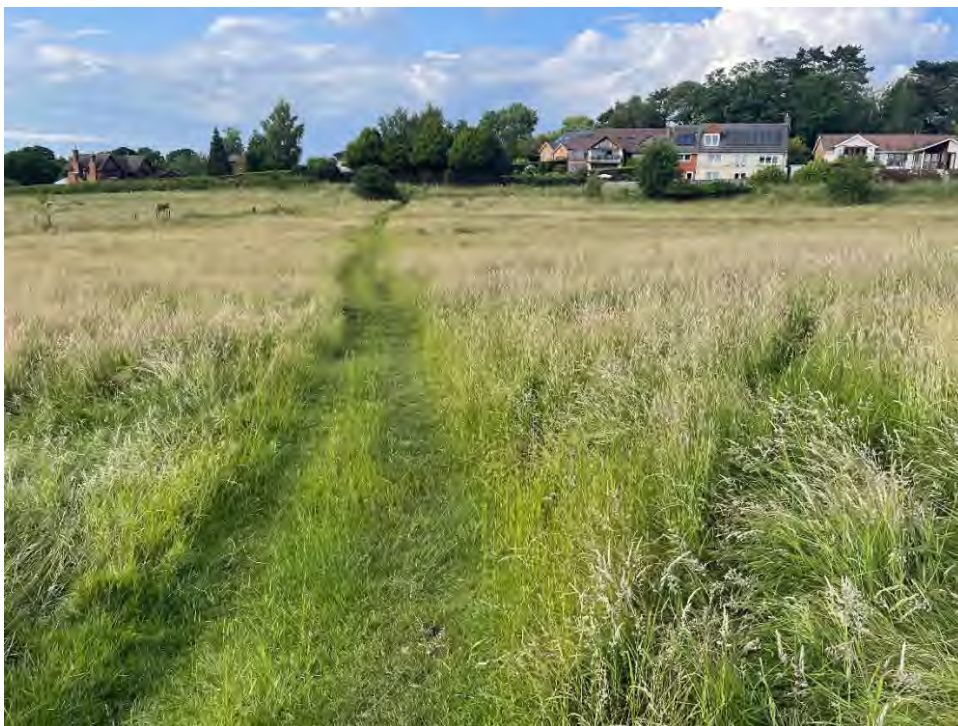
*Plate 20 Looking north across the field of ridge and furrow earthworks crossed by a public footpath north-west of Market Bosworth*

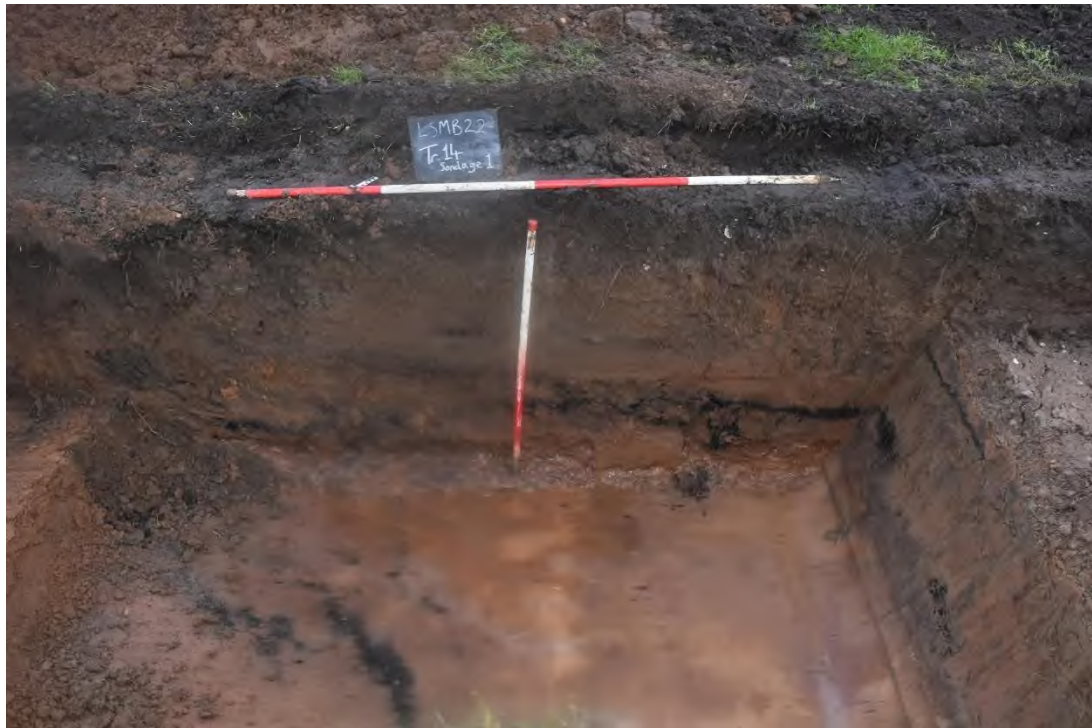
Plate 1; Trench 14, Sondage 1 into possible palaeochannel [1407], direction of view southeast, 2m and 1m scales.

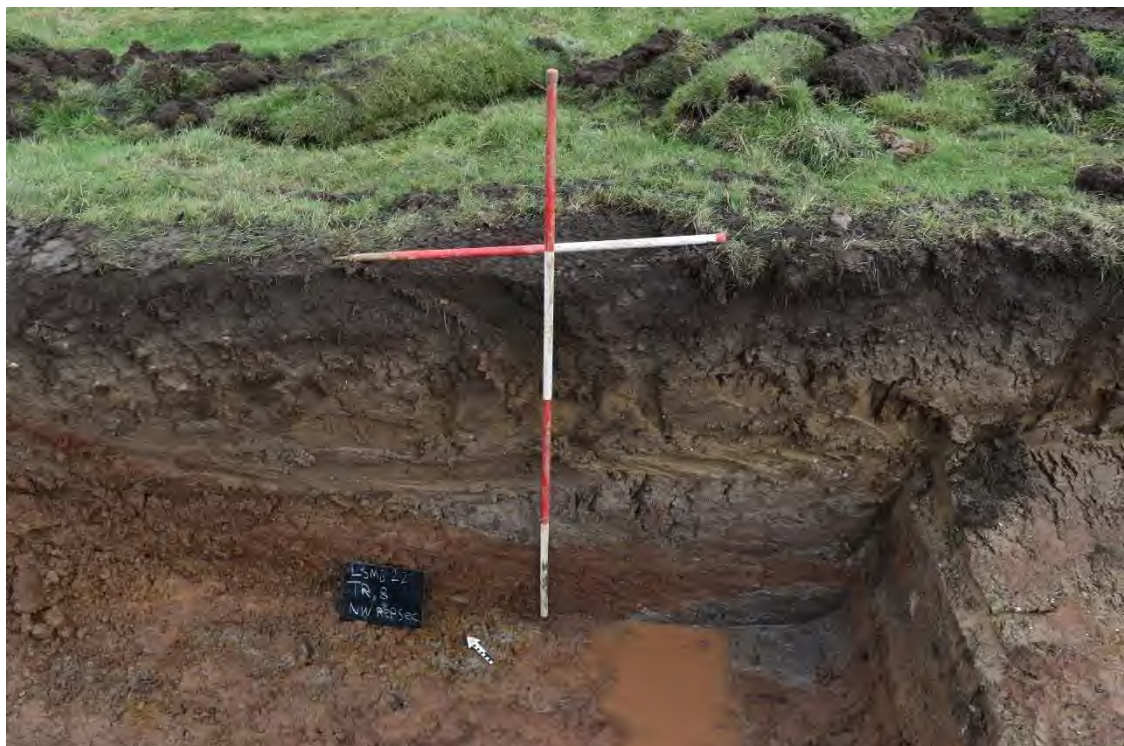
Plate 2; Trench 8, possible palaeochannel [809] covered by two colluvial layers (803) and (804), NW sec of sondage 1, direction of view northeast, 2m and 1m scales.

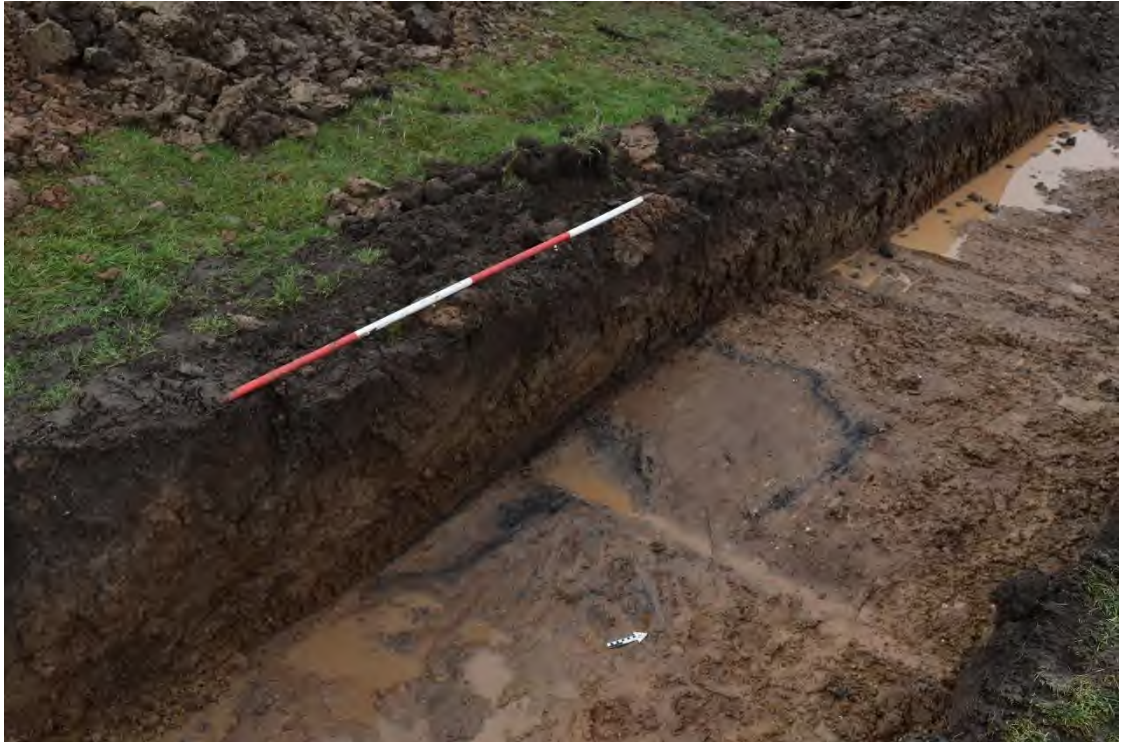
Plate 3; Trench 8, charcoal rich bands within layer (810)/ (805) in possible palaeochannel [809]. Direction of view south, 2m scale.

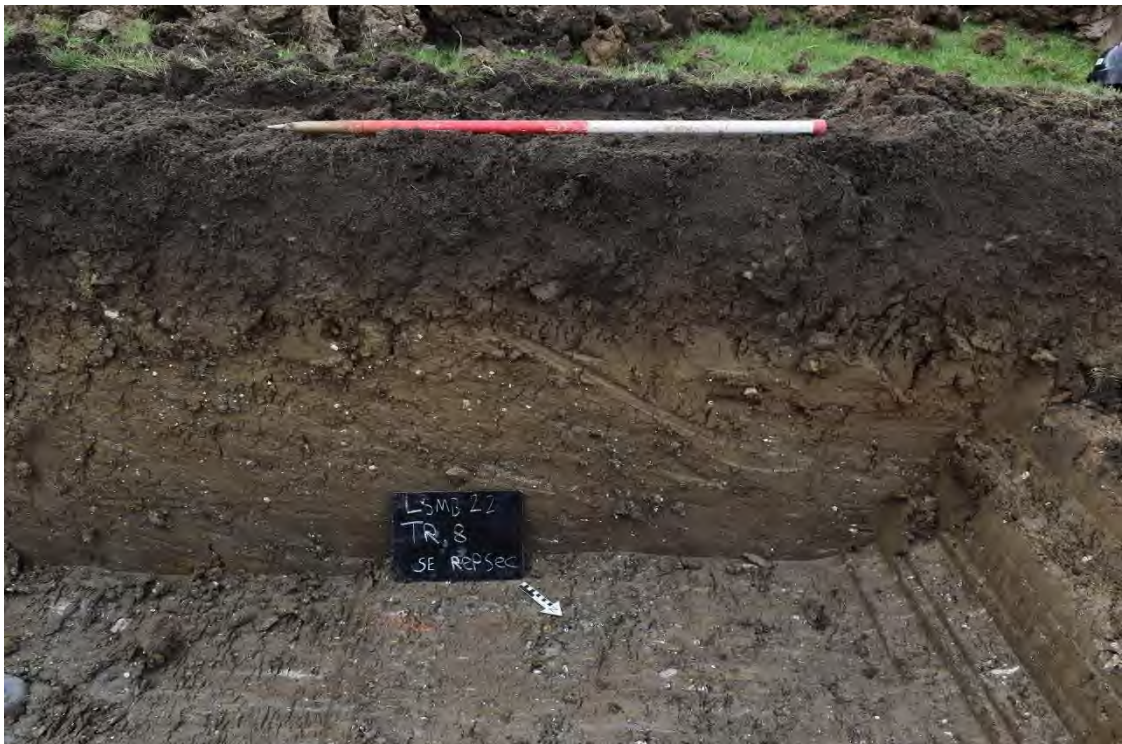
Plate 4; Trench 8, Rep sec in SE of trench shows two colluvial layers (803) and (807)/(804) that lie above natural. Direction of view southwest, 1m scale.

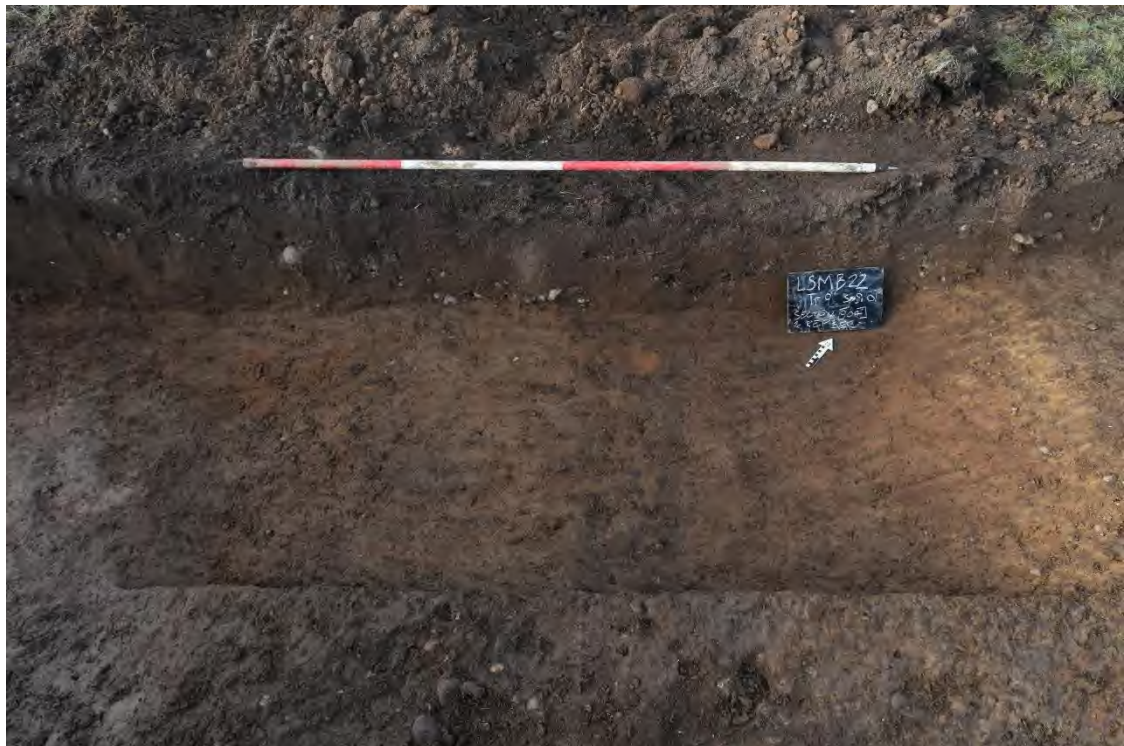
Plate 5; Trench 9, Furrow [904], direction of view northwest, 2m scale.
