# Heritage Statement

Land off York Close, Market Bosworth

On behalf of Gladman

Date: 28th June 2024 | Pegasus Ref: P21-2986

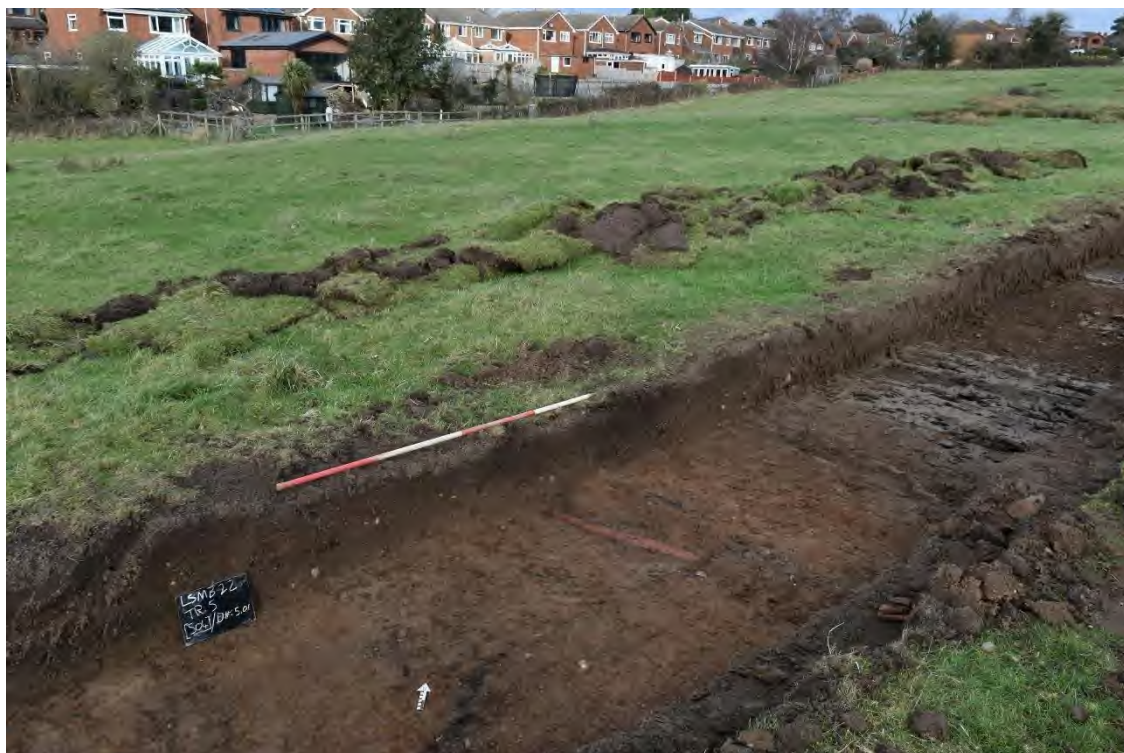
Plate 6; Trench 5, Furrow [504] with land drain running through it, direction of view west, 2m scale.

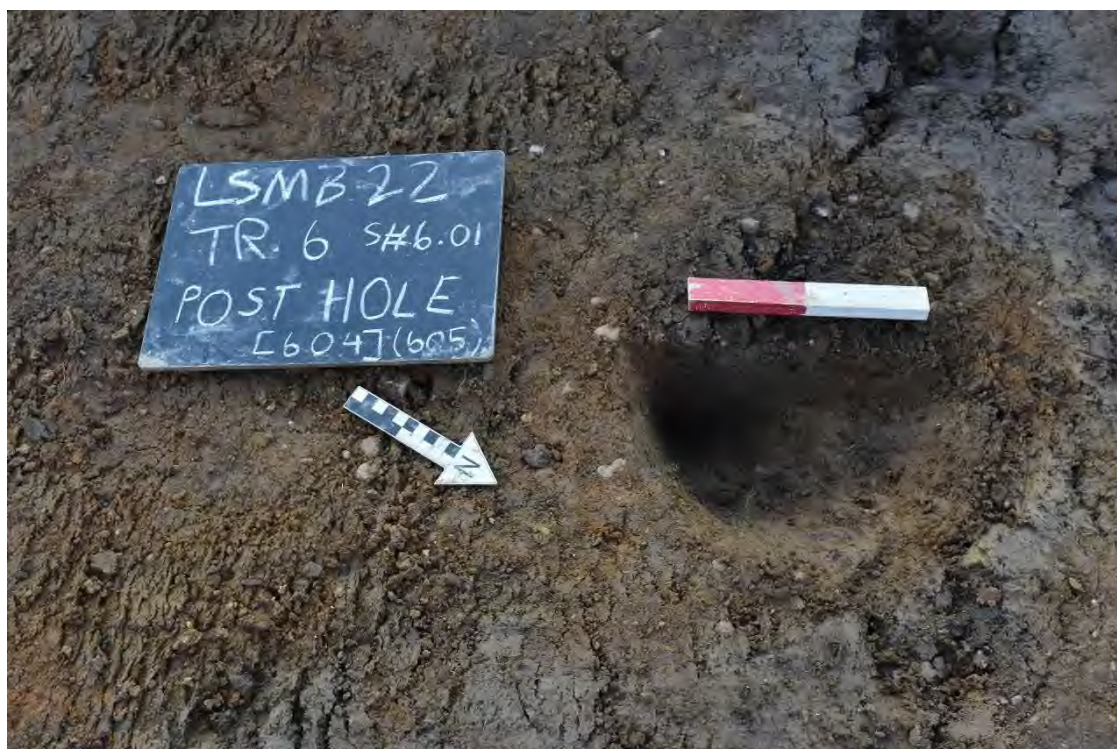
Plate 7; Trench 6, posthole [604], direction southwest, 0.20m scale.
