## Land at Ratby Lane, Markfield – Proposed Pedestrian Crossing

### **Stage 1 Road Safety Audit**

<b>Report Title:</b>	Land at Ratby Lane, Markfield – Proposed Pedestrian Crossing
<b>Report Produced for:</b>	Leicestershire County Council
<b>Report Dated:</b>	12 September 2025
<b>Document Reference &amp; Revision:</b>	MAL/RLPC/RSA1 Rev0
<b>Report Produced by:</b>	Meraki Alliance, Watkin Avenue, Old Colwyn, Conway LL29 9NN Naomi Cook - <a href="tel:+44">Tel:+44</a> (0) 7818026263
<b>On behalf of:</b>	DTA Transportation

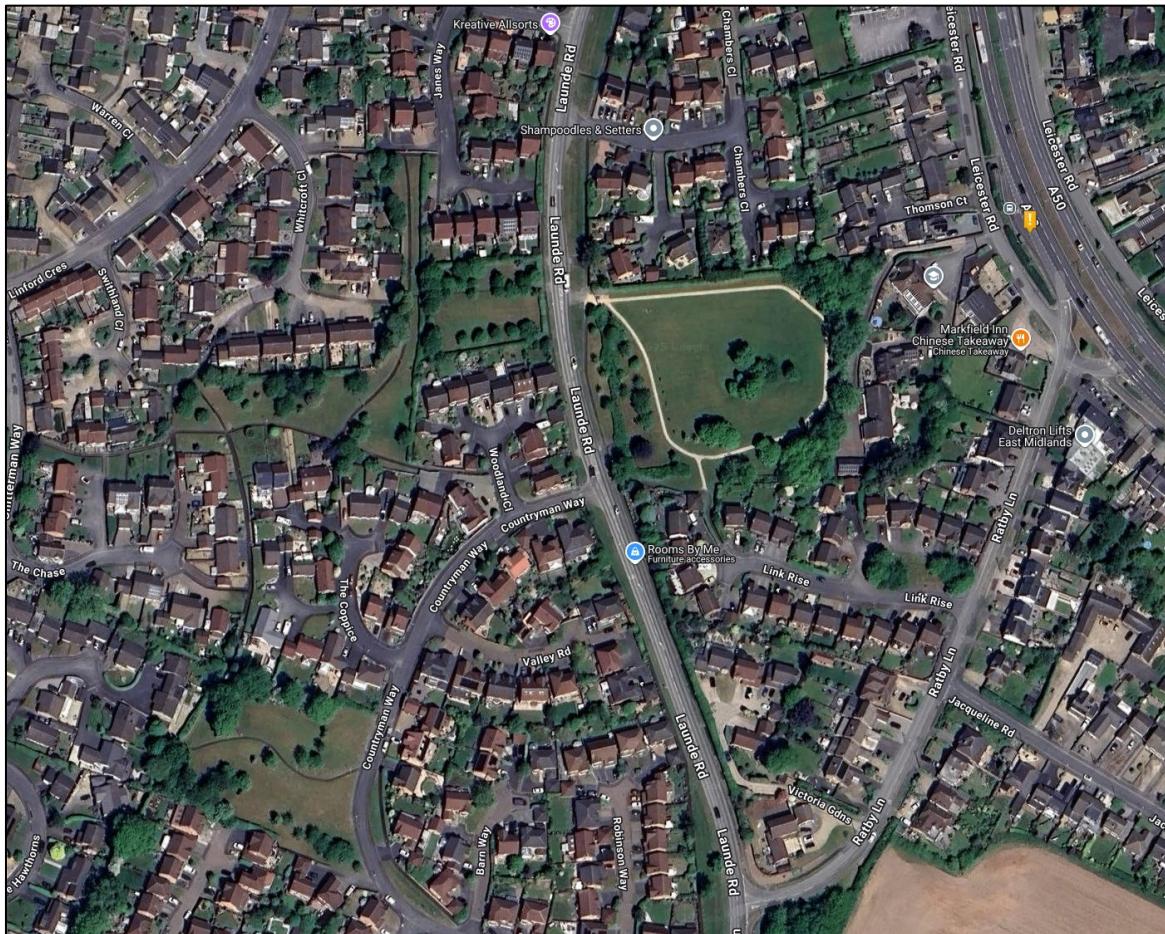
**Figure 1: Collision data**

Examination of the data indicates that there has been no PICs recorded on the roads immediately affected by the improvement works.

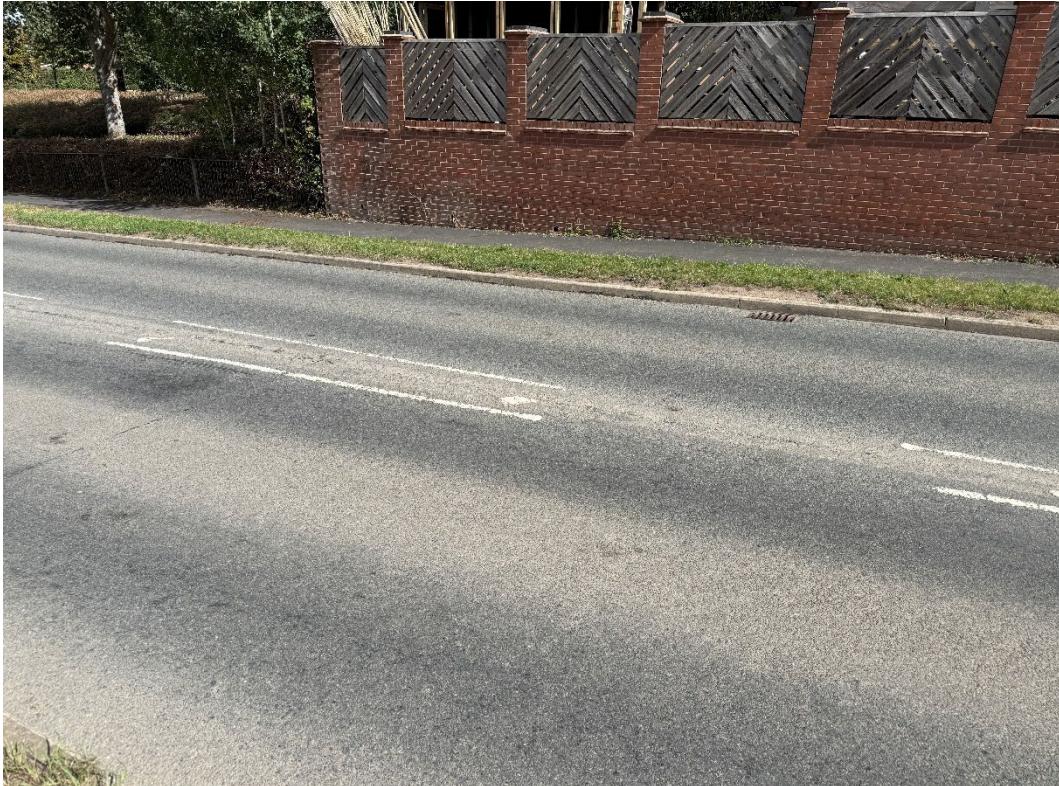
PROBLEM	1-1
Location:	Proposed pedestrian crossing point
Summary:	Potential trip or slip hazard within the crossing point
<p>It appears that an existing gulley is located within the carriageway in the vicinity of the uncontrolled crossing which could lead to pedestrians slipping or tripping and falling into the path of a passing vehicle, increasing the risk of collisions involving pedestrians.</p>

<p><b>RECOMMENDATION</b></p>	
<p>Ensure that the pedestrian crossing is located away from the gulley.</p>

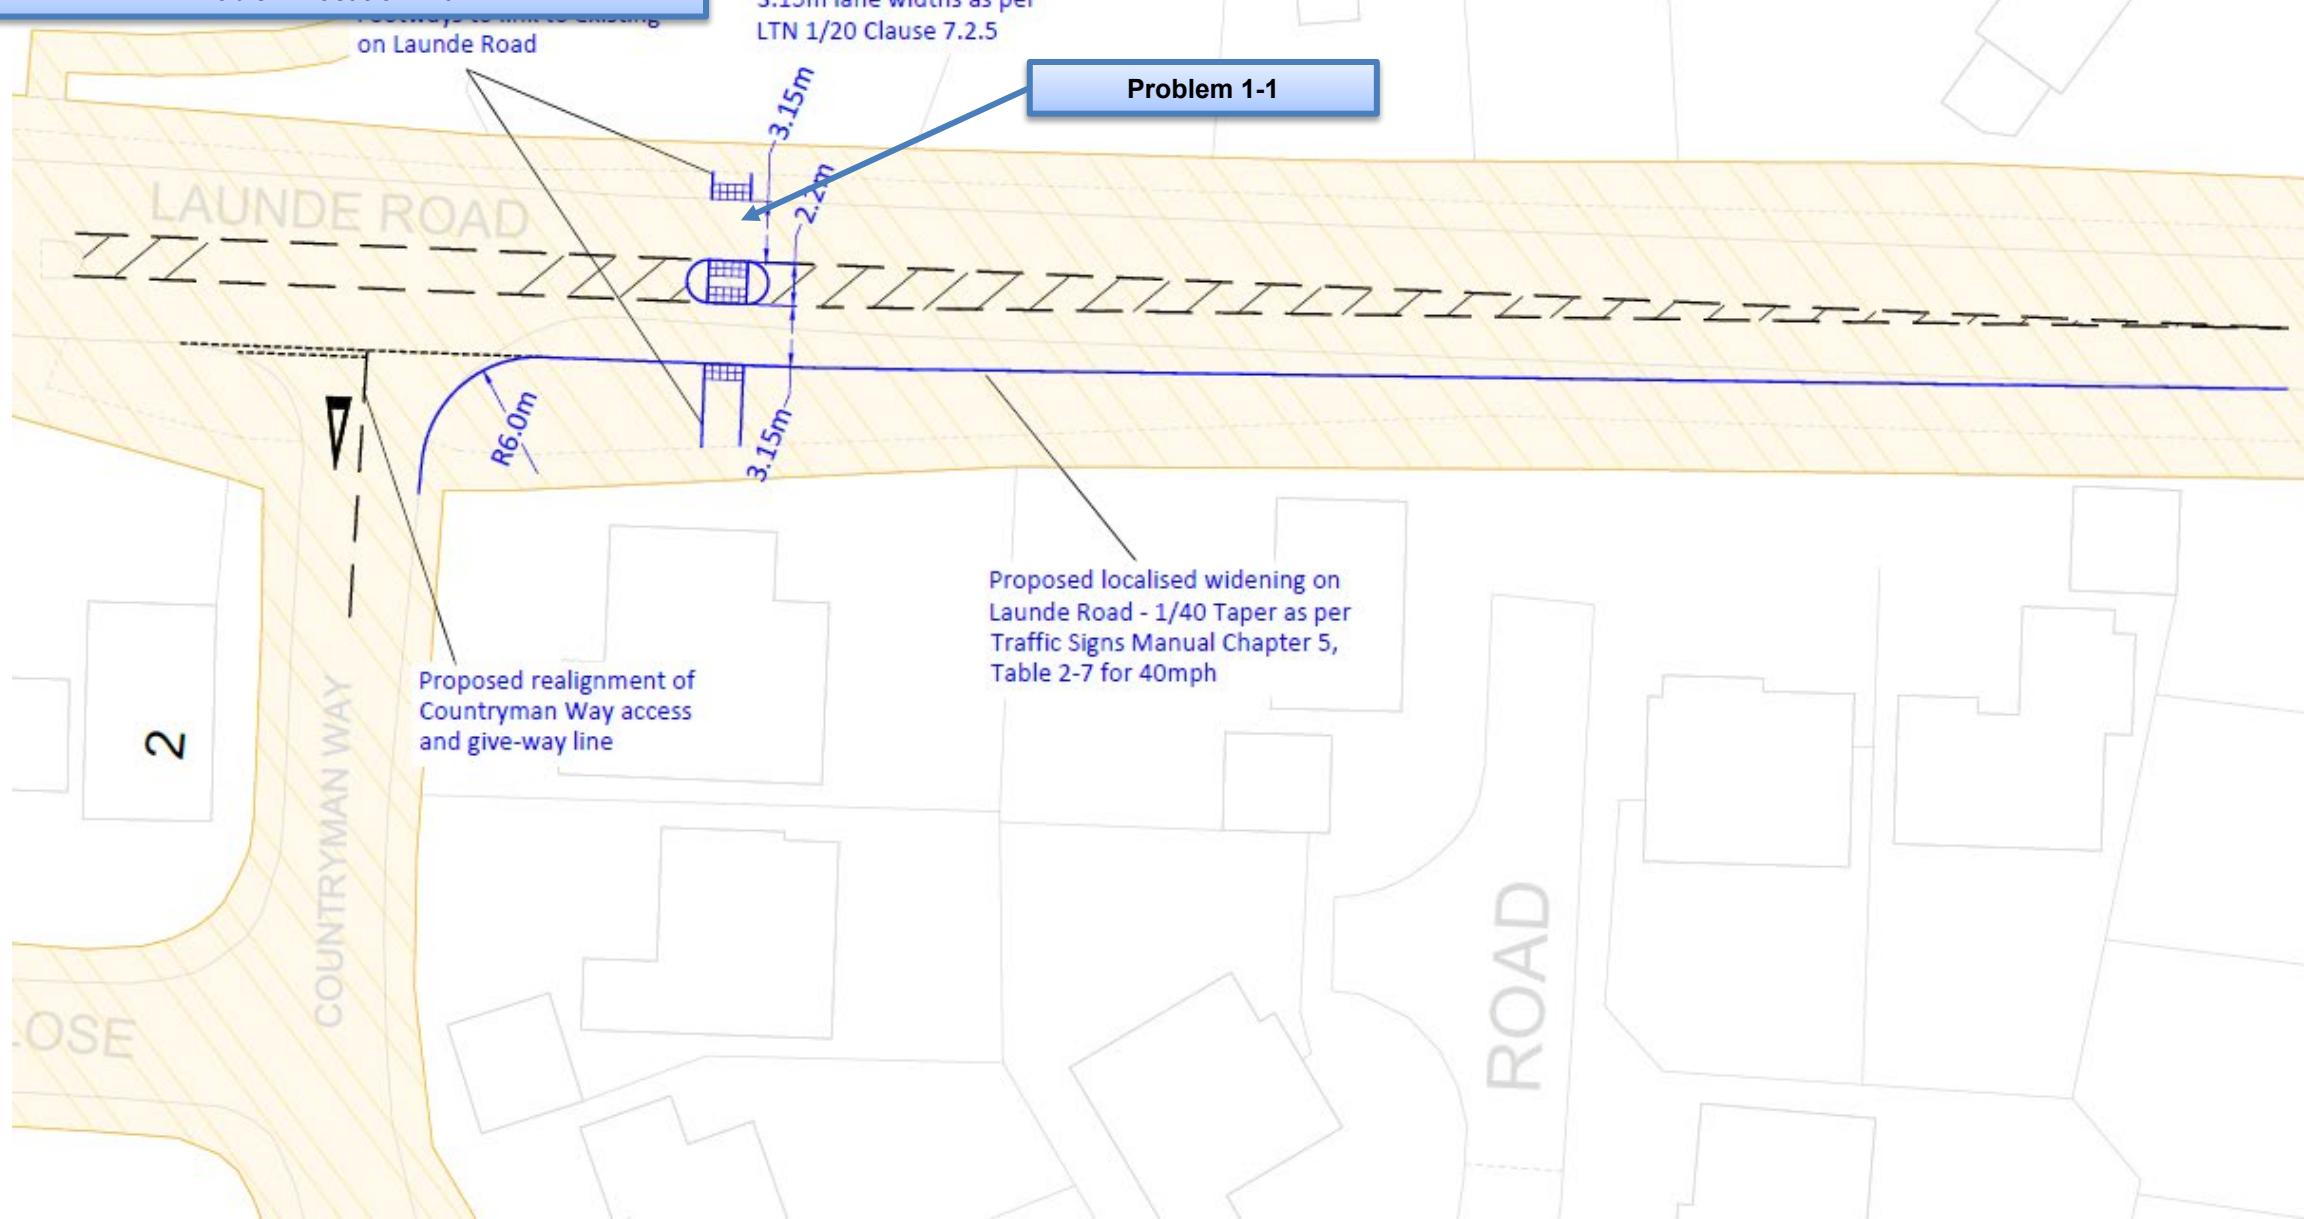
**Problem Location Plan**

This section details the findings of this Stage 1 Road Safety Audit. All locations of identified problems are illustrated on the plan included at **Appendix 2**.
