## SUPPORTING STATEMENT

Lawful Development Certificate Application

Class E - Swimming Pool Incidental to the Enjoyment of  
a Dwellinghouse

Hill Rise, Desford

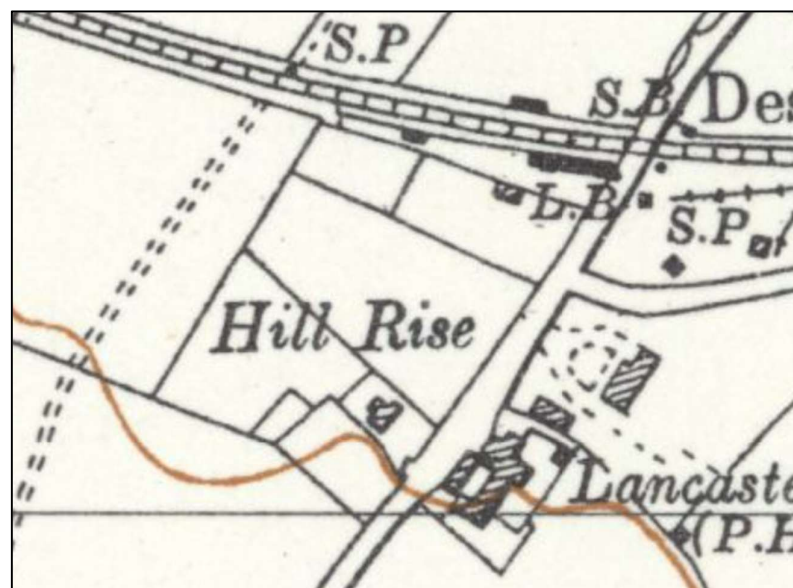
- 5.02 The 1955 map shows the same detached dwelling with pockets of land separated by boundaries. By this time, the land has been further separated by the line running from the northwest corner to the northwest boundary.

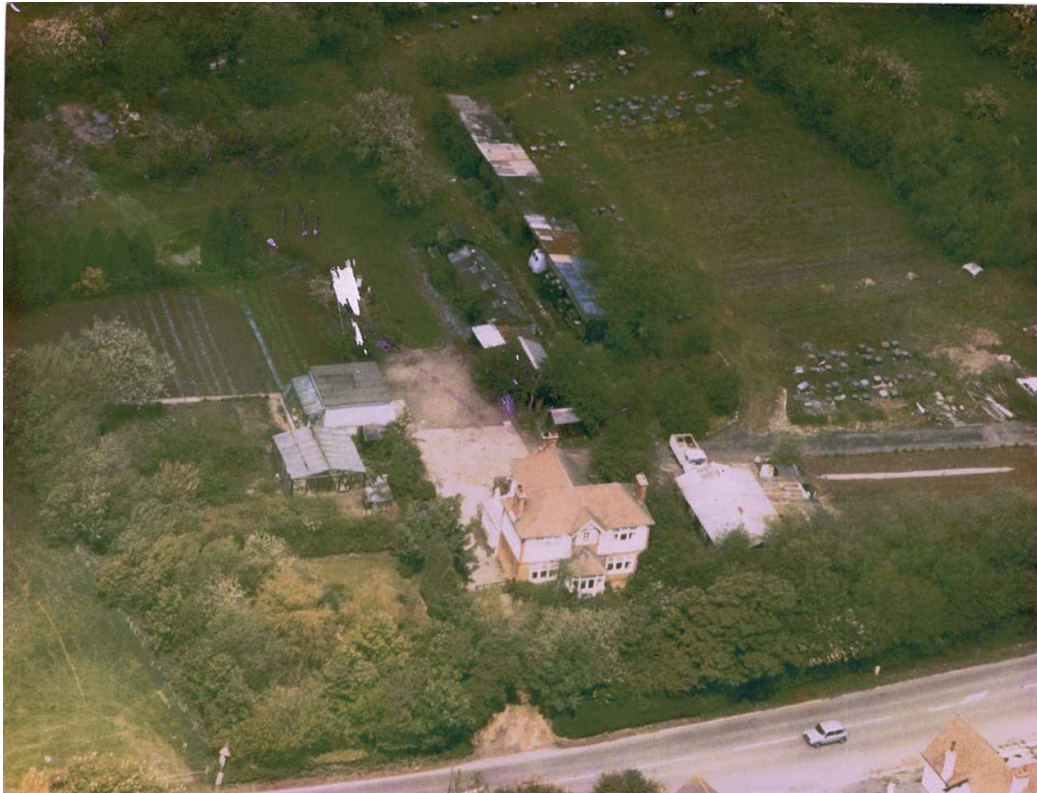
- 5.10 With more modern technology, the same photograph has been scanned to a more detailed and larger size.
- 5.11 A larger copy of the 'Inchley' photograph has been submitted as an application document, however for the purpose of this supporting statement a copy is below;

- 5.12 It is now possible to see the following features;
- The dwelling Hill Rise
  - The access to the front of Hill Rise
  - The access road leading off Station Road from the southeast
  - Two outbuildings to the northwest of the dwelling
  - A white roof building to the southwest of the dwelling
  - Buildings running northwest to southeast (the rear of a white vehicle can be seen amongst others)
  - Bee hives to the area immediately above the additional access point
  - Bee hives to the northwest boundary
- 5.13 With the larger Inchley photograph we are able, on the balance of probabilities, to determine the curtilage of the dwellinghouse extended to cover the land to the southeast of the dwelling.

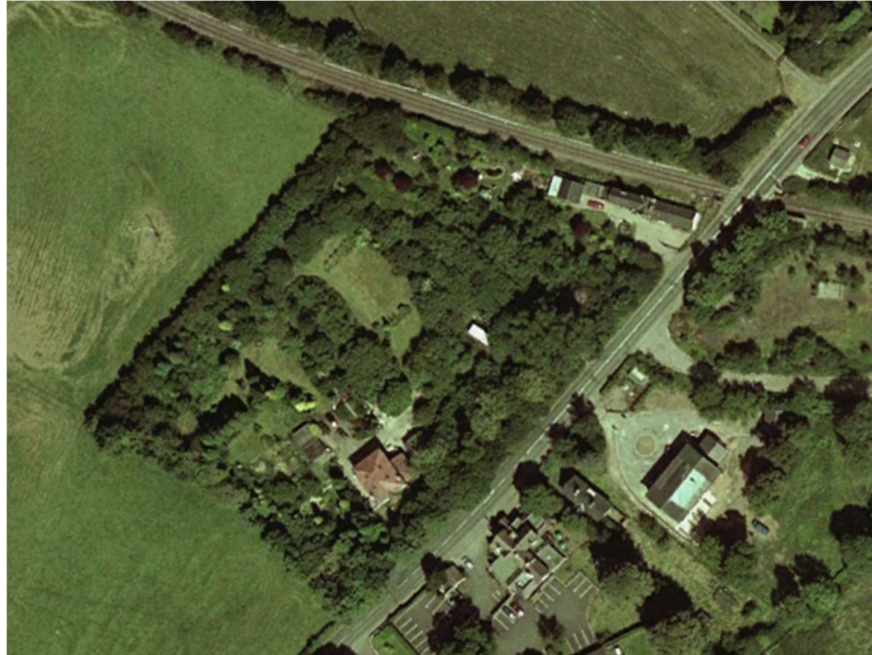
- 5.14 The aerial photograph below (December 1999) shows that there have been changes in the appearance of the dwelling.

- 5.15 There is evidence of the outbuildings to the rear of the dwelling and within the, now overgrown, curtilage to the northeast.
- 5.16 There remains a 'clearing' in the centre.
- 5.17 John Inchley lived at the property with his wife (a beekeeper) and, following his death, his wife was unable to manage the whole of the property.
- 5.16 This aligns with the fact that the 1999 aerial photograph shows that, save for the 'clearing' in the middle, the majority of the property had been left to 'self seed'.
- 5.17 The applicant has confirmed that;

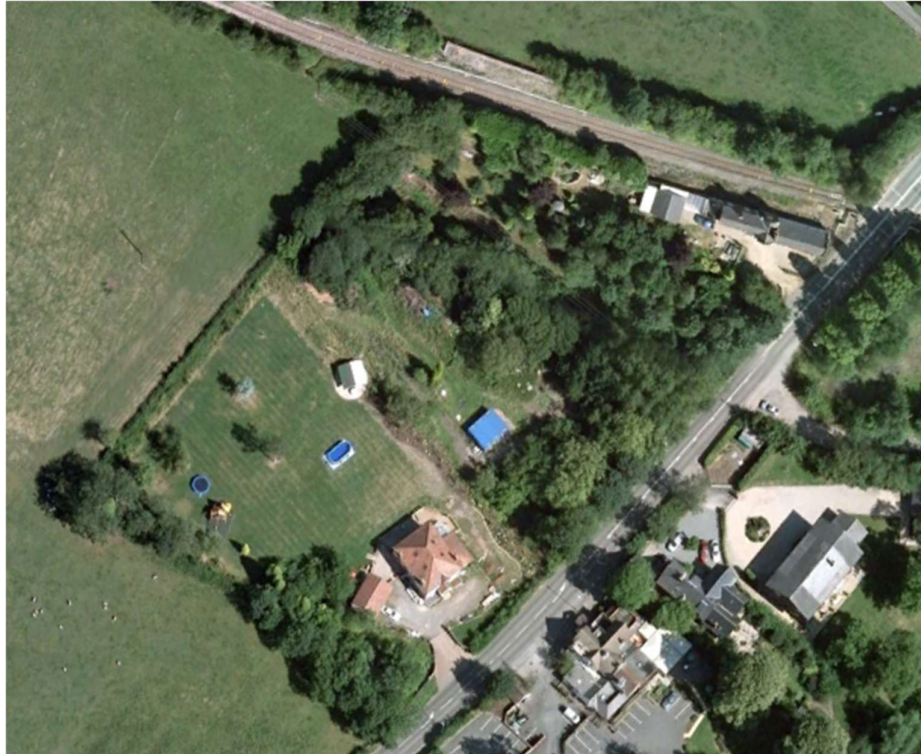
- 5.19 In the July 2000 aerial photograph below, it can be seen that the applicant has started to clear some of the overgrown area.
- 5.20 There is also a new summerhouse (white roof), three (blue roof) shipping containers and swimming/paddling pools.

- 5.21 As confirmed by the applicant, the bee hives had all been removed, along with other outbuildings associated with bee keeping.
- 5.22 The access road is no longer visible, again supporting the fact that the use and extent of curtilage has changed over time.
- 5.23 There is now a detached brick built outbuilding (garage) to the south west of the dwelling, constructed by the applicant.
- 5.24 All of these changes have all occurred within the curtilage of the dwellinghouse.
- 5.25 Further proof that the curtilage of the dwellinghouse has changed over time, increasing in size from the 1999 aerial photograph, but remaining less than the Inchley photograph.

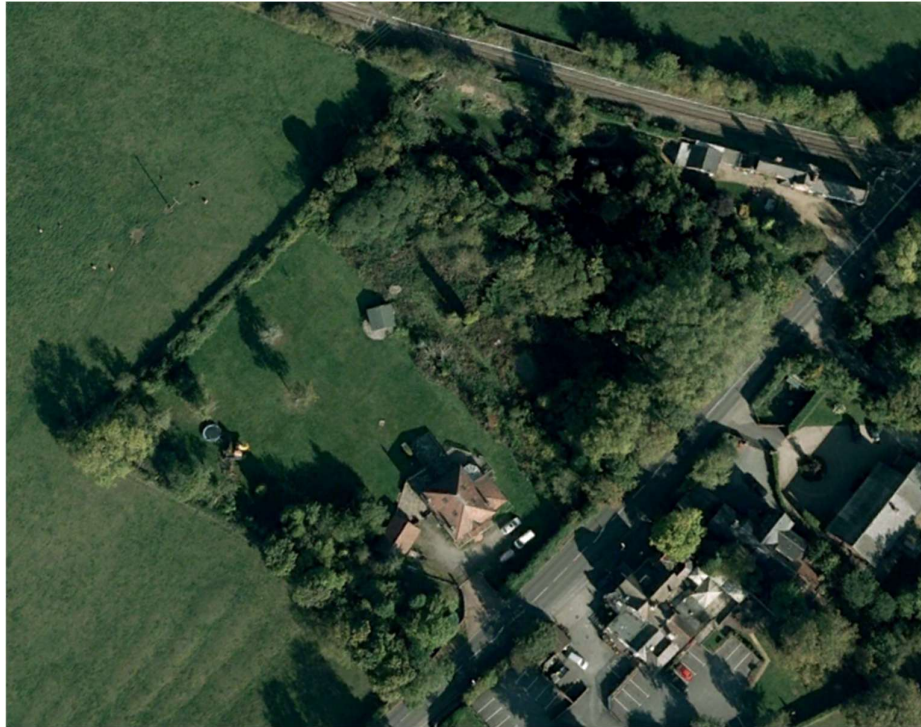
5.26 The next aerial photograph, with noticeable changes, is the September 2011 image;

- 5.27 Whilst the changes are not significant it can be seen that the blue roof containers have been removed and the area of land, previously cleared, is now showing signs of becoming overgrown.
- 5.28 The summerhouse remains and there is a clear line between what garden area is mown and tendered, the southwest side, compared to the more overgrown, northeast, area of the property.
- 5.29 It is becoming clear that, again, the curtilage is changing. It has become a smaller area than that which existed in the July 2000 photograph.

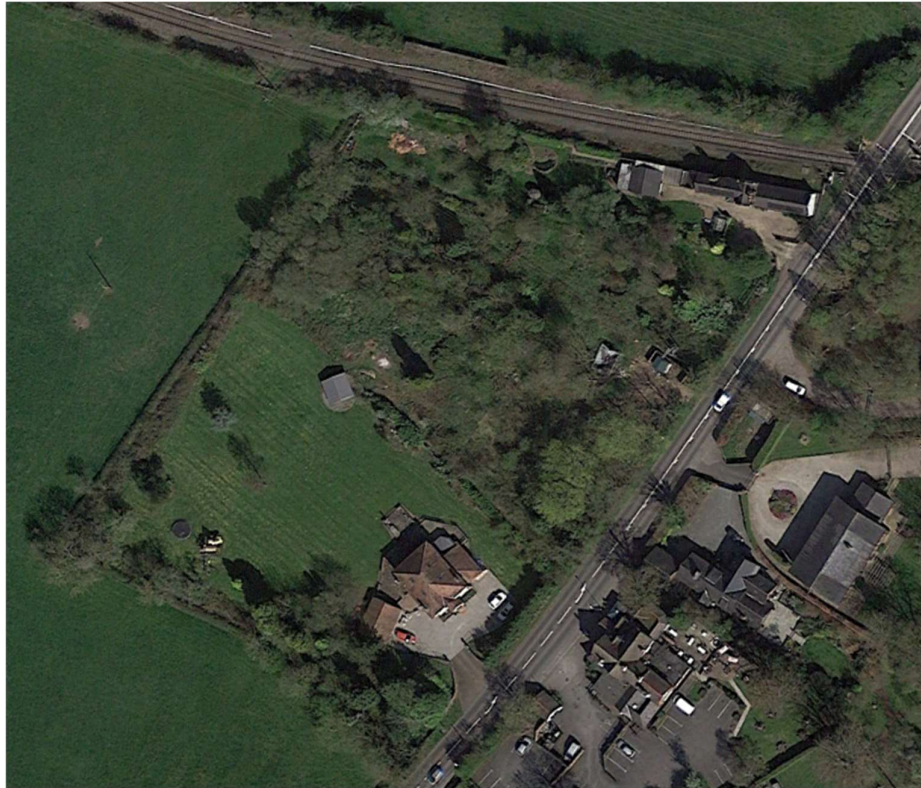
5.30 The next available image is that taken in April 2015;

- 5.31 By now, the overhead power lines (running northwest to southeast) have been removed and the substation, located fronting Station Road, has been constructed.
- 5.32 The summerhouse remains and there is a distinct, but partial, 'hedge line', giving a clear delineation of what could be considered curtilage.
- 5.33 However, the hedge line is not continuous, stopping short at the point of the summerhouse.
- 5.34 This break ensured that access between the two areas was available for the occupants and it did not form the total enclosure of the land.

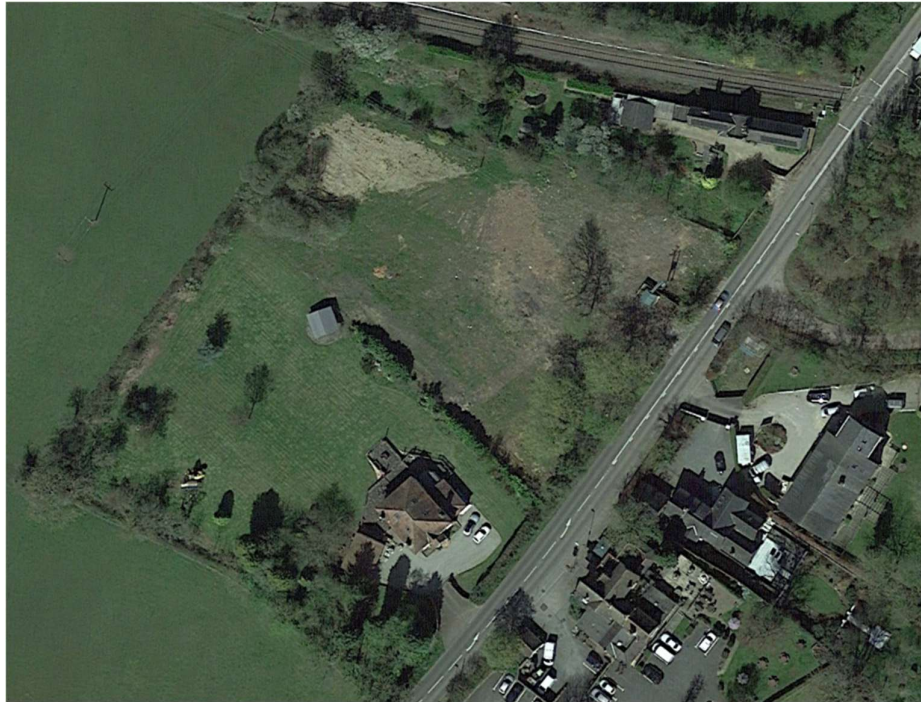
5.35 The next available image is that taken in April 2016;

- 5.36 It is evident that there have been several changes in the preceding 12 months.
- 5.37 The overgrown area to the northeast of the hedge line has been cleared, with trees fronting Station Road retained.
- 5.38 The summerhouse remains at the end of the hedge line and the break in enclosure becomes more obvious.
- 5.39 The curtilage has again changed.
- 5.40 However, there is no physical barrier to the occupants using the whole of the property for purposes ancillary to the dwellinghouse.

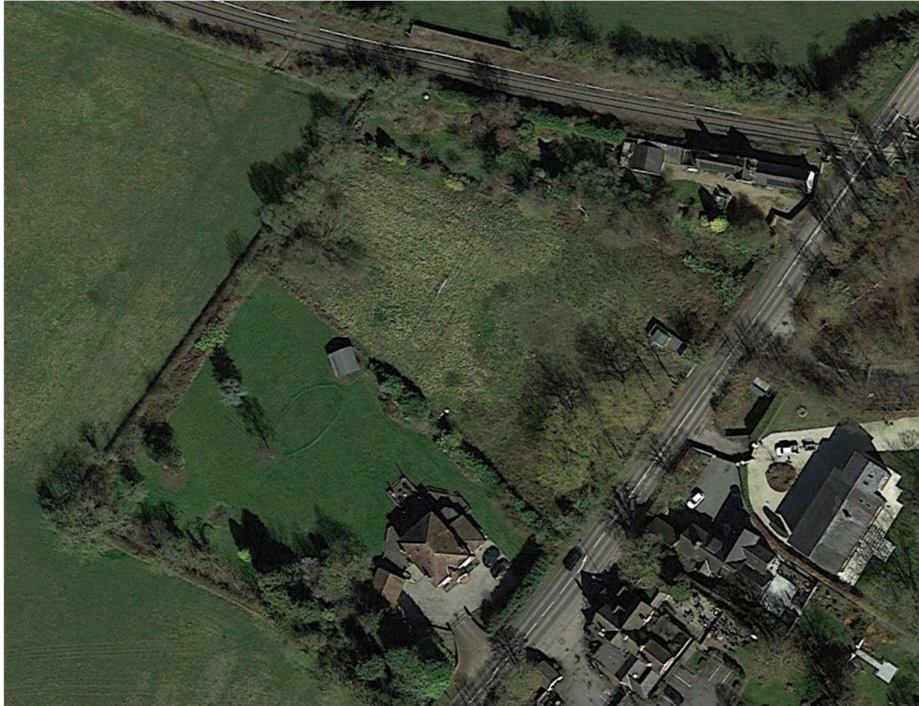
5.41 The next available image is that taken in April 2018;

5.42 Again, changes can be seen.

5.43 The land, previously cleared, is now less maintained than the land immediately to the rear of the dwelling.

5.44 The summerhouse remains, as does the hedge line, however it now appears that the break in the hedge has become overgrown.

5.45 There is a clear argument that the land to the northeast is no longer within the curtilage of the dwellinghouse.

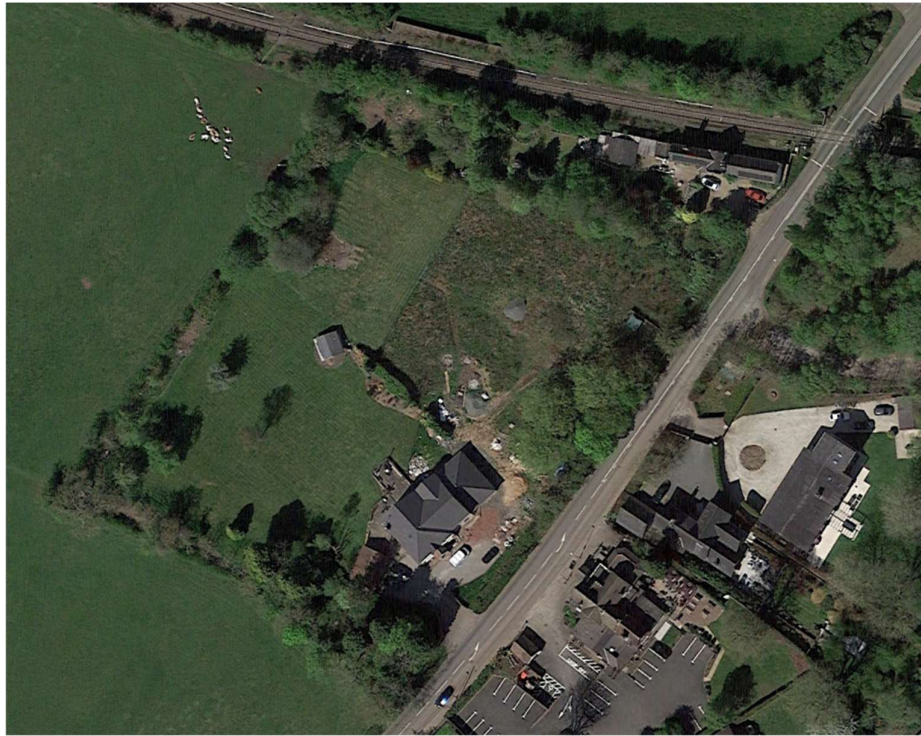
5.46 The next available image is that taken in April 2020;

5.47 At this point in time the construction of the extension to the dwelling can be seen under construction.

5.48 The summer house remains, along with a smaller central section of the hedge line.

5.49 There is no longer a break in the hedge to the northwest and the section, adjacent to the extension has been removed.

5.50 The upper section of the northeast area is now mowed and has become curtilage.

5.51 The lower section remains more overgrown, however it is evident that areas are being used as materials storage for the extension.

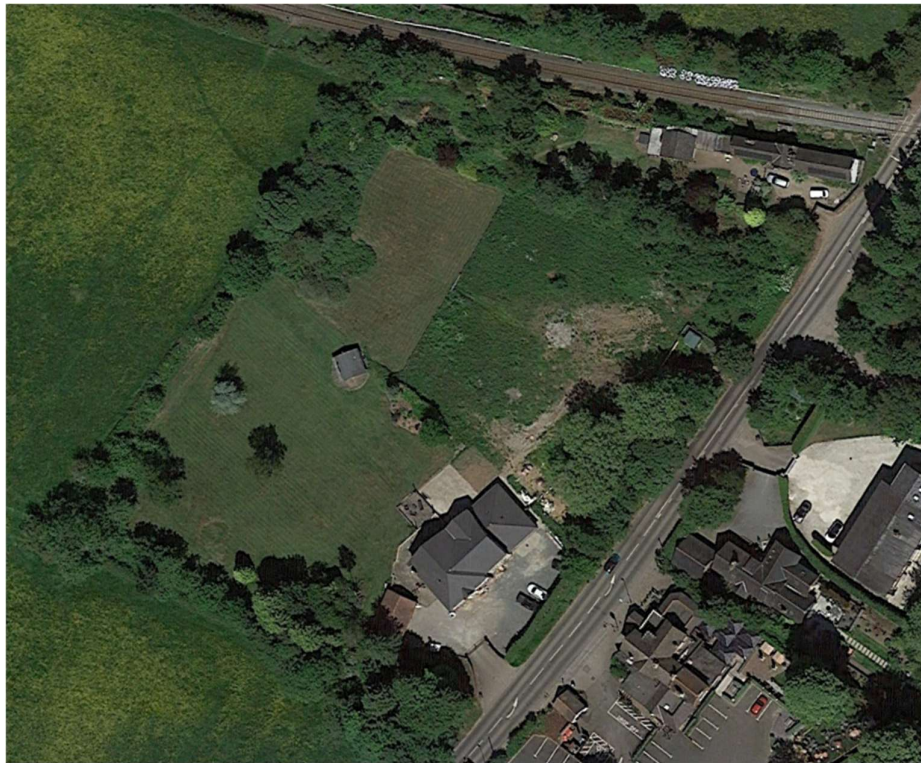
5.52 The next available image is that taken in June 2021;

5.53 The side extension has now been completed.

5.54 The summerhouse remains

5.55 The hedge line, previously forming a physical demarcation, has been reduced to a small section, with supplementary planting in front.

5.56 The northwest zone is now well maintained.

5.57 The southeast zone is less maintained than the northwest.

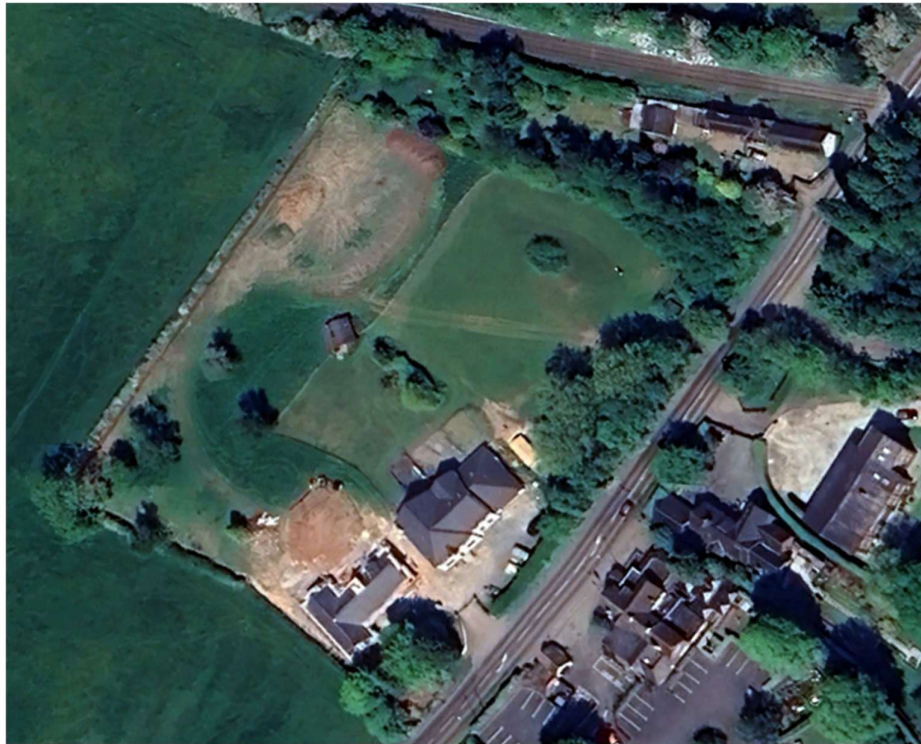
- 5.59 Whilst there is an image dated February 2022, it is blurred, therefore the next available image is that taken in May 2023;

- 5.60 This shows the completed outbuilding to the southwest, for which the LPA issued a Lawful Development Certificate (21/01144/CLP) issued May 2022.
- 5.61 The summerhouse remains, along with the now isolated hedge and planting.
- 5.62 The house has been extended and there is no longer any barrier or enclosure between the house and the zone to the northeast.
- 5.63 What is traditionally associated with 'garden' has now become a far larger area.
- 5.64 There is a distinct 'line' between garden zones, however this ties in with works carried out by the applicant to clear out the boundary ditches. Access was provided from the point on Station Road (further along from the traditional house entry) as can be seen by the 'track marks' across the garden to the northeast boundary.
- 5.65 The curtilage has changed.

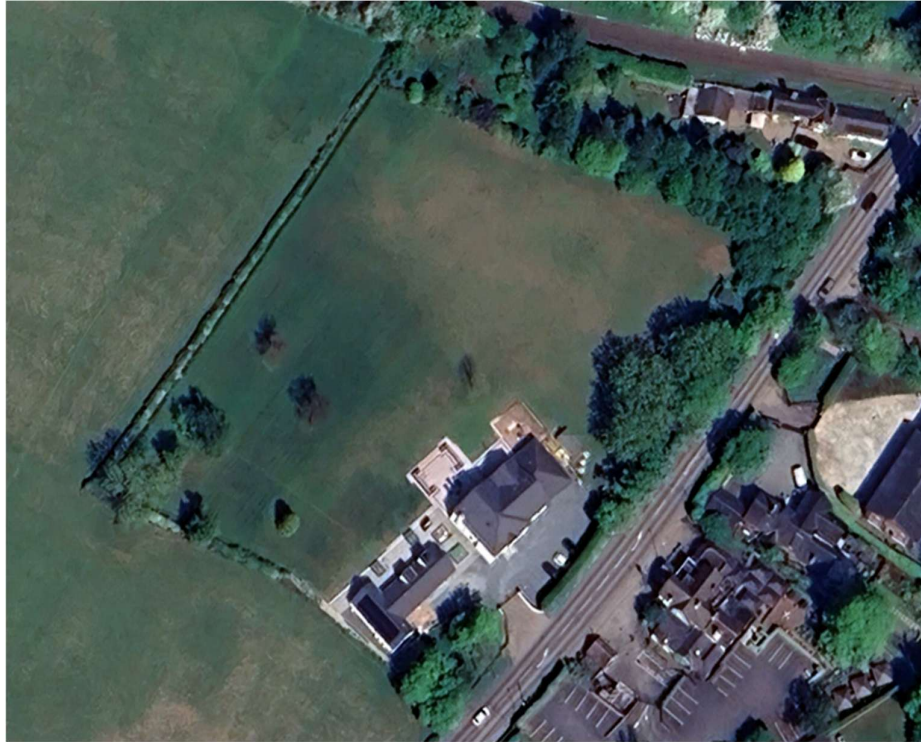
5.66 The next available image is that taken in May 2025;

5.67 The summerhouse has now been removed.

5.68 There is no longer any form of hedge line or enclosure of the garden.

5.69 Isolated trees remain towards the southwest corner, the northeast boundary has mature trees and the trees on the boundary to Station Road remain.

5.70 The whole of the area is now maintained as garden, for purposes ancillary to the enjoyment of the dwellinghouse.
