# Geo-environmental Assessment

Davidsons Developments

Lutterworth Road, Burbage

Ref: PJSG21-58-DOC-01

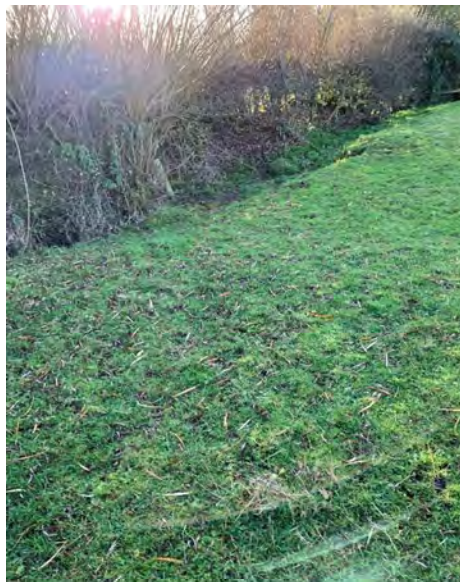
Photograph of dry ditch along field boundary of central field.

| Specifics | Details |
|---|---|
| <i>Surface Water Features (Site &amp; Vicinity)</i> | Several ditches are present on-site running alongside hedgerows, significant water was noted in the ditch located between the western and central field, flowing in a south easterly direction. The remaining ditches were noted to be dry. |
