# Technical Note Report

Davidsons Developments

Lutterworth Road, Burbage

Ref: PJSG21-58-DOC-02A

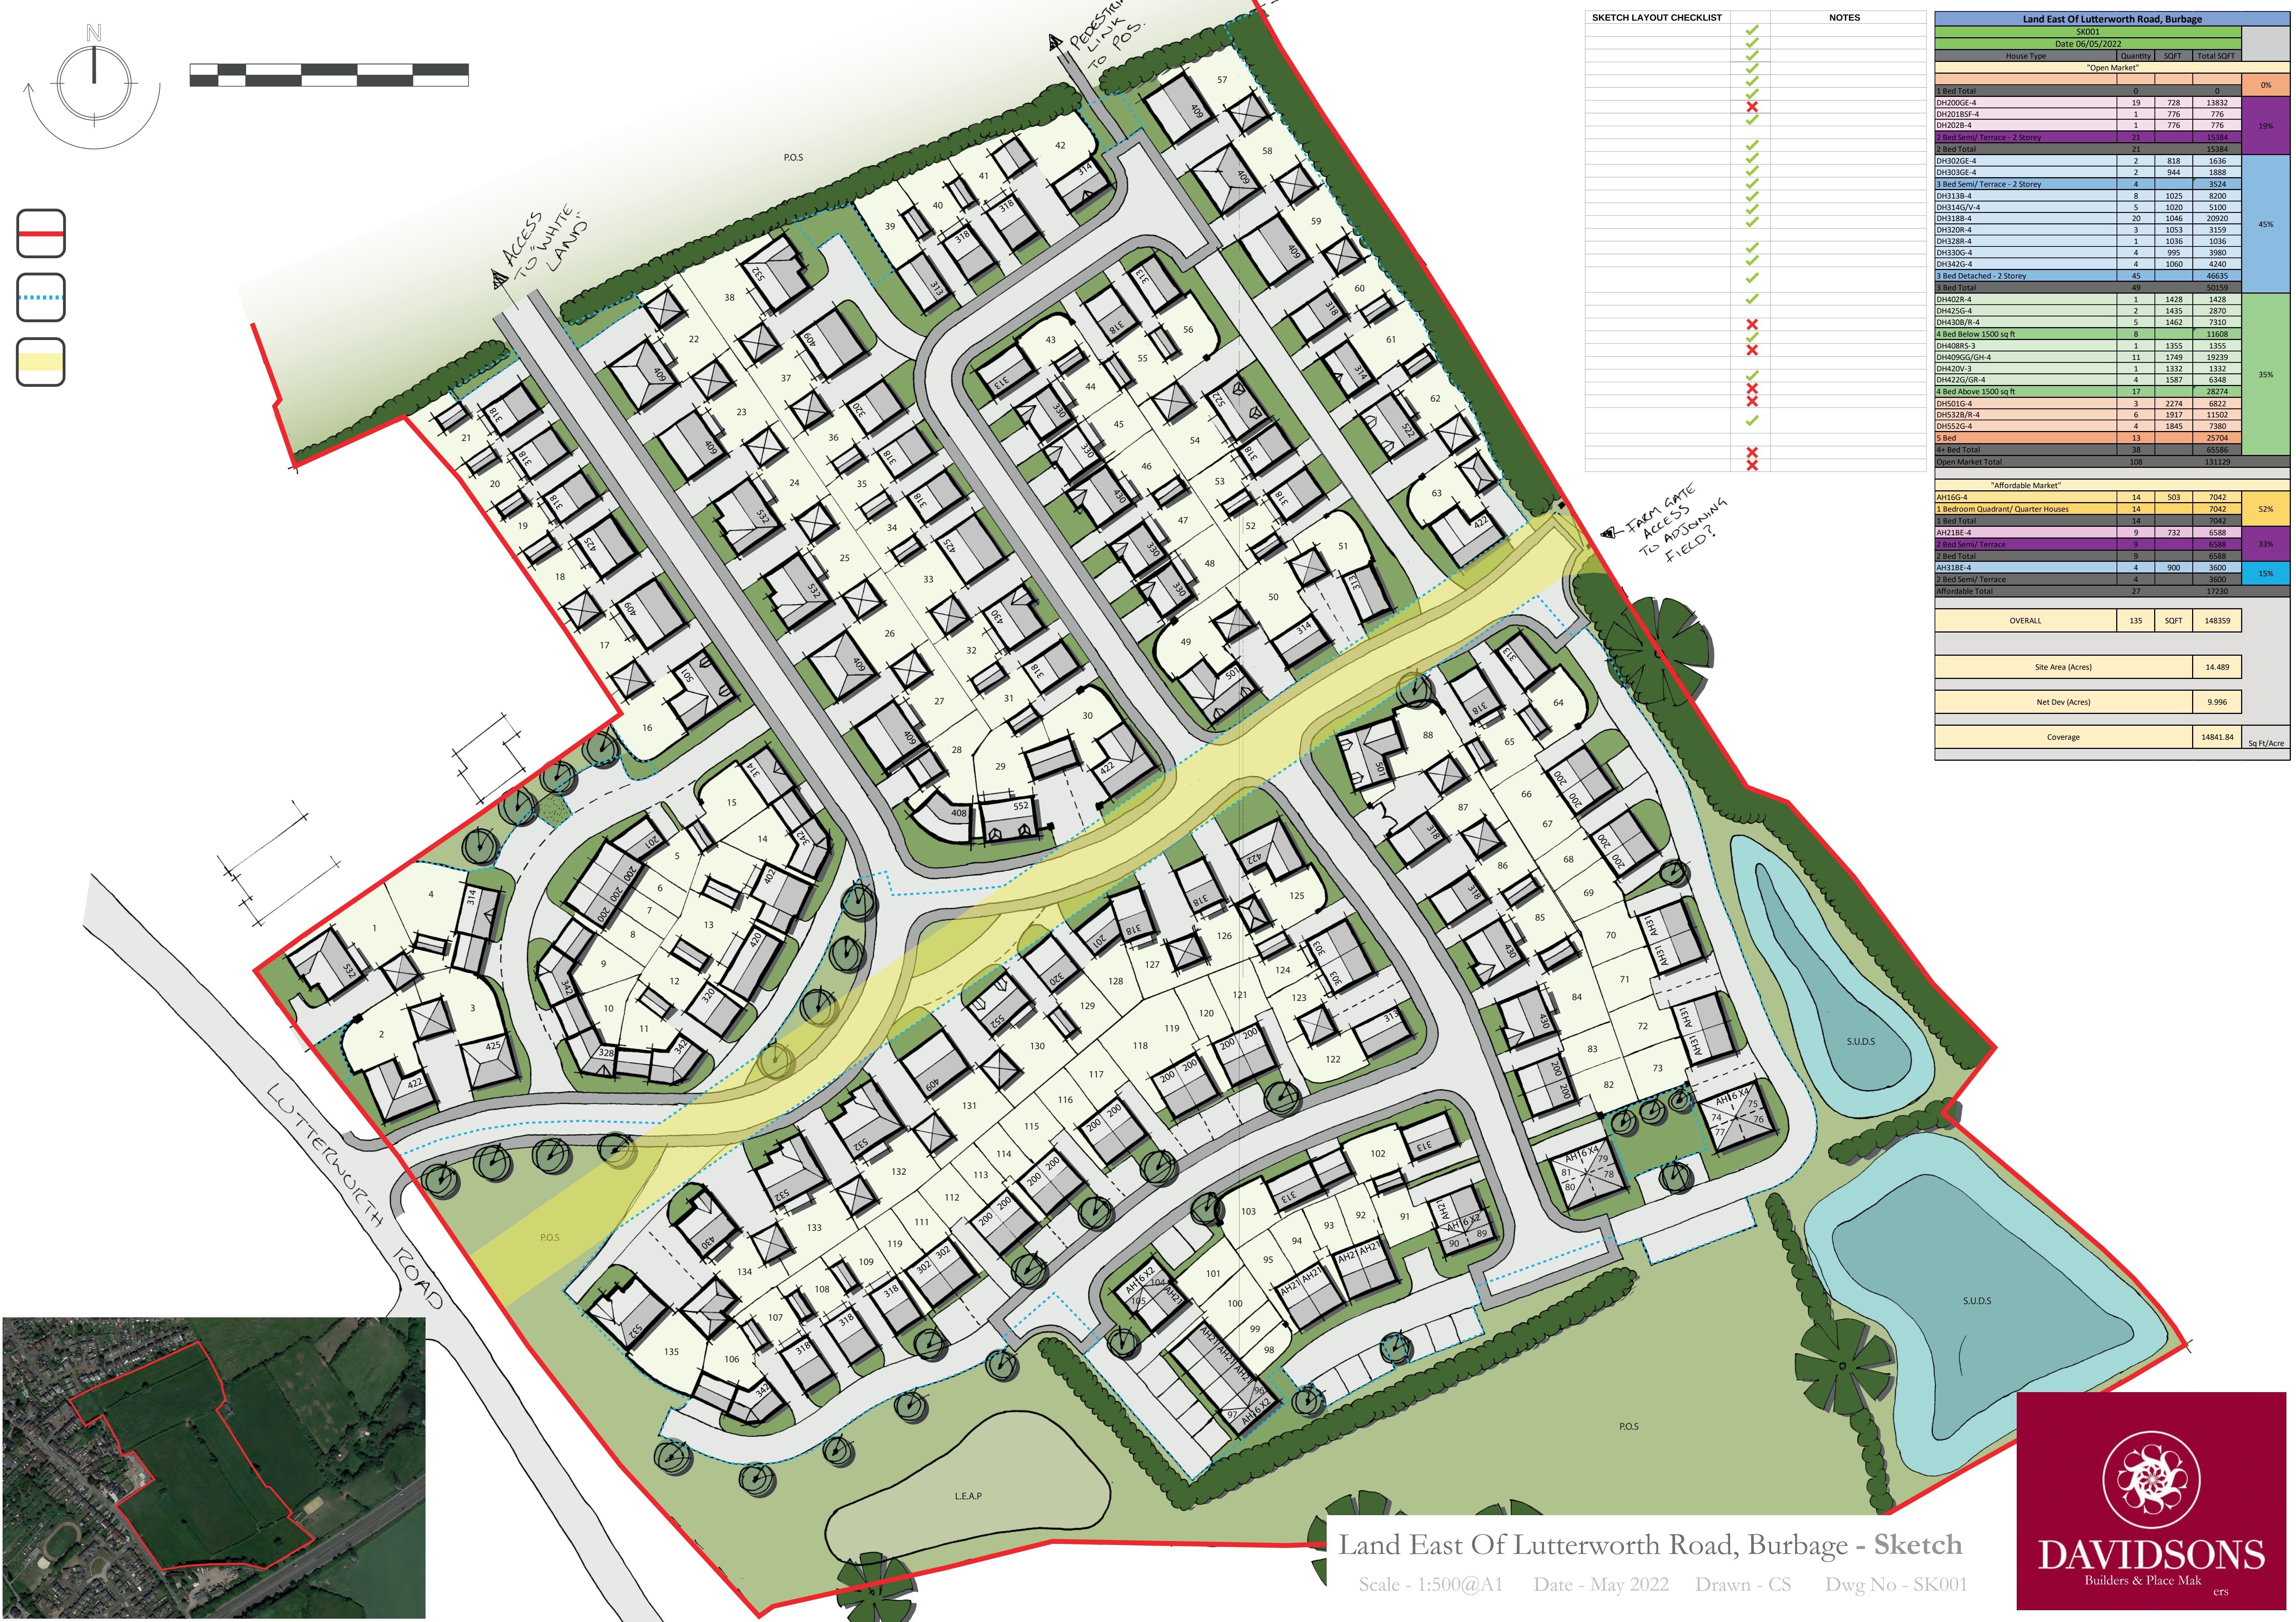
| Land East Of Lutterworth Road, Burbage | | | | |
|---|---|---|---|---|
| SK001 | | | | |

| Land East Of Lutterworth Road, Burbage | | | | |
