## **An Archaeological Standing Building Survey The Greyhound Inn Main Street Botcheston Leicestershire**

ABRS Report No 2023-GHBL\_v1

**ABRS Project No 2022-GHBL**

## An Archaeological Standing Building Survey, The Greyhound Inn, Main Street, Botcheston, Leicestershire (SK 48032 05036).

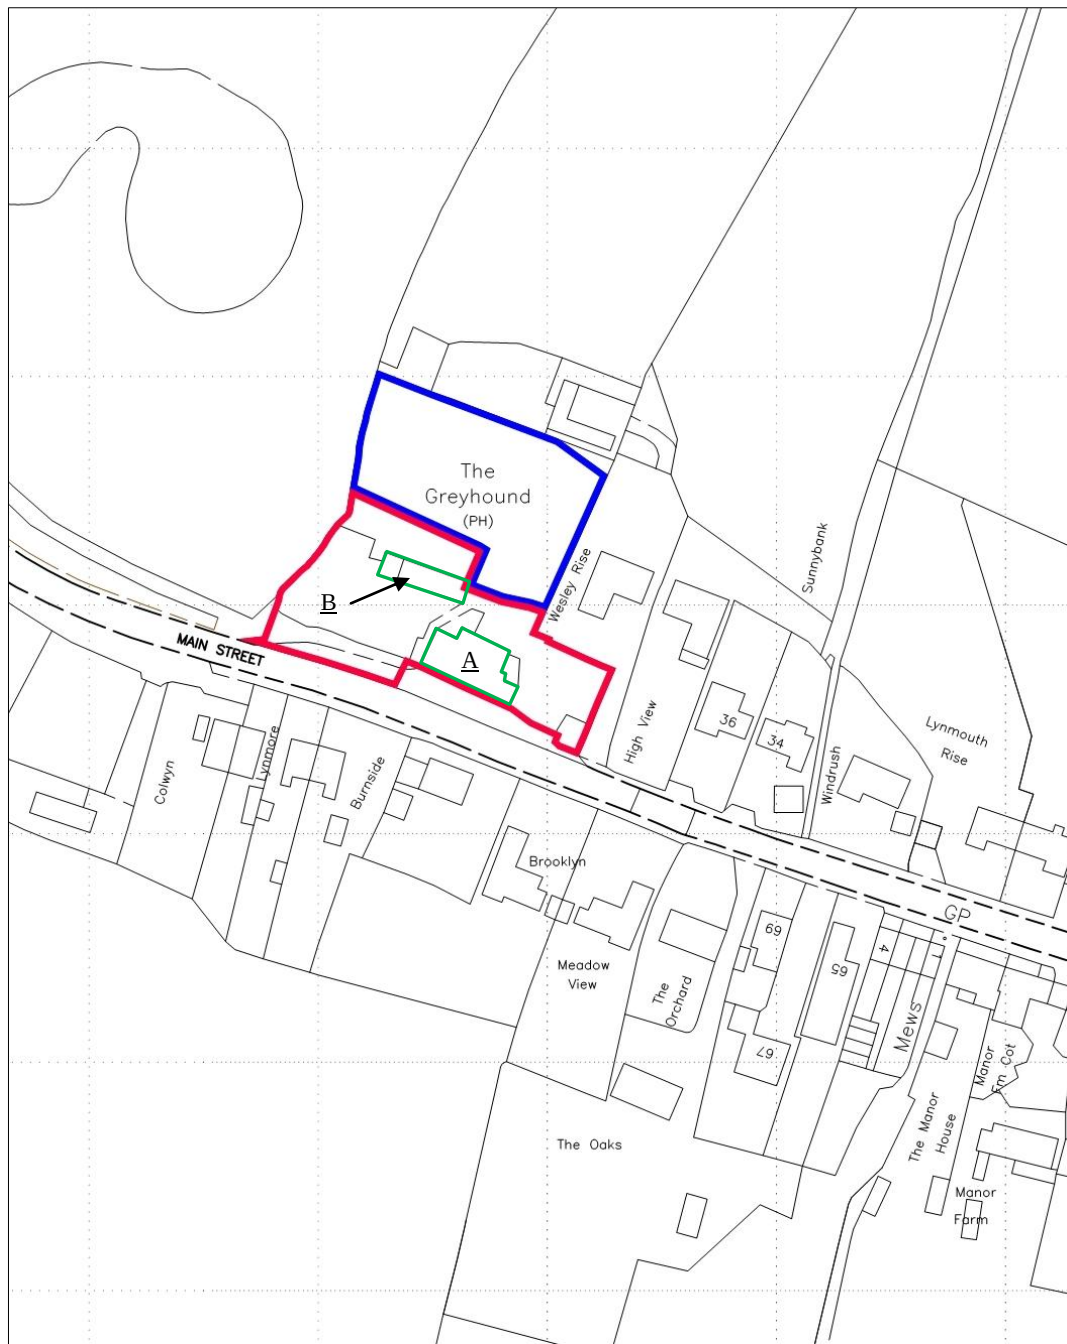
**Figure 8**  
Plan of the Proposed Development Area, Recorded Buildings in Green.  
(1:1250 (Provided by client))

The current floor-plan (Figure 8) again shows alterations, including the loss of the long narrow range and further alterations to the rear range.

*Orientation:* The buildings subject to this historic building recording are approximately rectangular in plan, the long axis is aligned west-north west – east-south east (*Figure 8*); for ease of description this is taken hereafter to be east – west; the principal elevation being that facing south. Where the terms ‘left’, ‘right’, ‘front’ and ‘back’ etc are used in the report, this is in relation to the principal elevations as viewed from Main Street. For the purposes of this historic building recording, a letter identification has been added to the buildings and number suffix have been added for significant partitions where required.

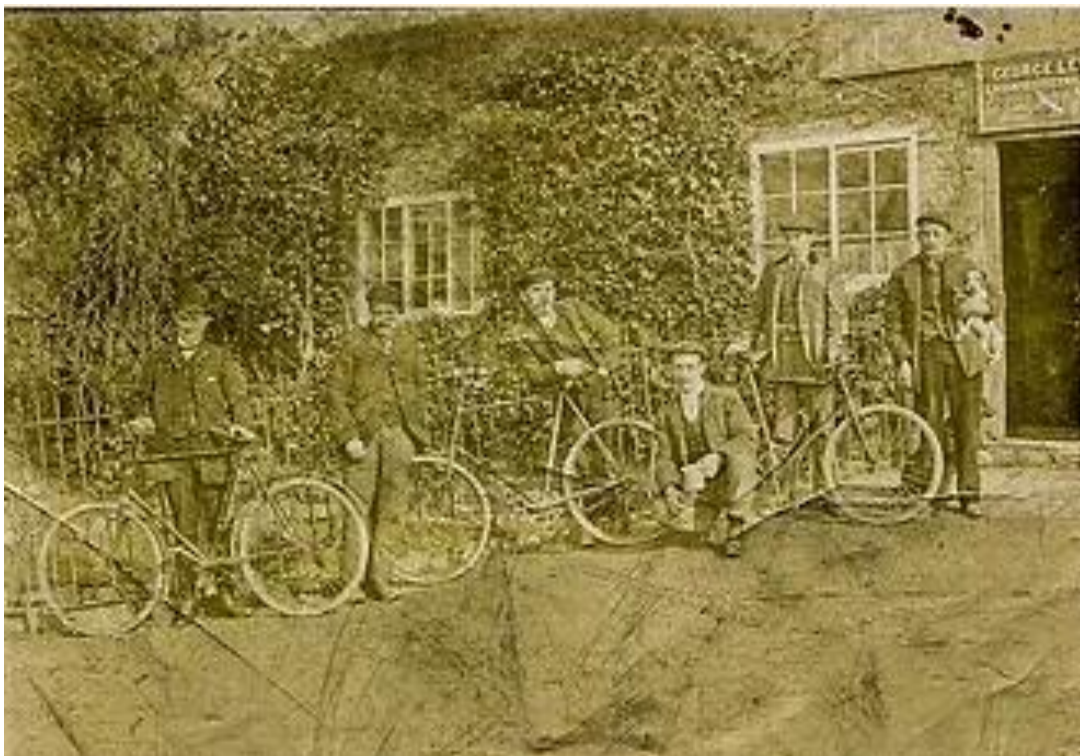
**Figure 9**  
Late 19th Century Photograph Showing Possible Doorway.  
([www.desfordheritage.org](http://www.desfordheritage.org))

The Greyhound Inn is linear building fronting Main Street; the two storey, predominately brick built roughcast rendered building under a pitched Welsh slate roof with brick ridge stacks (*Figure 10*). The central stack being lateral and set back from the ridge is reminiscent of a lobby entrance house; although there is no evidence of a corresponding doorway, but this may be as a result of later alterations to the principal elevation. A late 19th century photograph of the pub (*Figure 9*) does suggest there was originally a door here, which is supported by the boundary treatments recorded on the frontage by late 19th and early 20th century mapping. This would suggest a possible broad 17th to 18th century date for the building, although the easternmost ground floor window under its segmental arch head, if original may suggest an early 18th century date. It is possible that the first floor window in front of the stack, which is tall and narrow, may have originated as a stair window to light a staircase here, again supporting a potential lobby entrance plan.

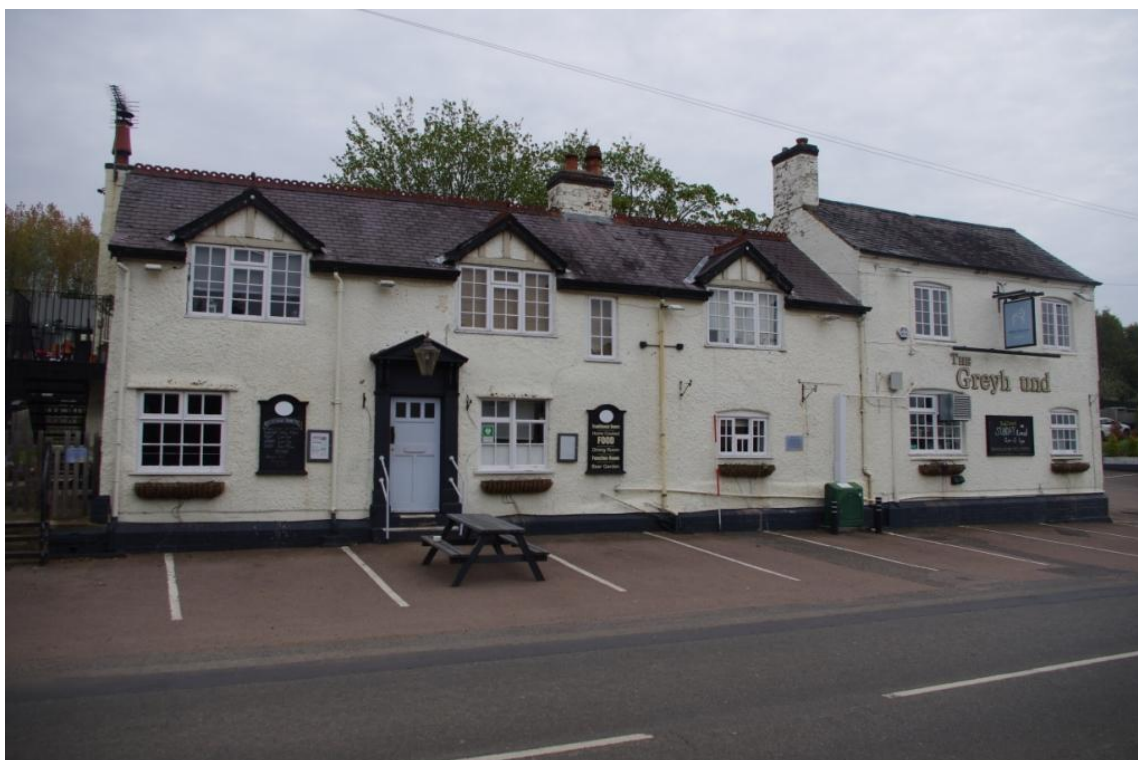
**Figure 10**  
Building A, Principal Elevation (Looking North – North East).

There is a clear and significant change in height visible on the principal elevation, with the easternmost bay being higher; this supports cartographic sources which indicated this easternmost bay was later. This easternmost bay is clearly 19th century in dimensions and appearance.

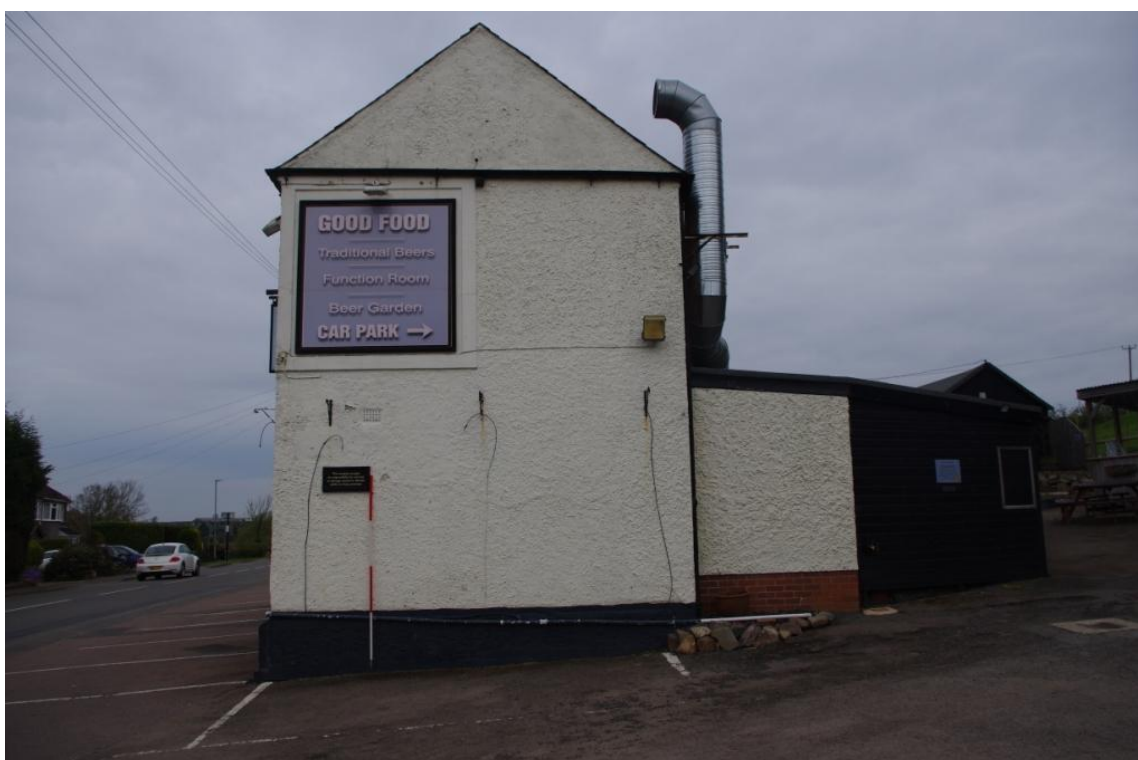
**Figure 11**  
Building A, East – South East Facing Elevation (Looking West – North West).

Both gables are largely empty (*Figure 11*). However, the western gable (*Figure 12*) shows evidence of a change to the roofline and changes in the render which may again, like the principal elevation suggest concealed framing, in the north west corner there is even a hint of a cruck blade (*Figure 13*). This is, however is far from certain.

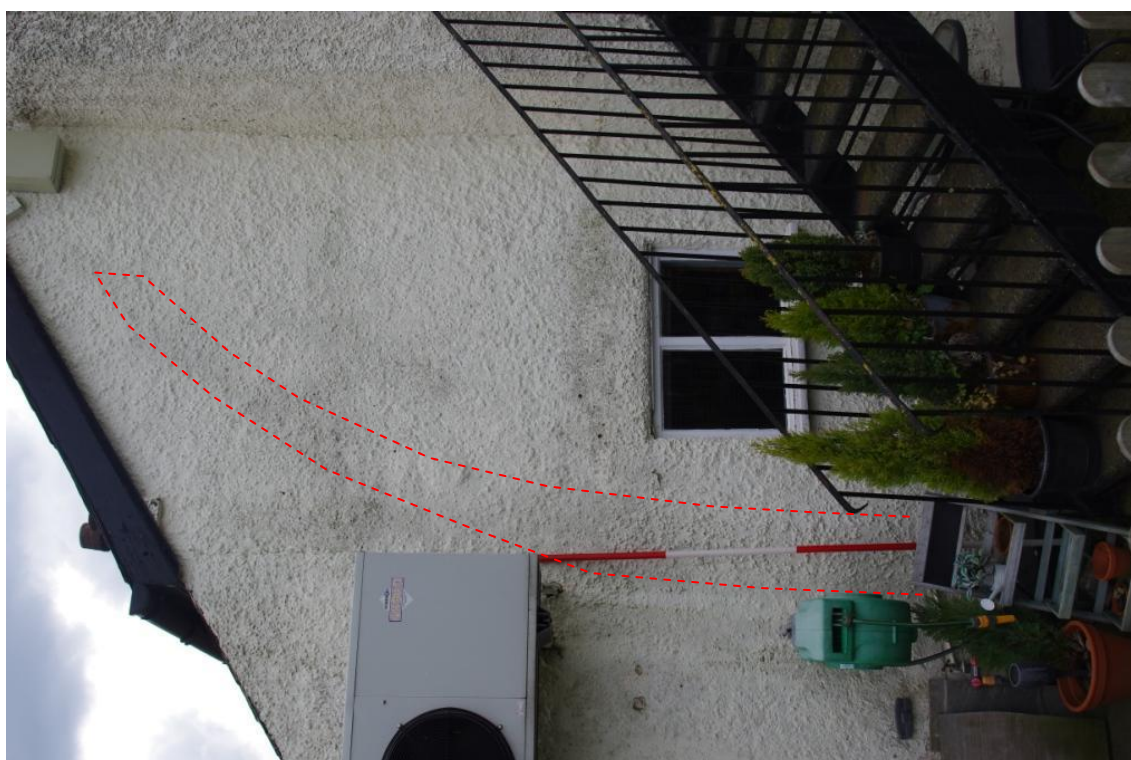
**Figure 13**  
Building A, West – North West Facing  
Gable, Possible Crack (Enhanced) in  
North West Corner  
(Looking South East).

There is also evidence to indicate that the westernmost bay is timber framed and includes very tentative evidence, in the form of discolouration to the render of a possible cruck blade in the north west corner. The easternmost bay is a 19th century extension.

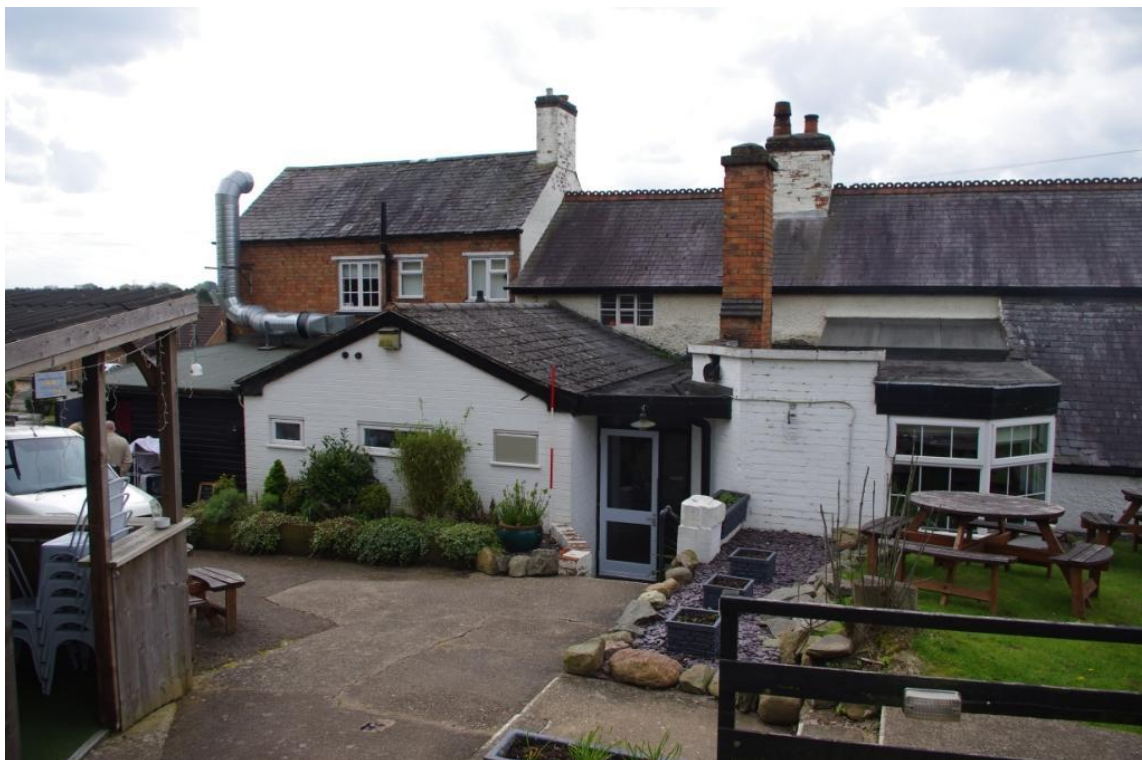
**Figure 14**  
Building A, Rear Elevation (Looking South).

The rear elevation is a confused collection of later extensions (*Figure 14*). The use of metric bricks for the two principal extensions indicates that these are post 1965 in date. To the west is a clearly earlier extension under a catslide roof and towards the centre is a large chimney. The chimney bricks are clearly 19th century in date which suggest another earlier extension here, which has been largely subsumed by the post 1965 flat roofed extension (*Figure 15*).

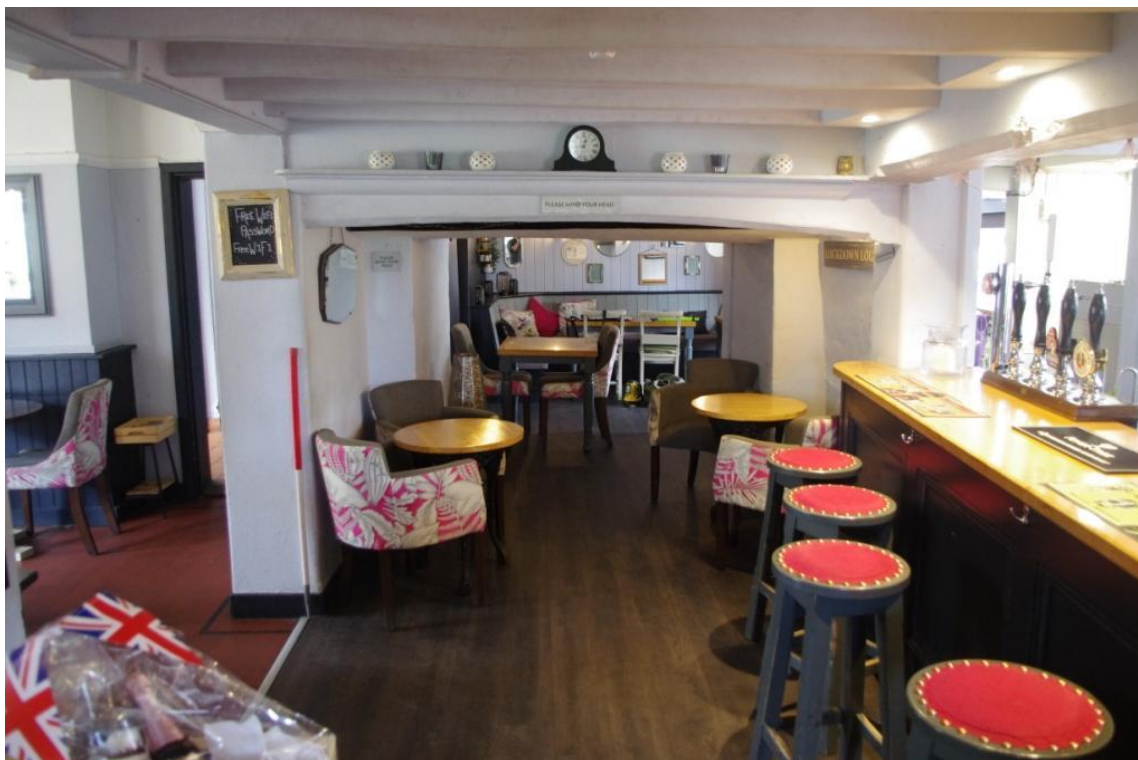
**Figure 16**  
A(2), Fireplace (Looking East – South East).

The westernmost bay is largely a single bay which now houses the servery against the front wall, but was clearly originally two separate bays. Against the rear wall at the centre of the bay is a large, much altered chimney breast (*Figure 16*) which confirms the building originated as a lobby entrance house, clearly a two unit plan with back to back fireplaces. The westernmost fireplace is finished with a chamfered and stopped timber overmantle. The scroll stop (*Figure 17*) is potentially early 17th century in date. The moulded mantlesheaf could, potentially be original as there are dated 17th century examples recorded, but modern paint prevents detailed examination. The easternmost fireplace has much rougher brexsummer with open mortice, which is again chamfered and stopped, however, later damage has removed the stop (*Figure 18*). This may reflect the different status of the rooms, the westernmost being the parlour and the easternmost being the living kitchen.

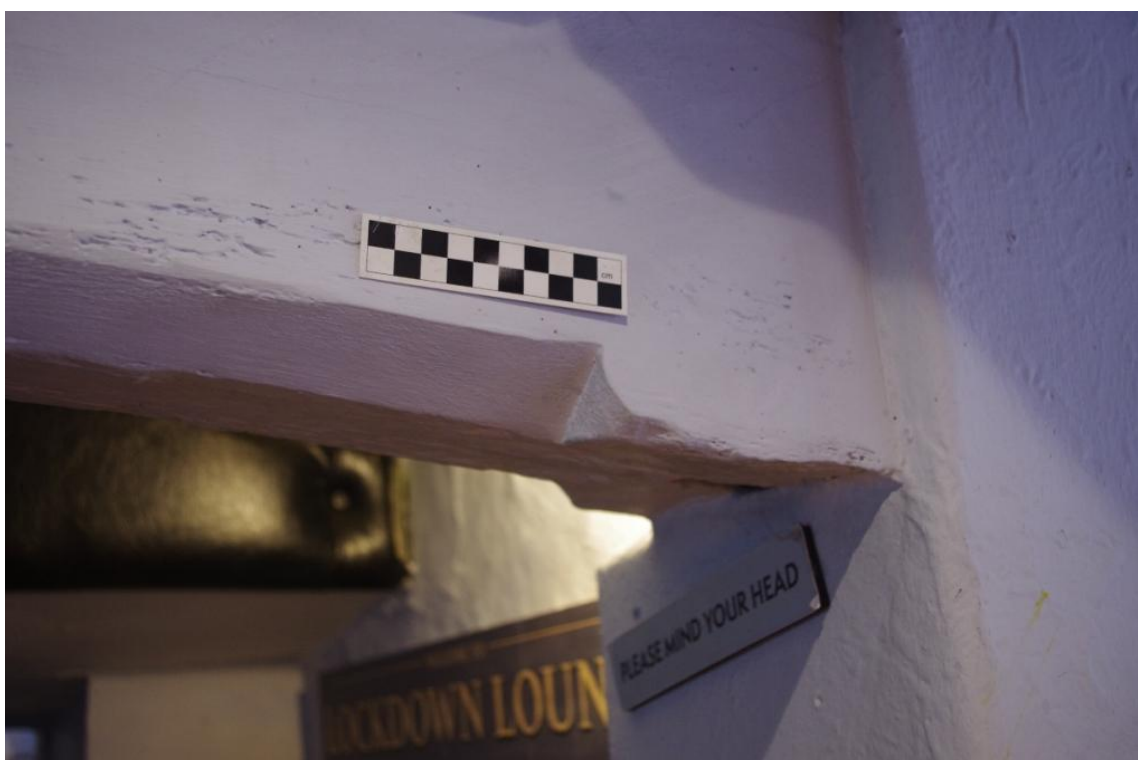
**Figure 17**  
A(2), Scroll Stopped Overmantle (Looking South – South East).

The ceiling in (2) is carried on a heavy chamfered and stopped bridging beam; the beam has an almost identical scroll stop to the overmantle indicating the two are contemporary. The joists are hand finished and are also likely to be contemporary and some have evidence of reuse.

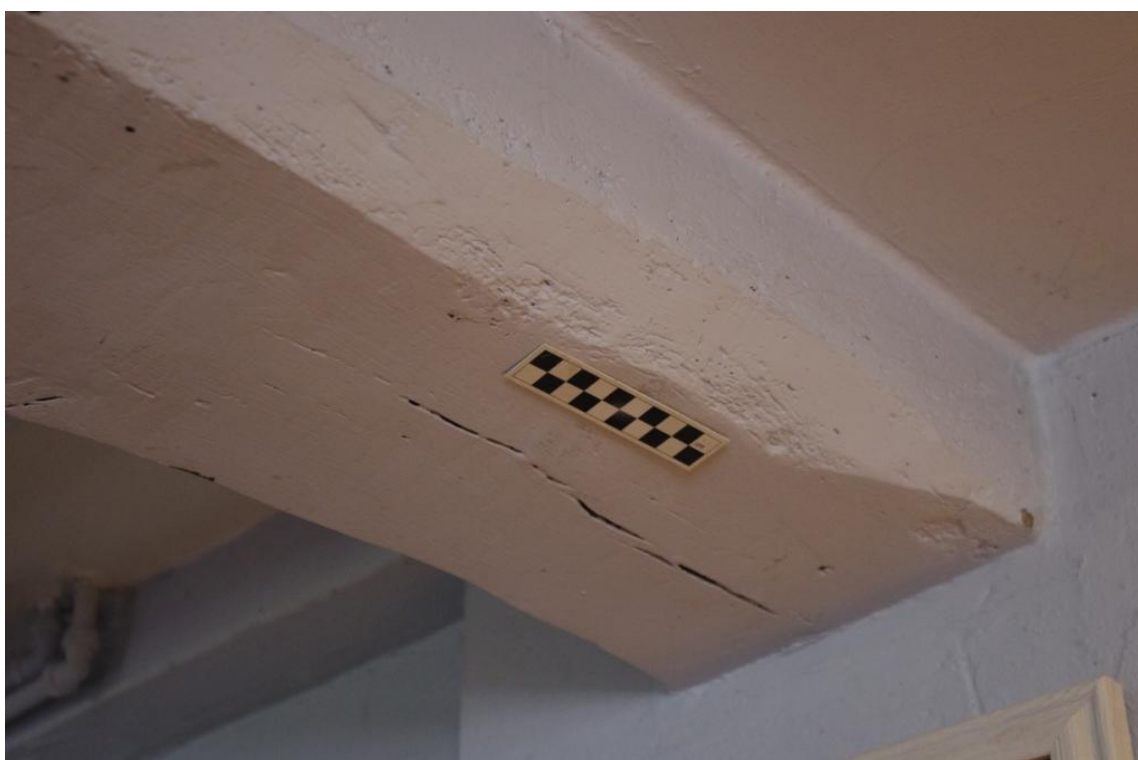
**Figure 19**  
A(1), Chamfered & Stopped Bridging Beam (Looking North East).

Interestingly, the beam in (1) is chamfered and stopped at its eastern end (*Figure 19*), this would suggest that the short section of wall between (1) and (2) could potentially be original. If so it may indicate that this western bay was originally two bays.

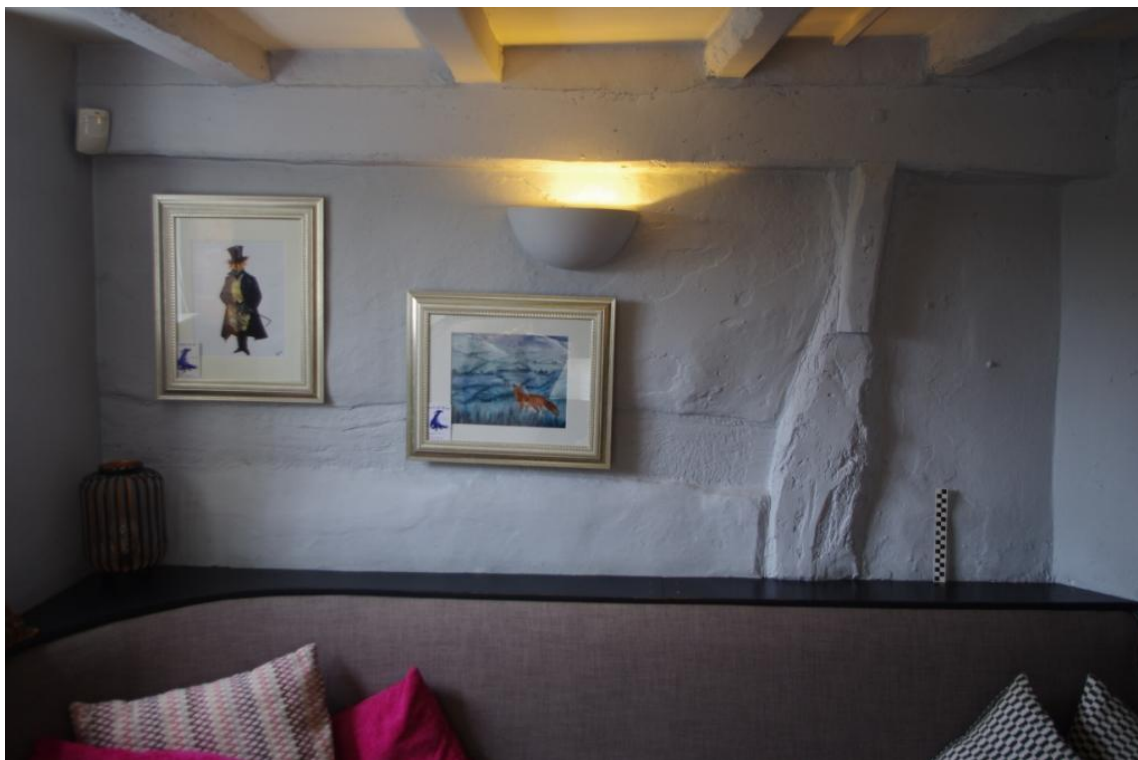
**Figure 20**  
B(1), Framing Visible in Rear Wall (Looking North – North East).

There is clear evidence of timber framing in the rear wall of (1) consisting of a post and rail (*Figure 20*). To the east is an angled projection in the wall which may again be remnant

framing. Both the gable and the front wall are unevenly finished suggesting further timber framing maybe concealed here also. The gable fireplace is modern brick.

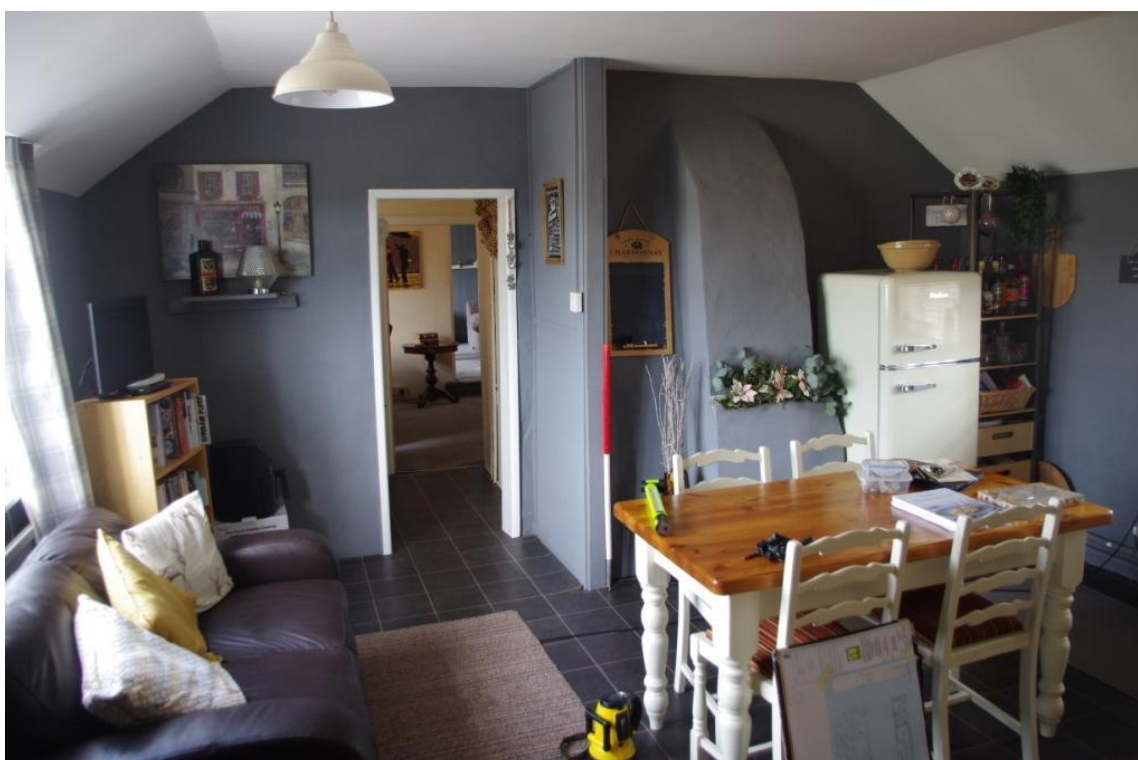
**Figure 21**  
B(8), Chimney Breast (Looking West – North West).

Access to the first floor is via a straight flight stair against the east gable, there is also an external, steel stair on the west gable. The first floor consists of the three principal bays (*Figure 25*), the easternmost being the 19th century extension. The first floor retains very little of historic or architectural significance beyond the historic plan-form. There is a large chimney breast between (7) and (8) (*Figure 21*).

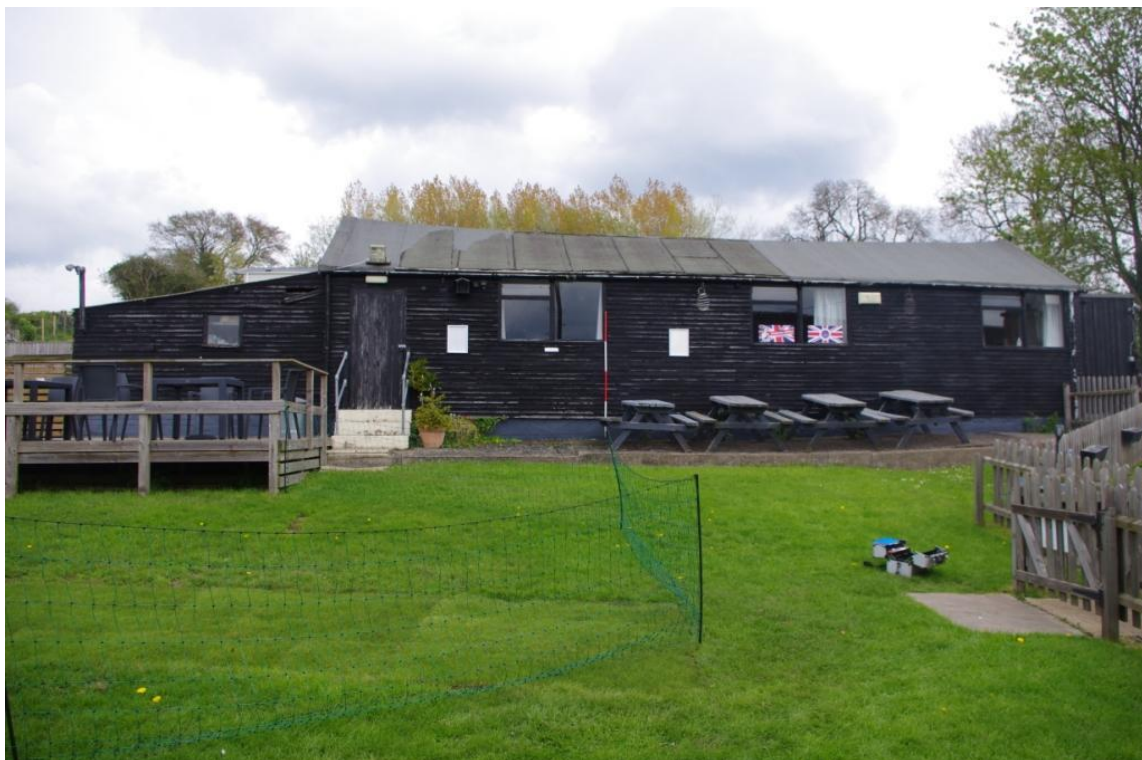
**Figure 22**  
Building B, South – South East Facing Elevation (Looking North – North East).

The Games Room is located some 8 metres north of the Greyhound. The timber built building is linear in plan under a pitched felt clad roof (*Figure 22*). Abutting the west gable is a lean to extension. There are modern windows on the south facing elevation, along with a single door to the west. On the east facing gable is a double door, the rear elevation is blank.

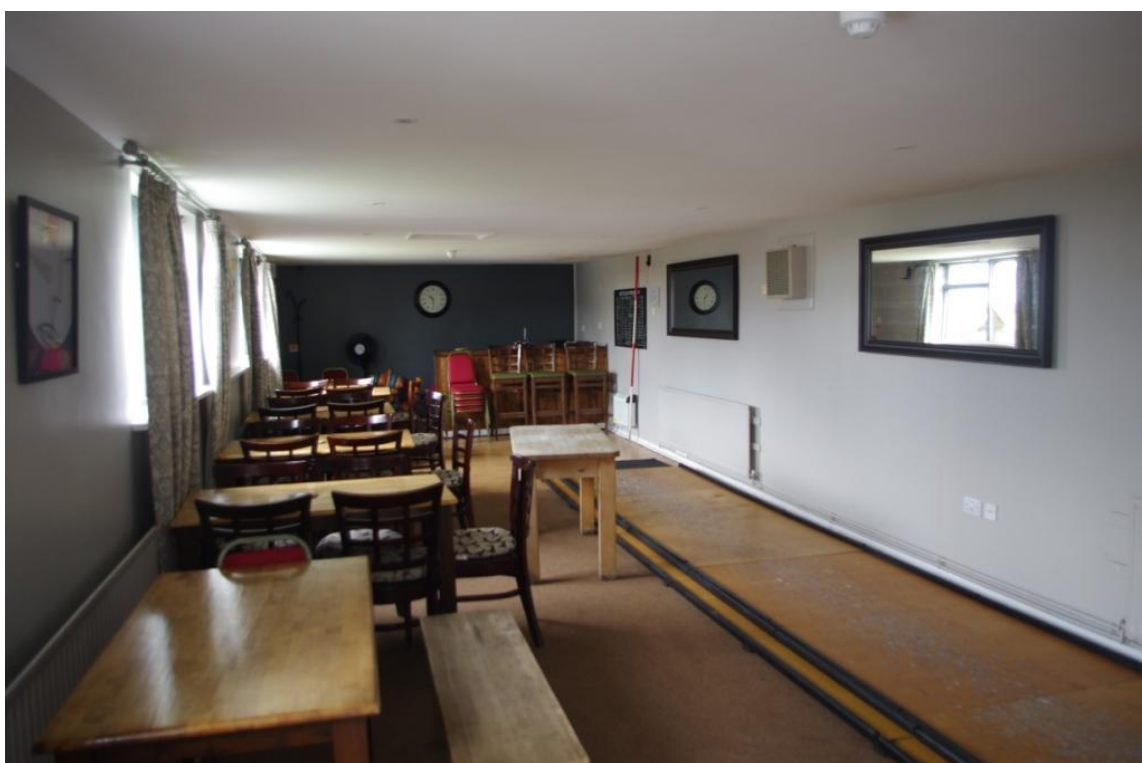
**Figure 23**  
Building B, General View, Internal (Looking West – North West).

Internally the building consists of a single bay (*Figure 24*) with a servery in the north west corner and a skittle alley against the rear wall. The interior is all modern with no visible evidence to indicate a construction date (*Figure 23*). Cartographic sources suggest the building could be as early as the 1920s; there was no visible evidence to confirm or refute this.
