## Preliminary bat roost assessment

| Site Location | 1 Church Field, Congerstone, Nuneaton, CV13 6NA |
| Document reference | CE4485 |

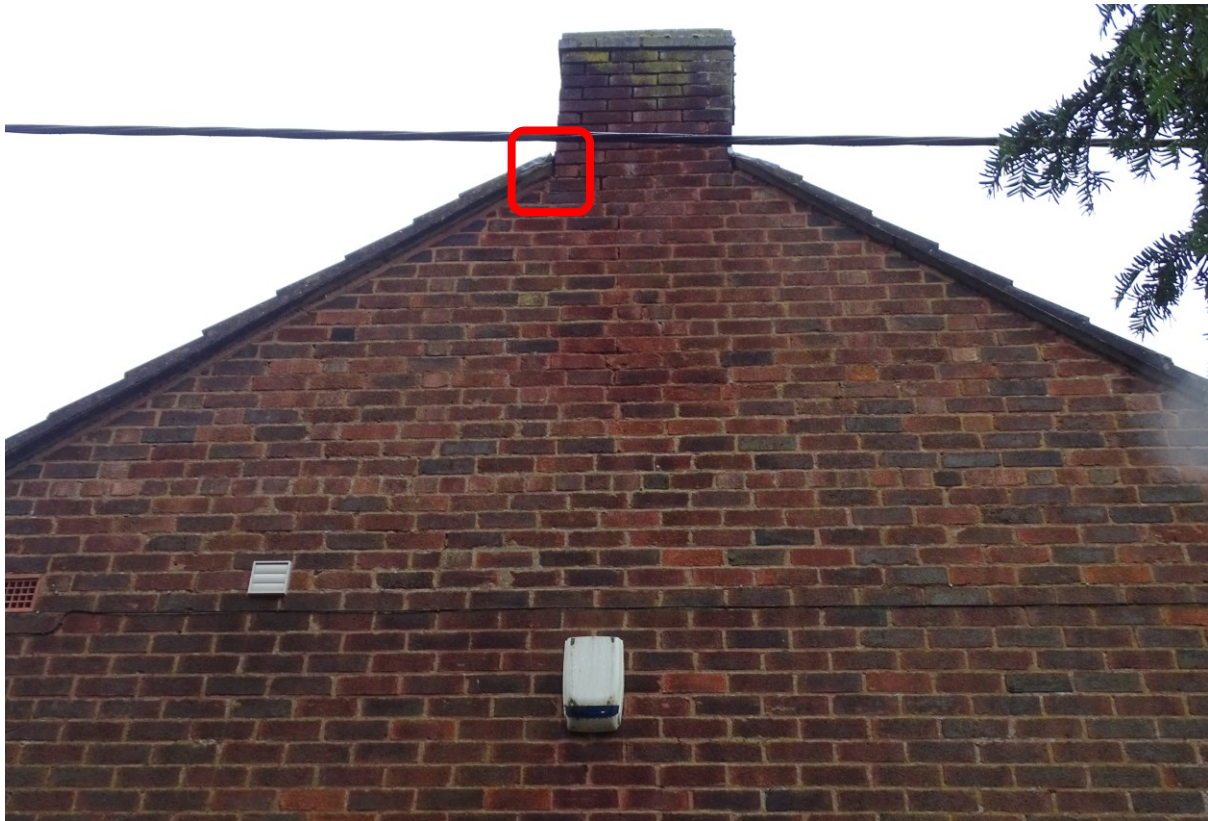
Image 5 – South facing elevation of the property offering a small gaps of adequate proportions to offer shelter/access for bats

- 6.6** In line with best practice survey guidelines, a structure that has demonstrated low value must have a further single emergence survey to rule out or confirm activity from bats. This survey should be carried out within the recommended survey season from May to August.

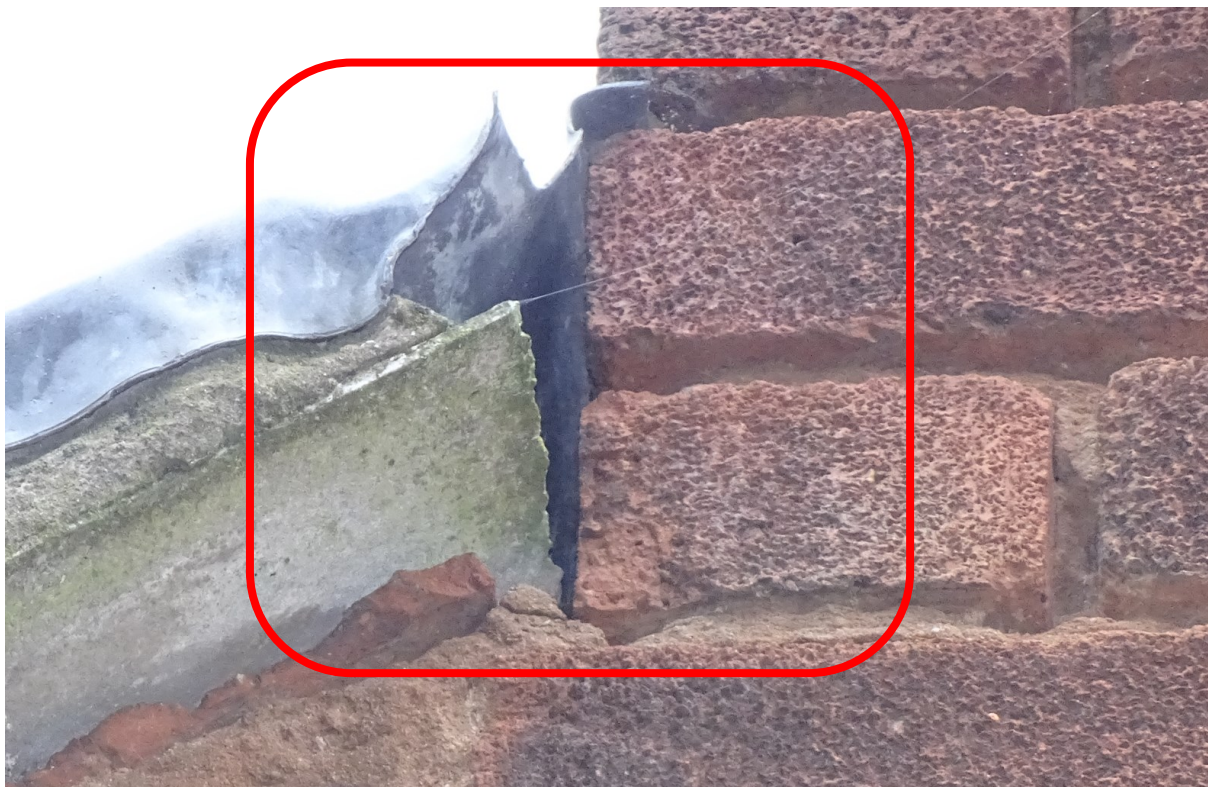
Image 6 – As per image five above

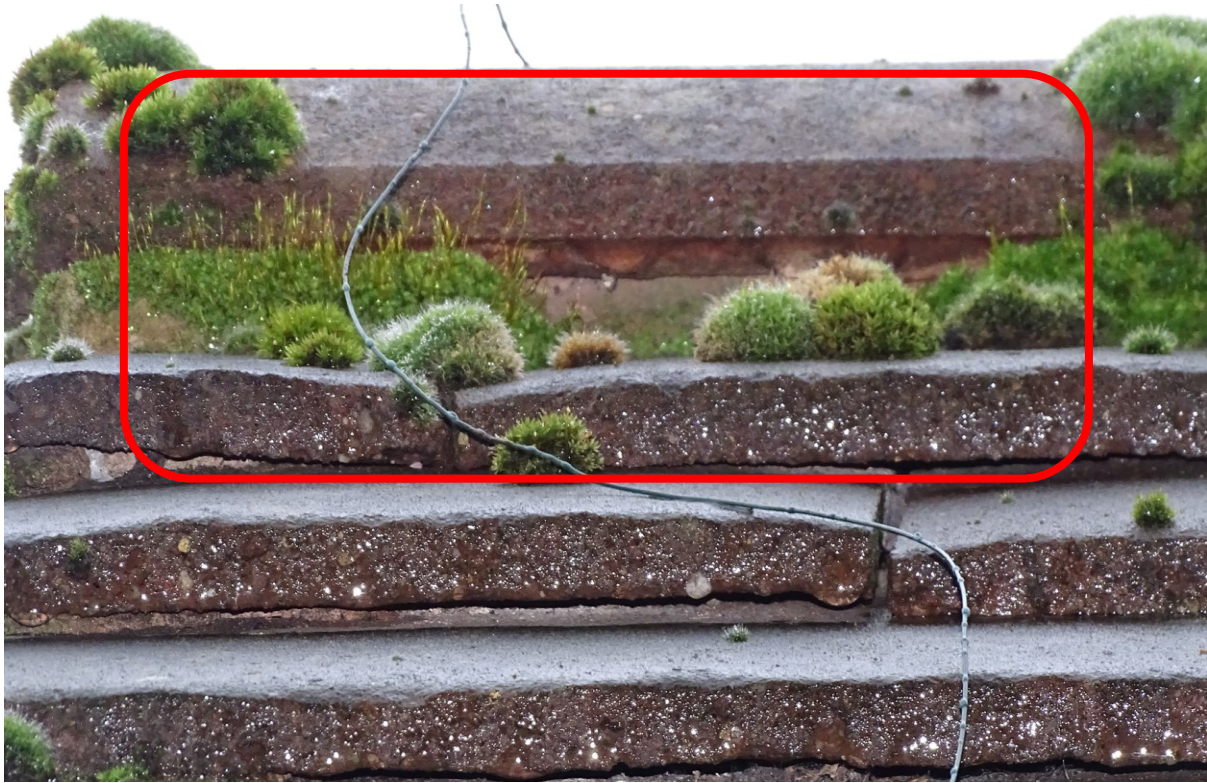
| External | Features of value to bats | Notes |
|---|---|---|
| Roof coverings | Yes | <p>The main dwelling roof coverings have demonstrated a fair level of condition to the East and West facing coverings.</p> <p>Roof lights within the East &amp; West elevations look to offer potential value to bats between the roof tiles and areas cur away for the roof light along with a small section close to the chimney which was visible from the West.</p> <p>The detached outbuilding has demonstrated gaps below a single ridge tile which looks to provide shelter/access opportunities for bats.</p> |

Image 9 – Gap below the ridge areas of the detached outbuilding which looks to offer adequate access opportunities for bats

**6.8** It is advised that no further works take place to the identified areas of value to bats at this stage as this may cause disturbance to bats and their roosts. see section 2.0 of this report

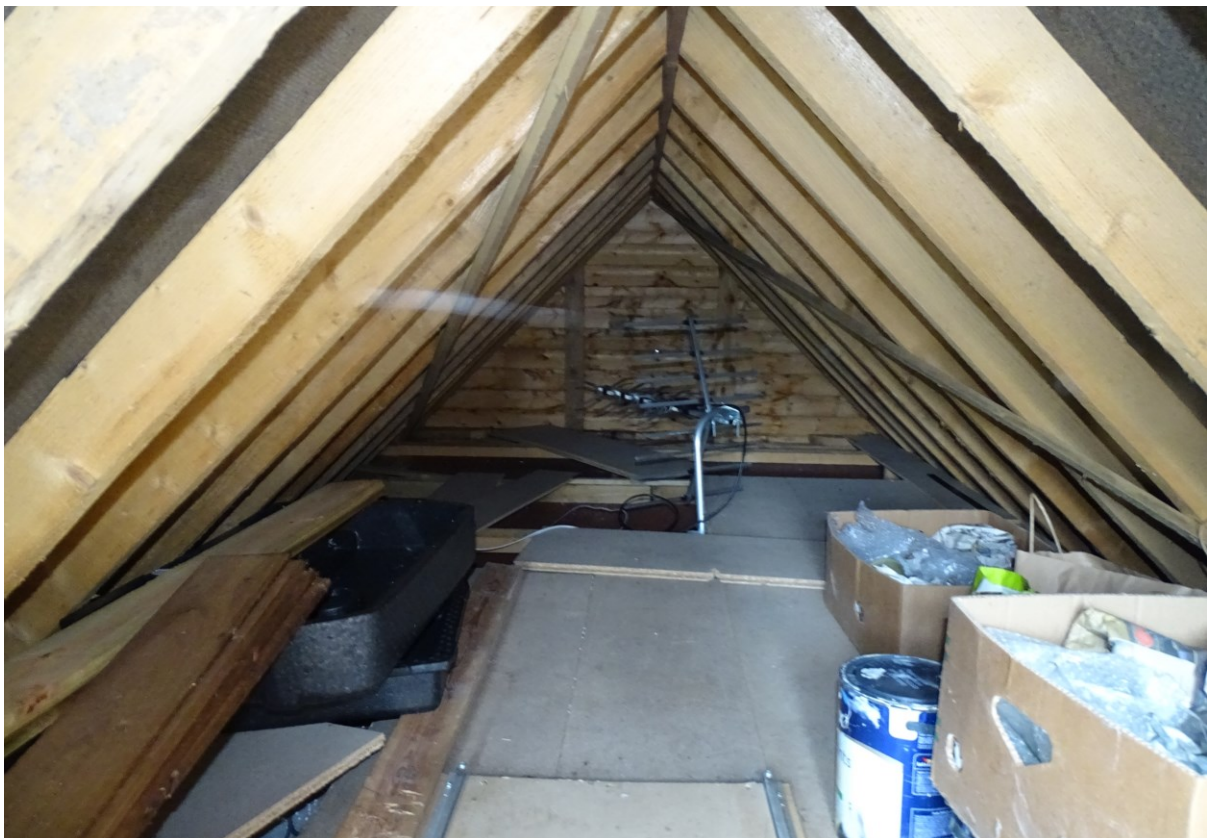
| Internal | Features of value to bats | Notes |
|---|---|---|
| Membrane coverings | Yes | <p>The upper roof void areas of the main dwelling have been previously overboard with only a small areas of void space within the eaves which was visible. A felt membrane was visible within this section.</p> <p>Felt membrane coverings were observed throughout the detached outbuilding.</p> <p>Such coverings may create suitable daytime roosting habitats commonly used by bats between the membrane and tiles where external access may provide access.</p> |
| Evidence from bats | No | No internal evidence of bat was identified within the roof void areas to both the main dwelling or outbuilding; however, we are unable to rule out or confirm any roosting evidence within the spaces between the roof coverings/eaves and felt membrane areas to both the main dwelling or outbuilding where evidence such as droppings wouldn't always be visible. |

Image 10 – Internal view from within the roof void spaces of the detached outbuilding

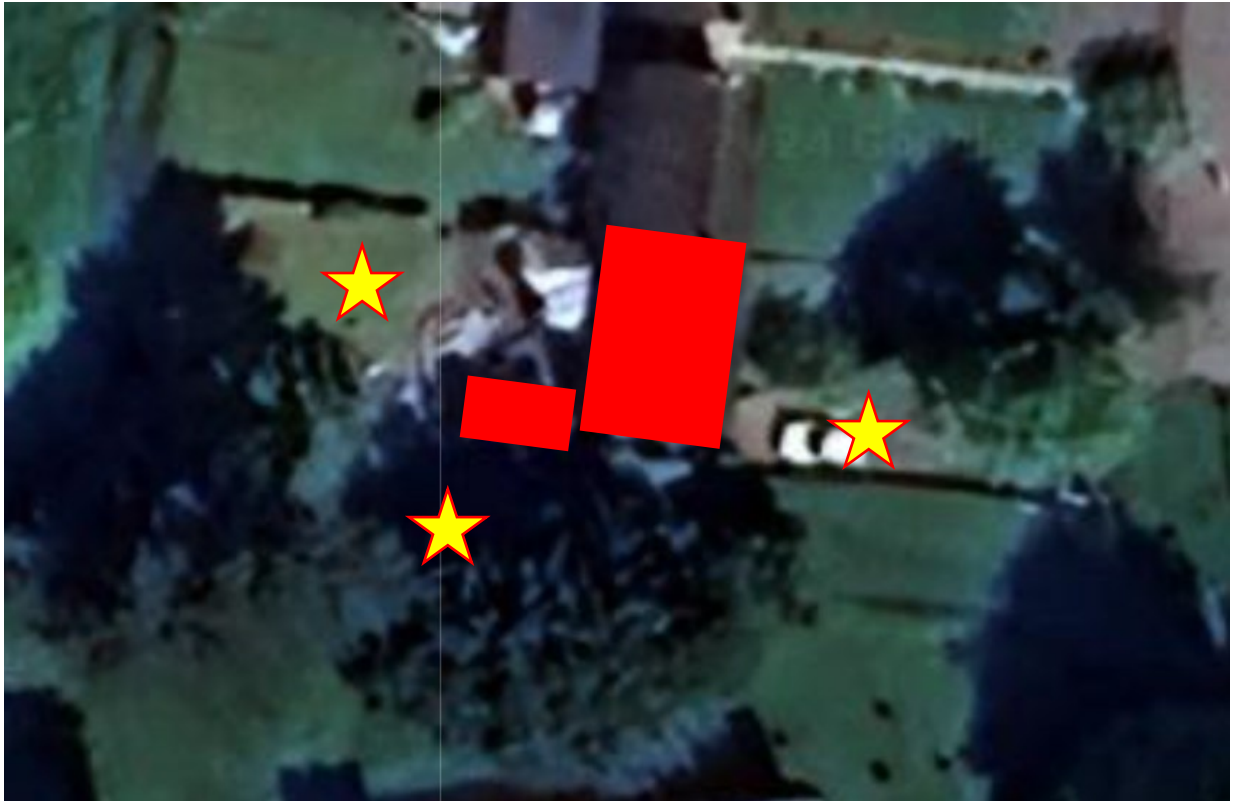
#### Appendix 4: Emergence Survey Location Points

Below site view to show suitable surveyor location points during each emergence survey to maintain visibility of the property.

In line with best practice survey guidelines, a total of three surveyors will be required to visually cover all elevations of the structure during each emergence survey.
