# GEO-ENVIRONMENTAL REPORT

| job number | C5007/25/E/7632 | date | 16.05.25 |
| site address | Land East of Stretton Croft,<br>Wolvey Road,<br>Burbage, Hinckley,<br>Leicestershire, LE10 3JB | | |

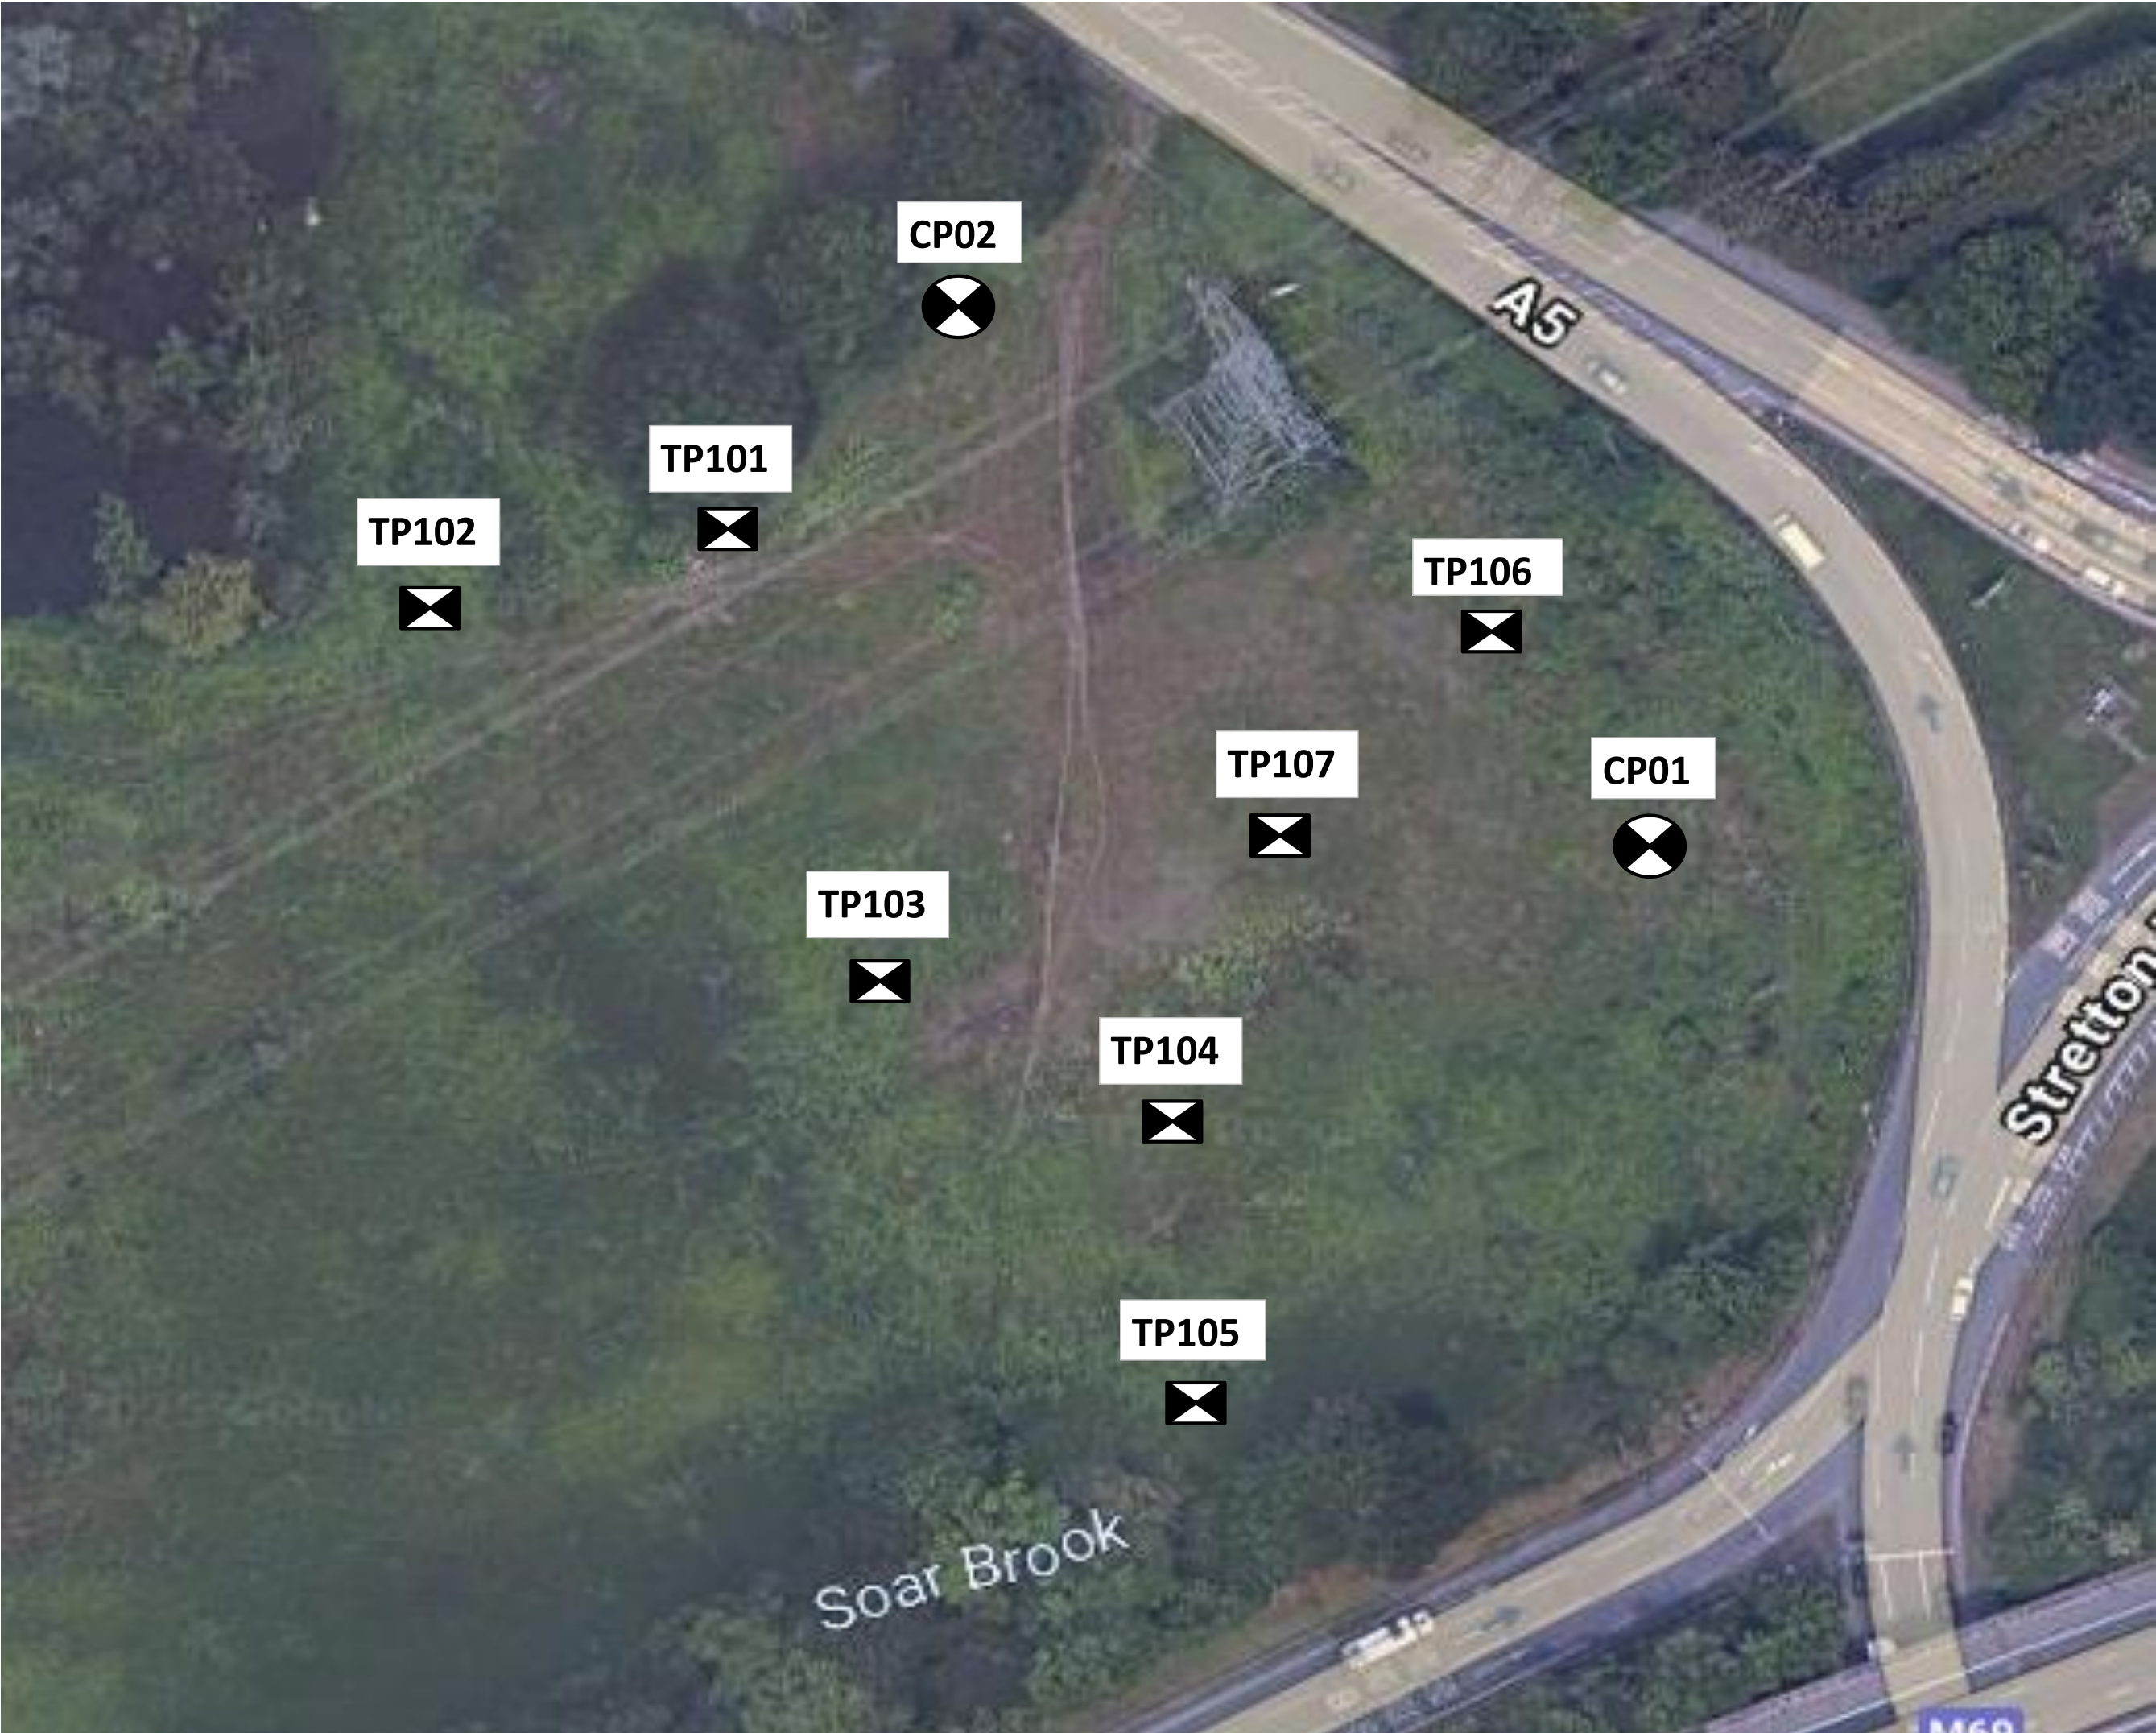
**Notes:**  
Investigation positions approximated from site operative's notes.
