### PHASE II GROUND INVESTIGATION

### CHERRY ORCHARD FARM HIGHAM ON THE HILL

Report No: 23018/1

OWL HOMES LIMITED

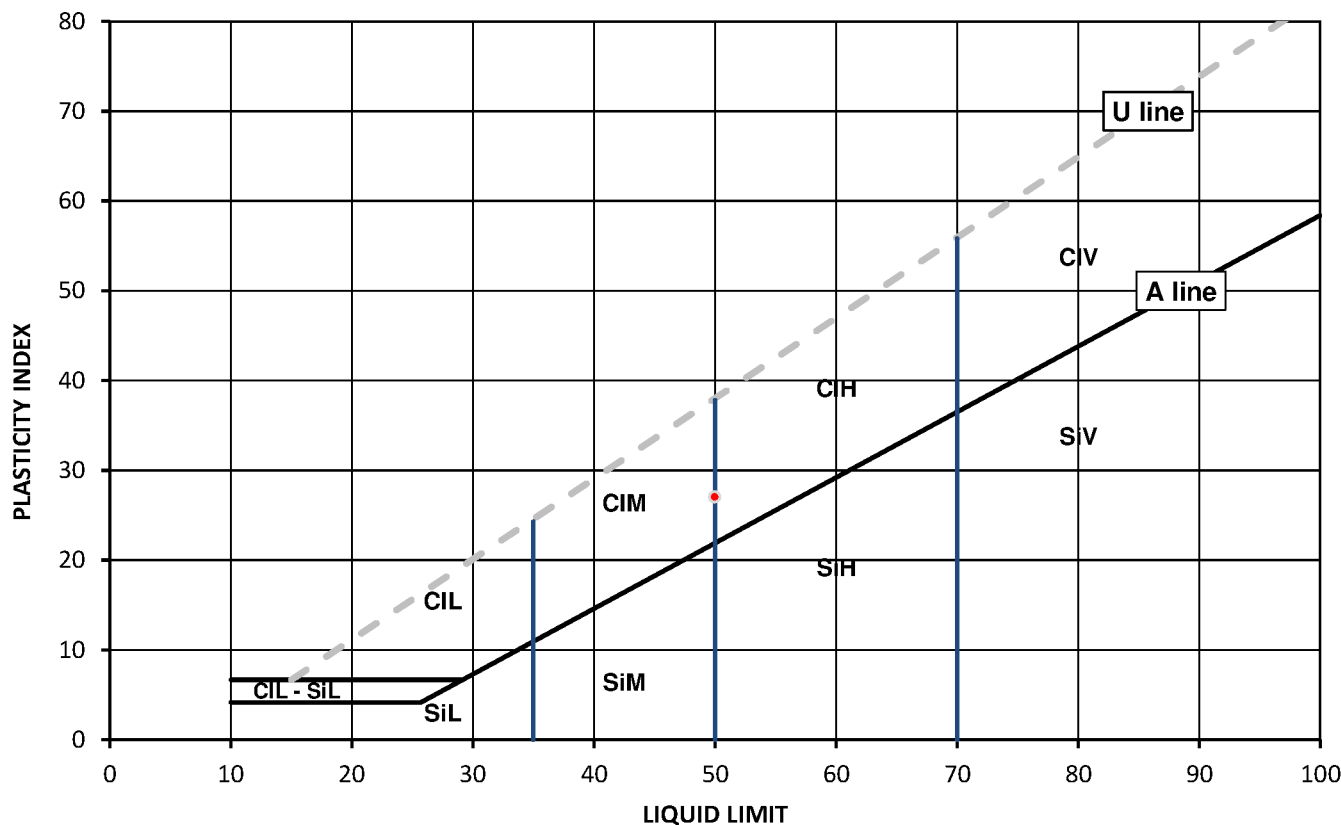
| As Received Water Content [ W ] % | Liquid Limit [ WL ] % | Plastic Limit [ Wp ] % | Plasticity Index [ Ip ] % | % Passing 425µm BS Test Sieve |
|---|---|---|---|---|
| 27 | 50 | 23 | 27 | 98 |

Legend, based on BS EN ISO 14688 2:2018 Geotechnical investigation and testing – Identification and classification of soil

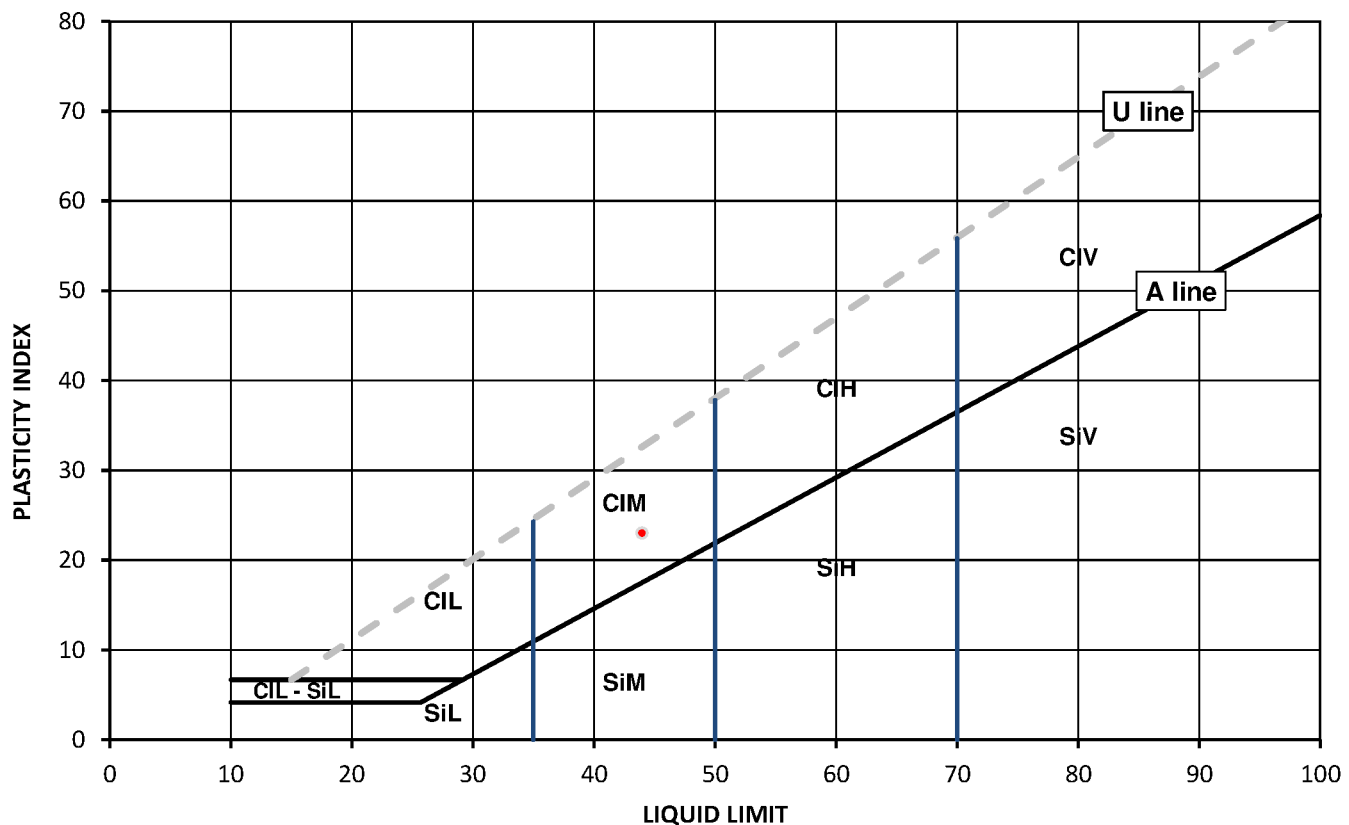
| As Received Water Content [ W ] % | Liquid Limit [ WL ] % | Plastic Limit [ Wp ] % | Plasticity Index [ Ip ] % | % Passing 425µm BS Test Sieve |
|---|---|---|---|---|
| 17 | 44 | 21 | 23 | 92 |

Legend, based on BS EN ISO 14688 2:2018 Geotechnical investigation and testing – Identification and classification of soil

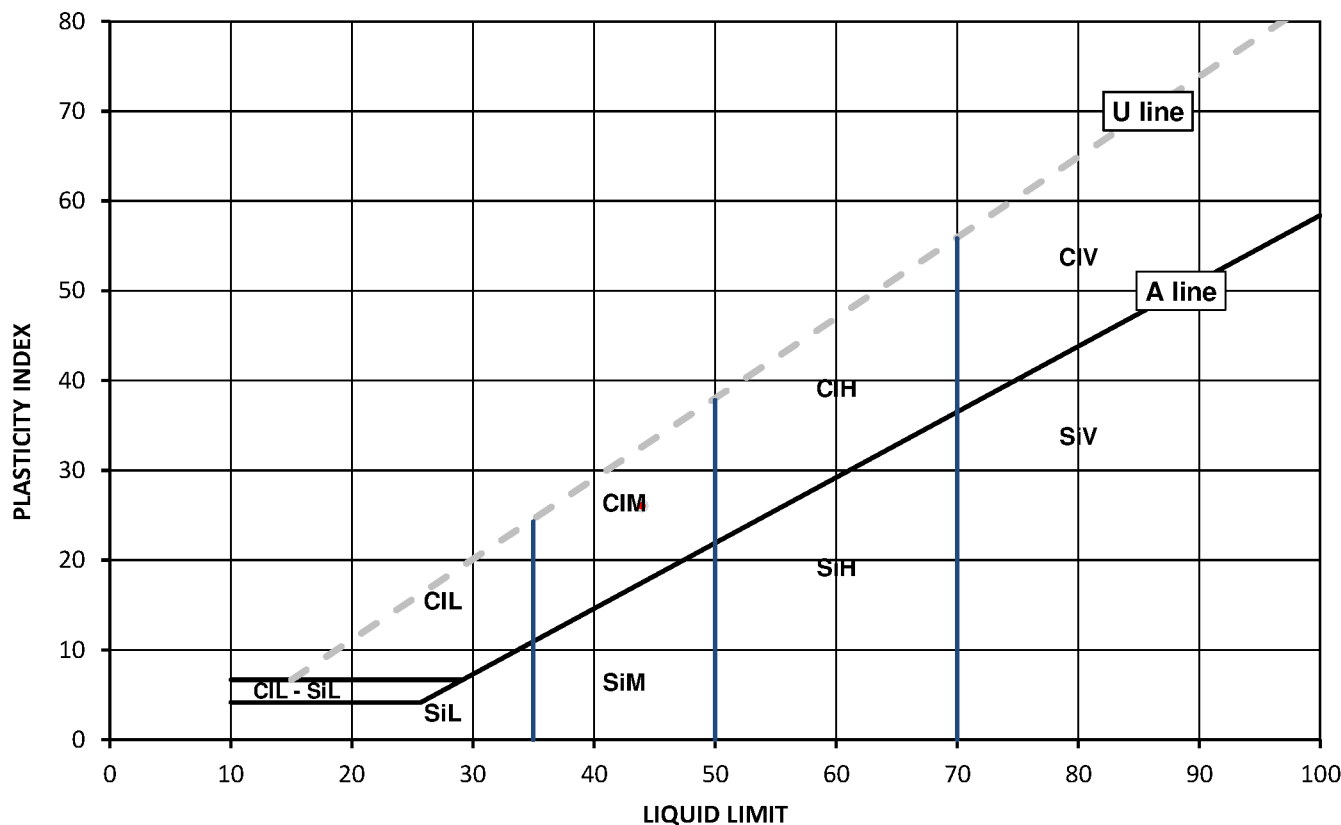
| As Received Water Content [ W ] % | Liquid Limit [ WL ] % | Plastic Limit [ Wp ] % | Plasticity Index [ Ip ] % | % Passing 425um BS Test Sieve |
|---|---|---|---|---|
| 15 | 44 | 18 | 26 | 92 |

Legend, based on BS EN ISO 14688 2:2018 Geotechnical investigation and testing – Identification and classification of soil

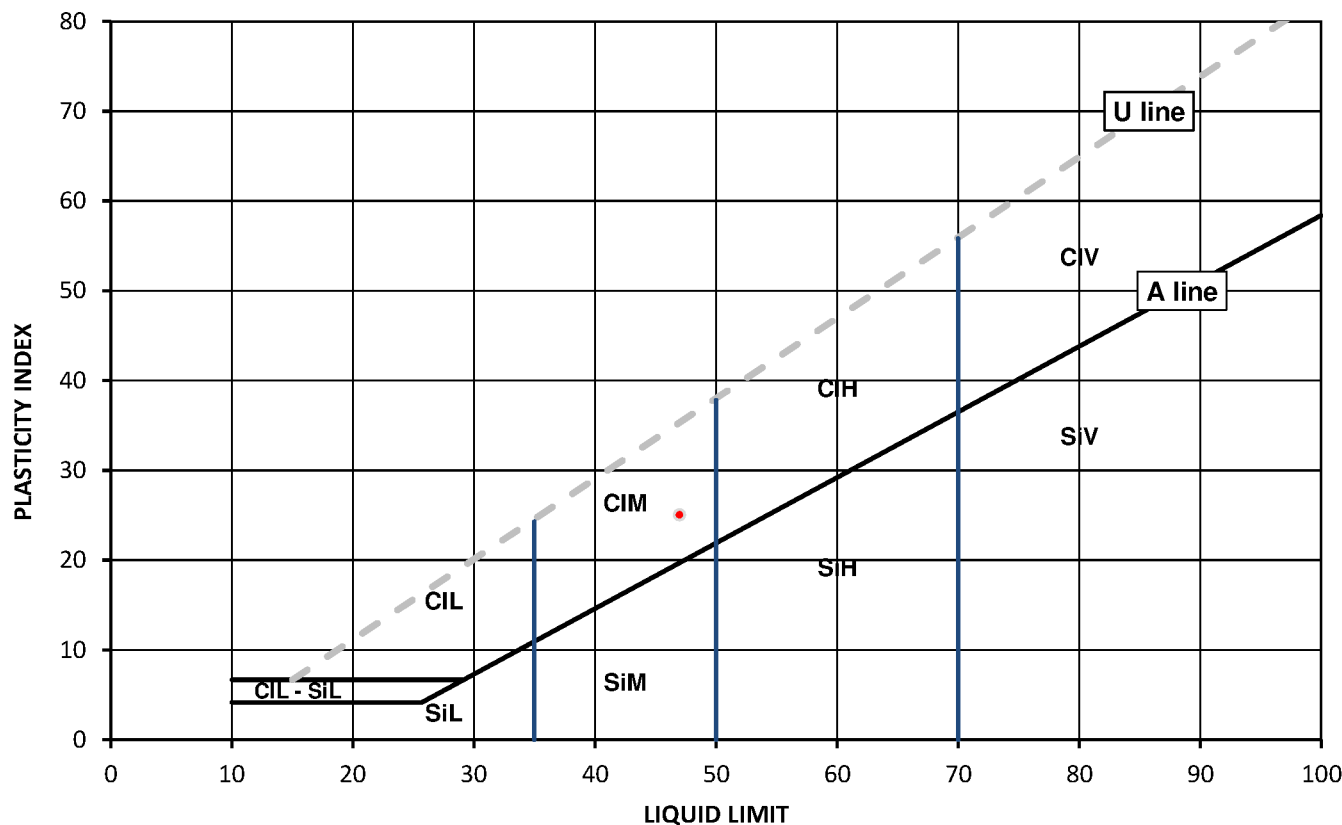
| As Received Water Content [ W ] % | Liquid Limit [ WL ] % | Plastic Limit [ Wp ] % | Plasticity Index [ Ip ] % | % Passing 425µm BS Test Sieve |
|---|---|---|---|---|
| 20 | 47 | 22 | 25 | 95 |

Legend, based on BS EN ISO 14688 2:2018 Geotechnical investigation and testing – Identification and classification of soil

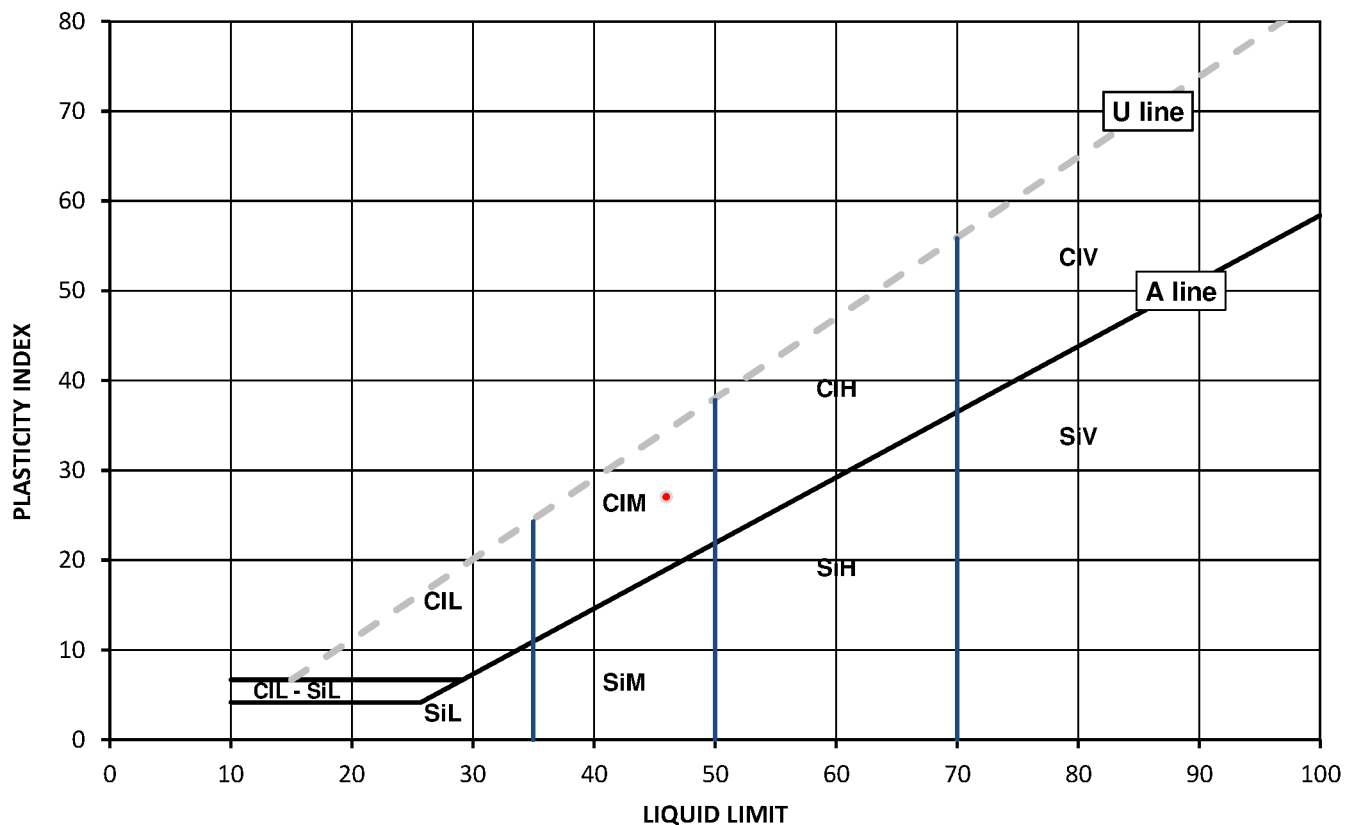
| As Received Water Content [ W ] % | Liquid Limit [ WL ] % | Plastic Limit [ Wp ] % | Plasticity Index [ Ip ] % | % Passing 425µm BS Test Sieve |
|---|---|---|---|---|
| 19 | 46 | 19 | 27 | 92 |

Legend, based on BS EN ISO 14688 2:2018 Geotechnical investigation and testing – Identification and classification of soil

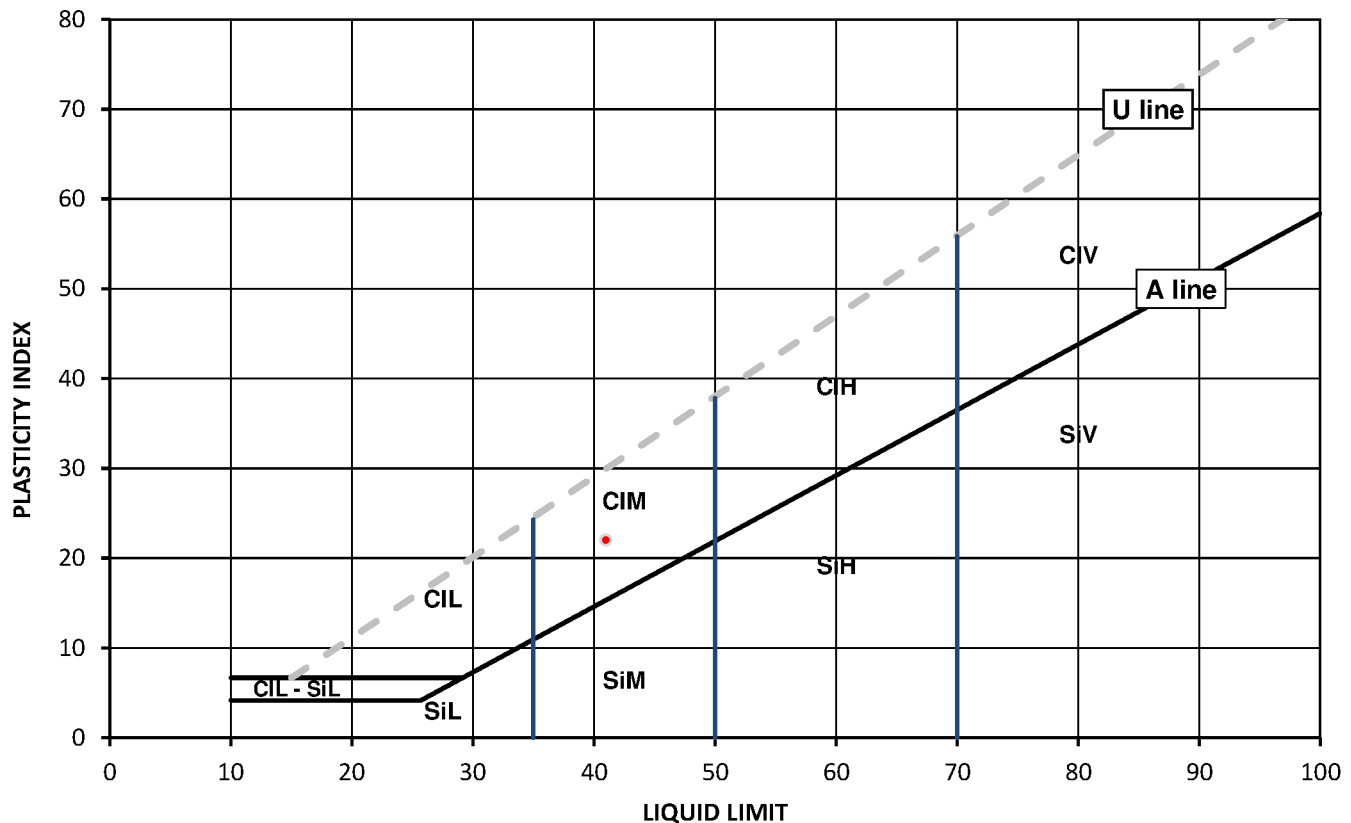
| As Received Water Content [ W ] % | Liquid Limit [ WL ] % | Plastic Limit [ Wp ] % | Plasticity Index [ Ip ] % | % Passing 425µm BS Test Sieve |
|---|---|---|---|---|
| 17 | 41 | 19 | 22 | 92 |

Legend, based on BS EN ISO 14688 2:2018 Geotechnical investigation and testing – Identification and classification of soil

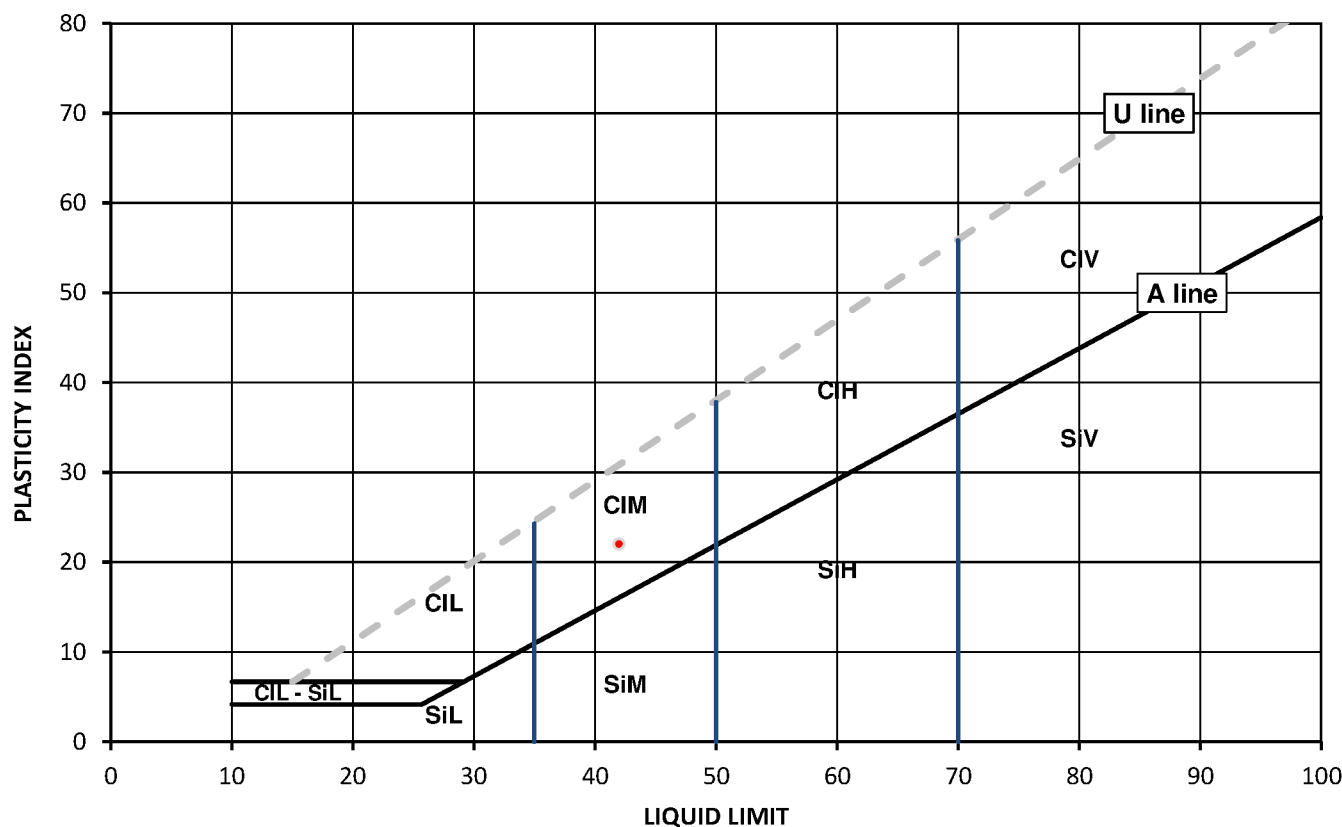
| As Received Water Content [ W ] % | Liquid Limit [ WL ] % | Plastic Limit [ Wp ] % | Plasticity Index [ Ip ] % | % Passing 425µm BS Test Sieve |
|---|---|---|---|---|
| 17 | 42 | 20 | 22 | 93 |

Legend, based on BS EN ISO 14688 2:2018 Geotechnical investigation and testing – Identification and classification of soil

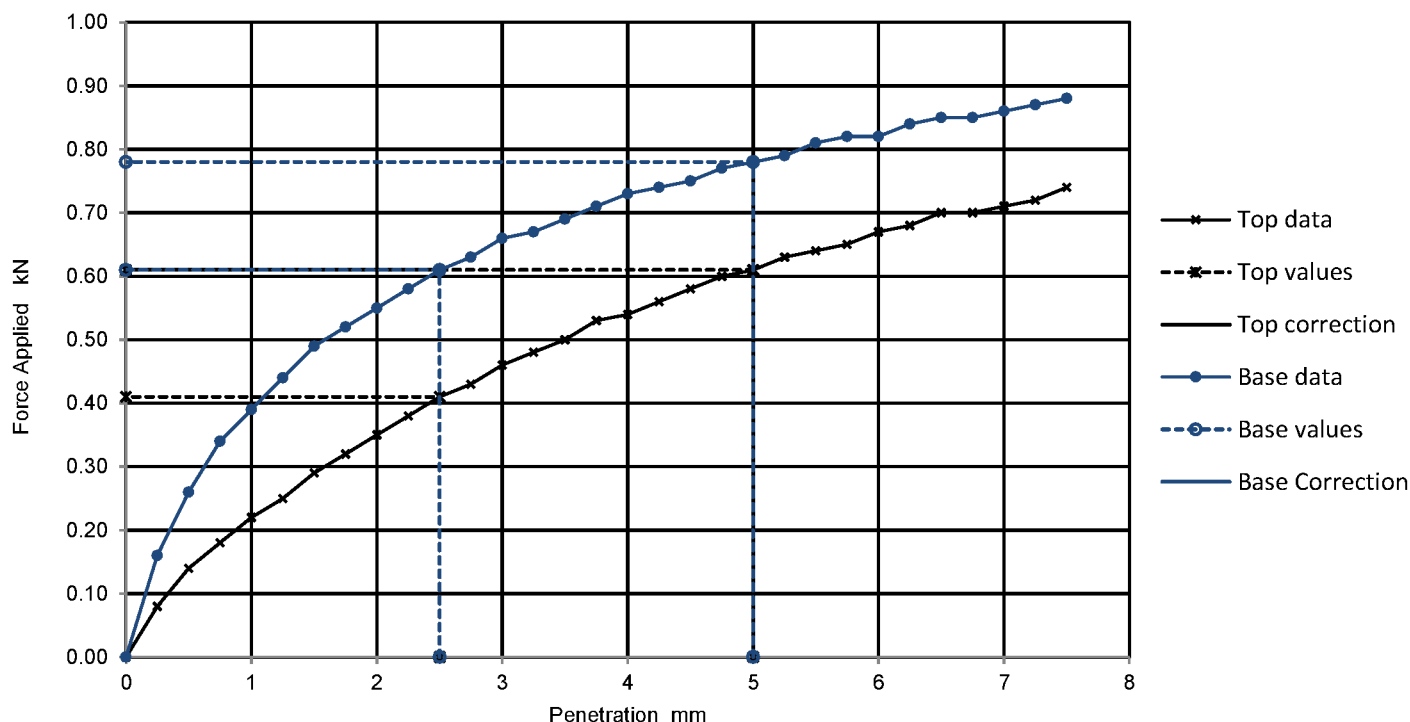
Force v Penetration Plots

Initial Specimen details: Bulk density: 1.97 Mg/m3  
Dry density: 1.59 Mg/m3  
Moisture content: 24 %  
Surcharge applied: 8 kg  
4.9 kPa

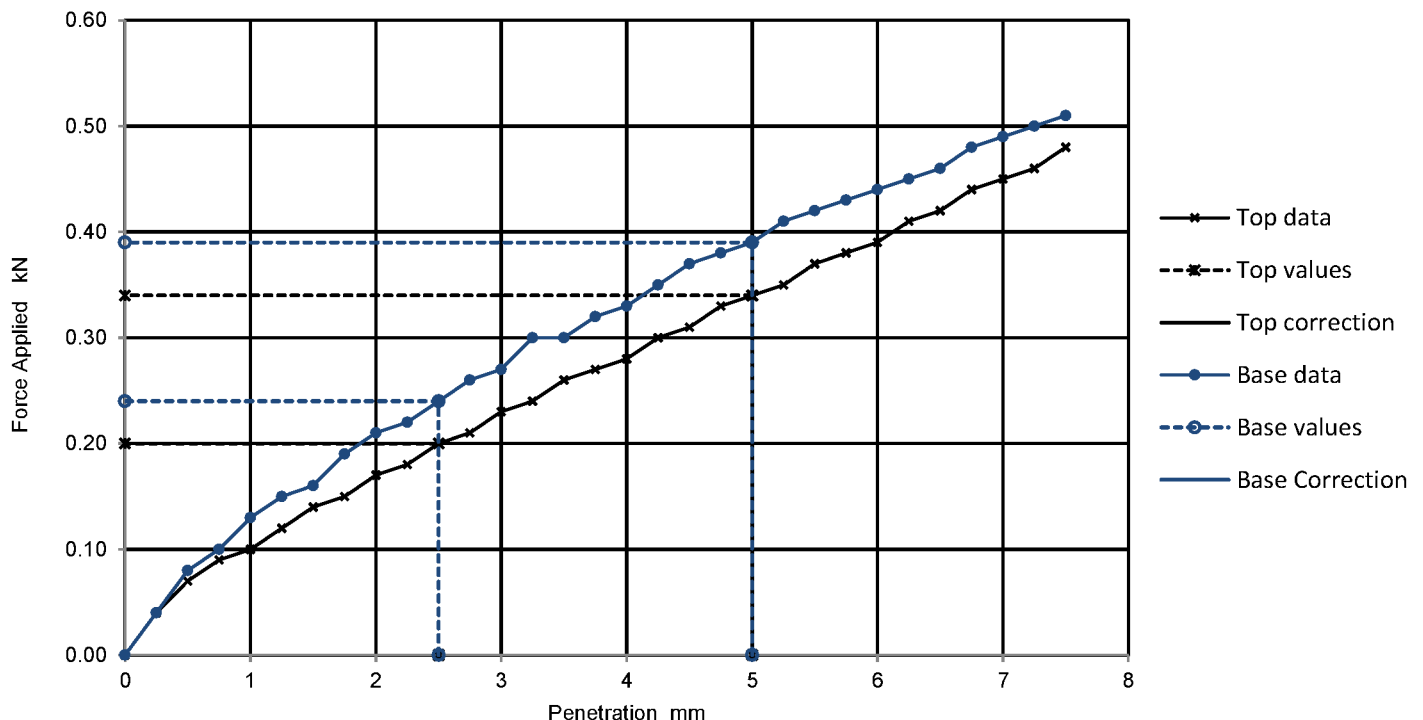
Force v Penetration Plots

Initial Specimen details Bulk density 2.07 Mg/m3  
Dry density 1.76 Mg/m3  
Moisture content 18 %  
Surcharge applied 8 kg  
4.8 kPa
