# Geo-environmental Assessment

Richborough Estates

Station Road, Market Bosworth.

Ref: PJSG20-21-RT-02

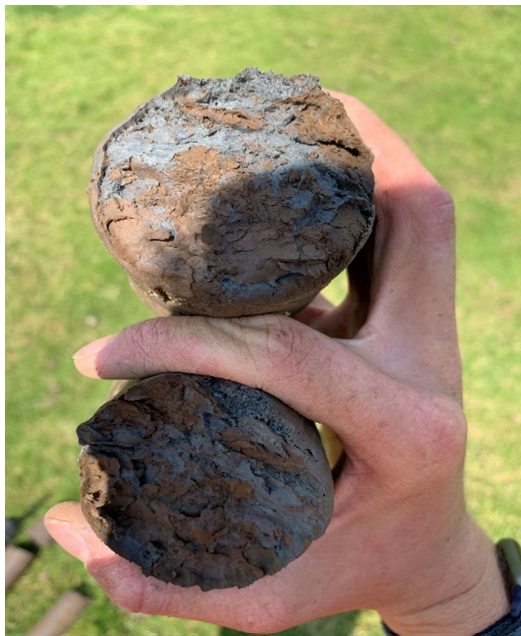
Example of the Bosworth Clay Member from a Window Sample core.

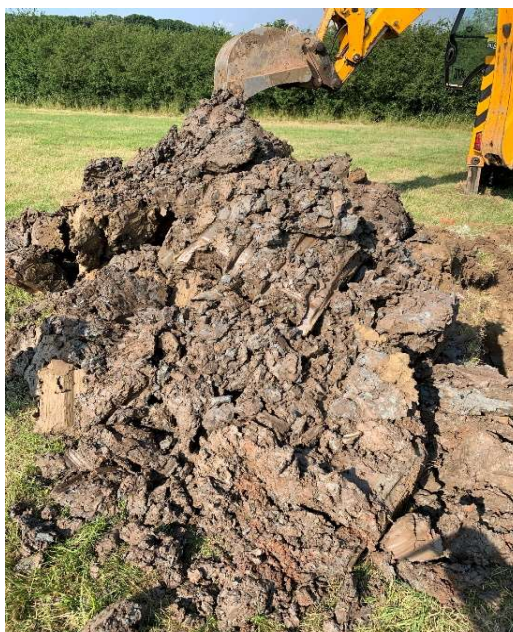
Example of the Bosworth Clay Member from Trial Pit arisings.
