# PRELIMINARY ROOST ASSESSMENT & DUSK BAT EMERGENCE SURVEYS

Cadeby Hall, Main Street, Cadeby,  
Leicestershire, CV13 0AX

Issue Date: 7 October 2026

Report No. 260710.CadebyHall.PRA.BES.v1.0

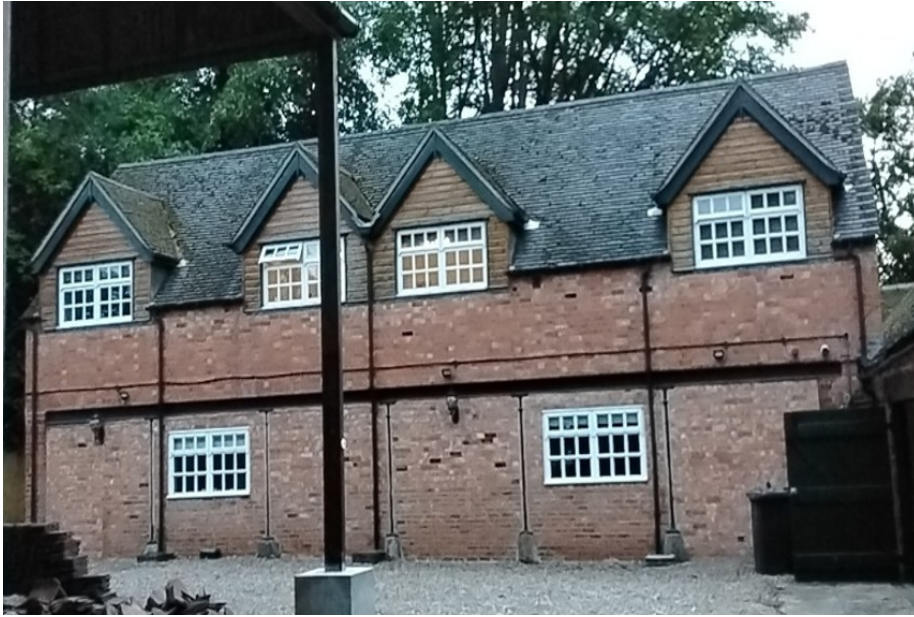
Building 1 (B1) comprised an occupied, two-storey dwelling constructed of solid brick beneath a gabled roof finished with slate. Gabled dormers were present on the northeast elevation with timber cladding present above the dormer windows. Wooden soffits, fascias and bargeboards were present, with no brick corbelling identified (see Figure 3).

*Figure 3 Building 1 northeastern facing elevation*

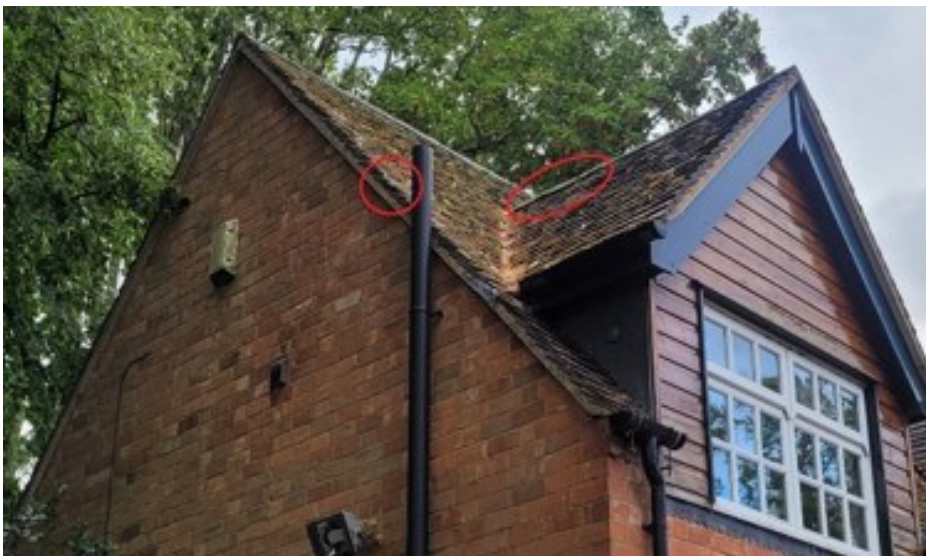
As seen in Figures 4 - 7, several potential access points for bats were identified externally, including gaps associated with the tile slopes, gable verges, ridge tiles, soffits, eaves and bargeboards. Additional potential access opportunities were identified at junctions between the roof coverings, verges and timber-clad gable sections. Potential roosting locations included areas beneath roof tiles and ridge tiles, between the roof covering and underlying lining, and around the tops of gable walls and associated roof structures.

*Figure 4 Lifted tiles and ridge southern elevation*

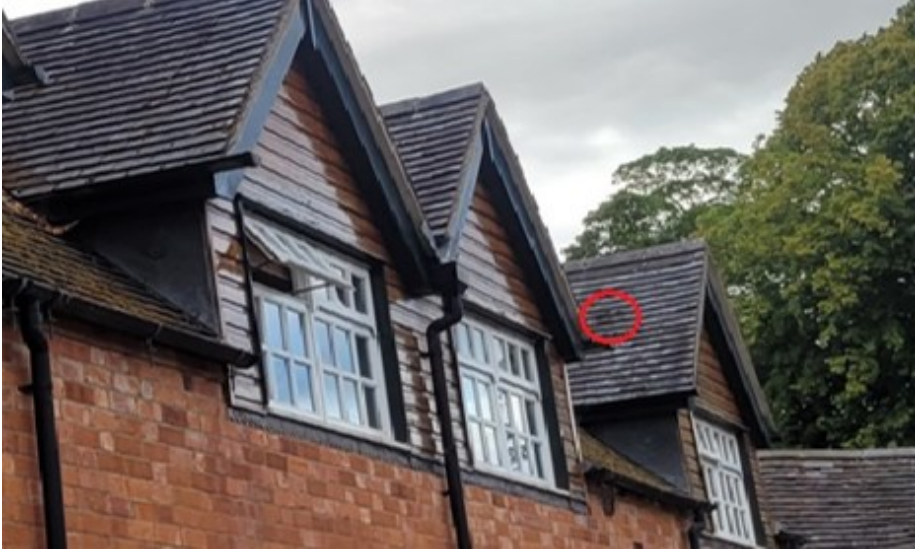
*Figure 5 Lifted tile dormer window facing south*

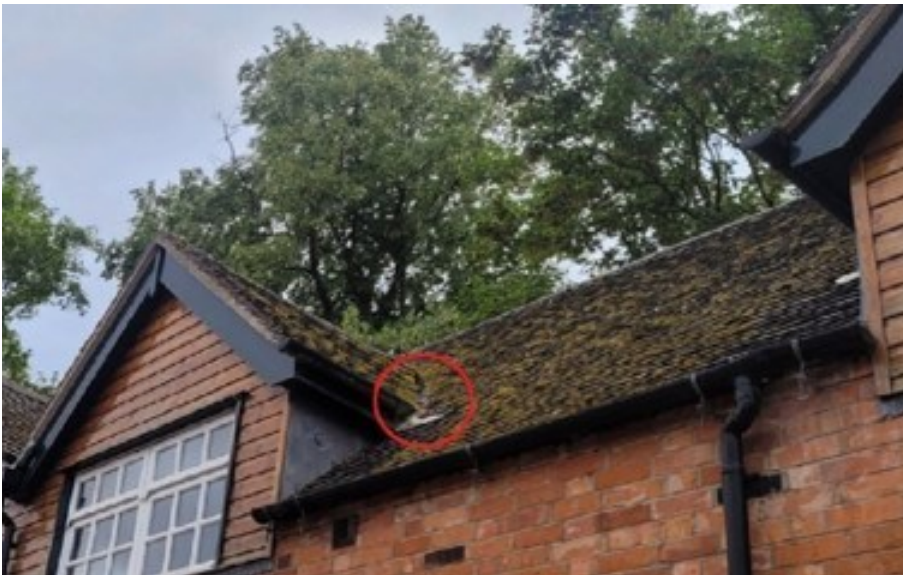
*Figure 6 Lifted lead flashing on junction facing east*

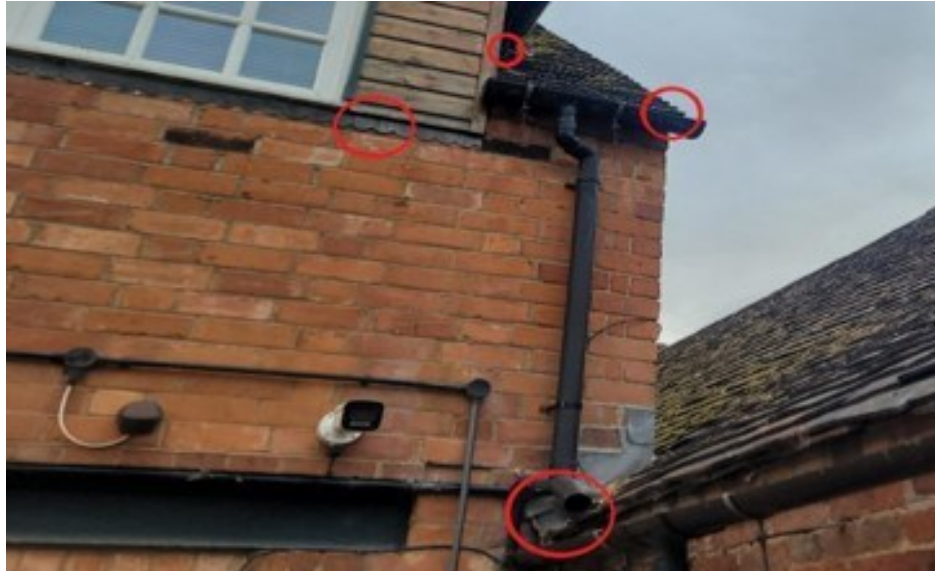
*Figure 7 Lifted lead flashing, tiles and trim*

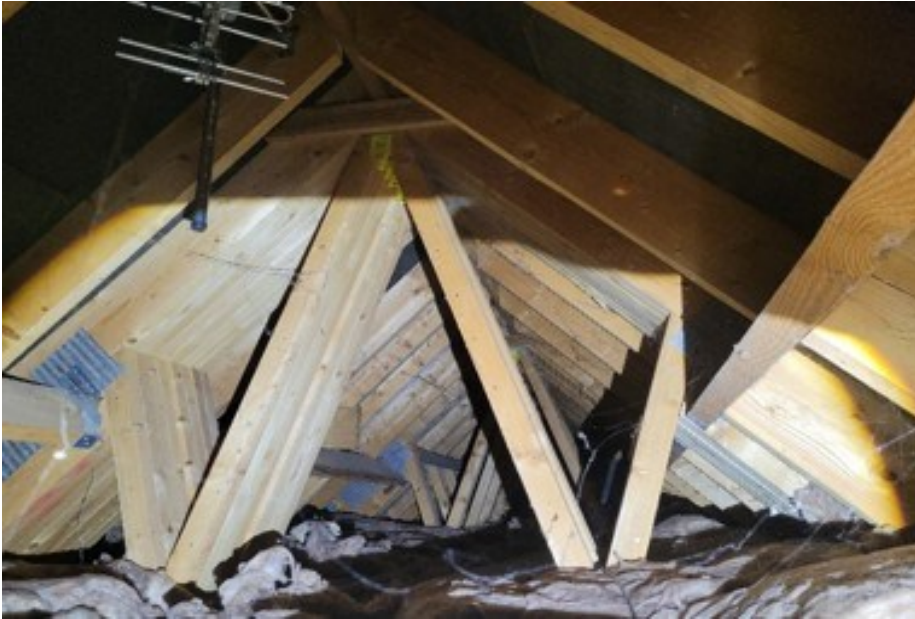
The roof void was accessed during the survey and comprised a pre-fabricated W-truss timber roof structure beneath a modern roofing membrane. As shown in Figure 8 the void was relatively shallow, with a maximum height of approximately 1.0m, and insulation was present between the ceiling joists at a depth of approximately 15cm. Minimal clutter was present within the roof void, comprising stored insulation materials, electrical wiring and associated items. A small number (~3) of old, dark droppings were identified within the roof void (see Figure 9). These were considered potentially consistent with old bat droppings based on their appearance and location; however, this could not be confirmed during the survey. No other potential evidence of bat use was identified within the roof void.

*Figure 8 B1 roof void*

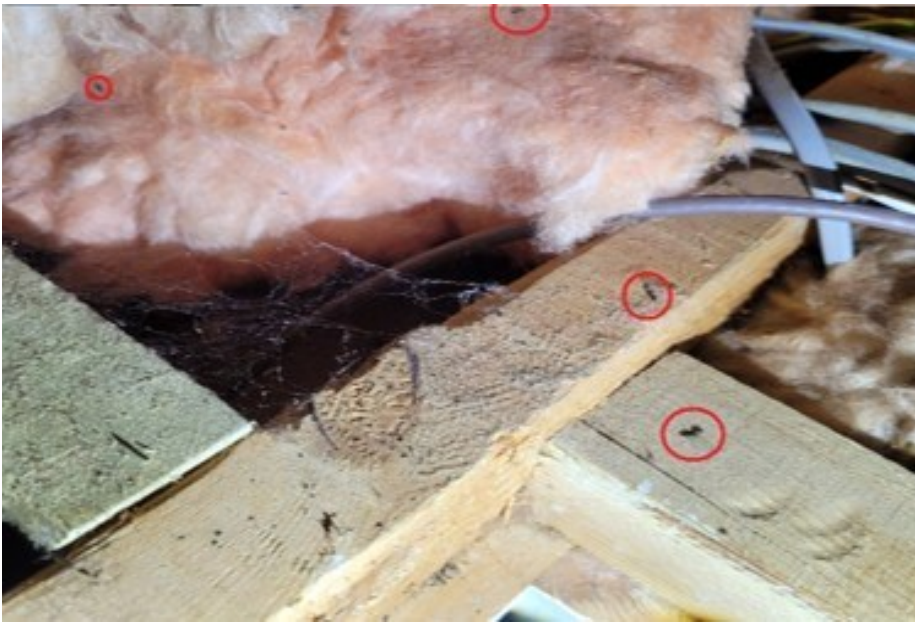
Taking into account the potential access points, available roosting features within the roof structure and the small number of possible old bat droppings recorded internally, B1 was assessed as having moderate potential to support roosting bats. The relatively shallow nature of the roof void and the building's continued occupation, resulting in regular disturbance, provide some limitations to its suitability for roosting bats. No confirmed bat roost was identified within B1 during the PRA or subsequent dusk emergence surveys.

*Figure 9 Droppings in B1 loft void*

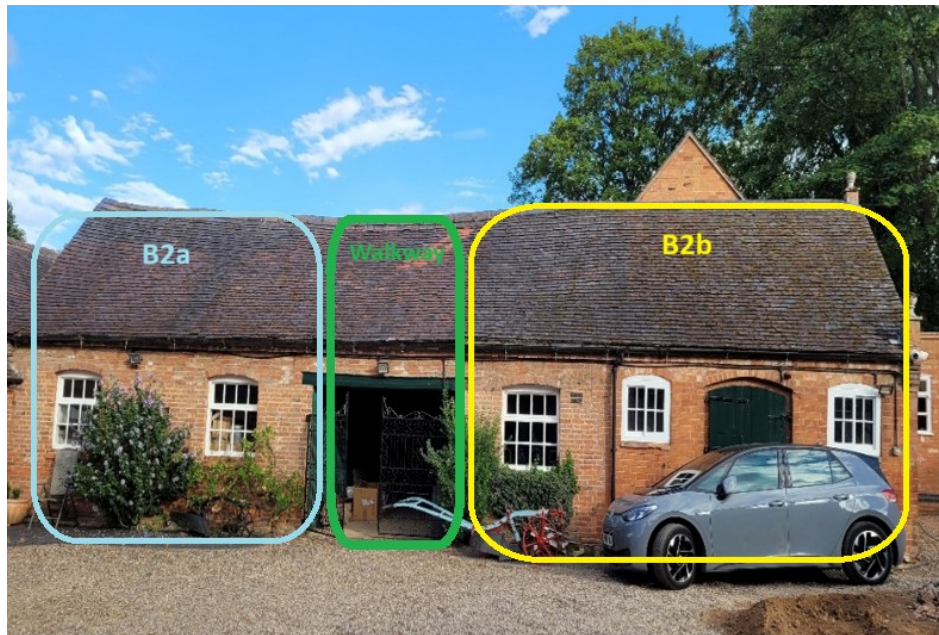
Building 2 (B2) comprised a traditional single storey agricultural building/barn currently used for storage. As shown in Figure 10, the building was constructed of solid brick beneath a gabled roof finished with clay tiles. The building comprised two interconnected sections, referred to as B2a and B2b, with the structures forming a connected building (see Appendix B).

*Figure 10 B2 northern facing elevation showing separate B2a and B2b areas and walkway (green) leading to rear of building and connecting the two separate rooms.*

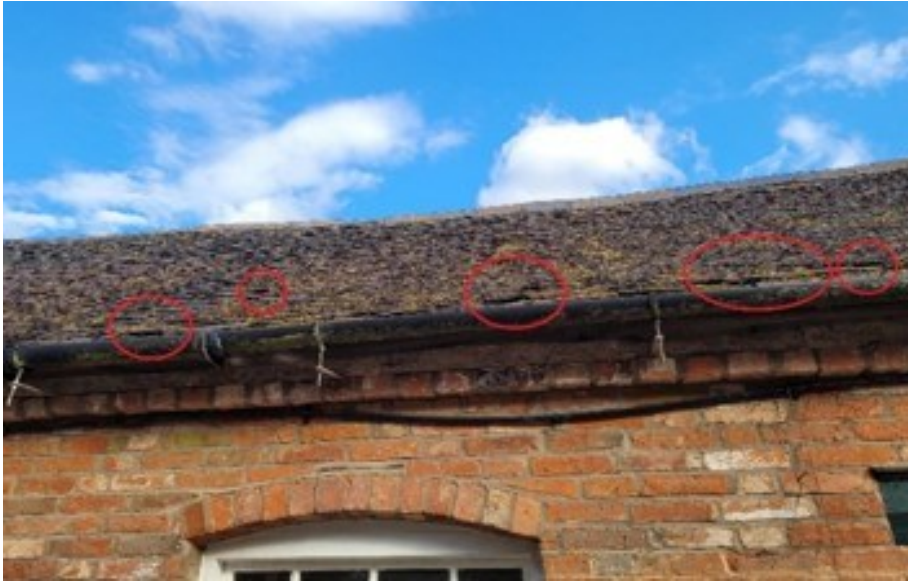
Potential access points were identified around the roof, including the tile slopes, gable verges, ridge tiles and areas of lead flashing, together with open doors/windows and defects within the roof covering (see Figures 11 - 13). In particular, gaps and defects within the roof covering allowed daylight to penetrate through the roof structure, as seen in figure 17. Potential roosting locations included beneath ridge tiles, between tiles and the underlying roof structure, around the ridge board, within holes or gaps in the brickwork, above gable walls and beneath areas of lifted lead flashing.

*Figure 11 Lifted tiles B2*

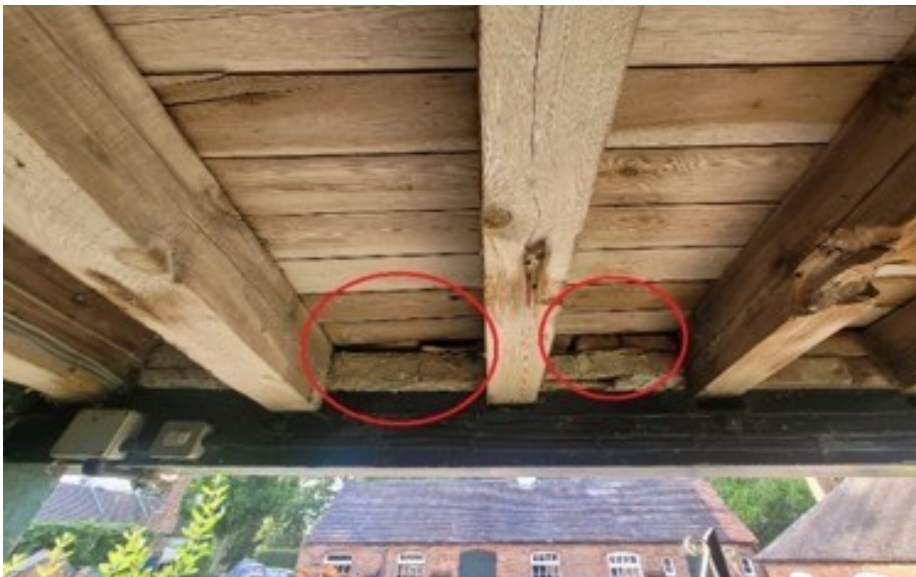
*Figure 12 Gaps in brickwork at eaves in center of B2*

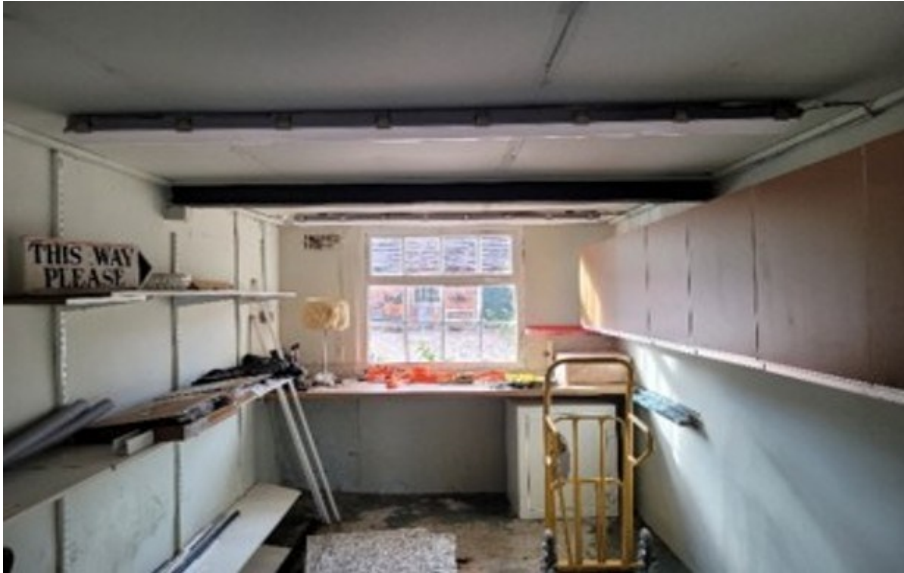
*Figure 13 B2b open room*

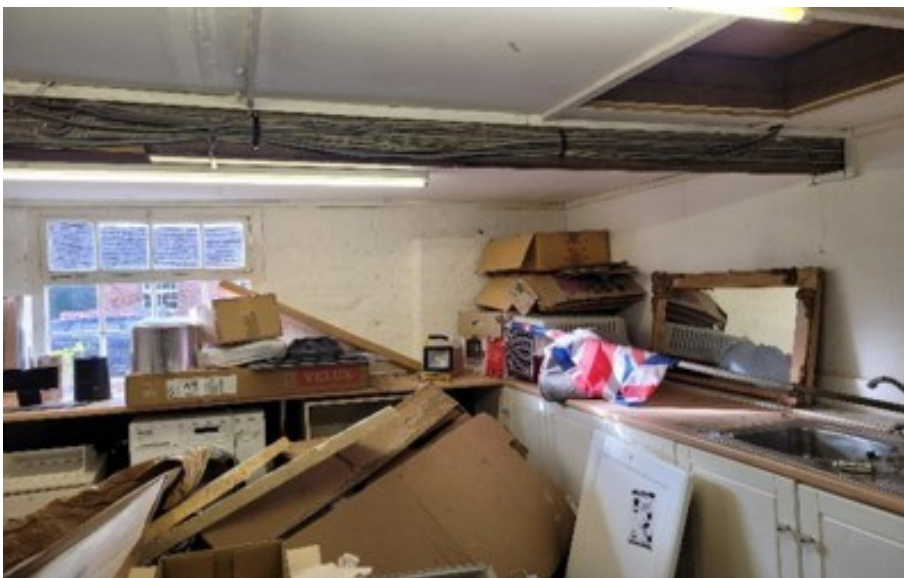
*Figure 14 B2a open room showing loft location*

The roof void within B2a was accessible and comprised a traditional timber rafter construction with a timber frame and bitumen felt lining. The void reached approximately 2.0 m in height and contained no insulation at ceiling level. Minimal clutter was present within the void, allowing substantial areas of open roof space to remain available.

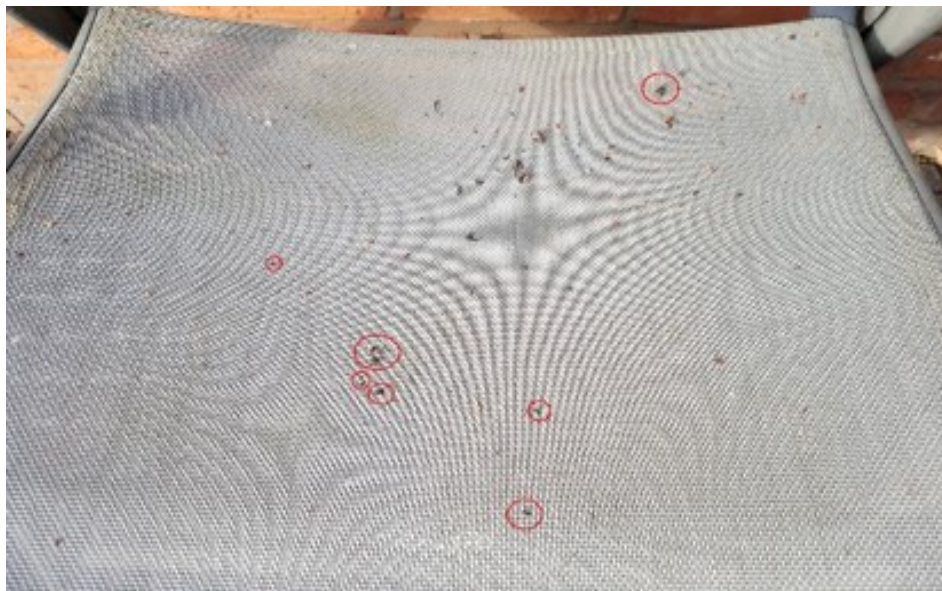
Clear evidence of bat use was identified within B2a. Approximately 20-30 mixed-age bat droppings were recorded throughout the accessible roof void, with a further 10-20 recorded

*Figure 15 Droppings on chair beneath lifted tiles*

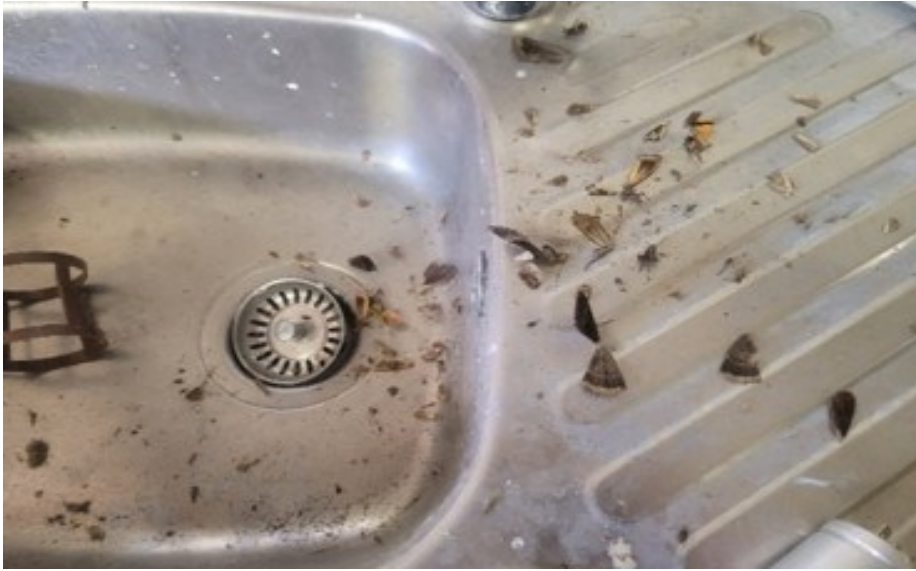
within the room below. Of those within the room around 5-10 were located directly beneath the loft hatch with the remainder scattered elsewhere within the room. Feeding remains including moth and butterfly wings and other insect remains, were also recorded within the roof void and room below. Further droppings were also identified externally, including on a chair beneath potential roosting features such as lifted lead flashing and displaced roof tiles (see Figures 15 - 19).

*Figure 16 Feeding remains and droppings beneath loft hatch in B2a*

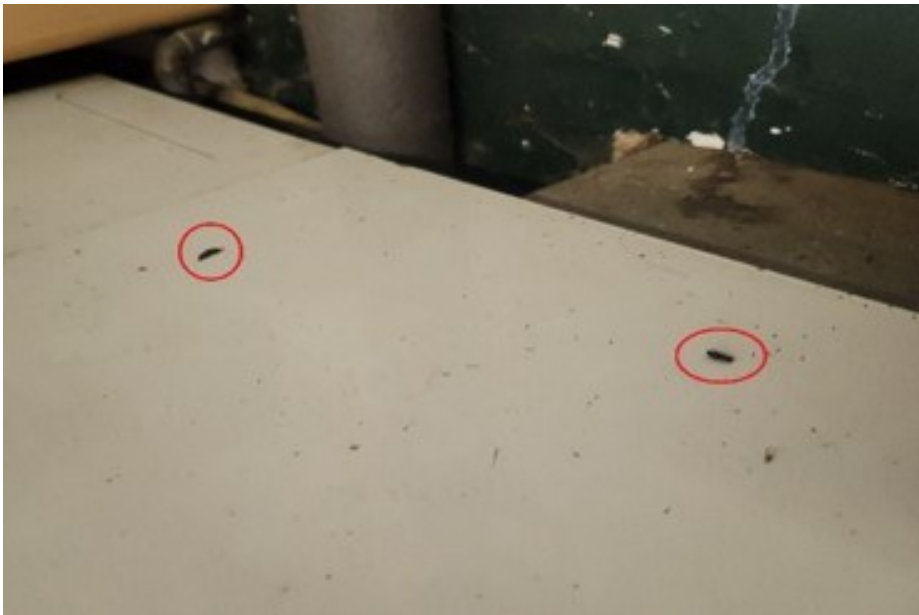
*Figure 17 Bat droppings on fridge in B2a*

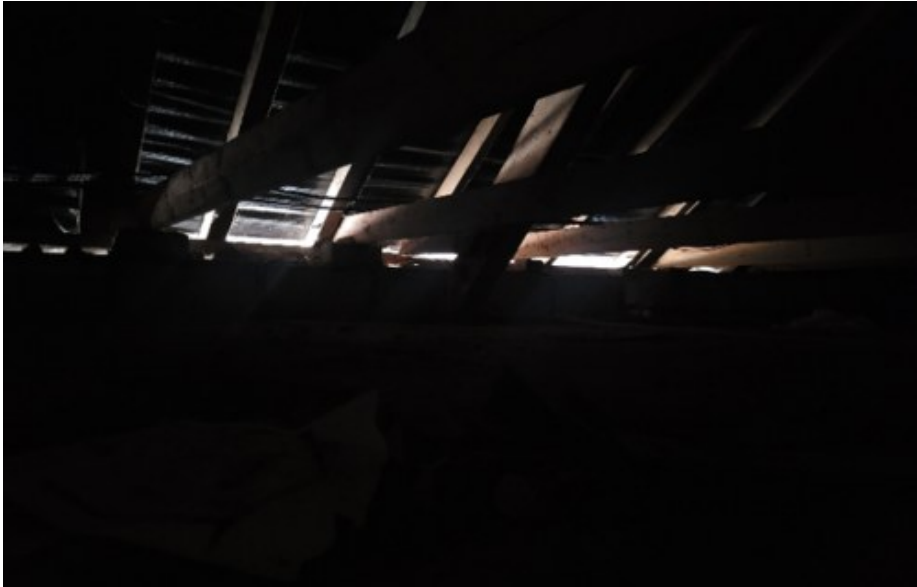
*Figure 18 Light ingress through roof into B2a loft*

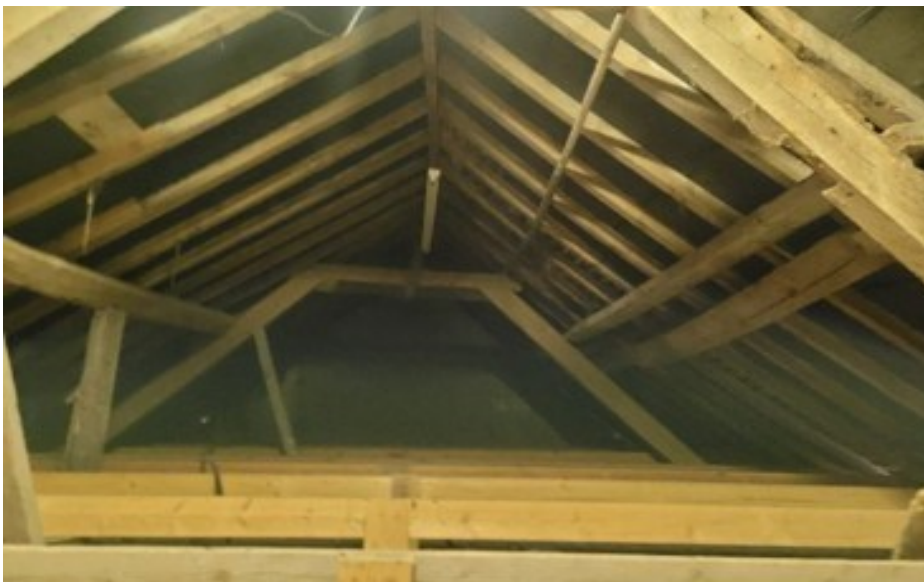
The quantity and distribution of the evidence recorded indicate that bats were regularly using B2a. The evidence was distributed throughout the accessible roof void rather than being confined to a single location, with additional evidence directly below the loft access point. The roof void and associated roof features providing suitable opportunities for roosting, with the open structure and available access points providing suitable conditions for brown long-eared bats in particular. The locations of recorded droppings and other evidence of bat use are shown in the PRF map in Appendix B (Figure 30).

*Figure 19 B2a loft void*

- Retention of the existing B2a roof void should be prioritised wherever practicable, as this is the area in which evidence of brown long-eared bat use was recorded and from which bats were confirmed to emerge. Where retention of the existing B2a roof void is not practicable, a dedicated replacement brown long-eared bat roost should be incorporated into the development. The replacement should comprise an enclosed, dark roof void of at least equivalent size and suitability to the existing B2a void, with a minimum clear internal height of approximately 2.0 m and a footprint no smaller than the existing roof void. The void should comprise a traditional timber-rafter roof structure with open internal roof space and no insulation at ceiling level, replicating the existing conditions where practicable. Suitable bat access points should be incorporated to provide continued access to the void, with the final location, dimensions and construction details confirmed by a suitably qualified and appropriately licensed bat ecologist and, where required, Natural England as part of the mitigation licence. The

replacement roost should be provided prior to the loss or alteration of the existing roost wherever practicable.

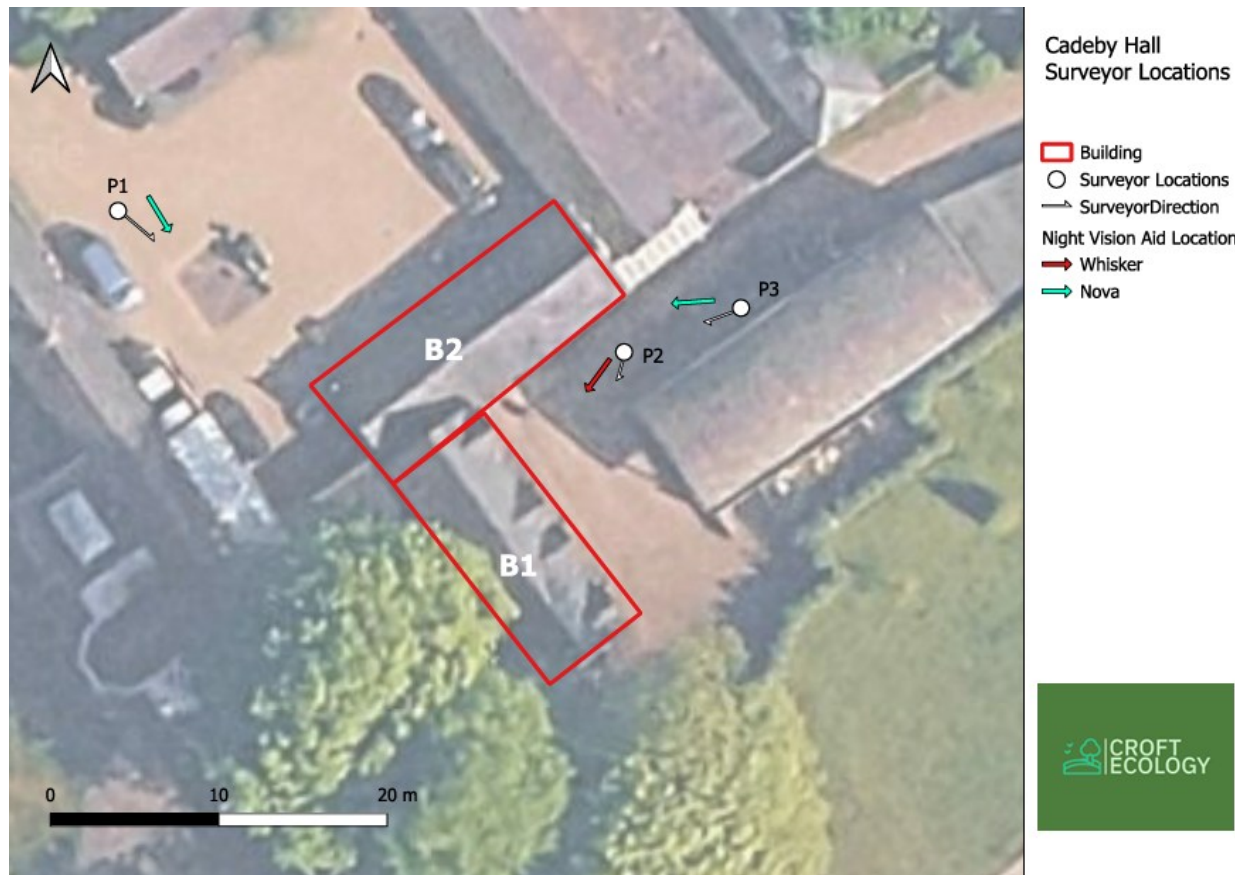
Figure 20 Paired surveyor and NVA positions

Three surveyors, equipped with EMT2 Pro and Magenta Bat 4 bat detectors and Nightfox Whisker and Nightfox Nova infrared cameras along with additional infra-red floodlights made observations of any bat activity or bat emergences both from and around the existing building(s), focusing on areas with potential roosting features. Echolocation calls were analysed with Kaleidoscope when required. Paired surveyor and camera locations are illustrated in Figure 19.

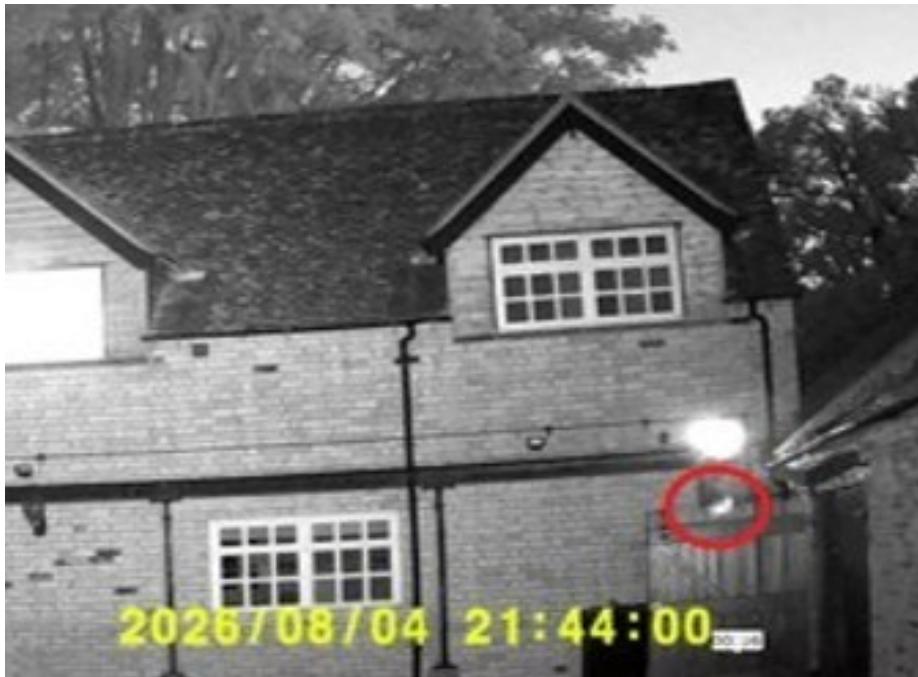
The first brown long-eared bat was observed emerging from the open doorway of B2 at approximately 21:43 (48 minutes after sunset) and then re-entering through the same door less than a minute later. Two further brown long-eared bats were subsequently confirmed emerging from the same doorway at approximately 21:44 and 21:51. Review of the associated infrared footage confirmed the emergence and re-entry behaviour.

*Figure 21 Brown long-eared bat emerging*

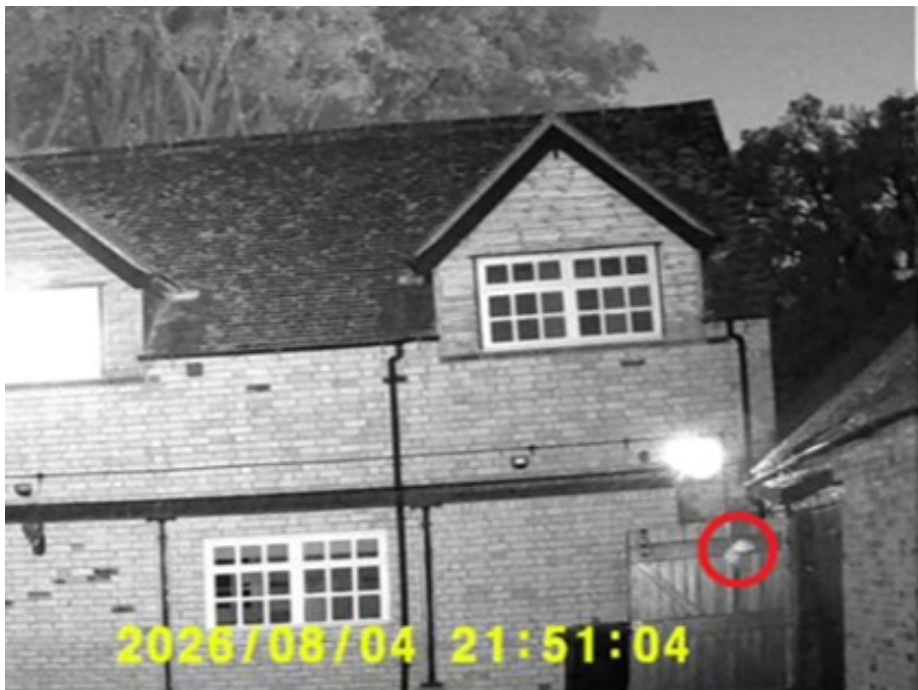
*Figure 22 Brown long-eared bat emerging*

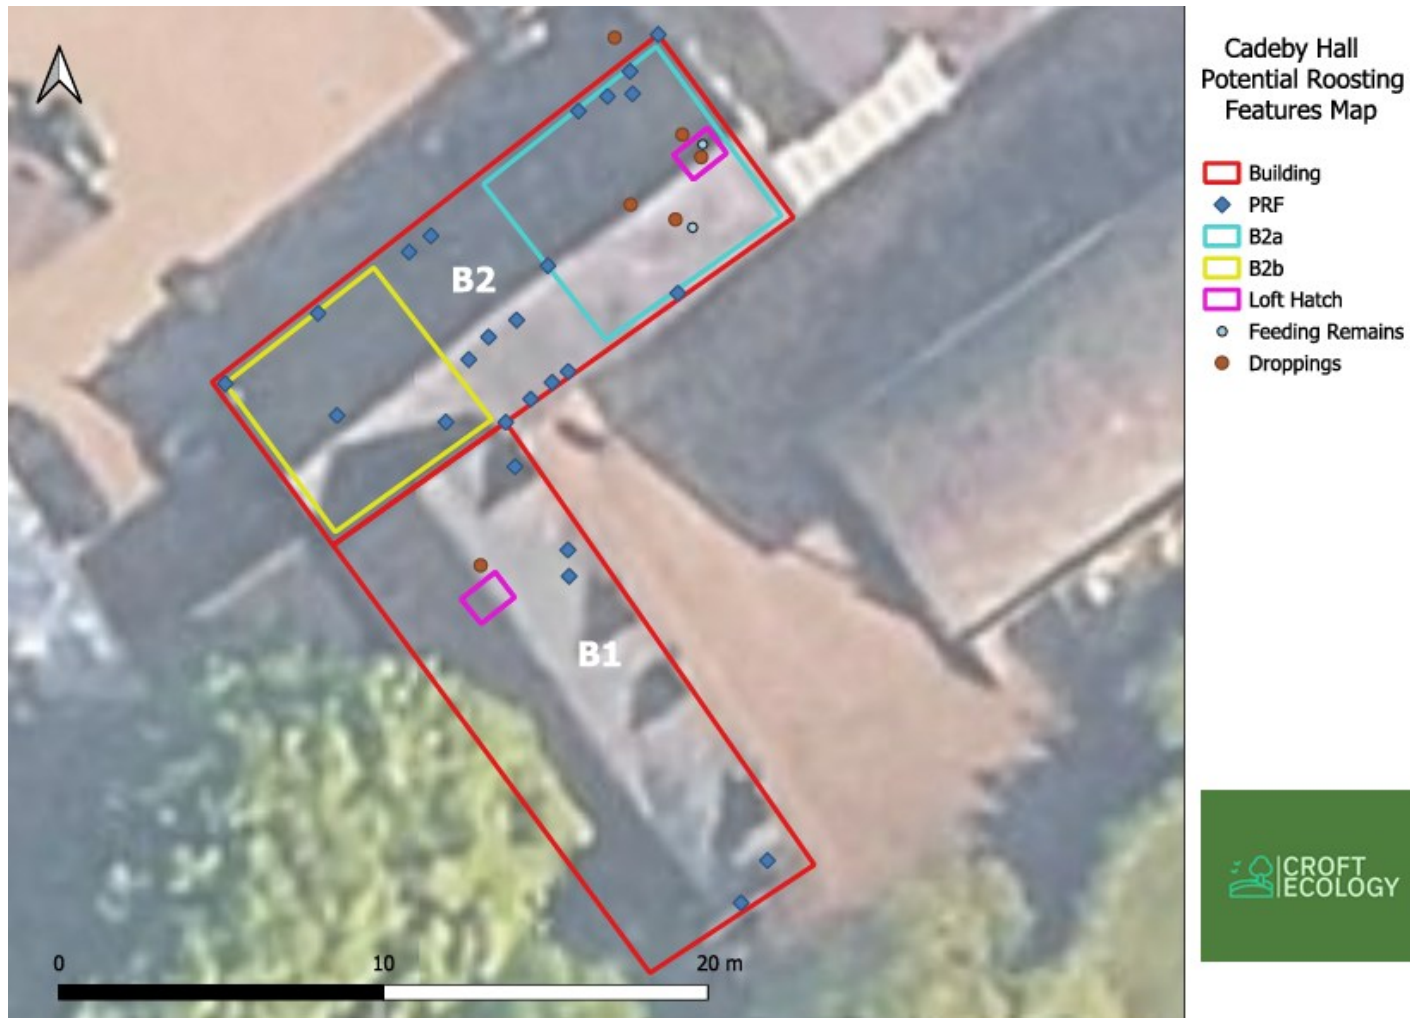
Figure 29 Map showing identified PRFs, locations of droppings and loft hatches
