# Clayton Ecology

## PBRA/Bat Emergence and Activity Survey

164 Markfield Road  
Ratby

August 2024

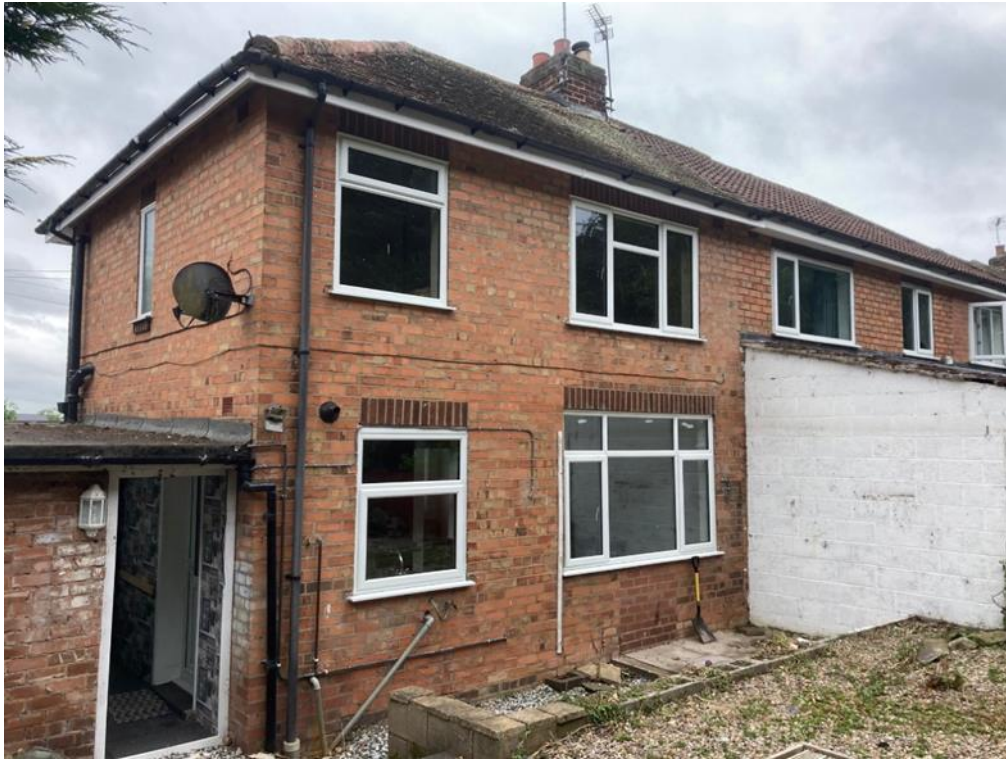
The survey building is a red brick cavity walled two-storey residential dwelling. The roof is an unlined wooden A framework, covered in clay tiles. There is a garage extending from the eastern elevation which is well sealed. The windows and doors are UPVC and are generally well fitted to the main building. The soffits and fascia boards were generally well sealed and flush to the wall. See photographs 1 to 3 inclusive.

**Photograph 1: The north elevation of the building and garage.**

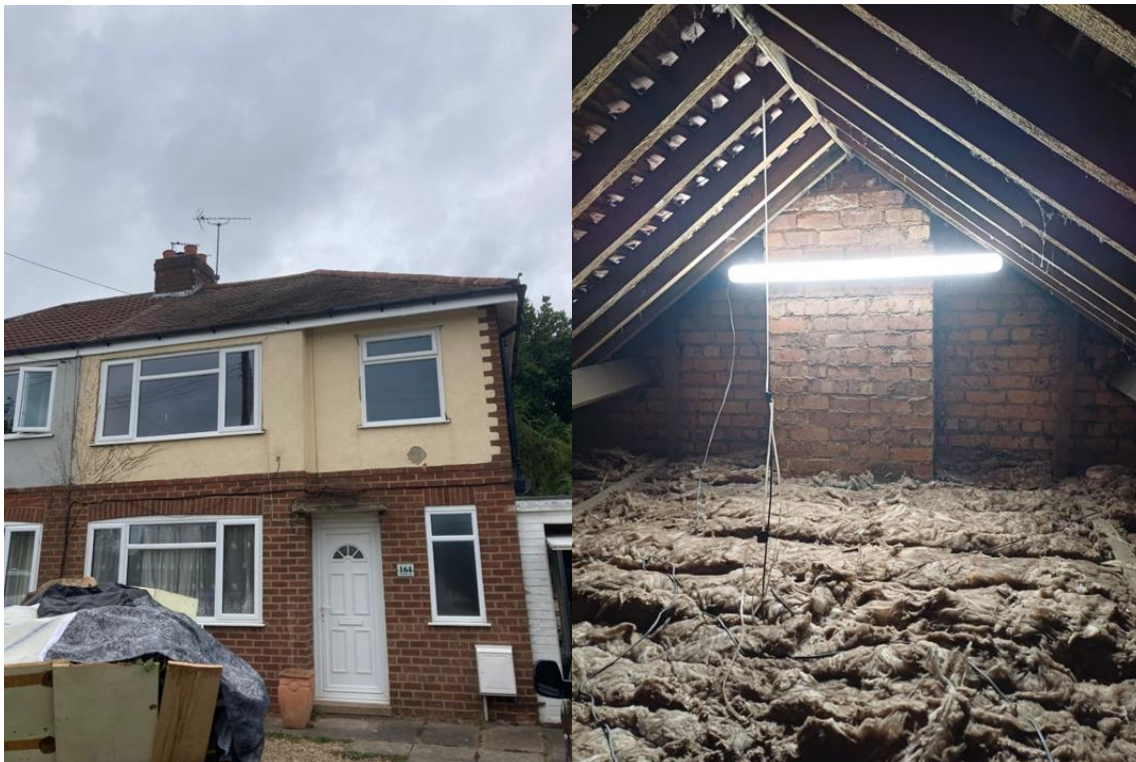
**Photograph 2 & 3: The south elevation of the building and view of the internal roof structure.**

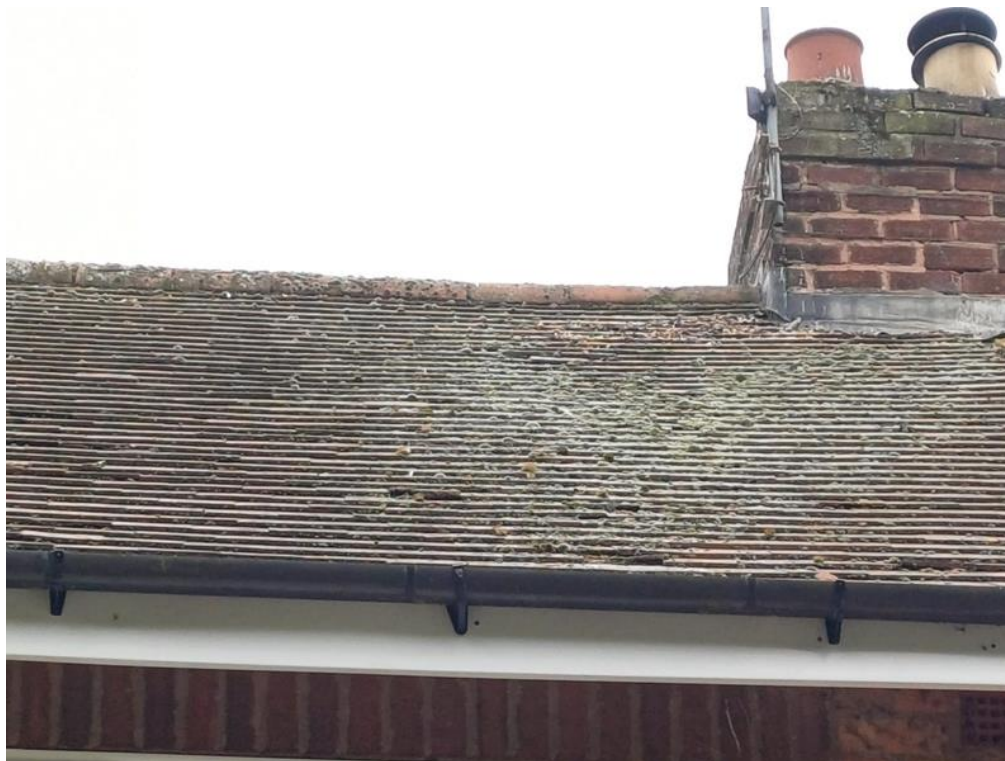
- Gaps between the lead flashing and tiles at the front of the building.
- Gaps in the soffit and fascia boards at the front and rear of the building.
- Gap in the upper storey window at the front of the building.
- Gaps and loose mortar along the ridge tiles at the front and side of the building.
- Gaps in the mortar at the side of the building.
- Gaps in the brickwork of the chimney at the rear of the building.
- Loose mortar and raised tiles at the rear of the building.

**Photograph 4: Raised tiles at the rear of the building.**

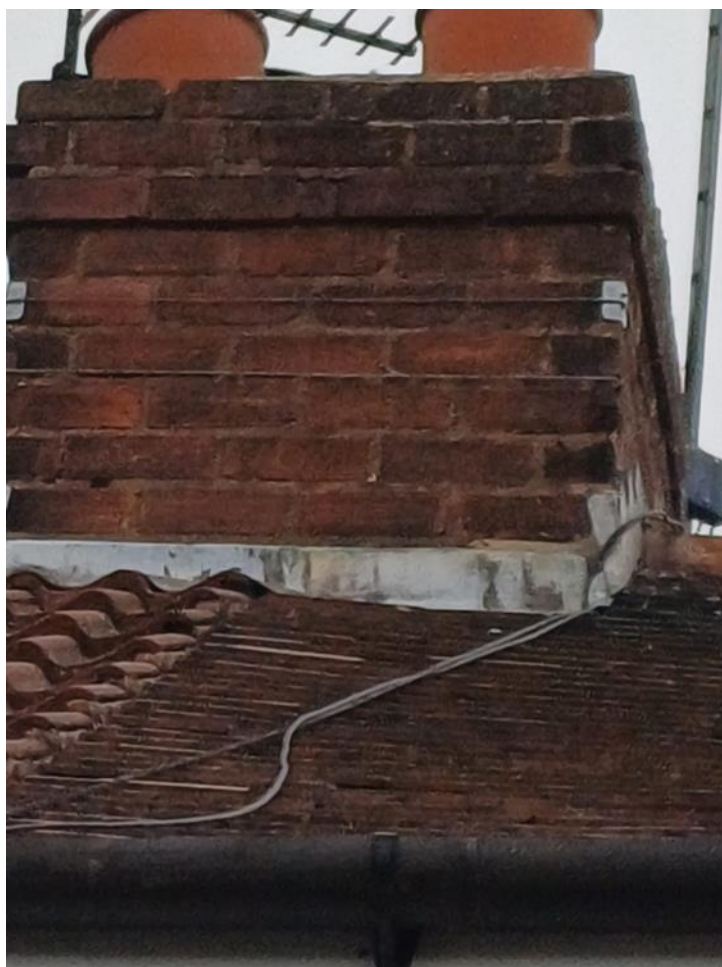
**Photograph 5: Gap between the lead flashing and tiles at the front of the building.**

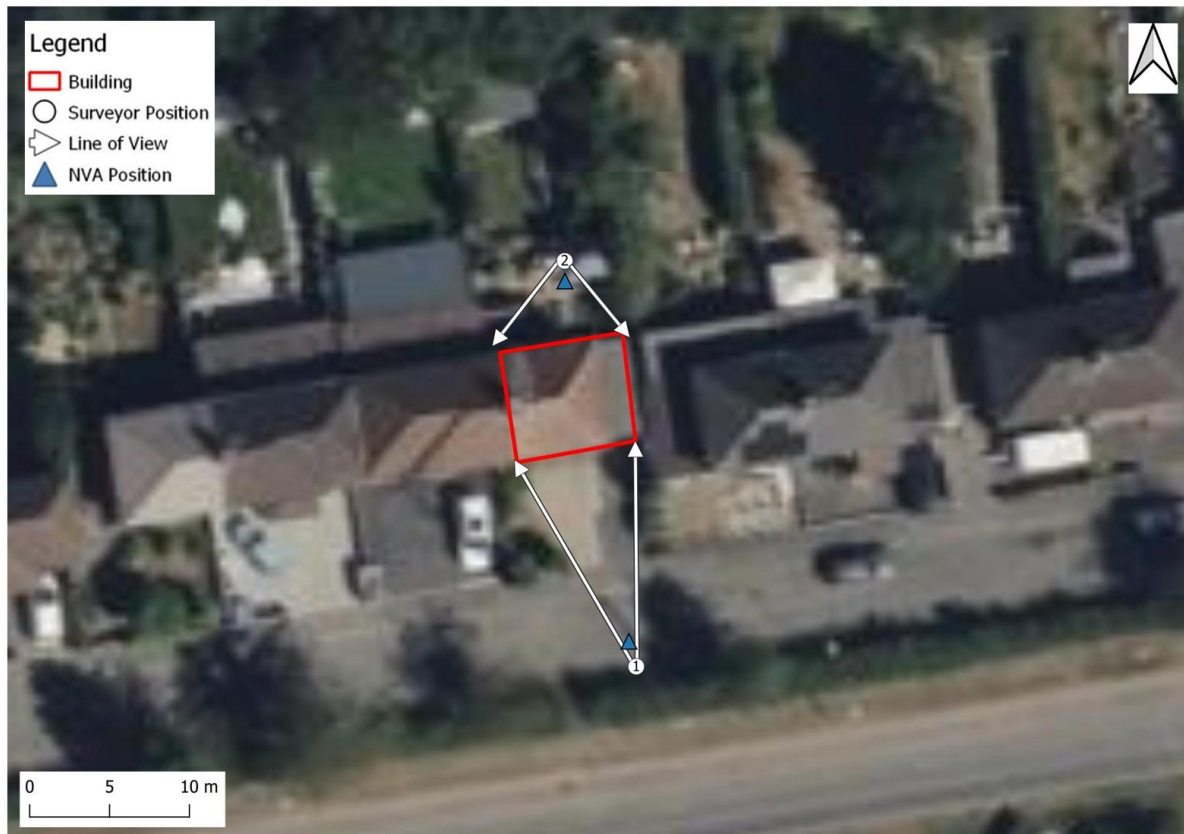
At the close of this survey no bats were seen to emerge or associate with any parts of the building by any of the surveyors. In addition: the NVA recordings were reviewed and no bats were seen emerging from the building during the survey period.

Figure 2: The surveyor/NVA positions during the emergence survey.

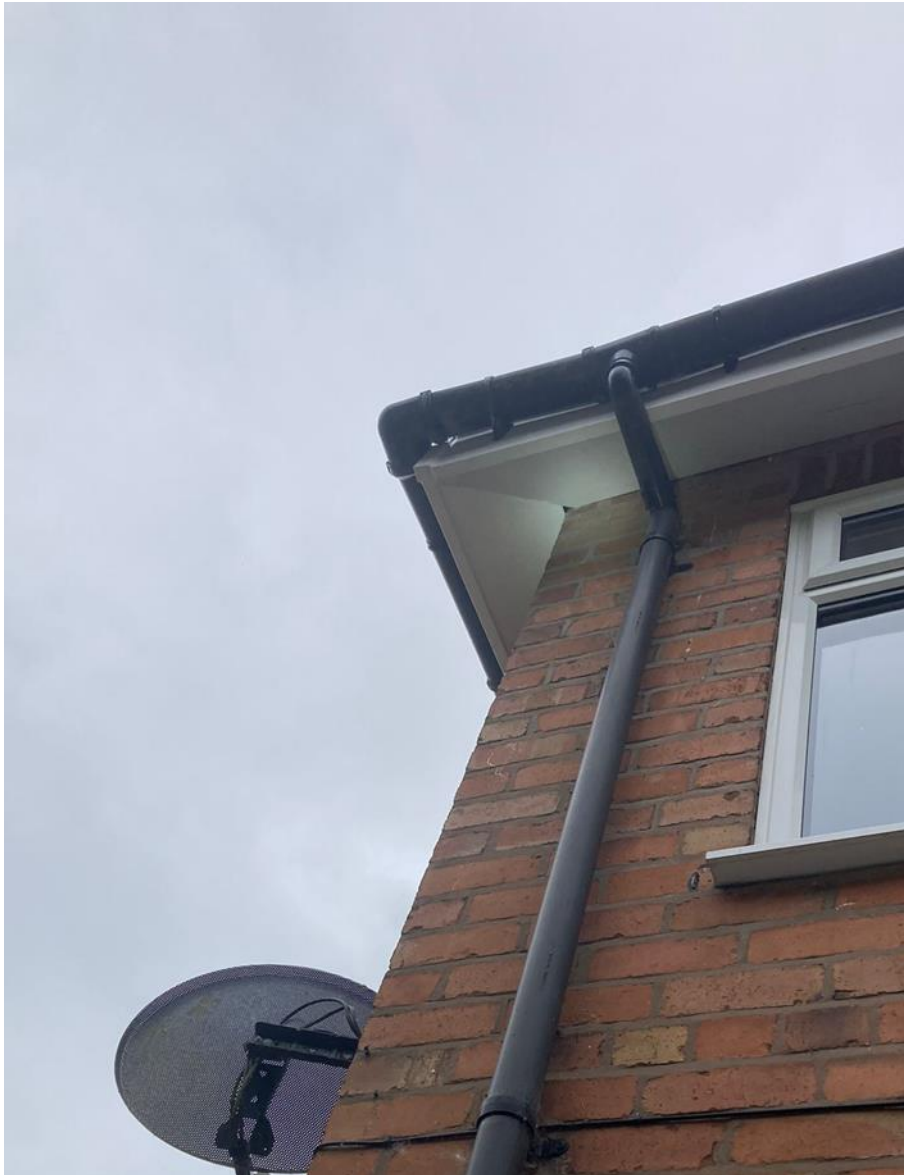
There was evidence of bird species having utilised the structure for nesting, as bird droppings were found directly under an access point in the soffit at the front of the property. These were small droppings and were determined as Blue tit (*Cyanistes caeruleus*), however no birds were seen utilising the structure during either of the surveys.

Photograph 6: Access point in the soffit directly above the bird droppings.

Evidence of nesting birds (droppings under an access point) within the building was located during the survey.

As breeding bird evidence is present, there are seasonal constraints - works are required to take place outside of the bird breeding season of March to August. However if works are planned within the breeding bird season, an ecologist should be consulted to undertake a breeding bird survey immediately prior to the planned works.

In the event that an active bird nest is found during the planned works, it must be retained in situ undisturbed until the nest is no longer in active use. A nest is classed as active when it contains eggs or chicks and when it is being built.

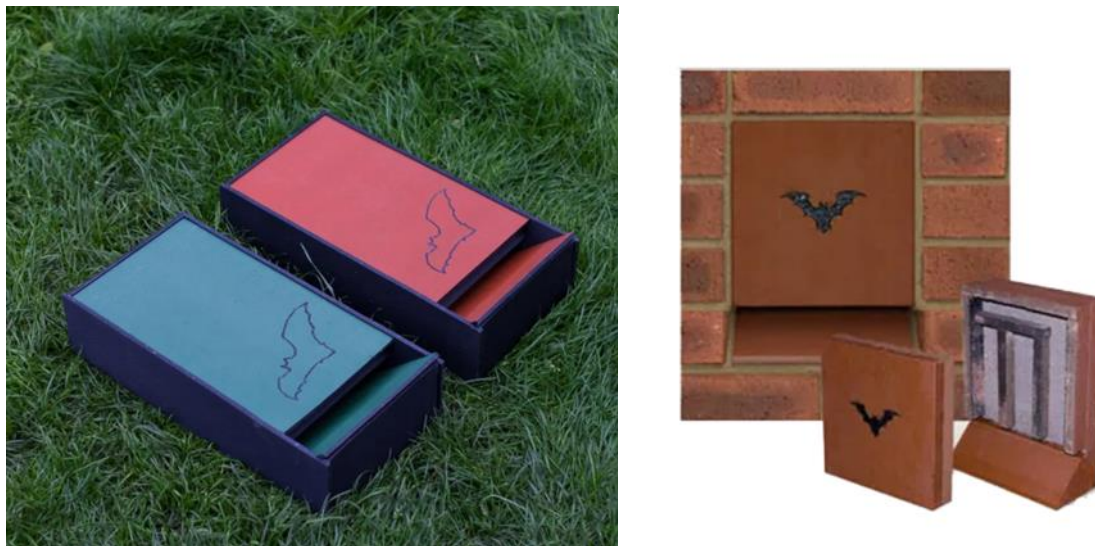
**Figure 3: Photos of crevice type bat boxes that are available.**

It is therefore recommended that a single integrated bat box: Integrated Eco Bat Box Crevice or Ibstock Type C (see Figure 3 below) or similar should be combined into the new building elevation, at the highest point possible, approximately 3 metres.
