# *Former Moore's Arms*

6 Orton Lane, Norton juxta Twycross, Warwickshire, CV9  
3PU.

Archaeological Evaluation.

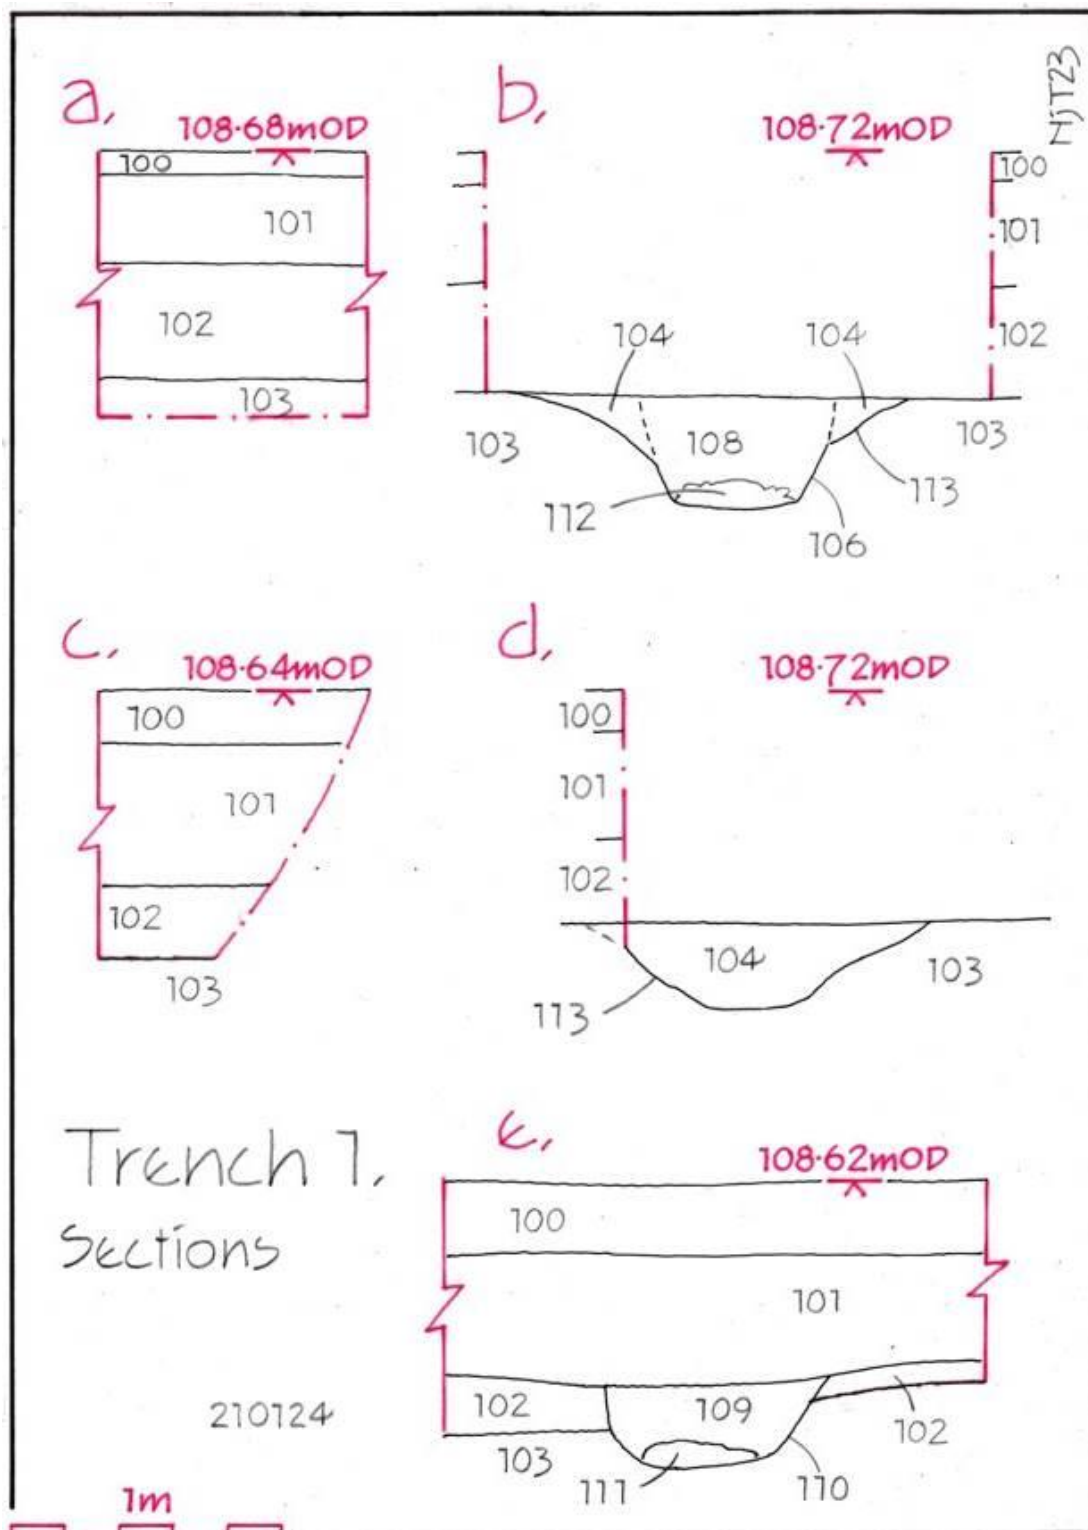
Fig.8: trench 1 sections.

The surface of the natural substrate (103), consisting of a stiff light grey clay with the occasional component of small stones, was recorded at a roughly level height of about 107.80m AOD throughout the trench. At the southwest end a single linear ditch feature [113], aligned north-south, was recorded. Sample excavation showed it was about 0.30m deep, 1.30m wide and filled by a single deposit (104) comprising an olive-brown, silty-clay with some light-grey clay mottling throughout the deposit. No finds were recovered from this fill, which was itself truncated by a later, sub-rectangular shaped pit [106] measuring 1.85m long, 0.75m wide and 0.40m deep, also orientated north-south along the central axis of the ditch fill (104). Construction of this pit penetrated about 0.20m below the bottom of ditch [113] itself. It was filled at its base by the partially exposed, disarticulated skeletal remains of a cow, subsequently overlain by the (back) fill deposit (108), a mid-greyish-brown, silty clay with a significant amount of natural grey clay mottling throughout. A single sherd of C14 pottery was recovered from this deposit although it remains unclear if this was the original context of deposition or whether it was residually redeposited from the earlier ditch fill deposit (104) during the construction of the pit itself.

Overlying the natural clay substrate throughout the trench to a depth of up to 30m was a relict subsoil deposit (102) and truncating this layer towards the northeast end of the trench was another partially exposed, albeit undated, sub-rectangular pit-like feature [110] which also contained the partial skeletal remains of a cow. These comprised the spine and ribs face down, bent over more than forty-five degrees within a narrow pit. To the west of the spine, near the trench edge, was a pelvic bone and some smaller bones, possibly lamb. Sealing these remains and filling the remainder of the pit was a single undated deposit consisting of a brown clayey-silt, interestingly this was similar to the overlying

soil layer (101) which was itself about 0.30m thick and interpreted as likely redeposited modern material along the length of the trench.

Trench 1, placed to the west of the application site, recorded a single linear ditch [113] within the surface natural clay substrate although it is likely that it was constructed at the surface of the earlier relict subsoil layer (102) representing the earliest occupation horizon.

Truncating the infilled ditch along its central axis was a later pit [106] containing the partial remains of a cow, whether this event was deliberate or coincidental with the ditch alignment itself is unclear, but a single sherd of C14 pottery recovered from the fill of the pit (108) is likely residual, being redeposited during the excavation of the pit through the earlier ditch fill. This would indicate that the ditch is at least C14 in date.

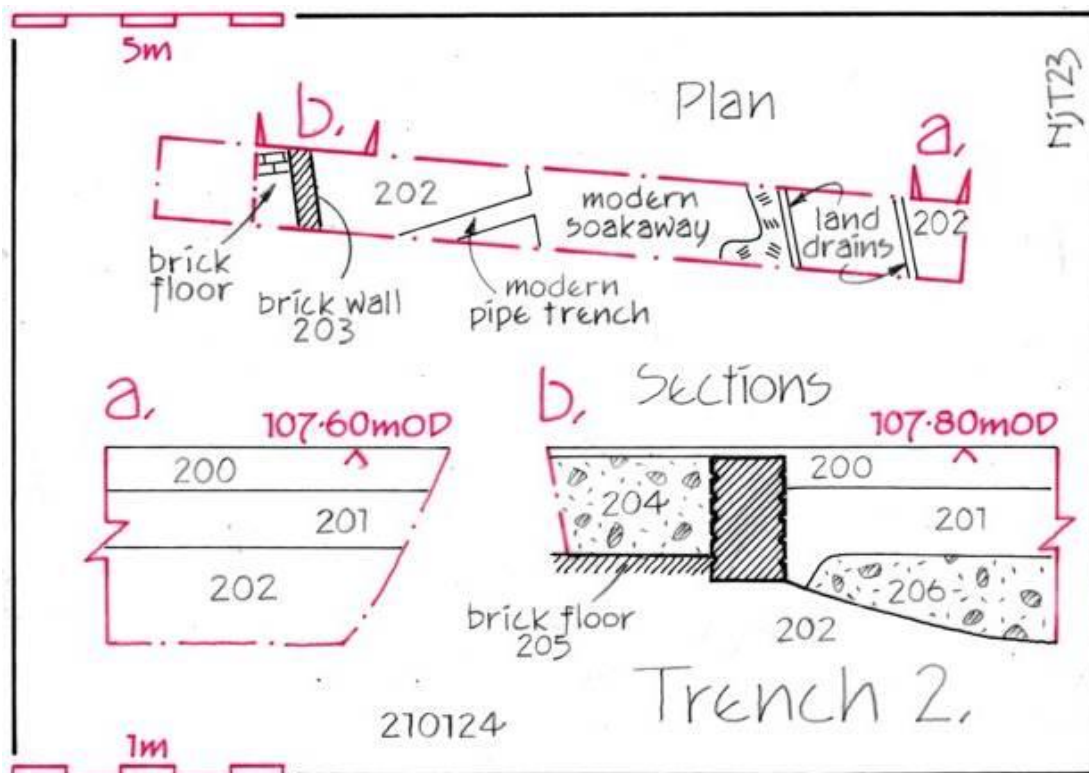
Fig.9: trench 2 plan and sections.

The surface of the natural substrate (202), consisting of a stiff red clay mottled throughout with light grey clay and containing a component of small stones, was recorded at a roughly level height of about 107.25m AOD throughout the trench. However, although it is likely that the surface level of the clay substrate is relatively intact, the stratigraphy suggests that some previous truncation of this deposit can be expected to have occurred within this part of the site during the creation of the existing carparking area.

At the southwest end of the trench, two modern land drains were recorded aligned northwest southeast.

Overlying the clay substrate within the eastern half of the trench was an undated 0.20m thick deposit (201) consisting of a greyish-brown, clayey-silt with a component of small stones. This was in turn sealed by a 0.16m thick modern carpark deposit consisting of crushed and compressed stone (200).

At the western end of the trench the clay substrate was sealed by a 0.30m thick deposit (206) of modern hardcore, comprising a mixture of brick rubble, redeposited natural clay, cement, stone and pebbles. This was in turn overlain by the deposit (201), the same recorded at the east end of the trench and sealing this the same carpark material (200).

A large modern pit, at least 4.0m wide and seemingly acting as a drainage soakaway truncated the central area of the trench immediately beneath the carpark deposits. A single linear trench approx. 0.30m wide connects with this pit on its western edge and is likely the main drainage channel feeding the soakaway.

Overlying the clay substrate at the northeastern end of the trench was part of the walled remains (203) and floor surface (205) of the former brick building recorded on the OS 1885 map.

The results from trench 2 within the northern half of the site suggests little earlier activity. The underlying deposits were clearly removed during the construction of the existing carpark area at least to the surface of the natural clay substrate and further modern truncation was observed within the central area of the trench where a modern drainage soak-away was recorded. At the west end of the trench was a brick wall and internal surface associated with a former building shown on the OS 1886 which appears to be part of a large range, probably farm buildings that formerly extended into the area to the north of the site.

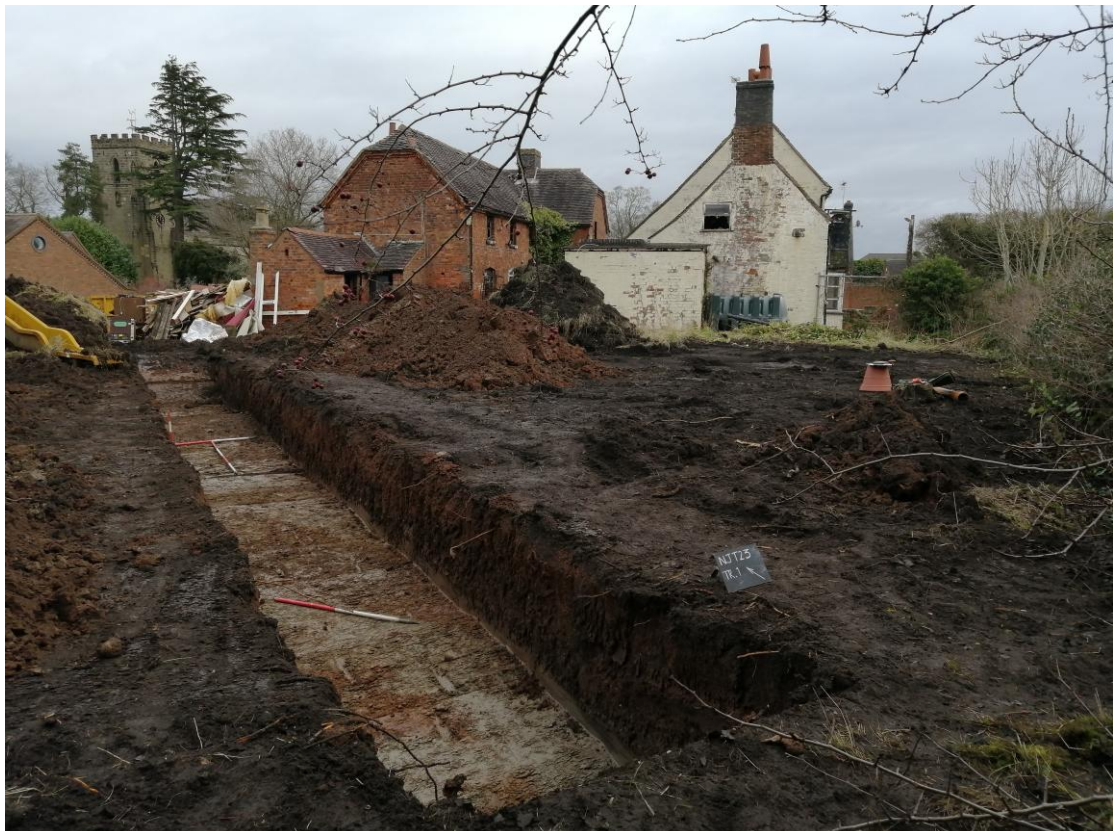
*Plate 2; trench 1 view northeast.*

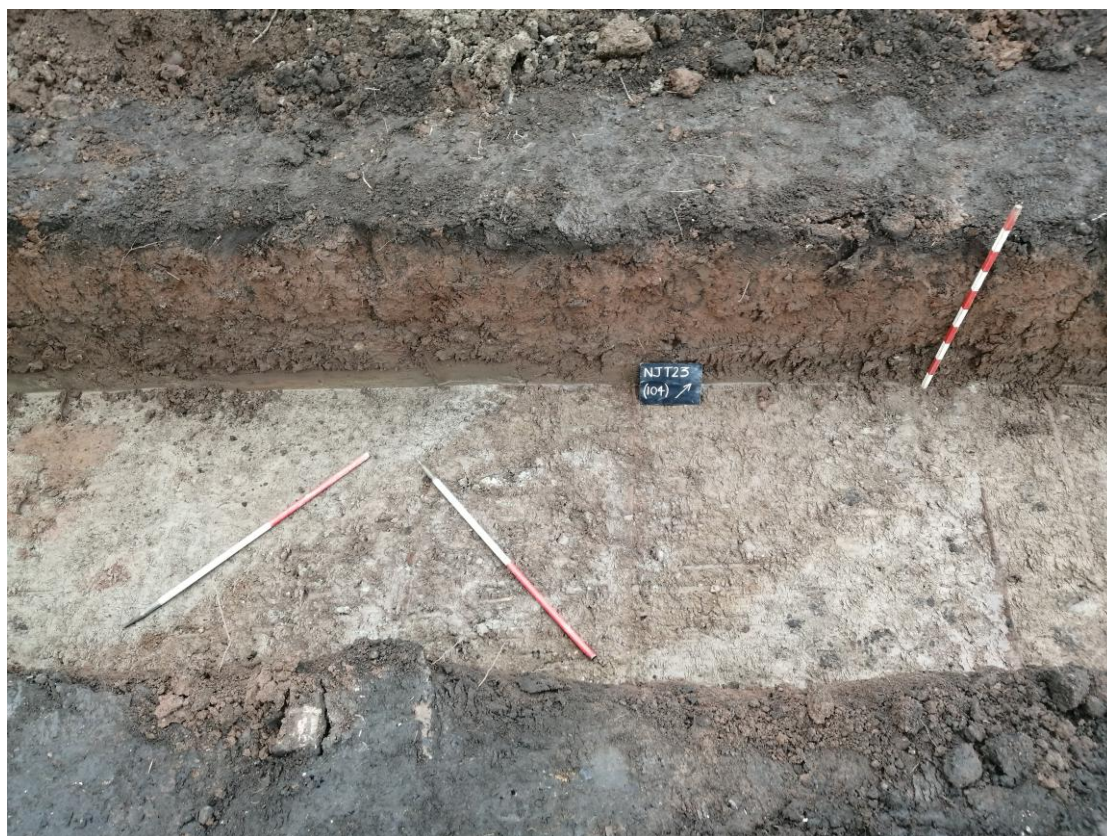
*Plate 3; ditch fill (104) and pit fill (108), view northwest.*

A single sherd of pottery weighing 29g occurred, in context 108. It is a fragment of a green-glazed jug in Chilvers Coton 'C' Ware, fabric CC2 of the Leicestershire County type-series (Sawday 1994). It is of C14 date. The sherd is large, sharp, and fresh, and appears reliably stratified.

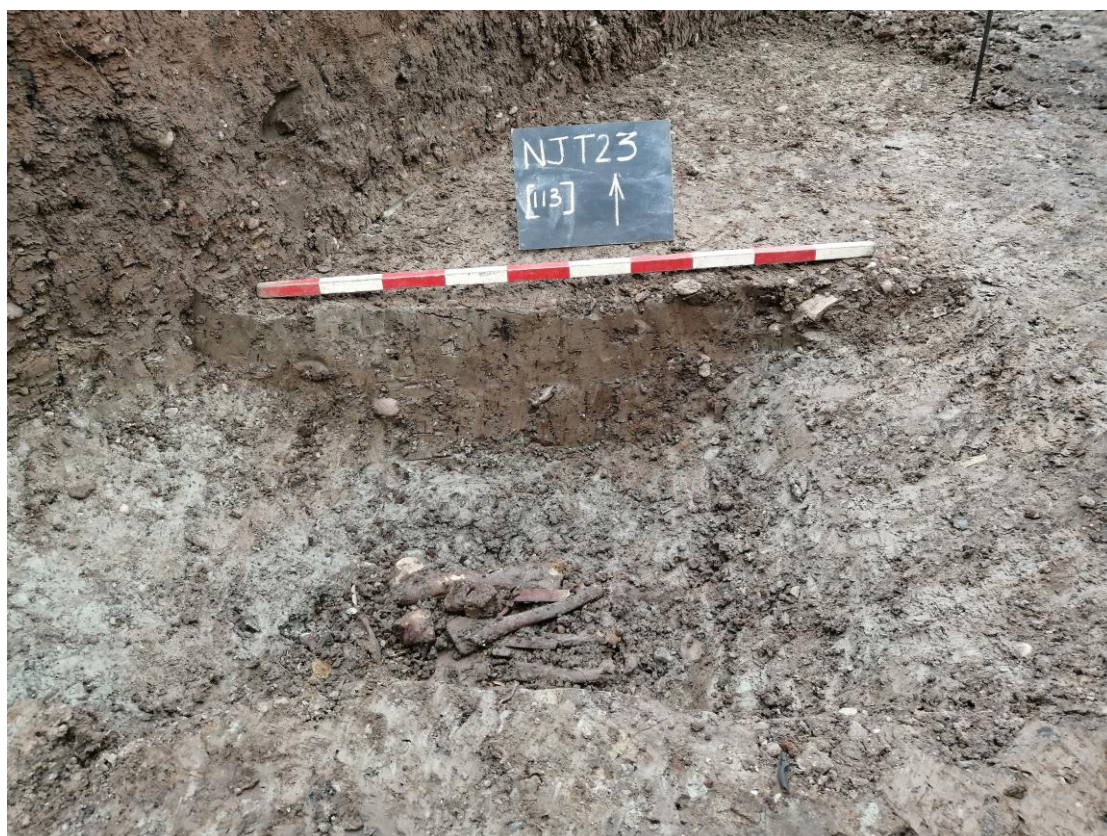
The bones in the ditch (Skeletal remains 112) belong to a large mammal, probably a cow. There is a bone towards the top of a group which appears to be a

Skeletal remains 112 represent at least two animals. The main skeleton comprises the articulated vertebrae, ribs and mandibles of an adult cow. There seems to be a broad anatomical coherence, suggesting that it is a single articulated skeleton, although the spine has clearly been folded into an unnatural position. There is a further group of smaller bones from a separate animal, adjacent to the mandibles, close to the northwest baulk. Two of these bones were examined and appear to belong to a neonatal animal, probably lamb.

*Plate 4; ditch [113] and pit [106] with skeletal remains (112), view north.*

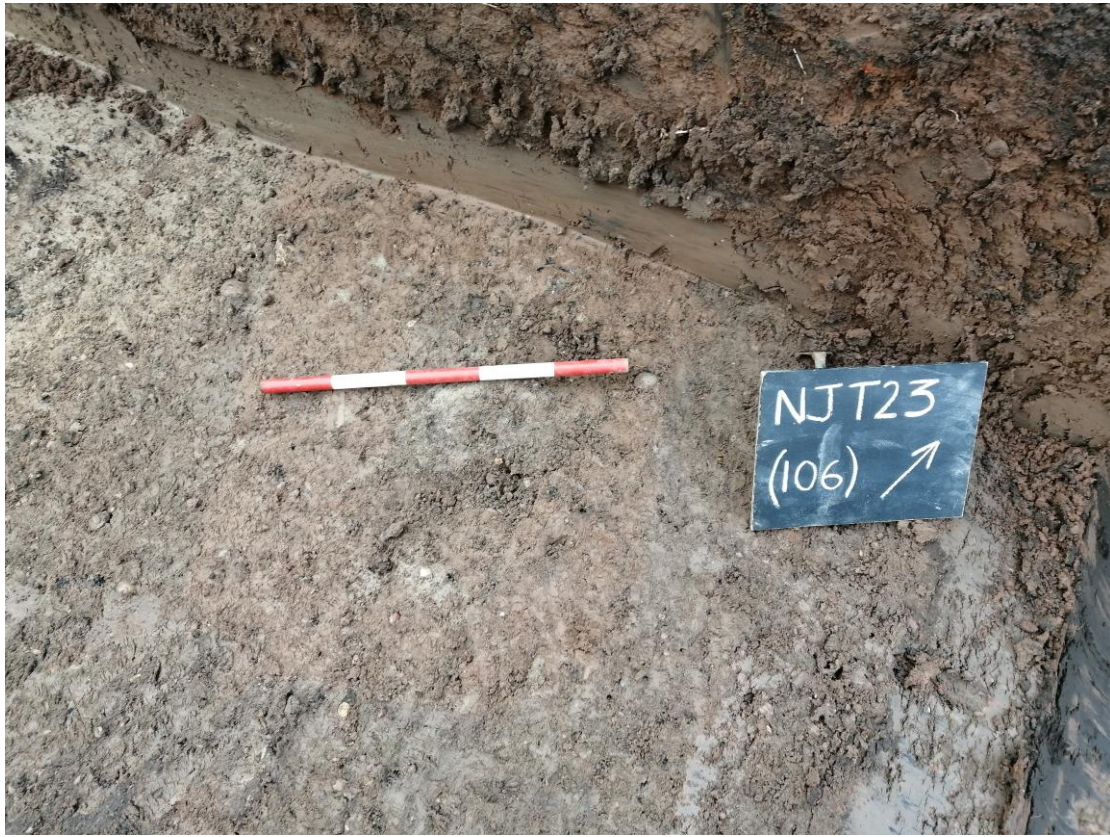
*Plate 5; fill deposit (109), view northwest.*

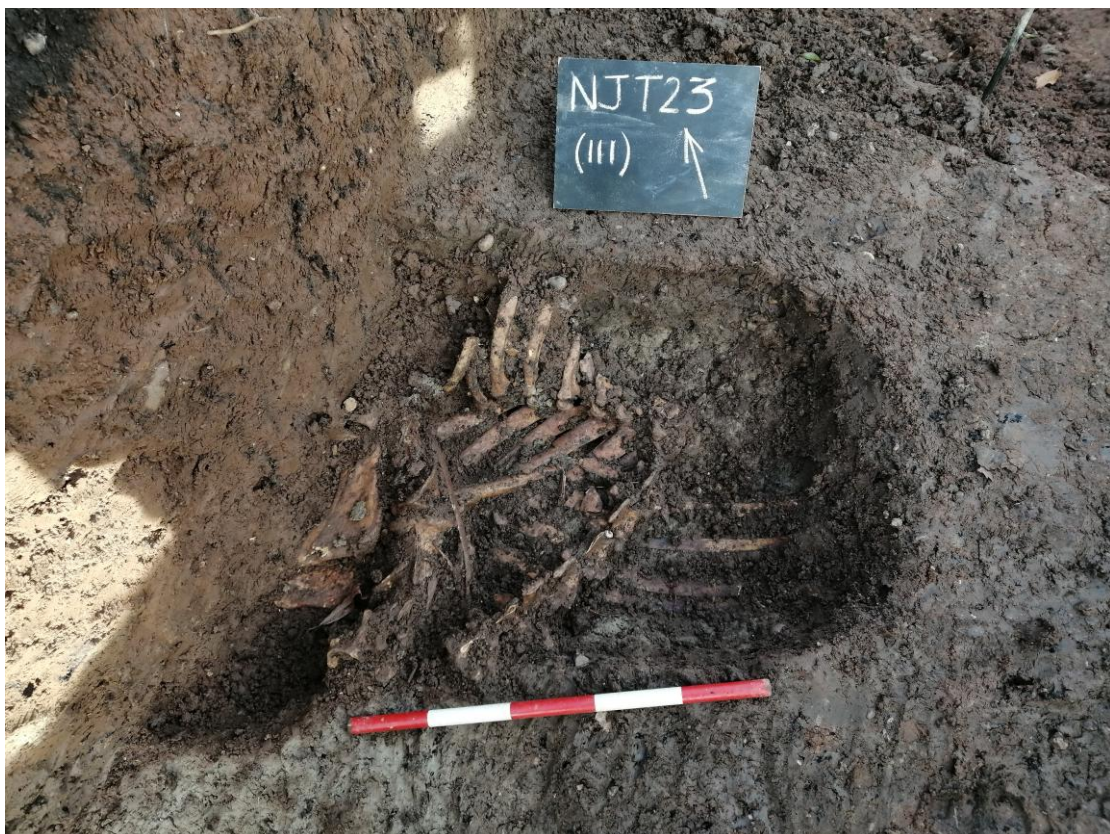
*Plate 6; skeletal remains (111).*

Truncating the subsoil layer towards the northeast end of the trench was another partially exposed, sub-rectangular pit-like feature [110] which also contained animal remains (111). These remains appeared partially articulated although, particularly the spine and ribs although bent in half as if to ensure that they fitted into the pit. The pit was filled with a single undated deposit consisting of a brown clayey-silt, similar in colour and composition with the overlying soil layer (101) which itself is redeposited and although undated, is possibly modern in origin. The remains themselves may be associated with the occupation of the Moore's Arms rather than being anything archaeological.

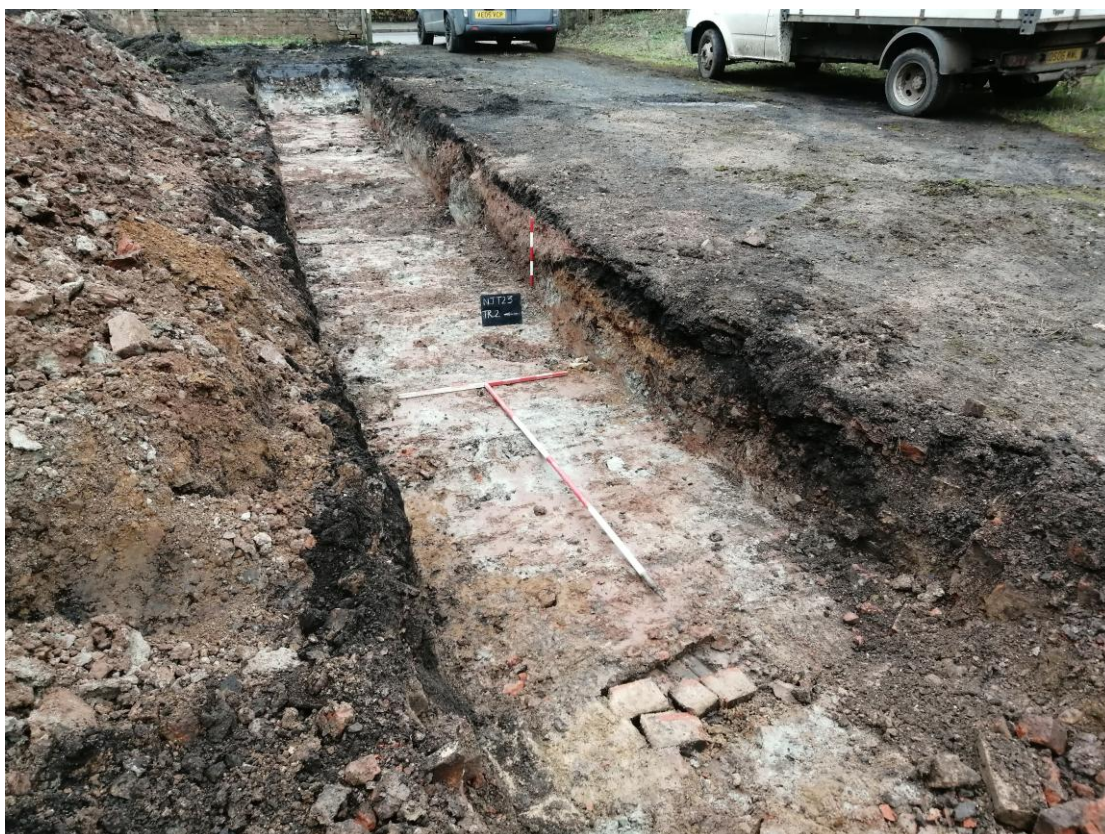
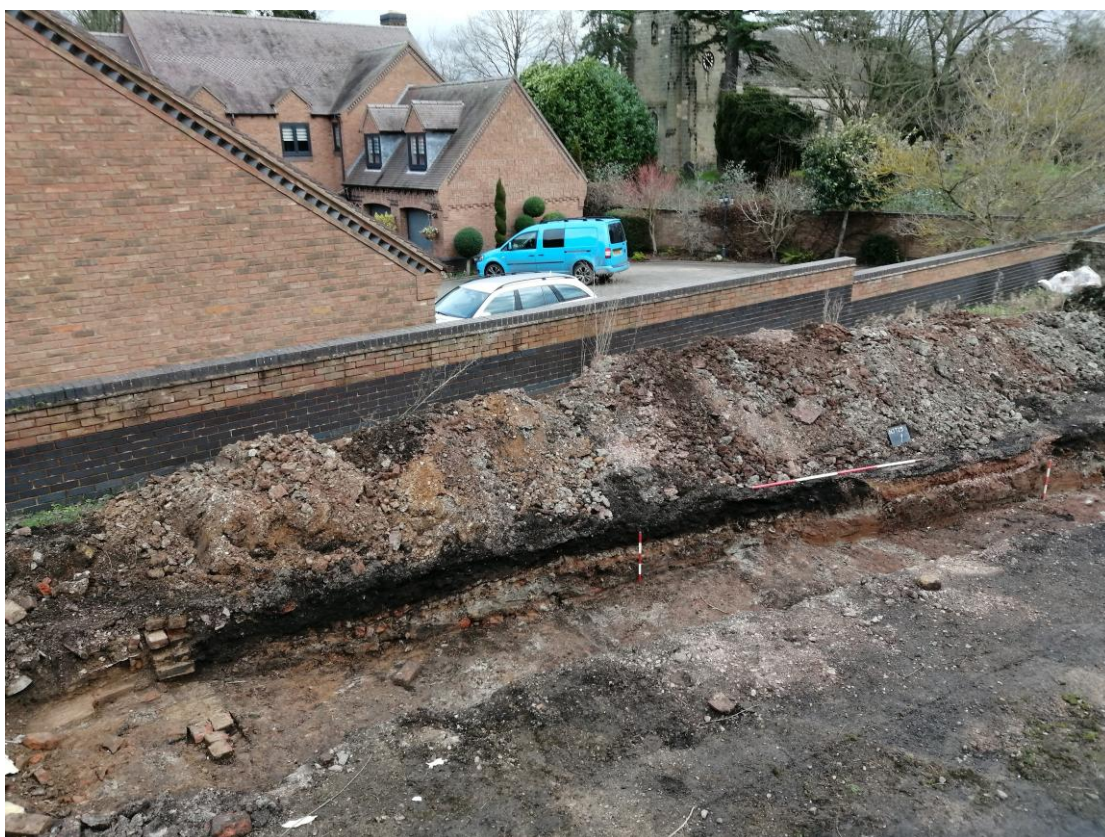
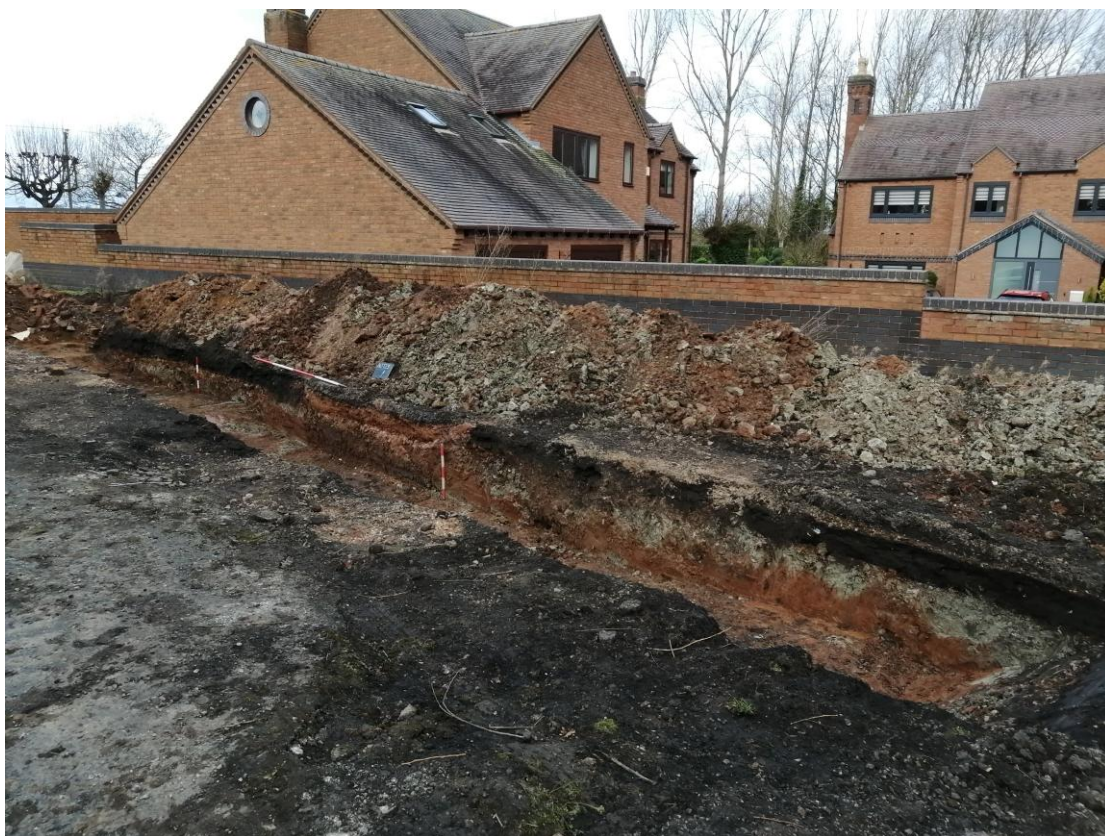
*Plate 9; trench 2, view east.*

*Plate 10; trench 2, view northeast.*

*Plate 11; trench 2, view northwest.*

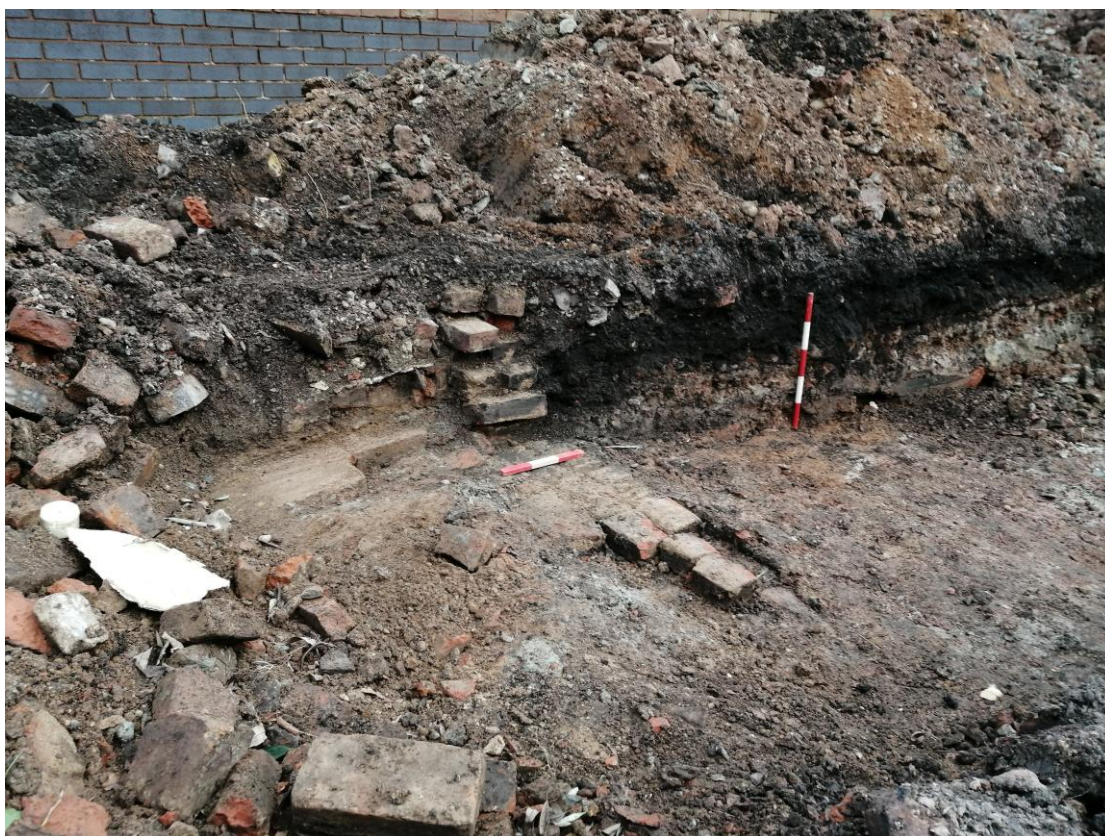
*Plate 13; section 2b, view northeast.*

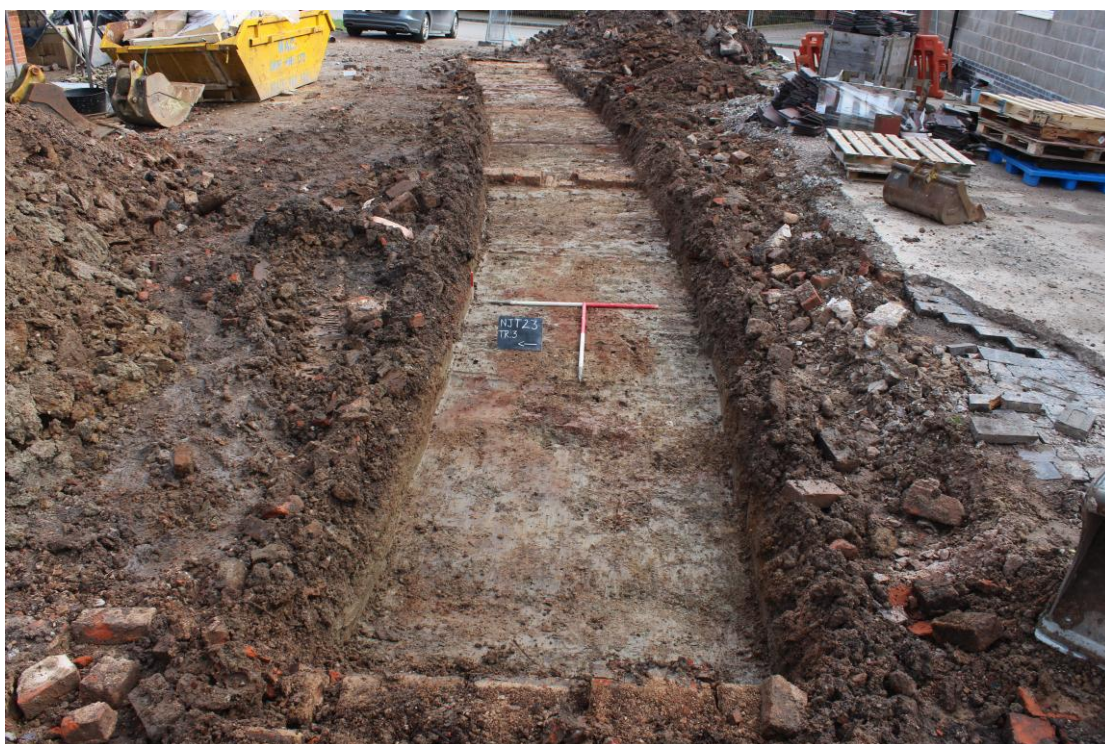
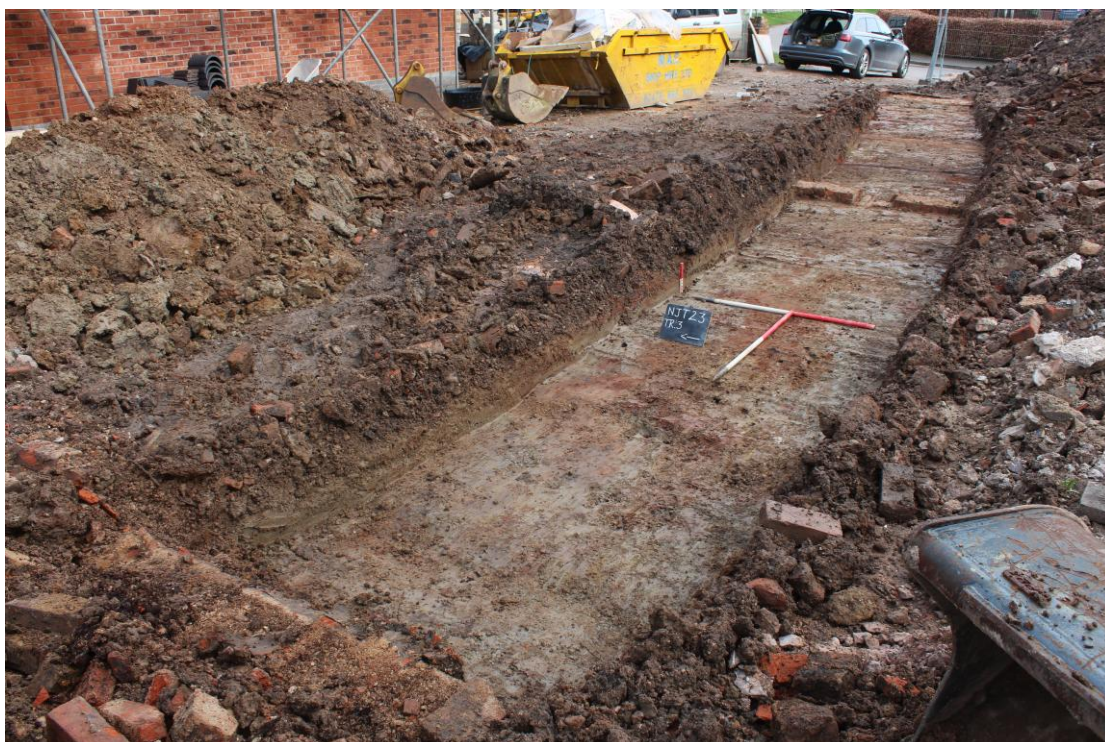
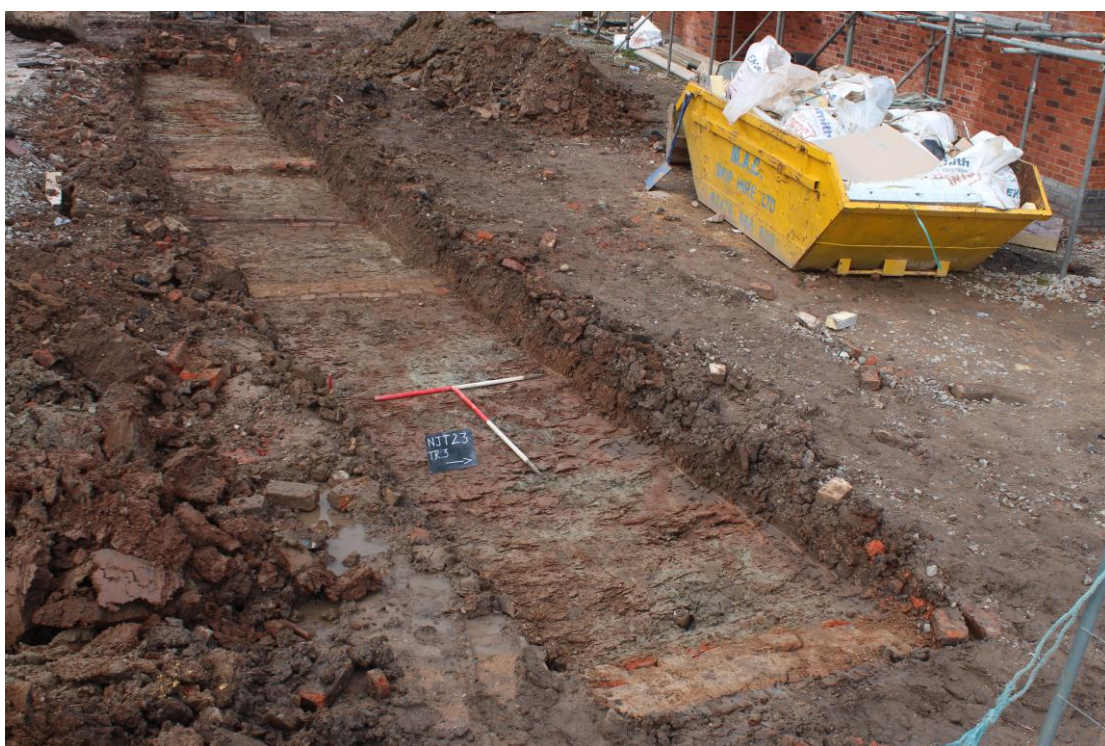
The surface of the natural substrate (301), consisting of a stiff red clay mottled throughout with light grey clay and containing a component of small stones, was recorded at a roughly level height of about 107.25m AOD throughout the trench. Some previous truncation of this deposit is likely during the construction of the former smithy (recently demolished); no archaeological deposits or cut features

*Plate 14; trench 3, view east.*

*Plate 15; trench 3, view northeast.*

*Plate 16; trench 3, view northwest.*

Trench 3 also revealed little previous activity other than that associated with the construction of the former smithy, only the walled remains of this building were observed within the trench, any overlying deposits being previously removed during its construction.
