LAND OFF WORKHOUSE LANE, BURBAGE,  
HINCKLEY

PHASE II SITE APPRAISAL REPORT  
FOR  
MATHER JAMIE

**Project Ref:**  
P9013

**Date:**  
August 2023

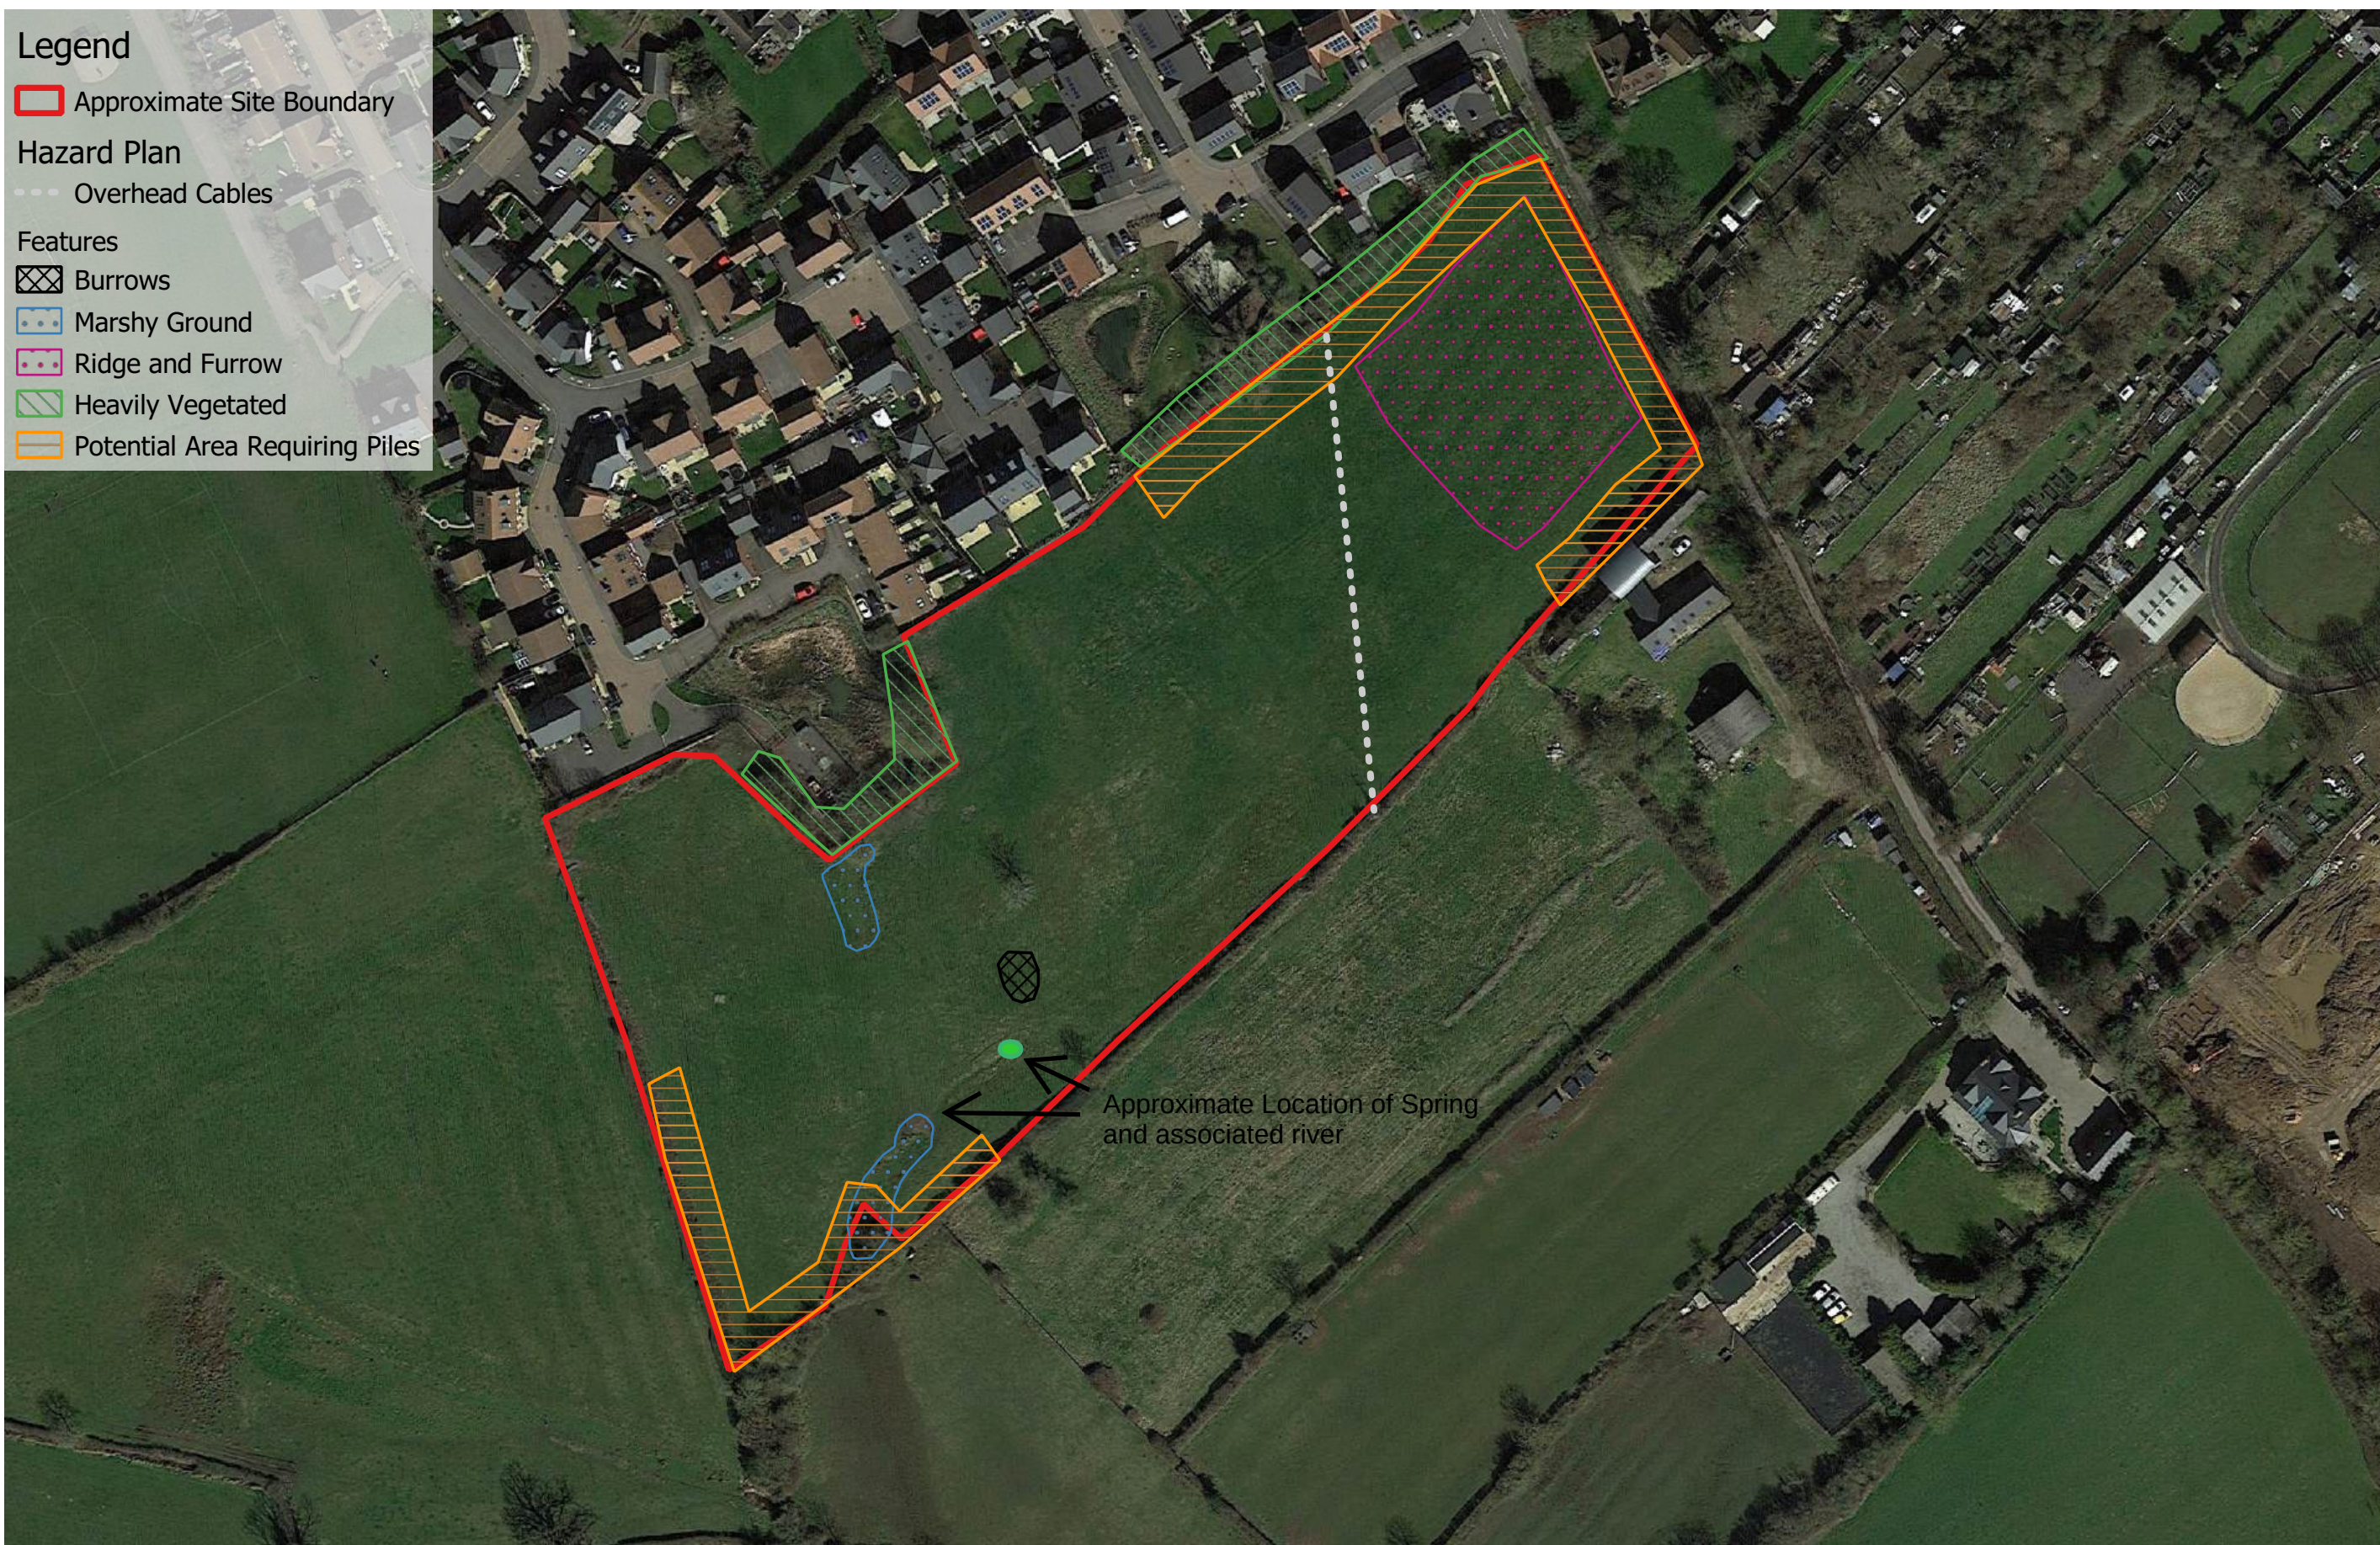
Heavily Vegetated

Potential Area Requiring Piles

Due to the presence of shallow, water-laden sand and deep soft or variable strata at this stage, it is recommended that allowance is made for 20% of the site to require piling.

Additionally, due to the influence of trees, it is possible that an additional 10% of the site could have foundations bearing at depths in excess of 2.5m begl (i.e within the engineer design zone); these areas are highlighted on the Foundation Zone Plan presented in Appendix K. Desiccation testing (to be undertaken in the summer months if trees are to remain or can be conducted at any time once removed) could be undertaken to determine a safe bearing depth for traditional foundations. However, until this is undertaken and given the variability of the soils, it would be prudent to allow for piling all plots within the engineer design zone.

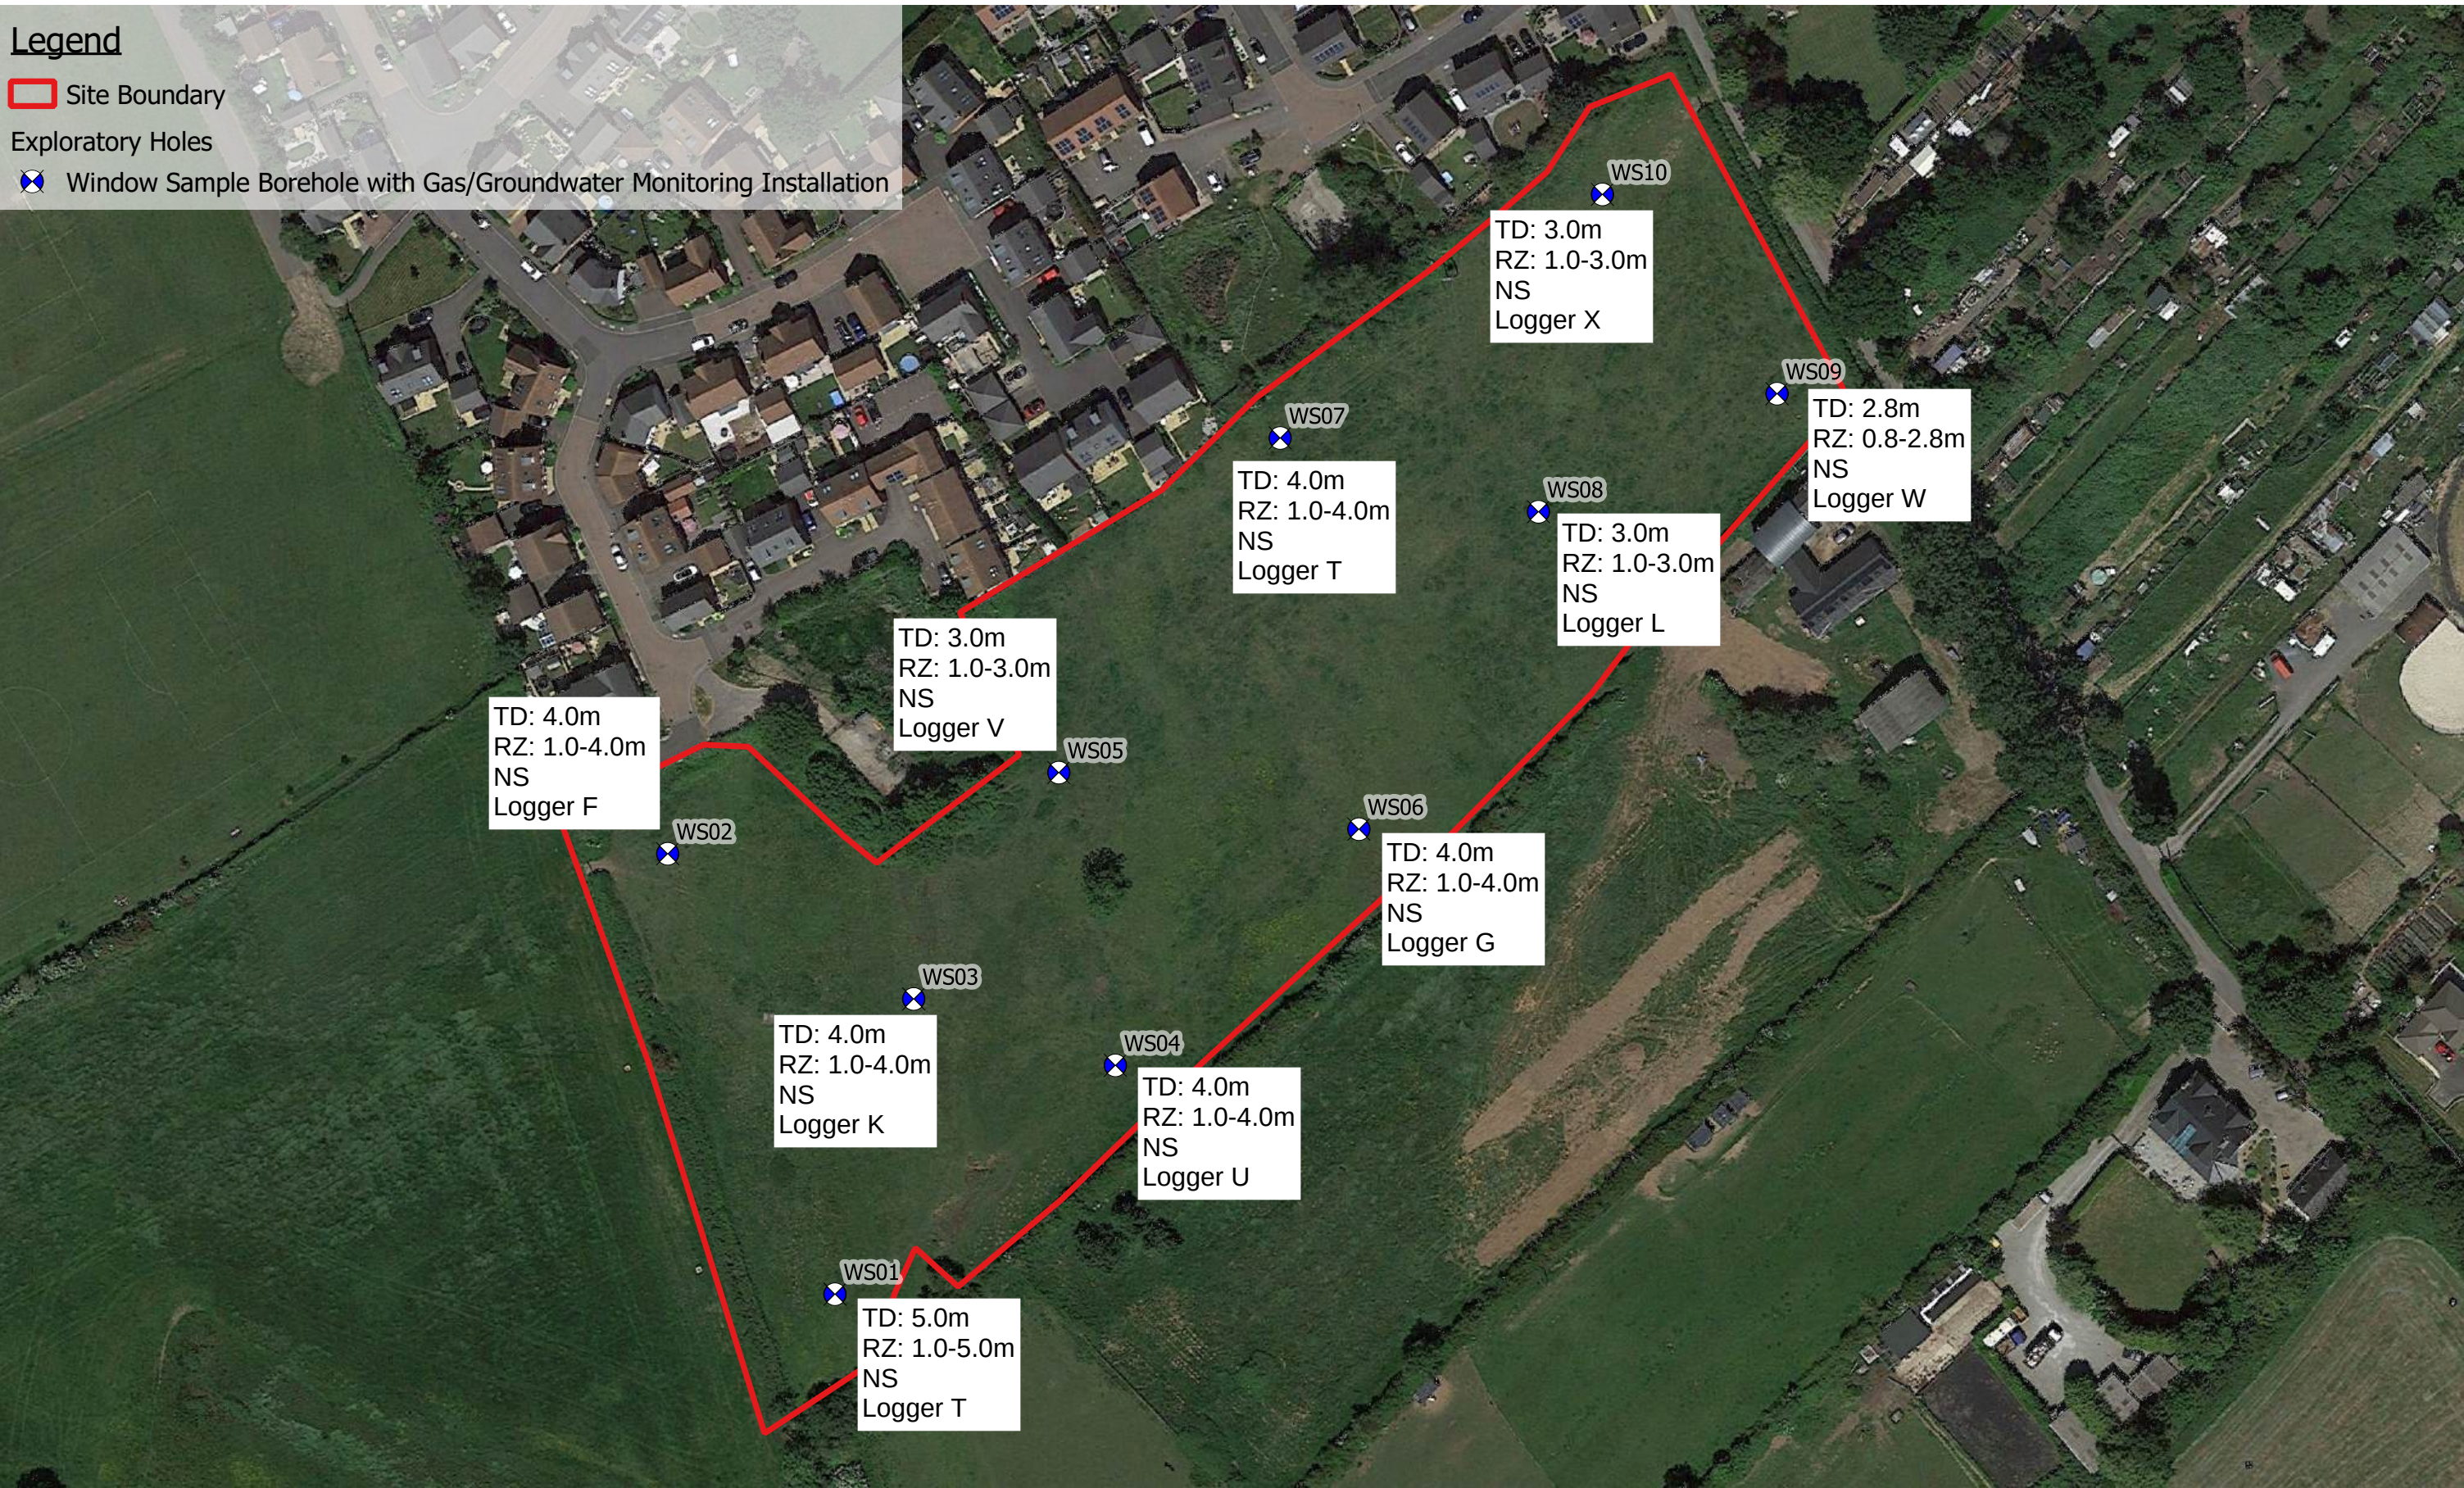
Exploratory Holes

Window Sample Borehole with Gas/Groundwater Monitoring Installation

The ground investigation fieldwork was conducted by WSP in 2019, comprising five windowless sample boreholes (WS01-WS05) and four trial pits (TP01-TP04) the latter used for soakaway testing. The purpose of the investigation was primarily to determine the groundwater conditions at the site to support a viability assessment for soakaway drainage. Groundwater was identified across the site at between 0.5m and 4m below existing round level (begl).
