# Former Burgess Factory Land of Brookfield Road Burbage

## CAPPING SUITABILITY (SOILS) ANALYSIS REPORT

Project no: BSH2145

Date: February 2024

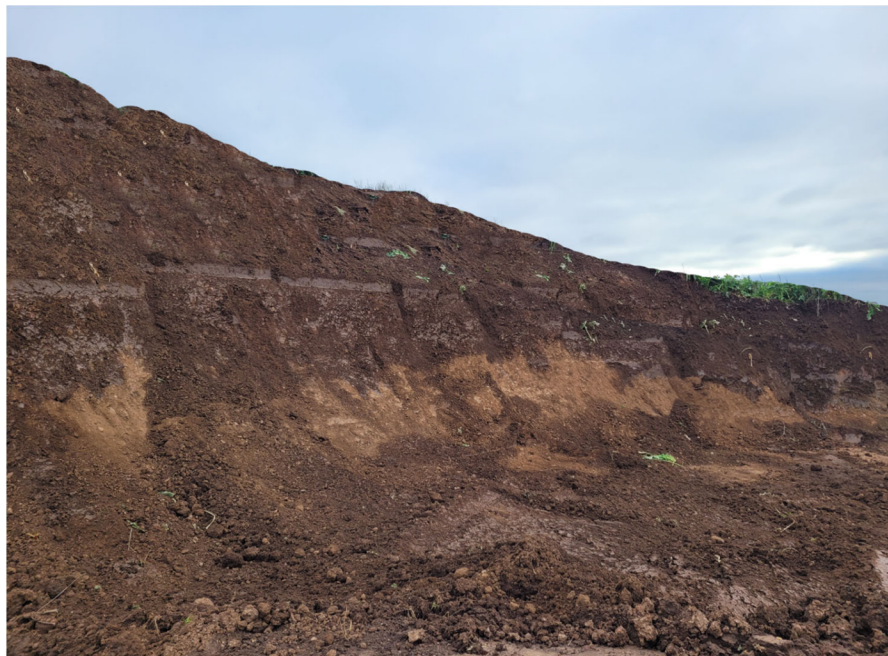
Photo 1 – Nuneaton Topsoil / Subsoil Stockpile

Due to no suitable topsoil / subsoils present on site for use within the capping system donor sites are required to ensure the capping system soils meet the requirements of the Remediation Strategy. A Persimmon Homes donor site was identified at their nearby development off Higham Lane, Nuneaton, CV11 6BD. The above donor site was visited on two separate occasions (11th January 2024 (topsoil sampling and testing) and 1st February 2024 (subsoil sampling and testing) by BSH's environmental

consultant to sample both stockpiles of topsoil and subsoil which have been identified as suitable for use.

Soil samples (20 No. topsoil samples and 20 No. subsoil samples) were recovered from separate stockpiles at the Nuneaton, Higham Lane donor site.

The laboratory testing results for both topsoil and natural subsoils confirm that stripped topsoil and subsoil stockpiled at the Nuneaton, Higham Lane donor site for re-use within the Burgess development is considered suitable for re-use to form part of the capping system.

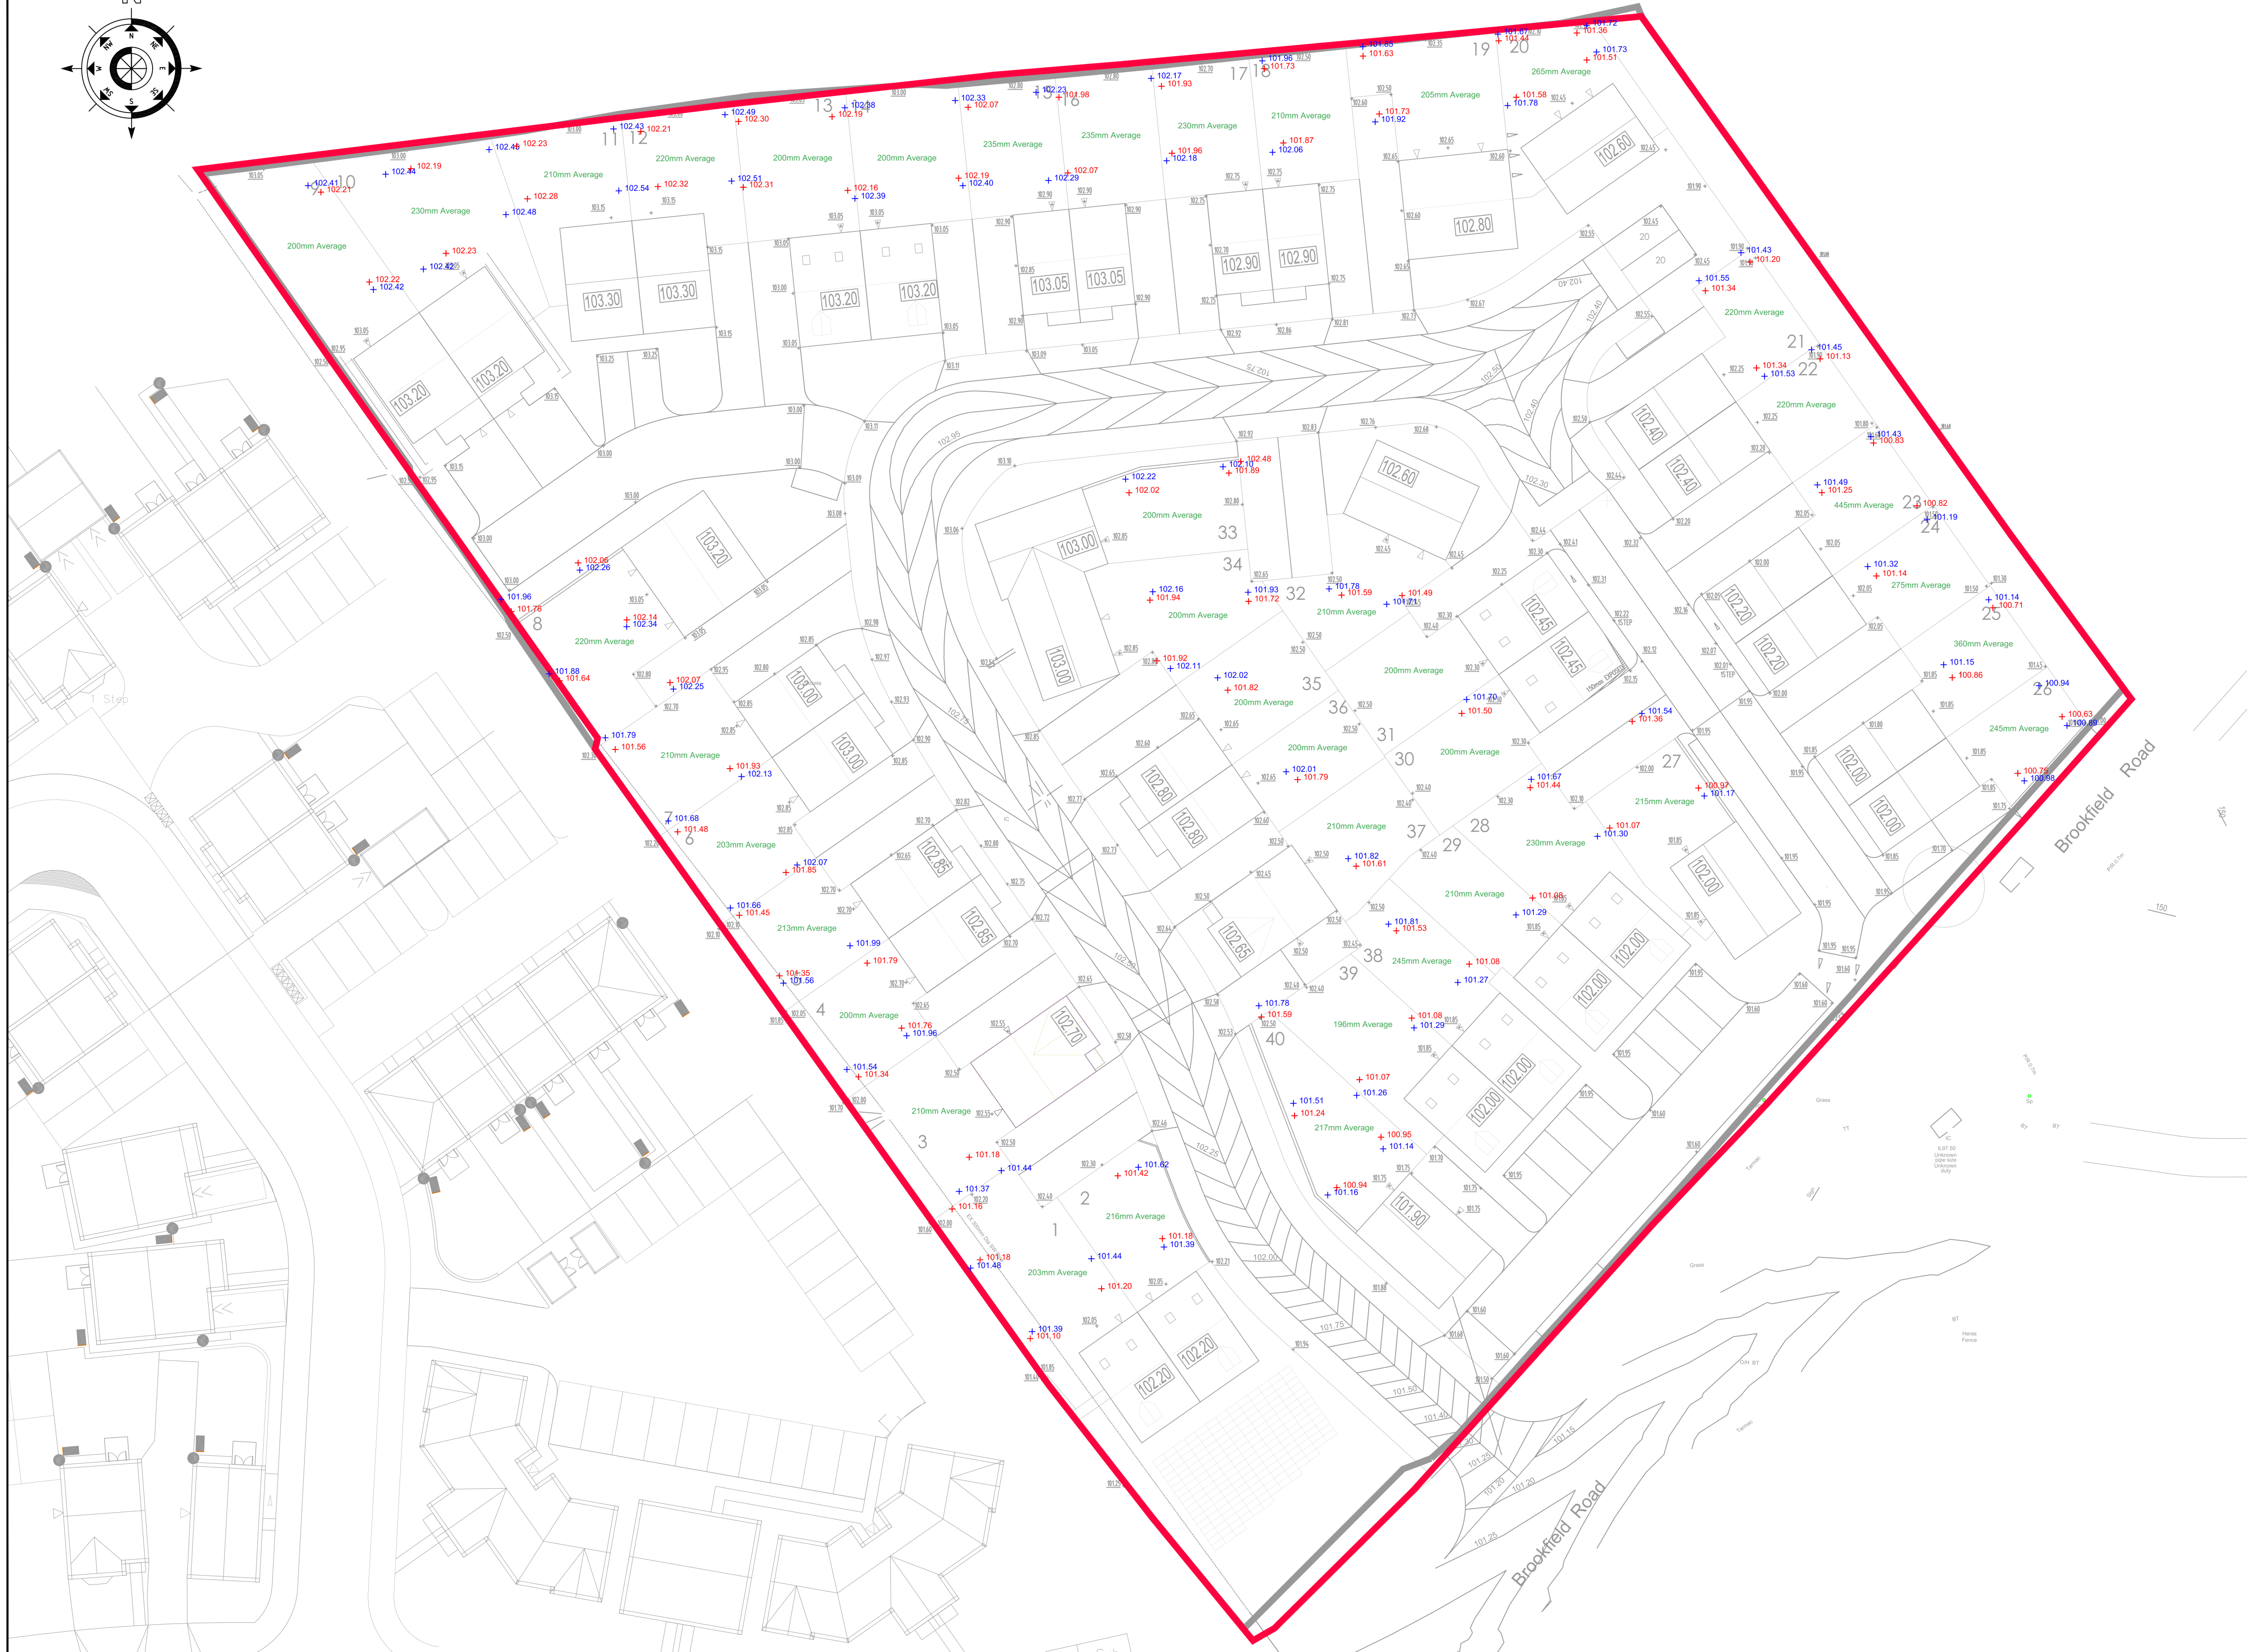
| 1:250 | BSH2145-002 | |

+ 101.49 Top of 200mm Thickness 6F2 Aggregate Layer

+ 101.27 Underside of 200mm Thickness 6F2 Aggregate Layer

BREAK LAYER WITHIN REAR GARDEN AREAS

The 200mm breaker layer (free draining aggregate) was placed by BSH Remediation during the main remediation works in 2023. An as-built survey showing the depth and extent of site won aggregate placed by BSH remediation is presented on Drawing No. BSH2145-002 within Appendix A. The site wide average of free draining aggregate is 209mm which exceeds the 200mm approved thickness.
