## **Phase I & II Geo-Environmental Assessment**

### **Land South of Poplar Terrace**

Congerstone  
Leicestershire  
CV13 6PE

**Date Issued:** 5<sup>th</sup> August 2022

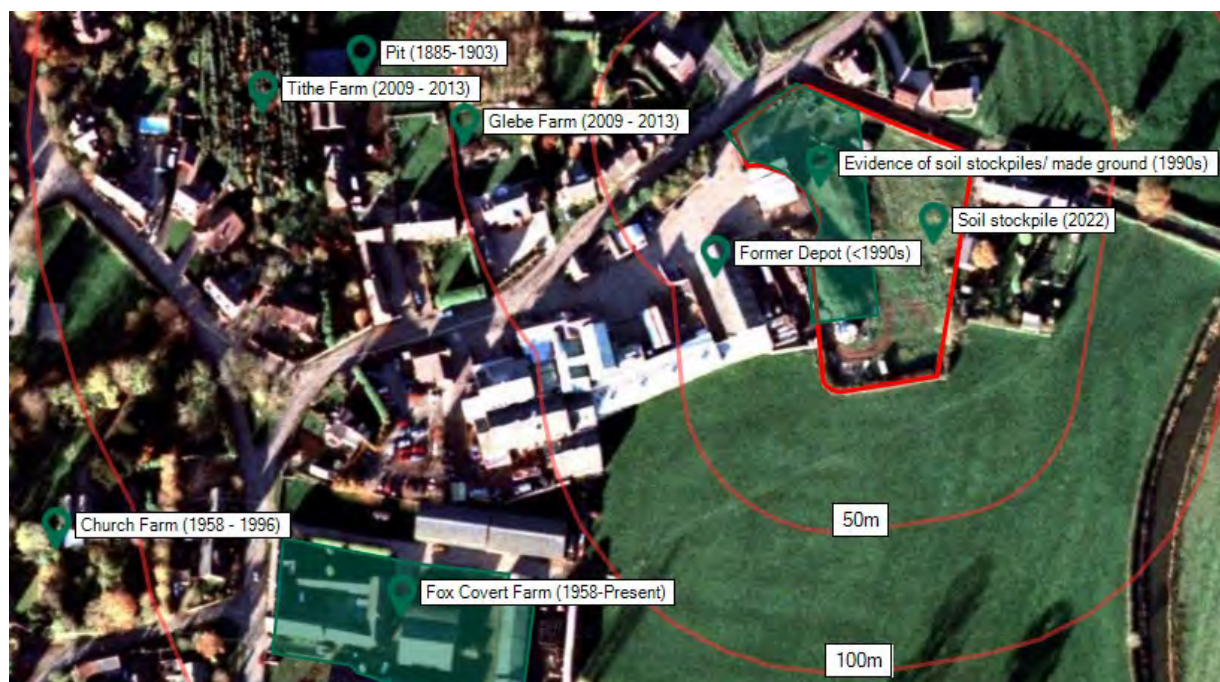
A summary of historical map data from 1885 to 2022 is summarised on the recent aerial photograph below. Key points are highlighted, and copies of relevant historic maps and any others examined during the investigation are included in this report as Appendix F.

- The area of investigation appears to have remained undeveloped throughout the majority of its history, despite much of Congerstone being established through the 20<sup>th</sup> century across the surrounding land. An aerial photograph from 1999 shows the west of the site may have contained some soil stockpiles/ made ground from surface, likely to have been associated with a commercial depot that was constructed to the west during this time. This facility has since been replaced by the houses along Dovecot Close, introduced in the last 10-15 years.

- Potentially contaminative land uses identified from historic maps in the surrounding area include infilled ponds approximately 20m west and 120m north west, and a possible gravel pit has also been identified 130m north west; appearing on maps from 1885 to 1903 respectively. A number of farms are also highlighted including Glebe Farm 100m west, Fox Covert Farm 120m south west and Church Farm 280m south west. The majority of the holdings recognised from historic records have subsequently been redeveloped with only Fox Covert Farm anticipated to be active at the time of writing.

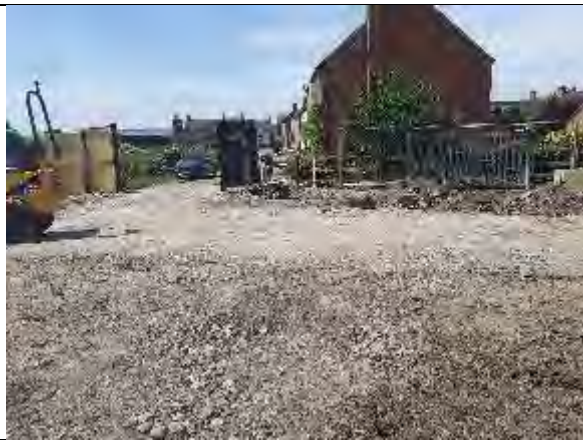
| <p>Photo 1: Image showing the entrance to the site and the site compound.</p> | <p>Photo 2: Image looking north west across the property.</p> |

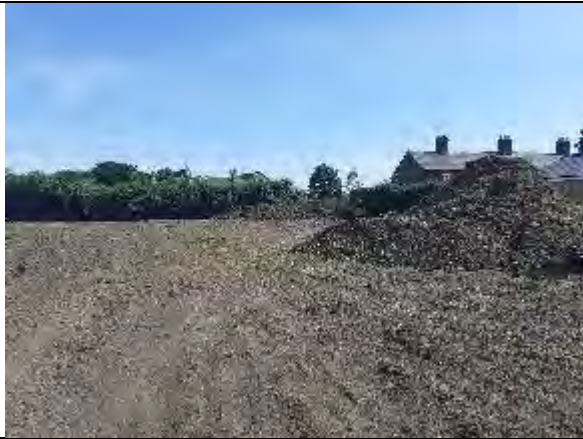
| <p>Photo 3: View looking north east across the site showing existing stockpiles of surfacing soil.</p> | <p>Photo 4: Photograph showing the profile of TP04.</p> |

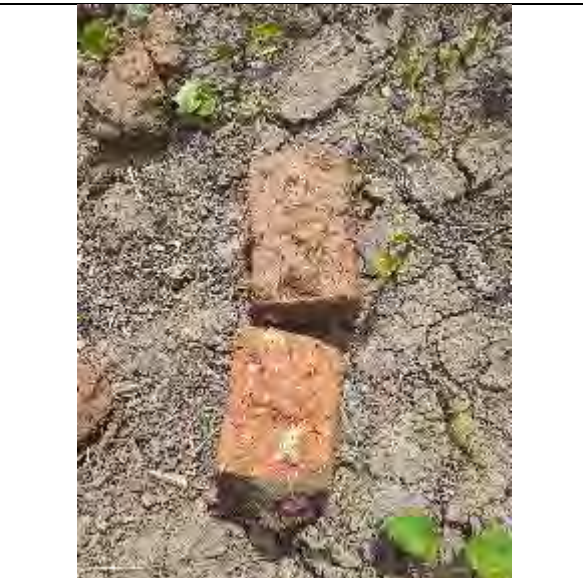
| <p>Photo 5: Image showing largely in-tact bricks recovered at TP05.</p> | <p>Photo 6: Image showing made ground materials at the surface in the north west corner of the site.</p> |
