**LAND REAR OF 193 SHAW LANE,  
STANTON UNDER BARDON  
LE67 9PW**

**POTENTIAL ROOST ASSESSMENT - BAT SURVEY**  
**Incl. Emergence Survey**

Ref: WCL/PBA/JH/1823(2)

1st August 2023

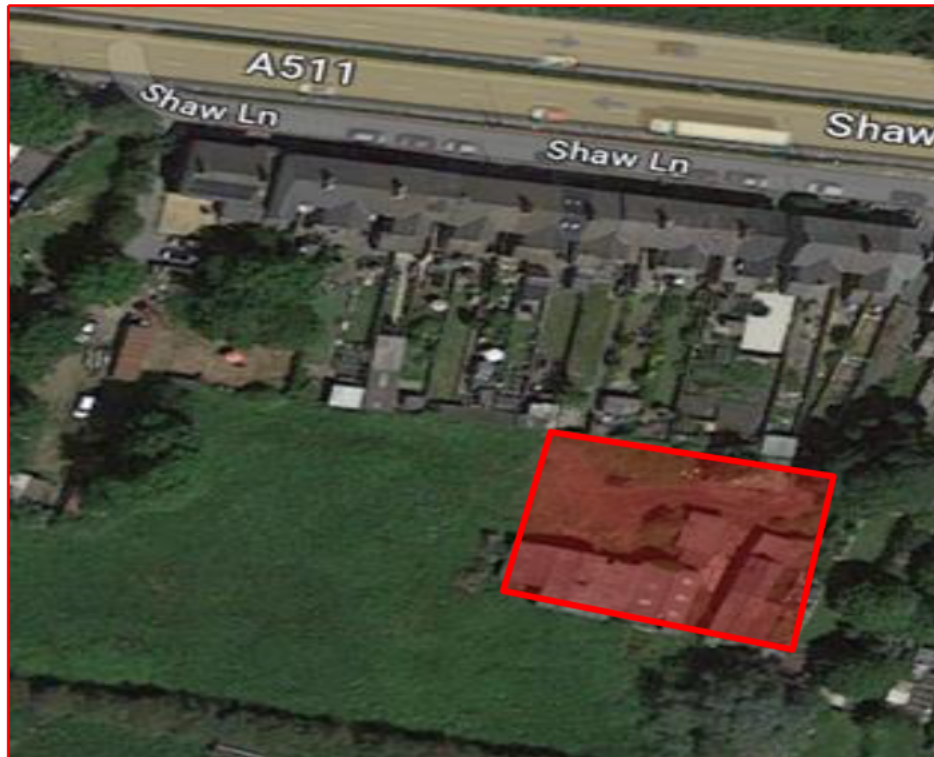
Fig. 1: Location of barns

All the surveys of the site encompassed the building referred to as the site, as shown (Figure 1).

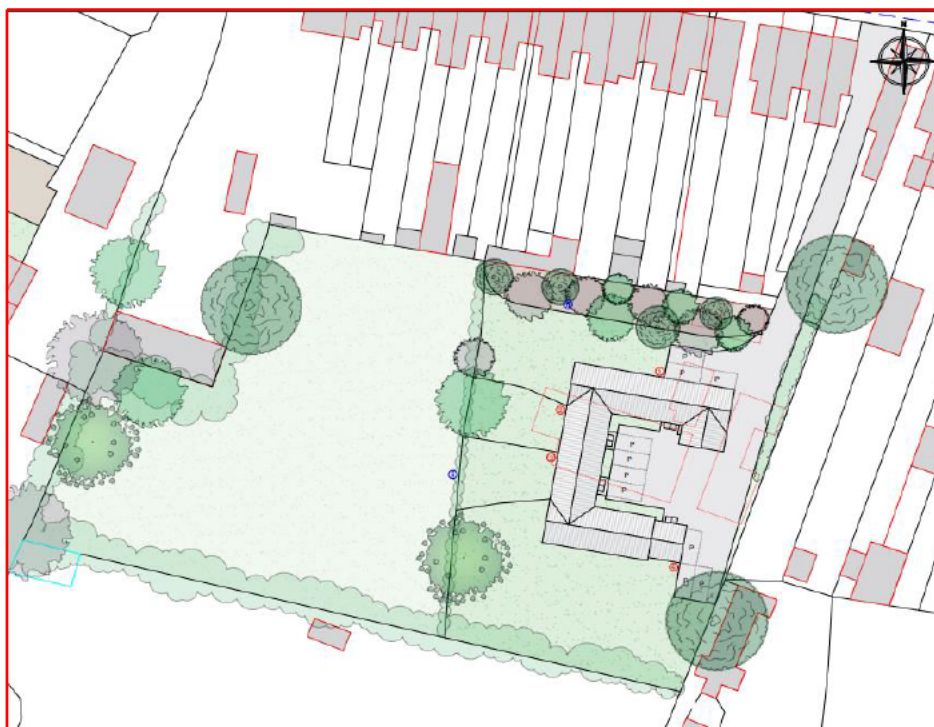
Fig. 2: Proposed re-development plan.

The proposal is for redevelopment of the buildings and hard standing for four (4) residential properties.

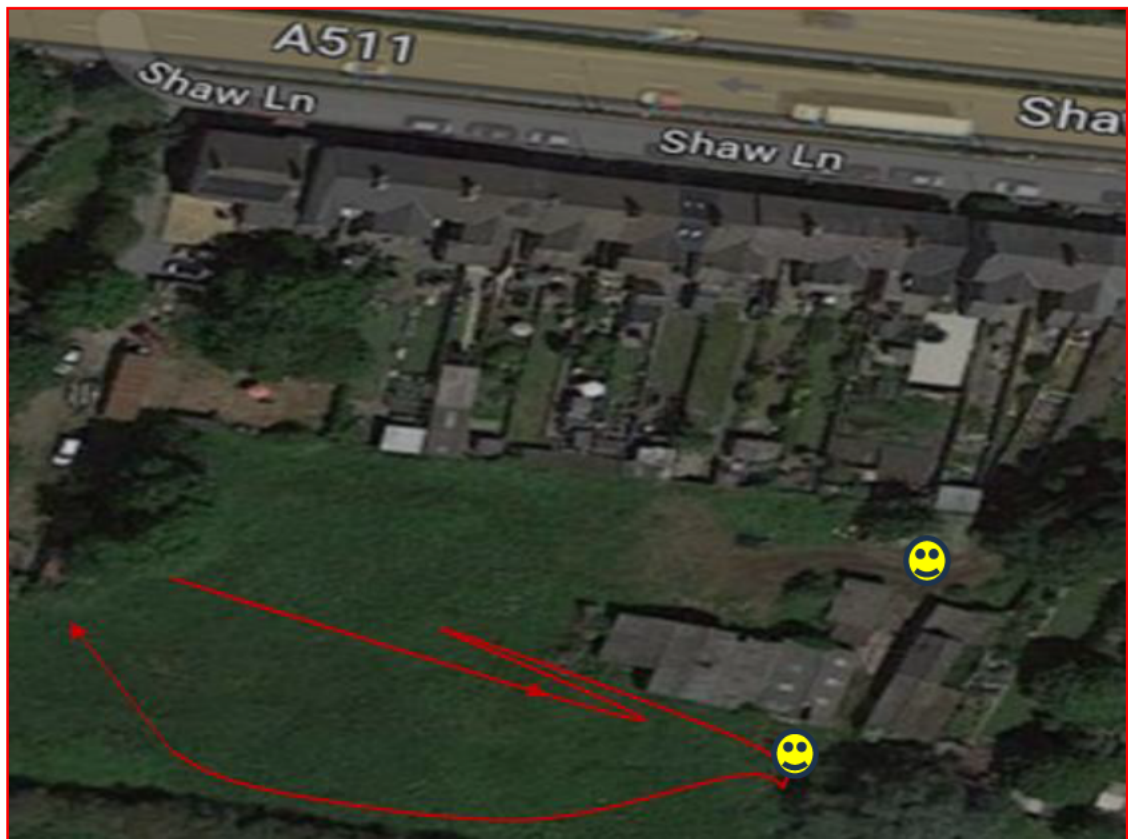
Fig. 2: Bat flight lines & foraging including location of surveyors

1st bat - Common Pipistrelle (*Pipistrellus pipistrellus*) was observed and recorded at 21.49  
flying & foraging around / over the hedge to rear of barns with the last  
recording at 22.13.

Single bat only seen and recorded on all occasions.

No bats were recorded or observed emerging from the barns.

1st bat - Common Pipistrelle (*Pipistrellus pipistrellus*) was observed at 21.50 foraging to  
rear of barns, no further observations or recordings made.

Bats were identified as foraging and flying to the rear of barns over the hedgerow.

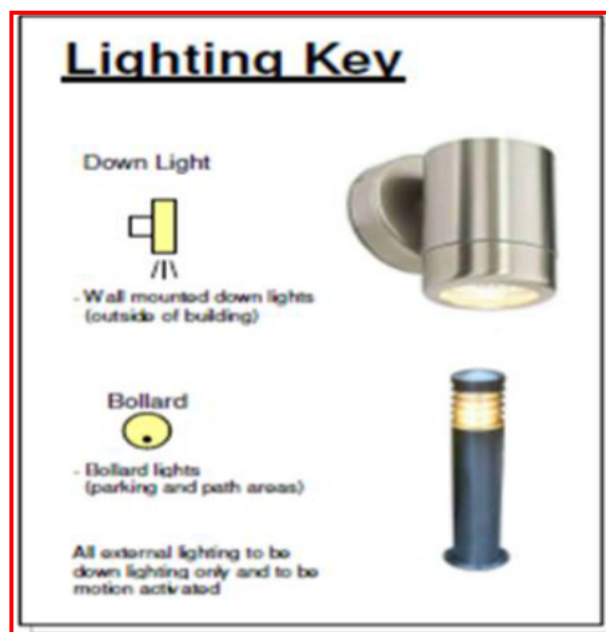
- B) A Bat Brick is Incorporated into each new build property – gable ends.  
eg. Ibstock Enclosed Bat Box 'B' or Ibstock Enclosed Bat Box 'C'

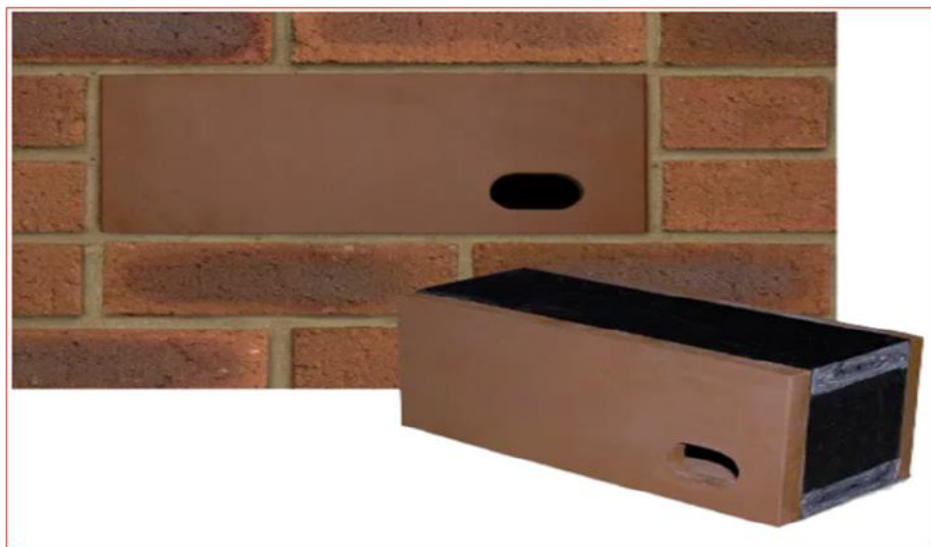
Eg. Ibstock Eco-habitat for Swifts

Four Bird bricks are erected on the property (eaves) – Swift Brick

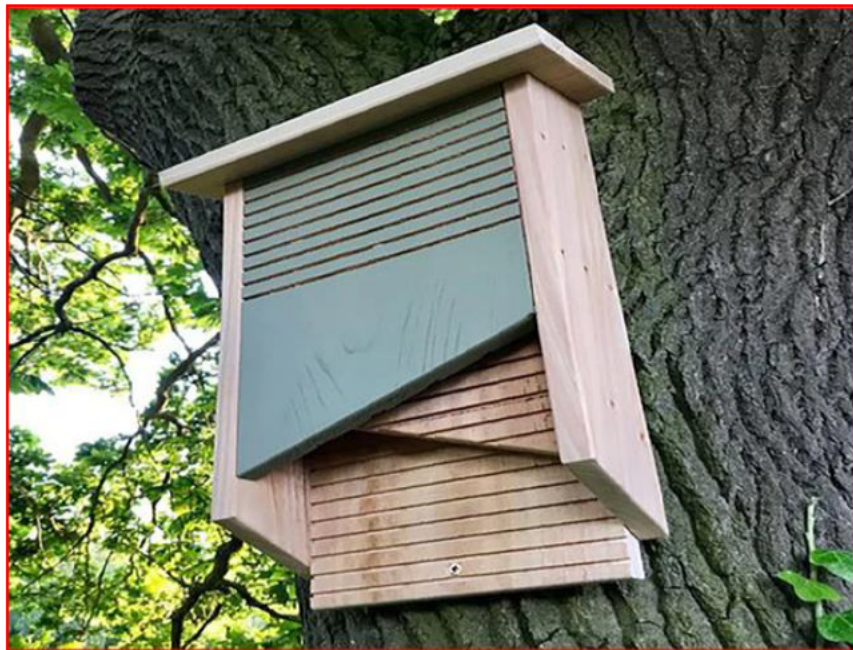
E BAT BOX

Two boxes are erected onto the boundary trees prior to works commencing.
