**Bat and Nesting Bird Method Statement for,  
Mr. and Mrs. Taylor.  
Building at,  
Dovecott Barn,  
Ravenstone Farm,  
Main Street,  
HIGHAM ON THE HILL,  
Leicestershire,  
CV13 6AH.**

**Map Ref SP 3814 9541  
2<sup>nd</sup> March 2026.**

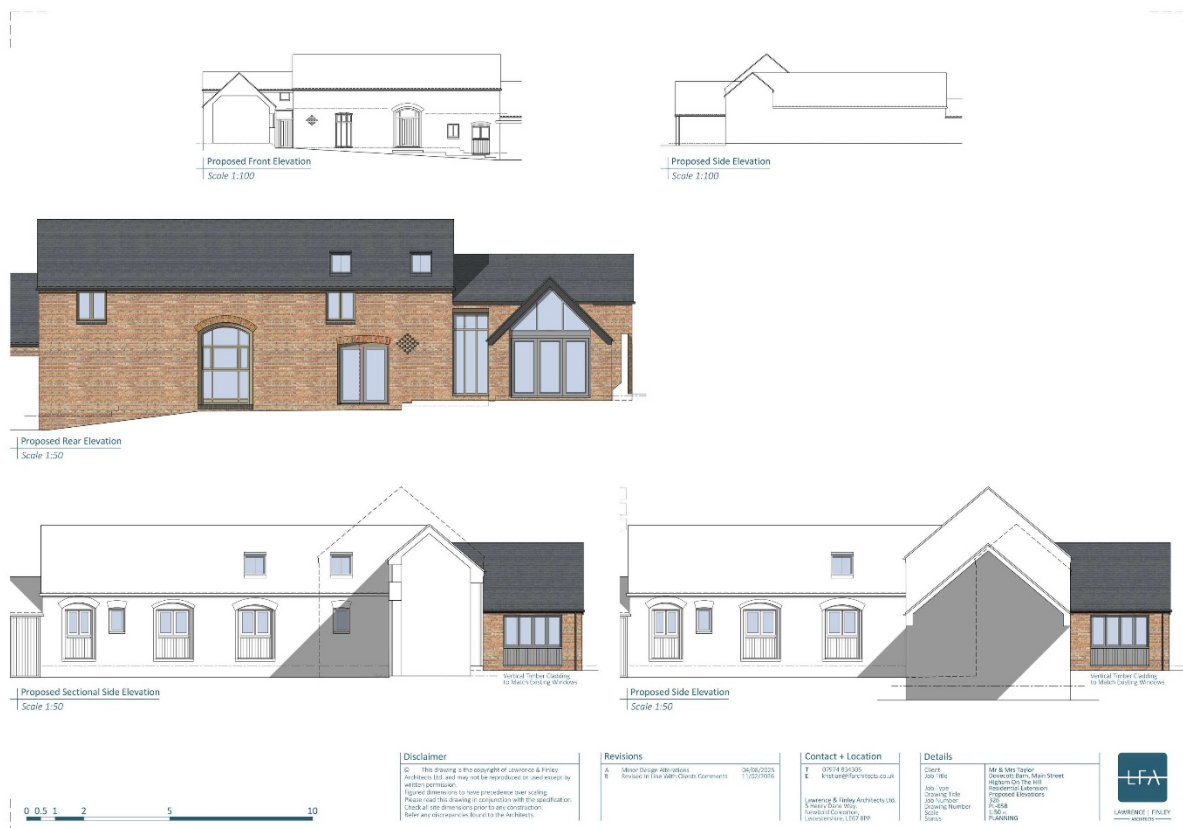
All roof lights are sealed units to stop water ingress to ceilings and to meet strict Building Regulations requirements regarding heat loss when installed. The installation of the roof light therefore will not introduce any new wind or cold egress points. The bats are roosting between the underside of the breathable roofing membrane and the plasterboard ceilings. The plasterboard is fixed to the underside of the rafters and therefore the bats are restricted to an area from the eaves to the ridge between the rafters. There is no access across the rafters. This is an enclosed area and the introduction of timber to fix the roof light in place will not extend within 1.2m of the known roosting area and will therefore have no impact on climate in the roosting space.

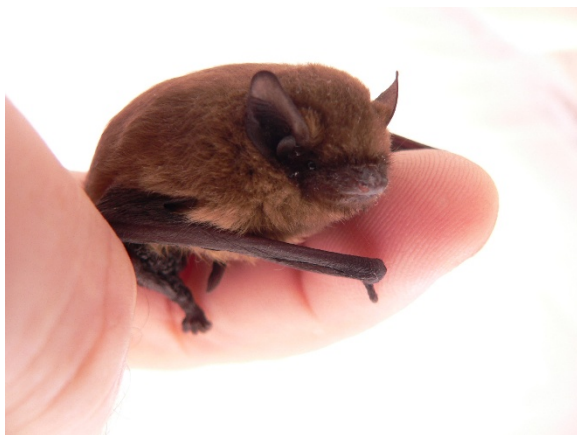
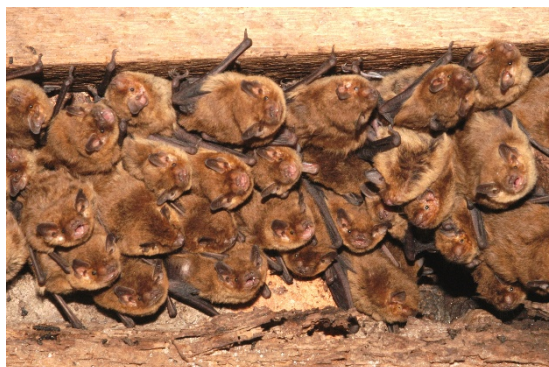
The common species of bats that are known to roost in this building and are evidenced from the emergence survey records, are crevice dwelling bats, the Common Pipistrelle. These bats are small and can use accesses as little as 50mm x 20mm. when found in buildings they appear no bigger than a thumb and have dark brown fur.

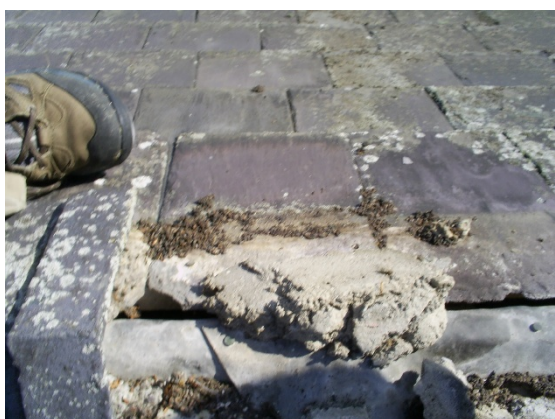
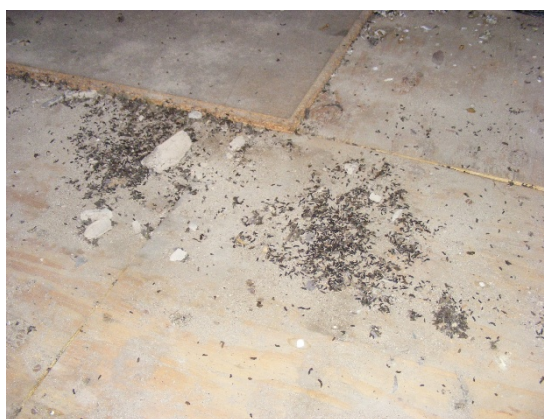
It is common to find bat droppings in places used by bats. These are small and often confused with mouse droppings. It is possible to distinguish between them as mouse droppings are hard whereas bat droppings, being only insect remains, crumble when rubbed between the fingers.
