**Phase 1 Land Contamination  
Risk Assessment**

**The Proposed Construction of 4 No.  
Semi-Detached Dormer Bungalows and  
1 No. Detached Dormer Bungalow (For  
Occupation by Persons Over the Age of  
55 Only) with Associated Parking and  
Amenity Space**

**Bethel and Bethesda Residential Care  
Home, Equity Road East, Earl Shilton,  
Leicester LE9 7FY**

3975D P1 Cooper Residential – Earl Shilton

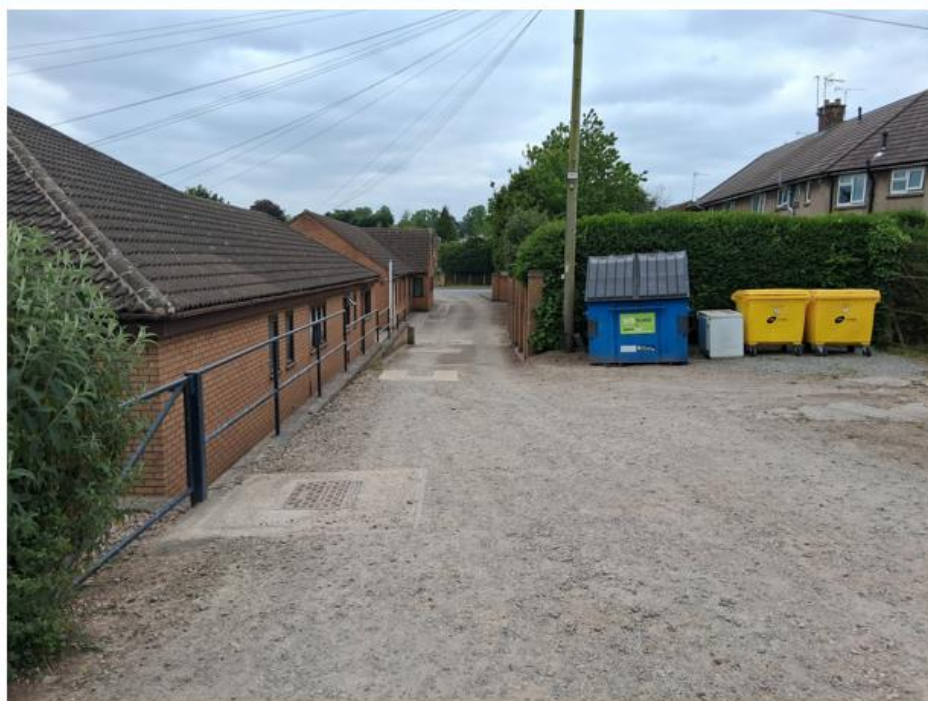
**Photo No.1: Facing south from the car-parking area on site showing the site access leading north off Equity Road East**

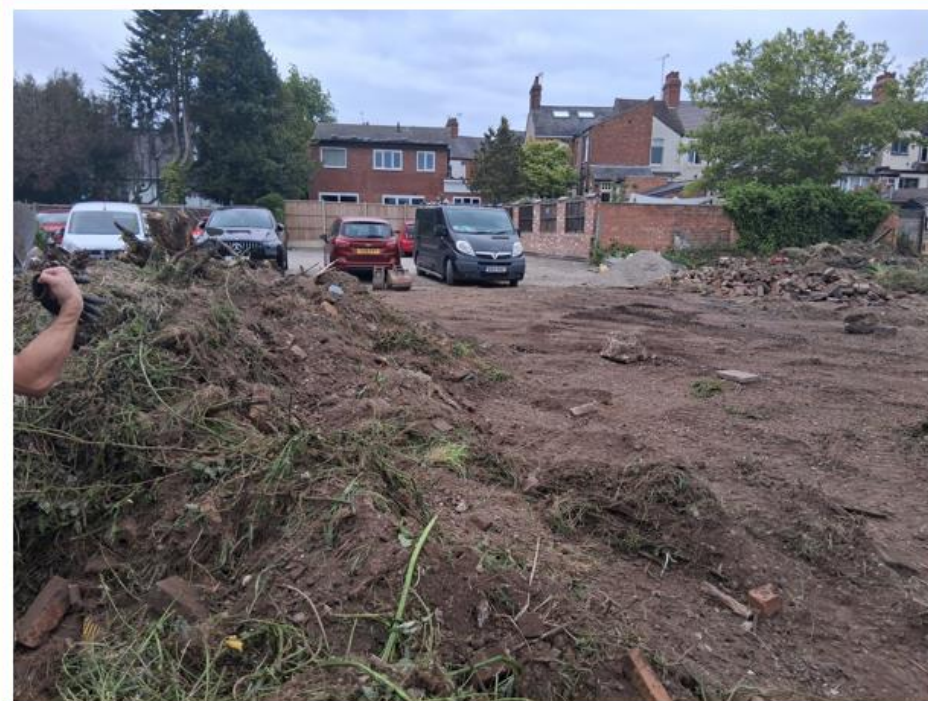
**Photo No.2: Facing west from the southern extent of the main site area showing the adj. car-parking area forming SW extent**

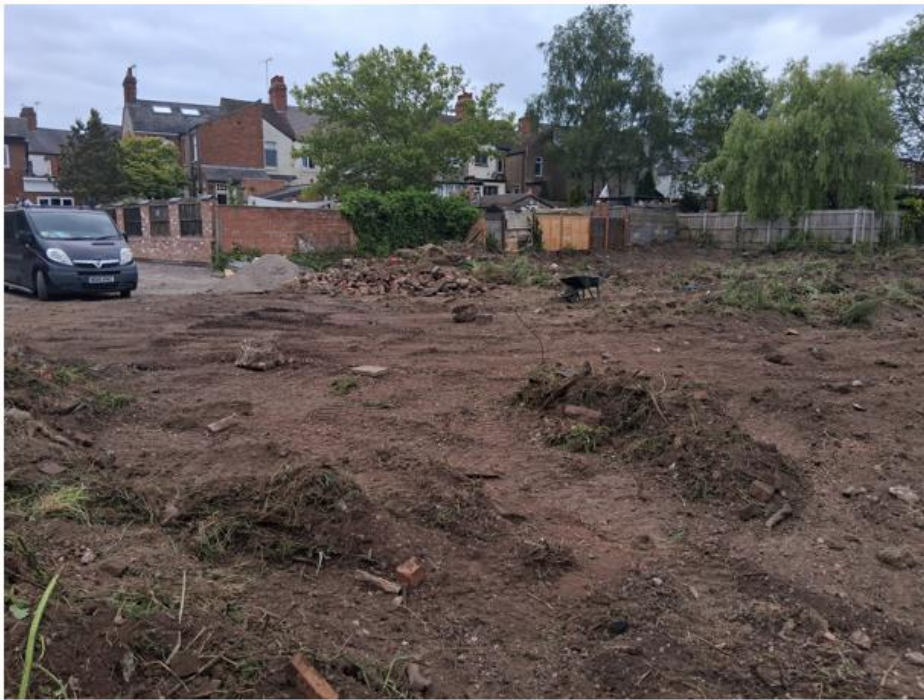
**Photo No.3: Facing NW from the SE extent of site**

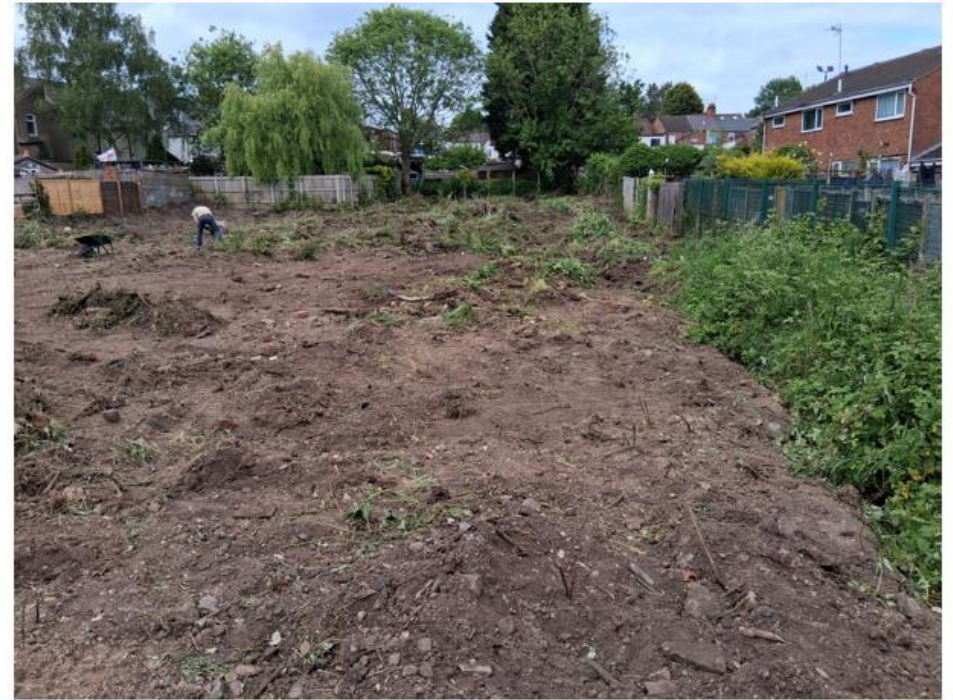
**Photo No.4: Facing north from the SE corner of site along the eastern boundary of site (right of photograph)**

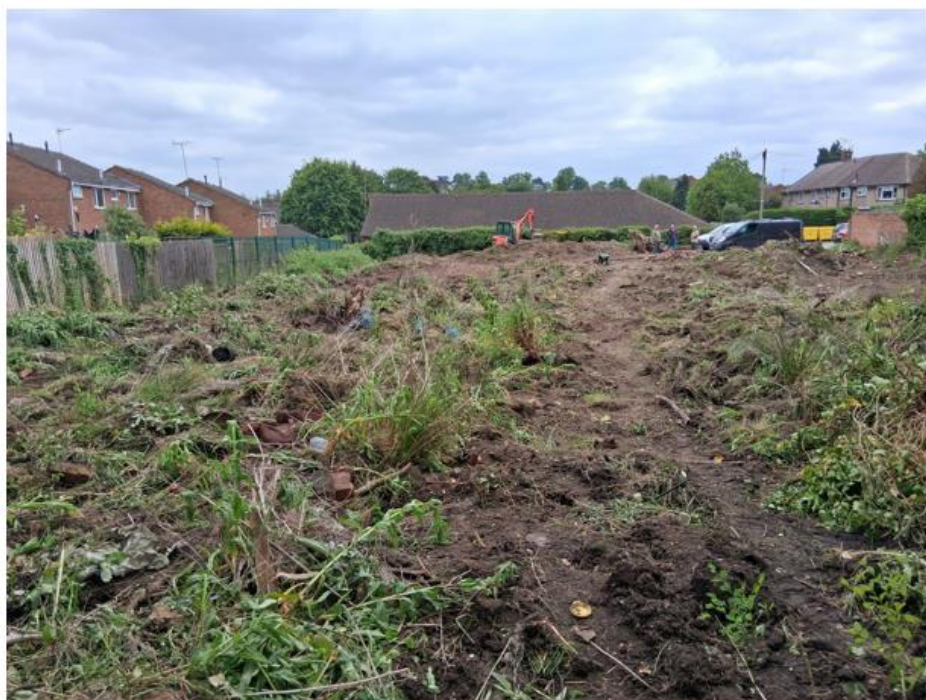
**Photo No.5: Facing south from the far north of site showing the site entirety and extent**

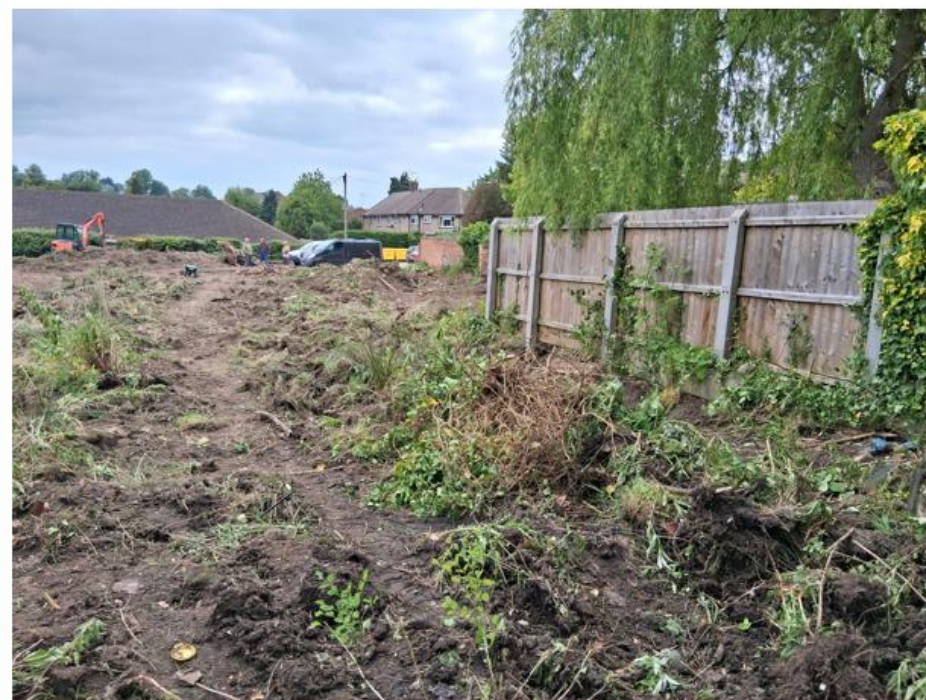
The site interior comprises a currently redundant and disused access route, small car-parking area and an expanse of recently cleared ground. Access to site was provided via the care home access route, leading north off Equity Road East before terminating at the car-park on site. The secondary access, currently disused and overgrown, extends west from the car-parking area to the nearby Station Road. The car-parking area was seen to be formed by gravelled hardstanding. The remainder of site then comprises a vacant plot of land which had recently been cleared of overgrown vegetation. The ground conditions underfoot largely comprised sands and gravels with anthropogenic inclusions such as brick, plastics and some scattered wastes and debris (i.e. domestic wastes such as food wrapping and containers).

No significant potential sources of contamination were noted on the site walkover beyond the made ground deposits noted underfoot.

**Photo No.6: Facing slightly SW from the north of site showing the general ground conditions occupying site entirety**
