## Preliminary Roost Assessment

Lord Nelson, 54 Wood Street, Earl Shilton, Leicester LE9 7ND

Vault Pubs Ltd

This report is prepared to inform a planning application with Hinckley and Bosworth Borough Council. This proposal can be described as the change of use to create a 5 bed HMO to the first floor and self contained flat to second floor. To include two storey rear extension, loft conversion with front and rear dormers and the addition of solar panels and a single storey rear extension to pub to provide additional seating with new staircase access.

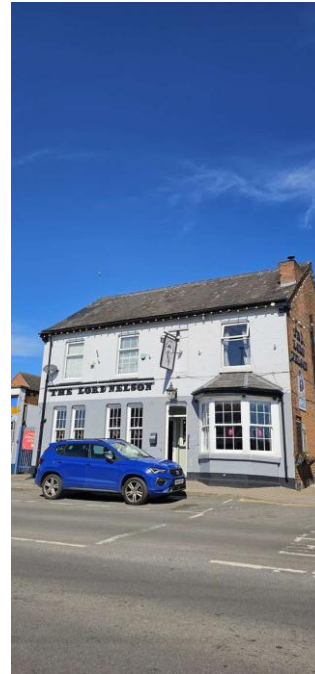
| <p>B1 is a two-storey, detached, brick-built public house. The main roof structure is gabled and constructed of slate. Internal voids were recorded within the building. No bat evidence was found during the survey.</p> <p>In line with Good Practice Guidelines (Collins, J (Ed) 2023), B1 is assessed to have moderate habitat value for roosting bats due to due to the frequent gaps between the roof tiles allowing direct access into the loft void for bats, in addition to more features that could be used by roosting bats.</p> | | | <p>B1</p> | |

Two bat emergence/re-entry survey will be required on B1, requiring 3 surveyors and to provide full coverage of the building's elevations. If bat roosts are confirmed in the building one additional survey may be required to characterise the roost and to inform an EPSL application to Natural England.

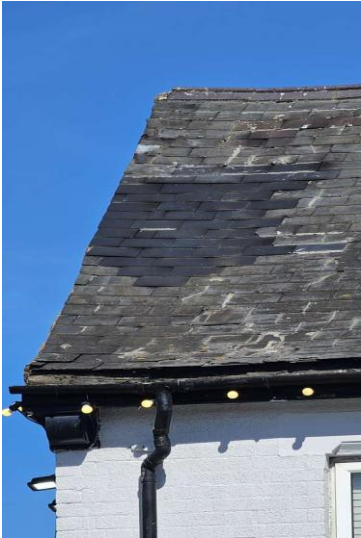
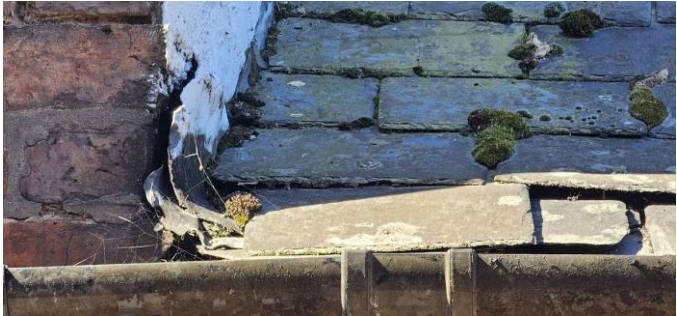
| | Roof | Slate | <p>The slate roof has some defects, including local gaps or damage. Areas of lifted tiles and gaps were present throughout the roof structure, with areas of missing mortar along the ridge tiles. Areas of lifted lead flashing were present throughout the roof structure and chimney.</p> | <div><p><i>Lifted tiles</i></p></div> <div><p><i>Lifted lead flashing and tiles</i></p></div> | |

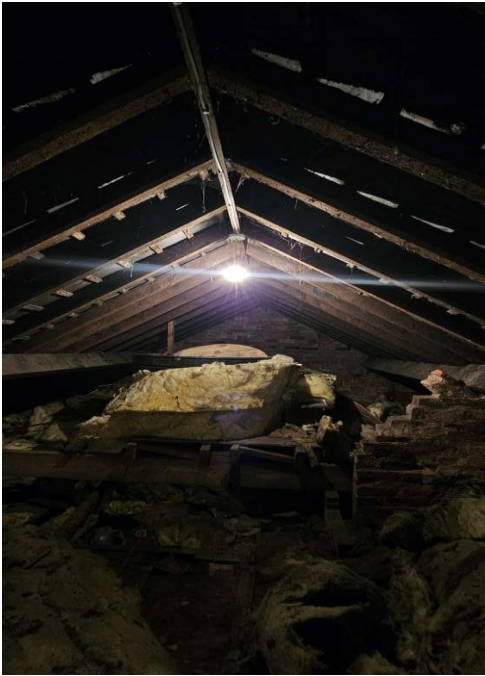
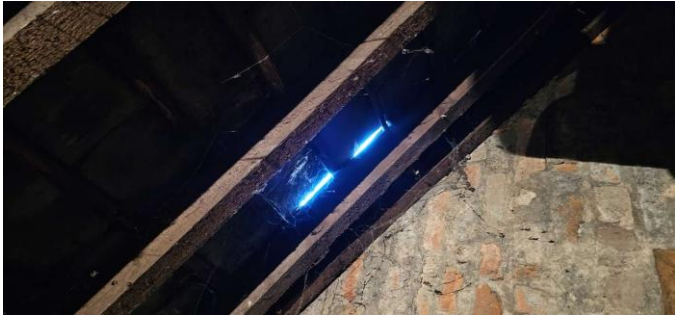
| | Voids | None | <p>A loft void measuring 12m in length, 6m in width, and 2m in height, with an approximate area of 72m<sup>2</sup>, was recorded. Gaps were observed throughout the loft void which provided direct access into the loft void for bats. Suitable roosting locations within the loft void included at the ridge convergence points.</p> | <div><p><i>Loft void</i></p><p><i>Gaps between tiles</i></p></div> |
