## Preliminary Roost Assessment

142 Hinckley Road, Burbage, Hinckley, LE10 2AH

This report is prepared to inform a planning application for: Double Storey and Rear Single Storey Extension.

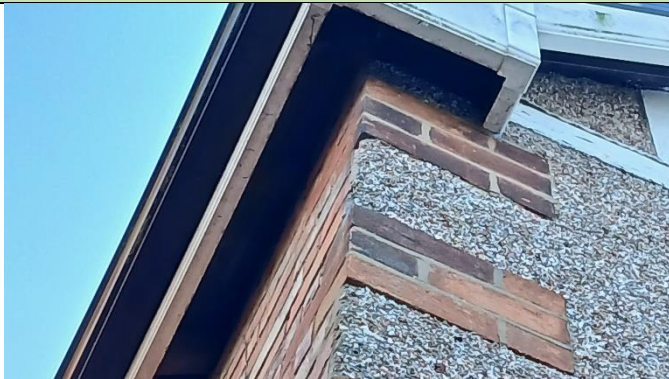
| The habitat value of B1a is <b>Moderate</b> | | | | |
|---|---|---|---|---|
| Walls | Brick and mortar.<br>Areas of pebbledash. | The brickwork and pebbledash are in good condition with no breaks or areas of missing mortar observed. | The walls present no roosting opportunity for bats. | |

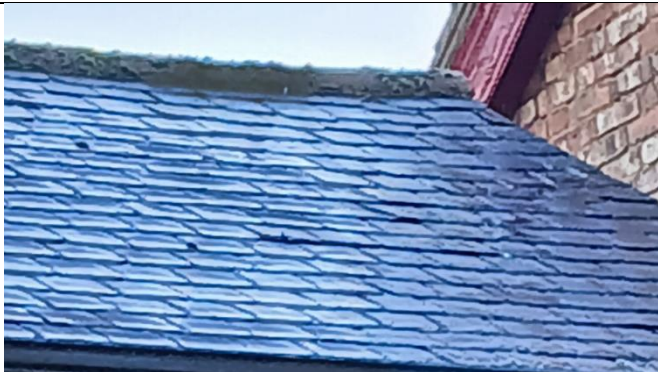
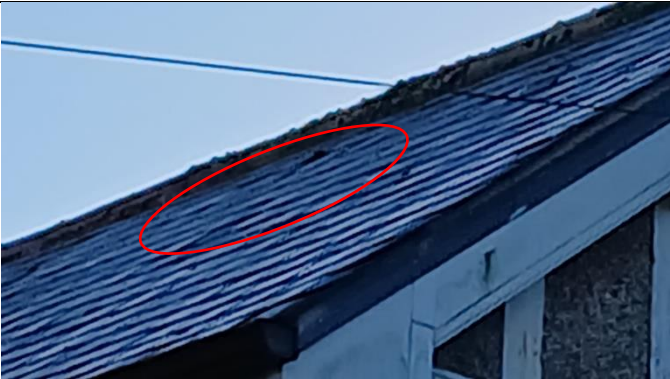
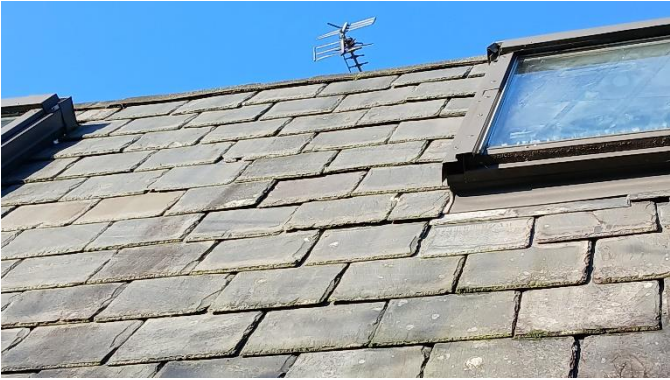
| The habitat value of B1a is <b>Moderate</b> | | | | |
|---|---|---|---|---|
| Roof | Overlapping tile. Pitched. | The roof is constructed of overlapping tiles. There are tile gaps interspersed throughout the field tiles. Around 10-15% of the total tile volume is lifted. Hip and ridge tiles are intact and fit flush to each other. | Gaps under the roof tiles, on the eastern and western elevations will provide roosting for small numbers of crevice dwelling species and may also provide access to internal void. | |

| <i>Recommendations</i> | <p>Two bat emergence survey is required during the active bat season (optimal May to August, suboptimal September) to confirm presence or likely absence of a bat roost in the building. The surveys should be completed during the optimal survey period May to August inclusive and be at least three weeks apart.</p> <p>Infra-red cameras should be used as an aid.</p> <p>Two surveyors and an additional IR camera would be required to provide full coverage of the building.</p> |

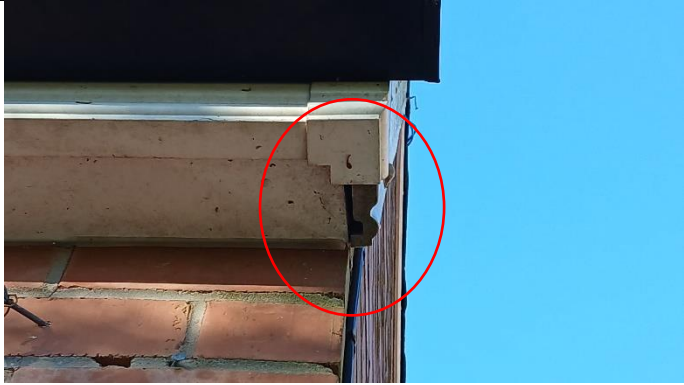
| Eaves | Closed eaves – soffit lined (uPVC). | Soffits are in a good condition and fit flush to the brickwork. There is a small gap at the northern end of the soffit on the eastern elevation. | The eaves and soffits present roosting opportunities for crevice dwelling species by way of a small gap corner of the soffit. These may also provide access internally. | |

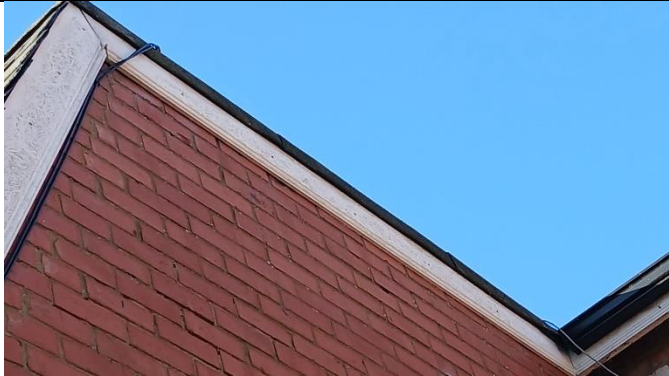
| Barge boards/fascia boards | Timber and uPVC | Bargeboards and fascia on the western and northern elevations have a number of small gaps between them and the walls. | The bargeboards and fascia will provide roosting for small numbers of crevice dwelling species. | |

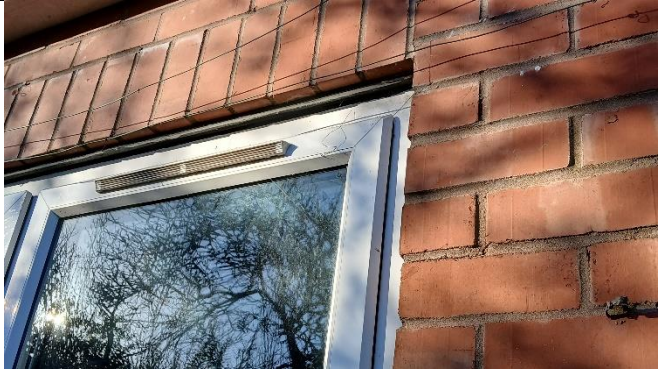
| Window/doors frames and lintels | uPVC | Windows and doors are tight fitting no gaps present. | The windows and doors provide no roosting opportunities for bats. | |

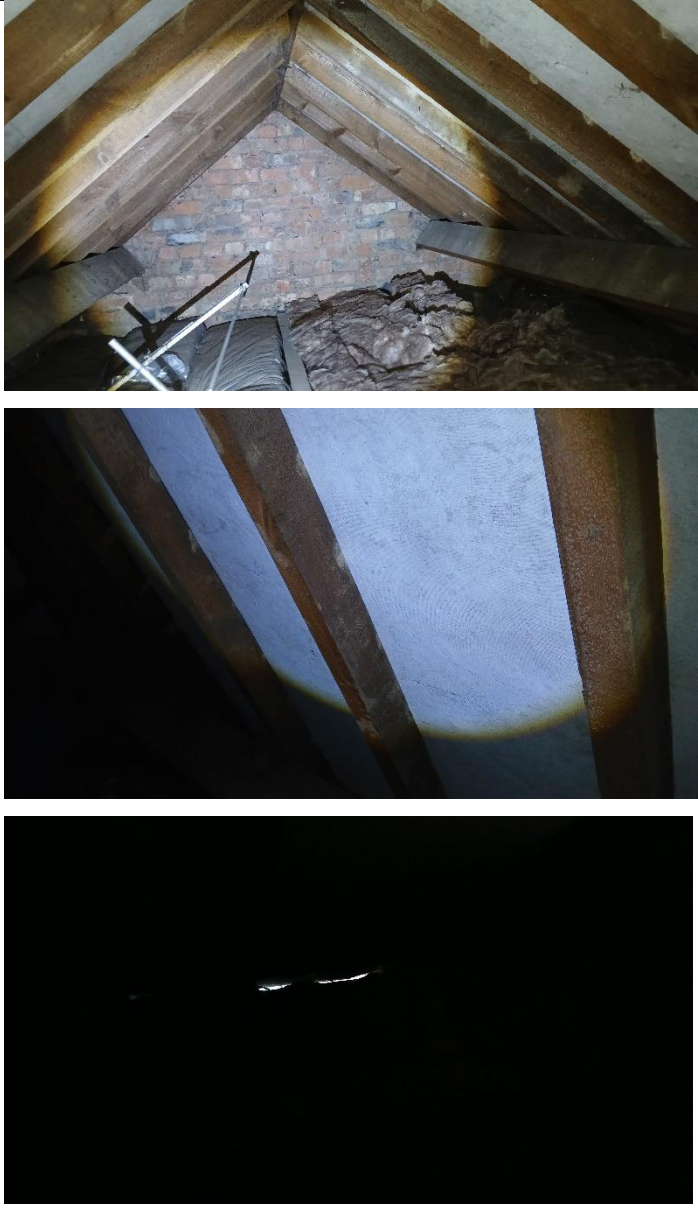
| Internal Void | Timber rafters and beams. Roof lining in some areas. | <p>Temp: 10.4oc<br/>Humidity: 57.7%<br/>Internal dimensions: 9m x 4m x 2.5m (L x W x H)</p> <p>The central void has exposed internal timbers with a felt lining. The internal timbers are in good condition with no cracks or breaks. The lining is also in good condition with no damage. Light ingress can be seen at the eaves.</p> | <p>The internal void provides points of ingress, and roosting opportunities for bats. The area was searched for evidence of bats, but nothing was found.</p> | |

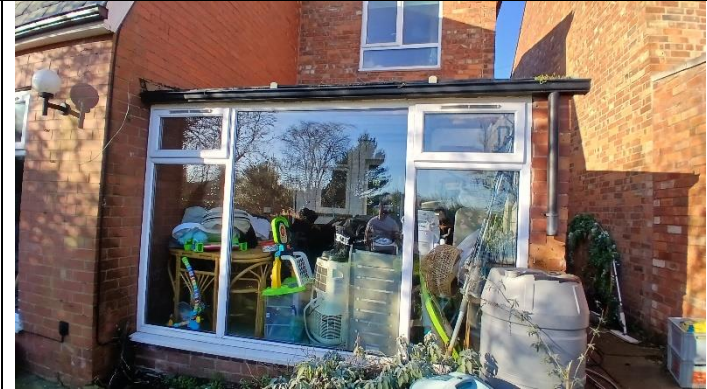
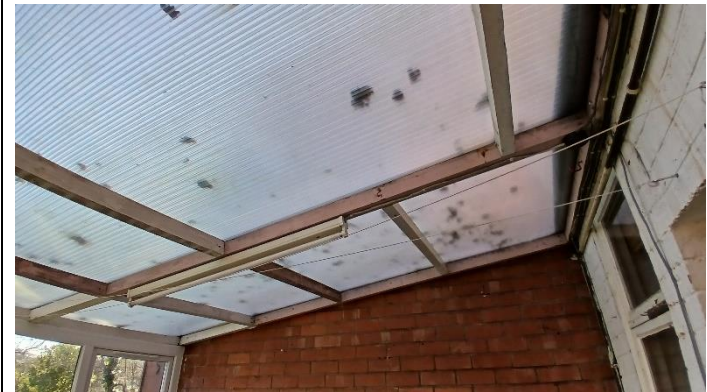
**B1b**

B1b is a small sunroom on the eastern elevation of B1a. B1b is brick and mortar in construction, with a corrugated plastic roof. There are no external roosting features on B1b. There is no separate internal void, and the area is unsuitable for roosting bats due to high light levels and lack of roosting opportunities.

The habitat value of B1b is **Negligible**.
