**FROG HALL FARM**

**SHEEPY MAGNA, CV9 2QX**

**STRUCTURAL REPORT  
ON  
STEEL FRAMED BARNs**

Structural Calculations

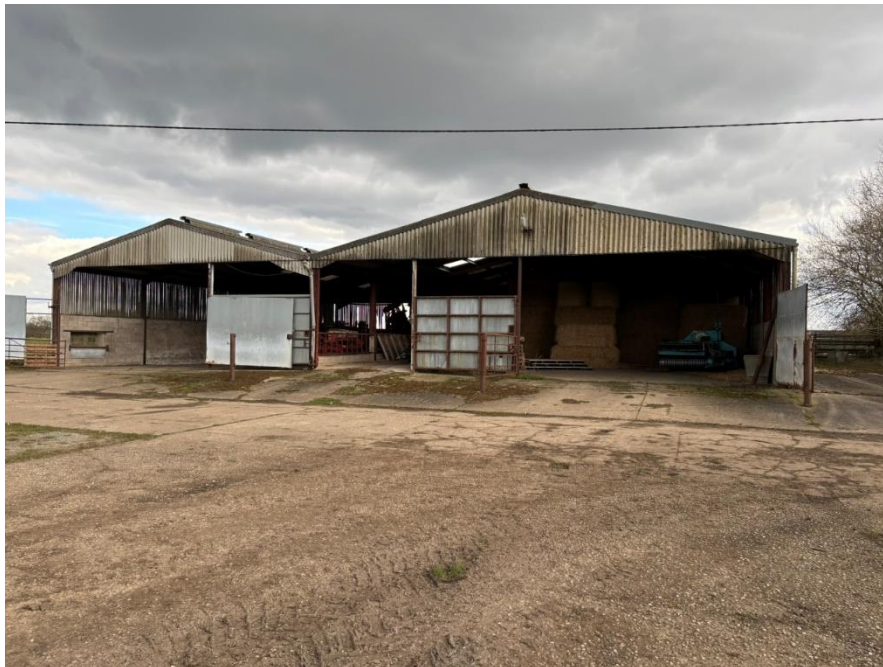
There are two parallel ridges, and a centre valley, all orientated E-W. The front of the barn (as shown on the cover of this report) is open and faces west.

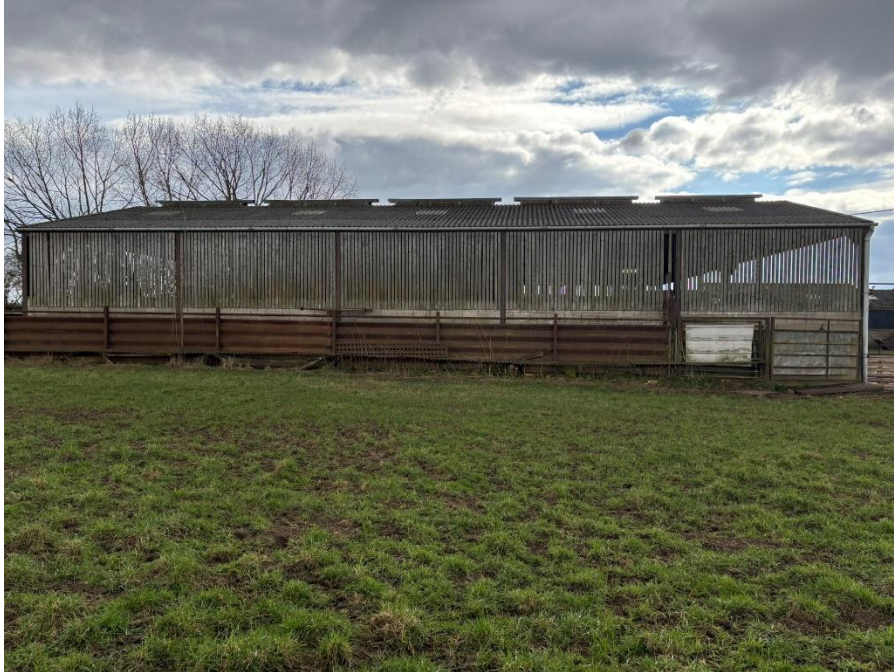
**Barn 1 North Elevation**

External walls are clad in concrete blockwork at low level and timber boarding above.

The cladding is showing signs of age but there is no evidence of structural movement or deficiency.

The barn walls stand plumb and there is no evidence of foundation movement.

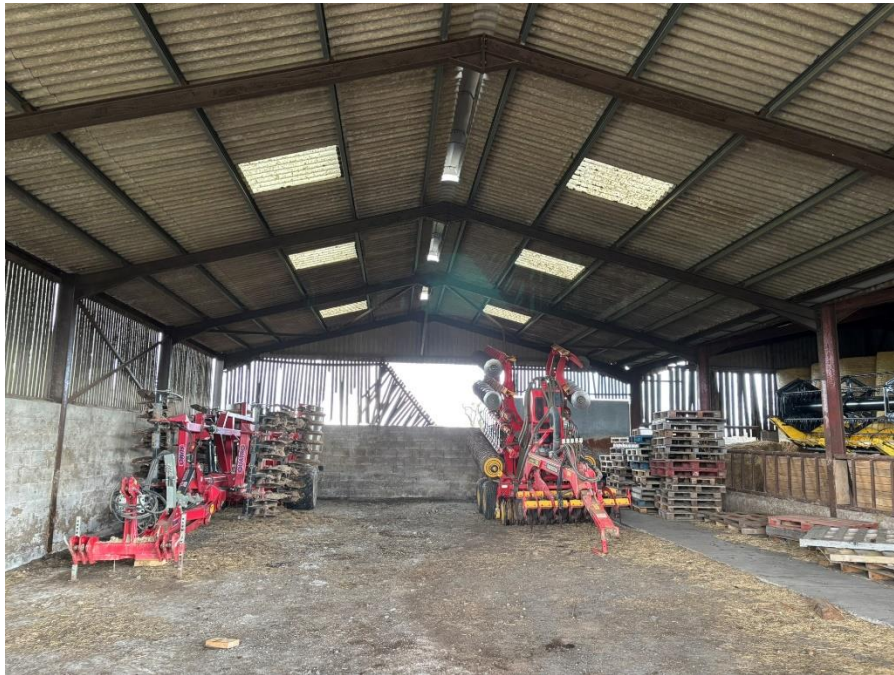
**Barn 1 Interior Looking East**

The steel portal frames in the older (south) part consist of:

- 203x133UB25 Principal Rafters
- 254x146UB31 Stanchions
- Haunched eaves and ridge connections

There is a steel tie bar running between the eaves haunches with a central anti-sag hanger from the ridge.

The corrugated cement sheet roof is supported on steel purlins at about 1.25m centres.

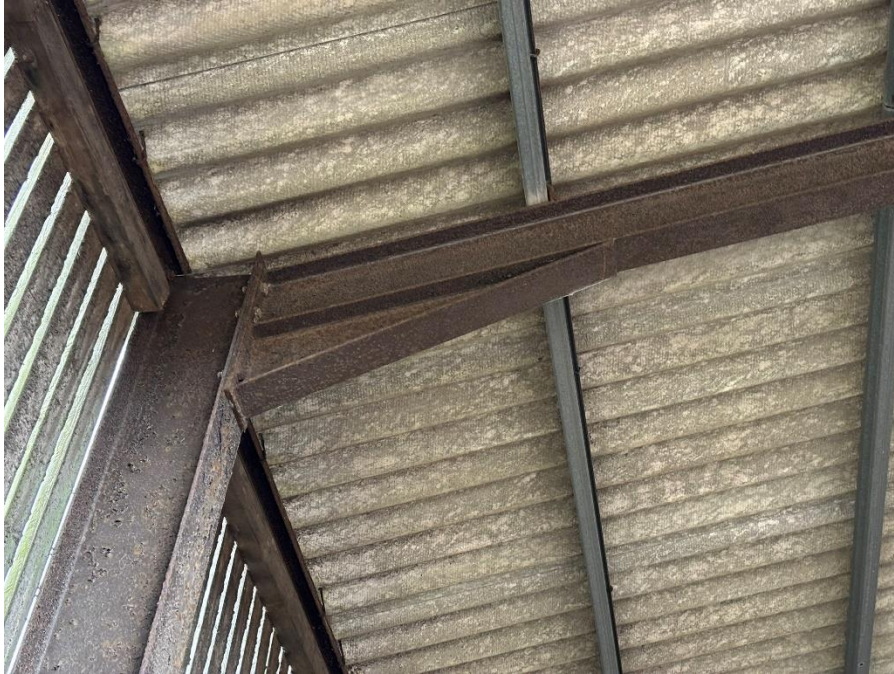
**Barn 1 Eaves Haunch**

The steelwork is affected by surface corrosion, but not to any significant degree structurally.

Steel stanchions and rafters are affected by surface rust and would benefit from a thorough wire brushing and treatment with an effective primer, but this is not an urgent requirement.

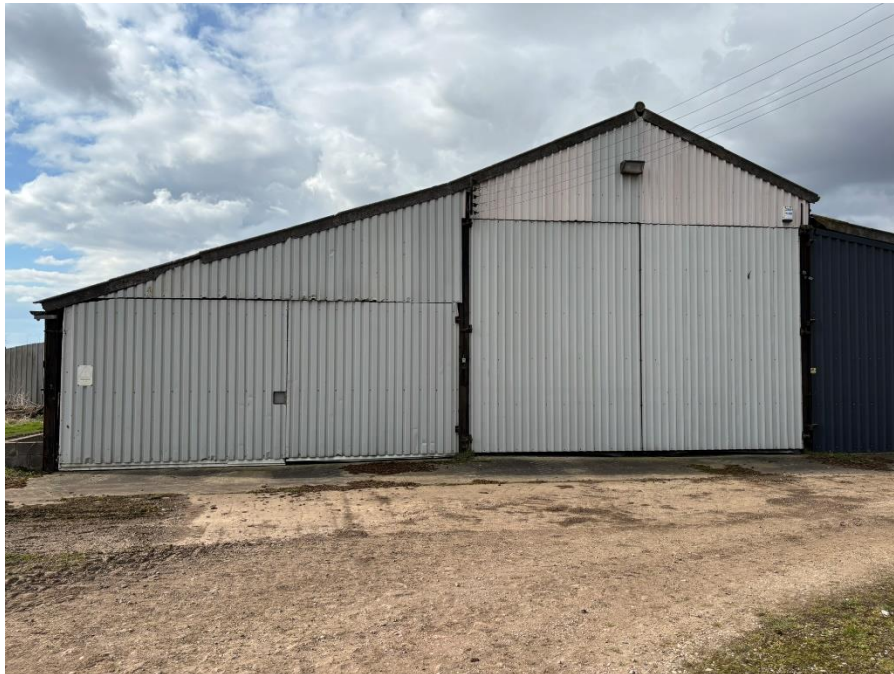
**Barn 2 East Elevation**

External walls are clad in a mixture of concrete blockwork at low level, timber boarding and metal sheeting. At the west end of the lean-to there is a brick wall which may pre-date the steel buildings.

The cladding is showing signs of age but there is no evidence of structural movement or deficiency.

The barn walls stand plumb and there is no evidence of foundation movement.

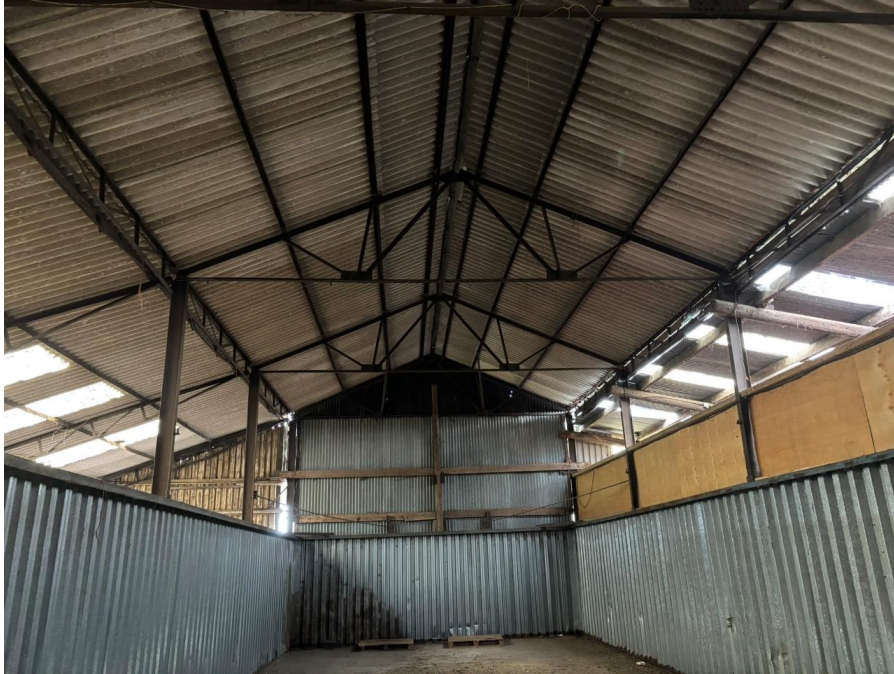
**Barn 2 Main Frame Interior**

In the double pitched section, the lattice trusses are of fully welded steel angles, fabricated from 50x50L section.

These have been well designed and fabricated and are intrinsically strong and efficient structural elements.

The frames meet the stanchions with moment connections that give stability to the structure as a whole.

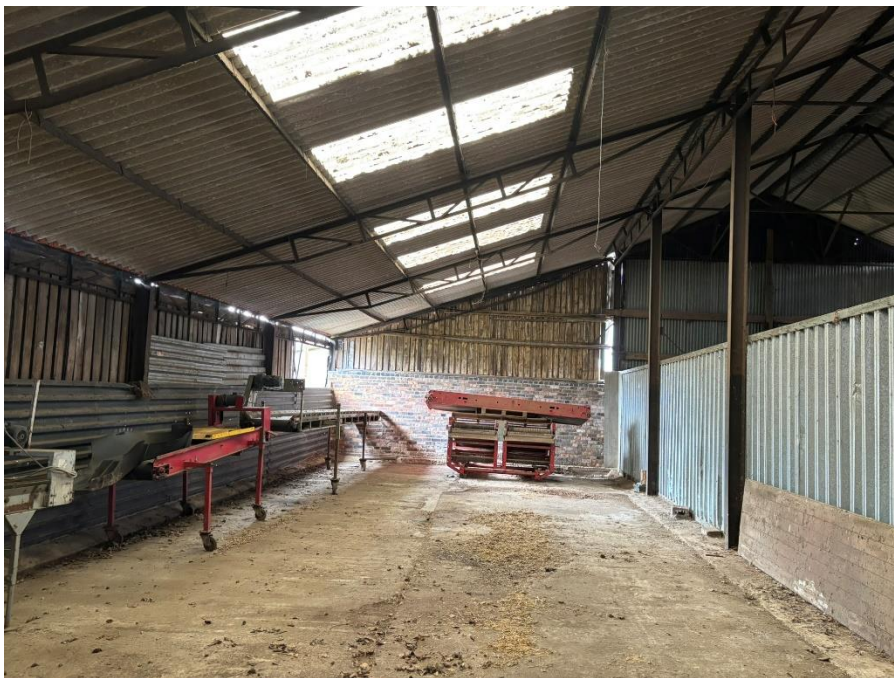
**Barn 2 Lean-to Interior**

In the lean-to the lattice trusses have parallel top and bottom chords, made from the same angle sections.

The corrugated cement sheet roof is supported on steel L purlins at about 1.4m centres.

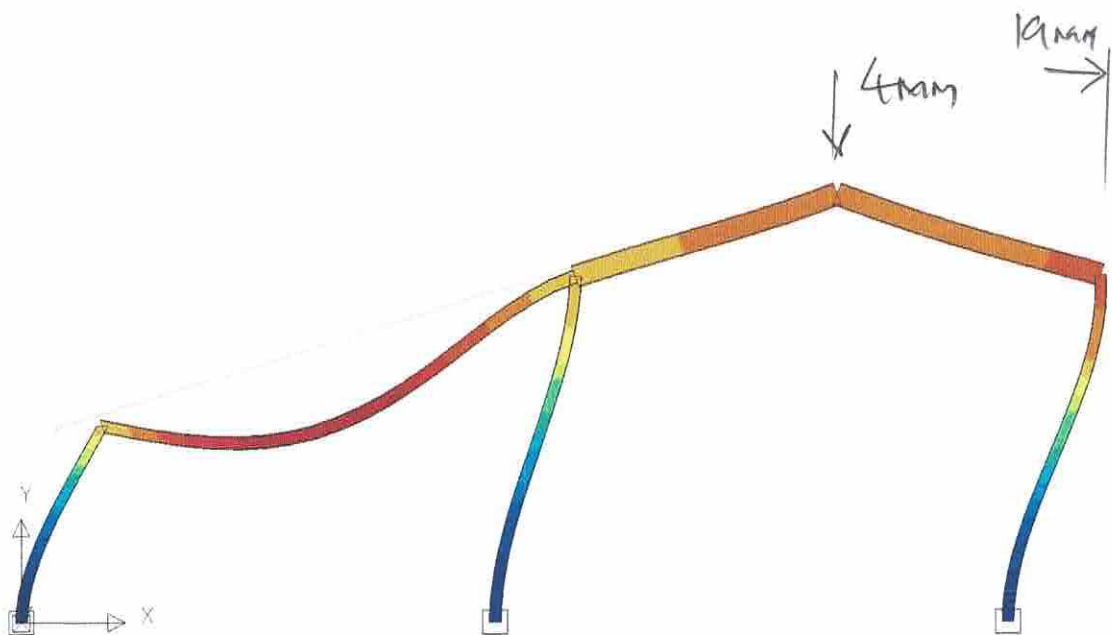
Displaced Shape, displacements magnified 73 times.
