Geotechnical &  
Environmental  
Consultants

Hinckley West  
Leicestershire

**Phase II Exploratory Investigation Report  
For  
Bloor Homes Midlands**

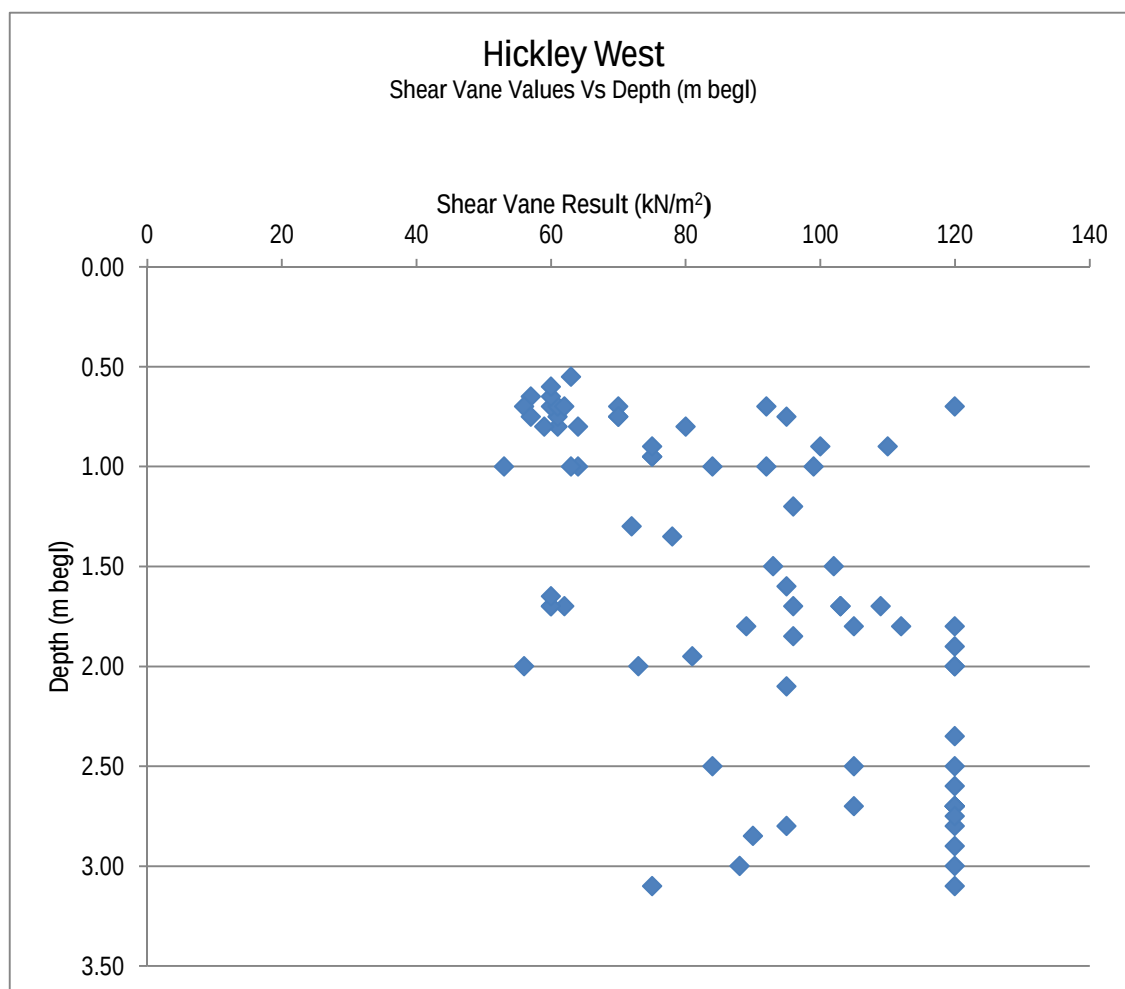
It should be noted that shear vane testing undertaken at depths greater than 1.00m was carried out ex-situ for health and safety reasons.

A graph showing shear vane results in relation to depth is presented on the next page.

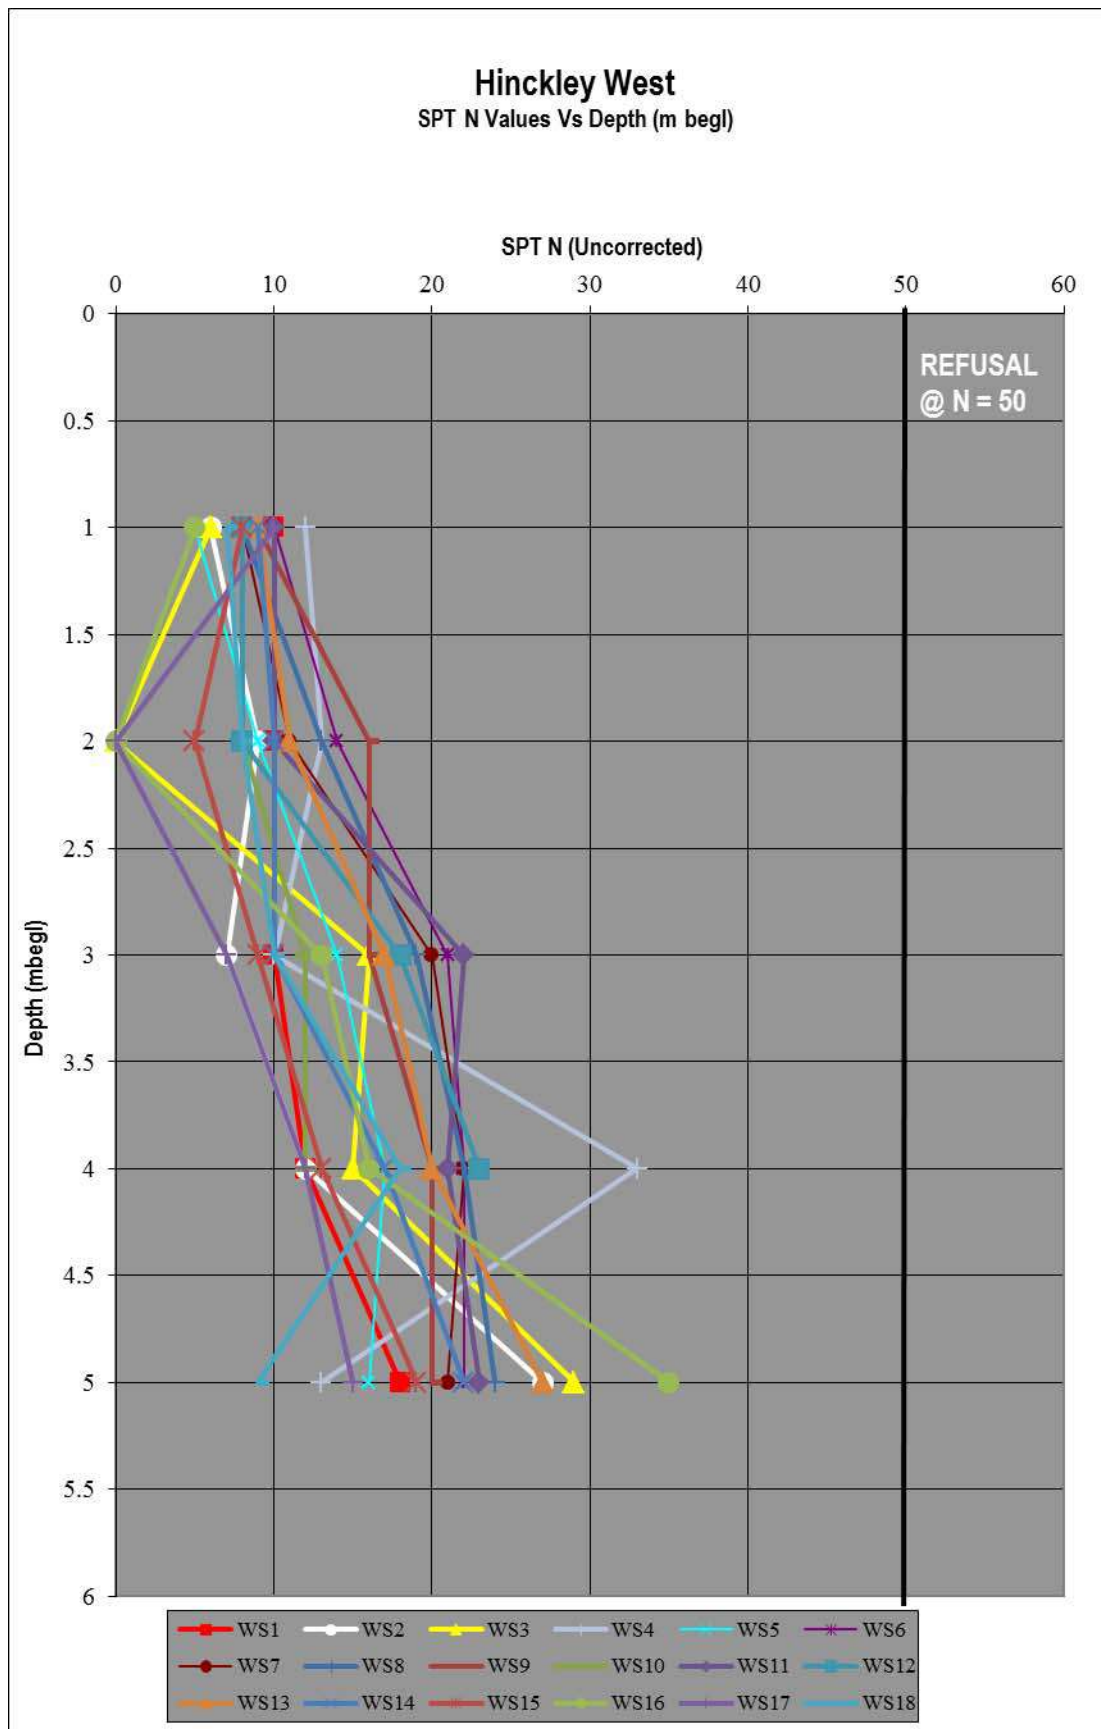
### 3.7 Standard Penetration Test (SPT) Results

The results show the SPT 'N' values to generally increase with greater depth and are recorded on the logs in Appendix V

An SPT Vs Depth Chart of the data obtained from the boreholes advanced at the site is shown on the next page.

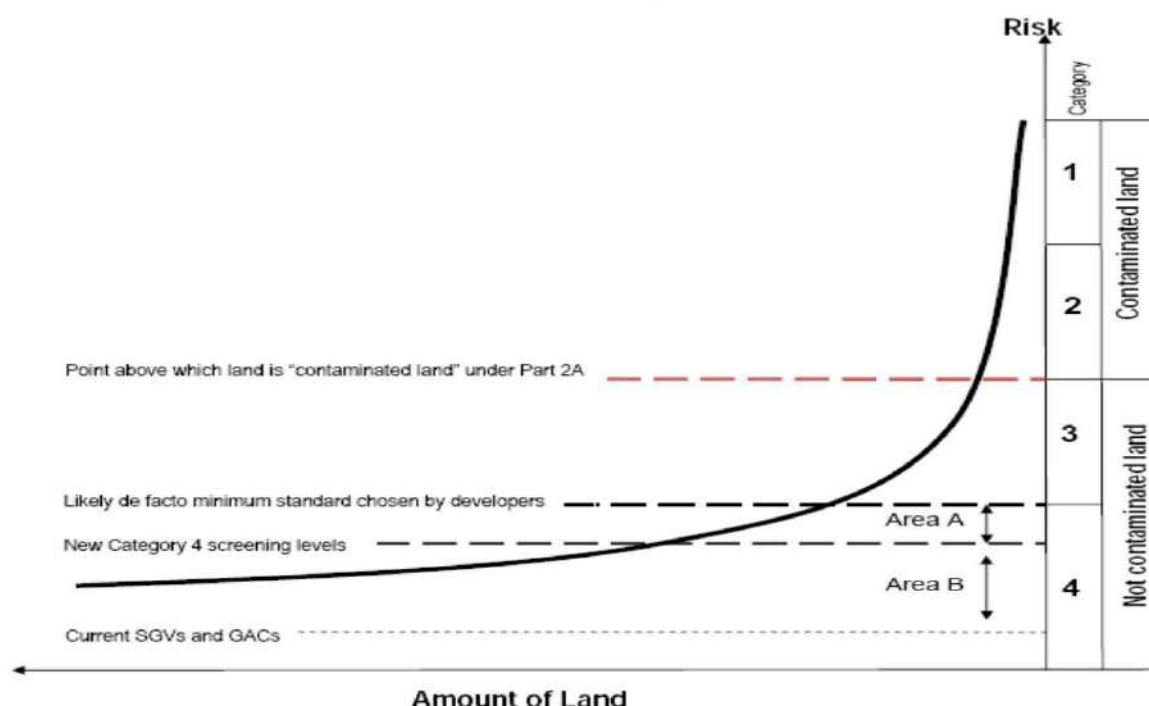
The foregoing categories are depicted in diagrammatical form in the following graph (taken from Defra publication SP1010):

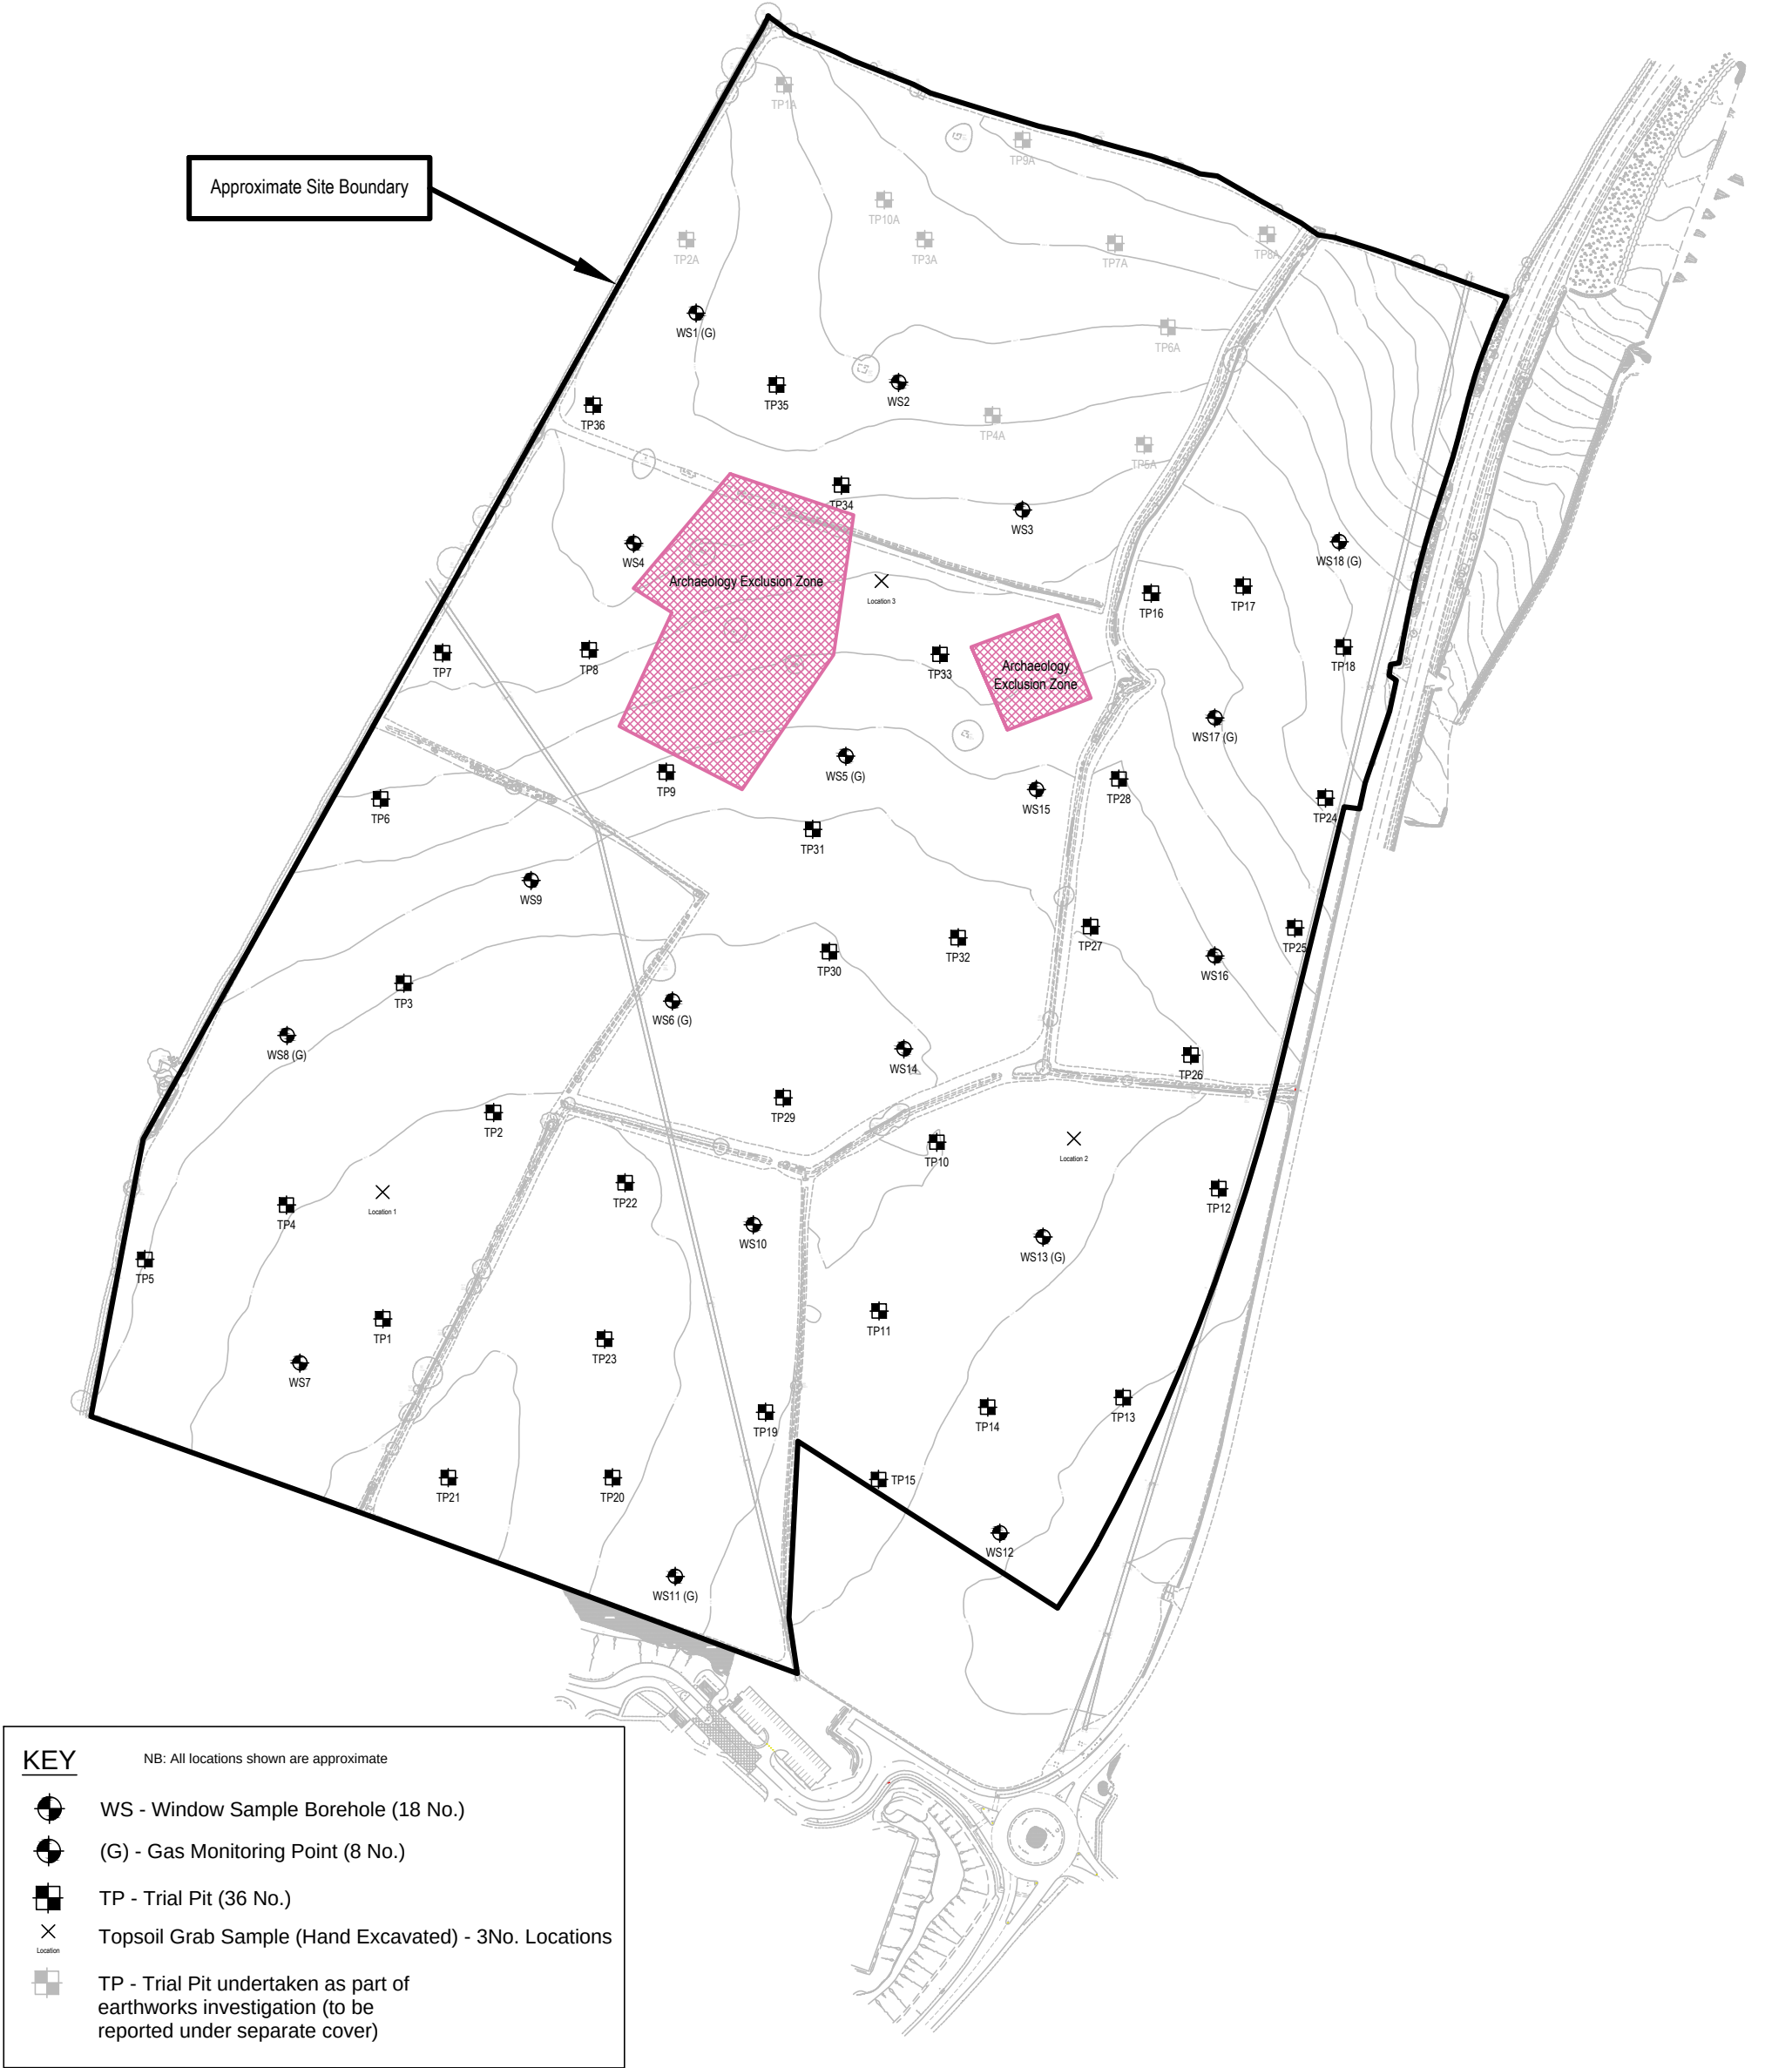
**Exploratory Hole Location Plan & GPS Co-ordinates  
(Figure No. D36147/04)**

The approximate locations of the exploratory holes are shown on the plan presented in Appendix IV (Figure No. D36147/04). Exploratory hole locations were positioned using a hand held GeoExplorer 5T GPS, with a claimed sub-metre accuracy of approximately 1m; accuracy subject to satellite coverage, line of-sight conditions etc. The GPS coordinates are presented on a separate sheet in Appendix IV. The exploratory hole logs are presented in Appendix V of this report.

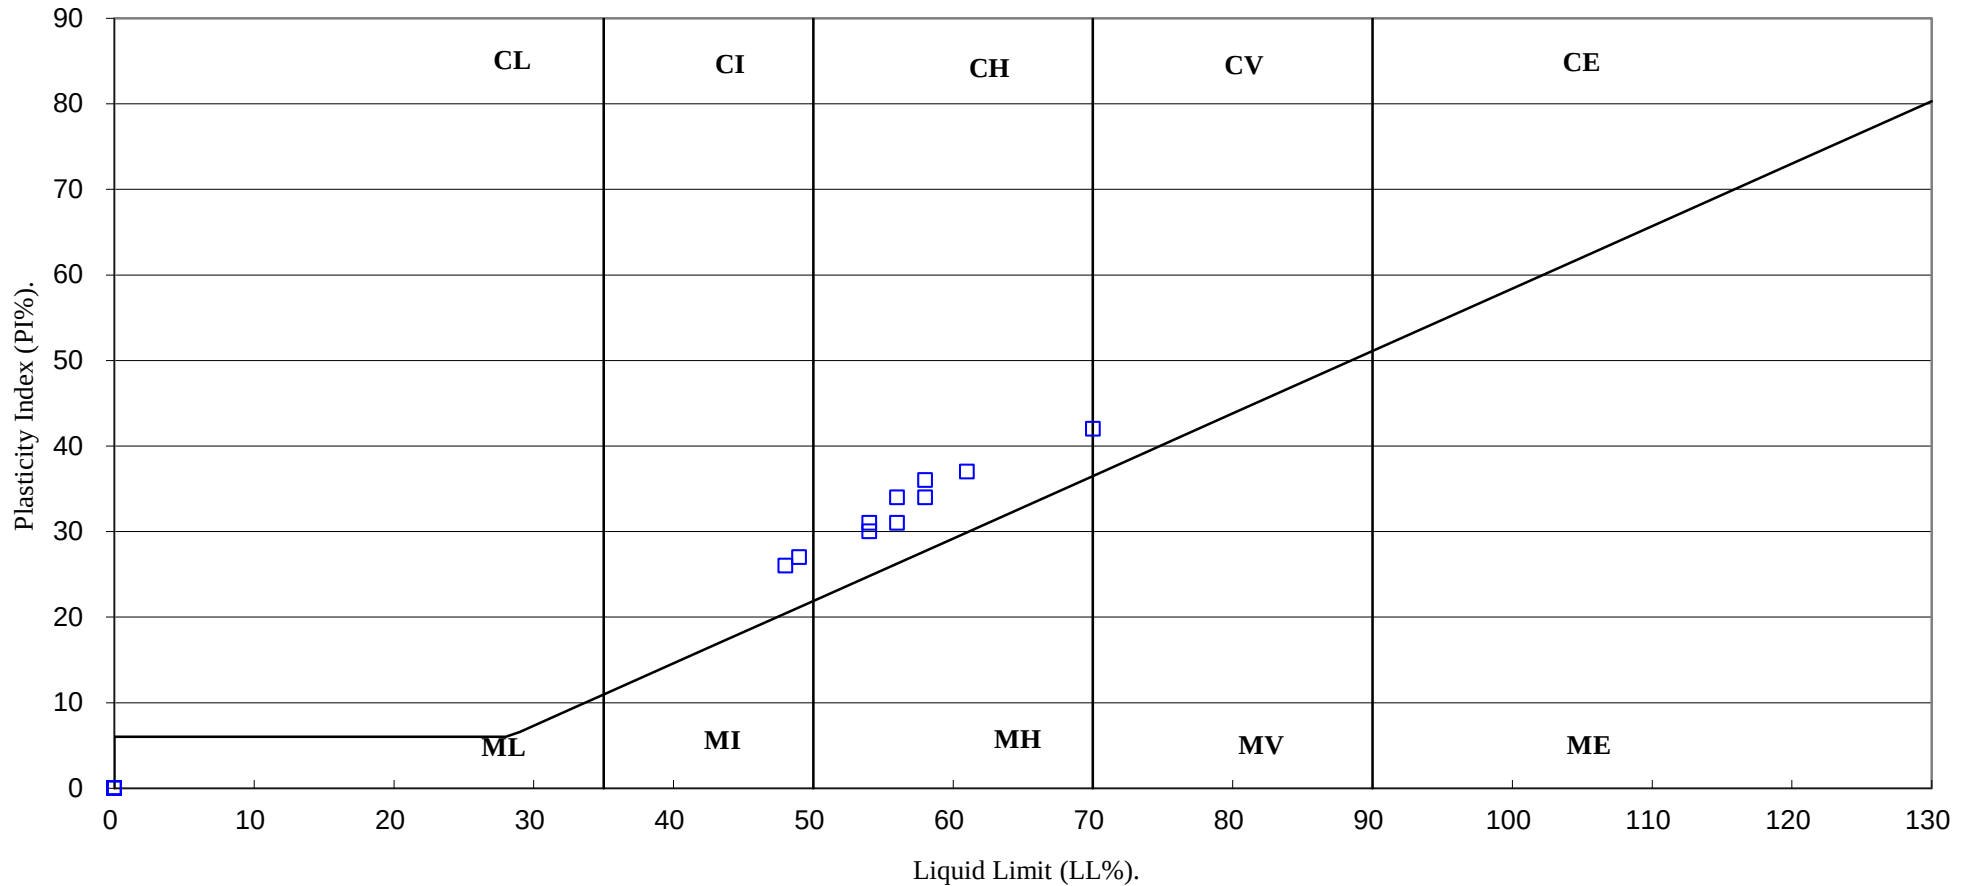
# PLASTICITY CHART FOR CASAGRANDE CLASSIFICATION.

In accordance with NHBC and BRE Guidance, Table 2 reveals that the visually cohesive soils analysed (i.e. Clay) may be generally regarded as being of medium volume change potential. The one sample analysed which reported a high volume change potential relates to an exploratory hole location within the field towards the southwest corner of the site. We would recommend that soils of high volume change potential are assumed for design purposes in this field, and that soils of medium volume change potential are assumed for design purposes across the wider site area. The analysis of the two Silt samples confirmed these soils to be non-plastic (i.e. they exhibit no significant volume change potential).

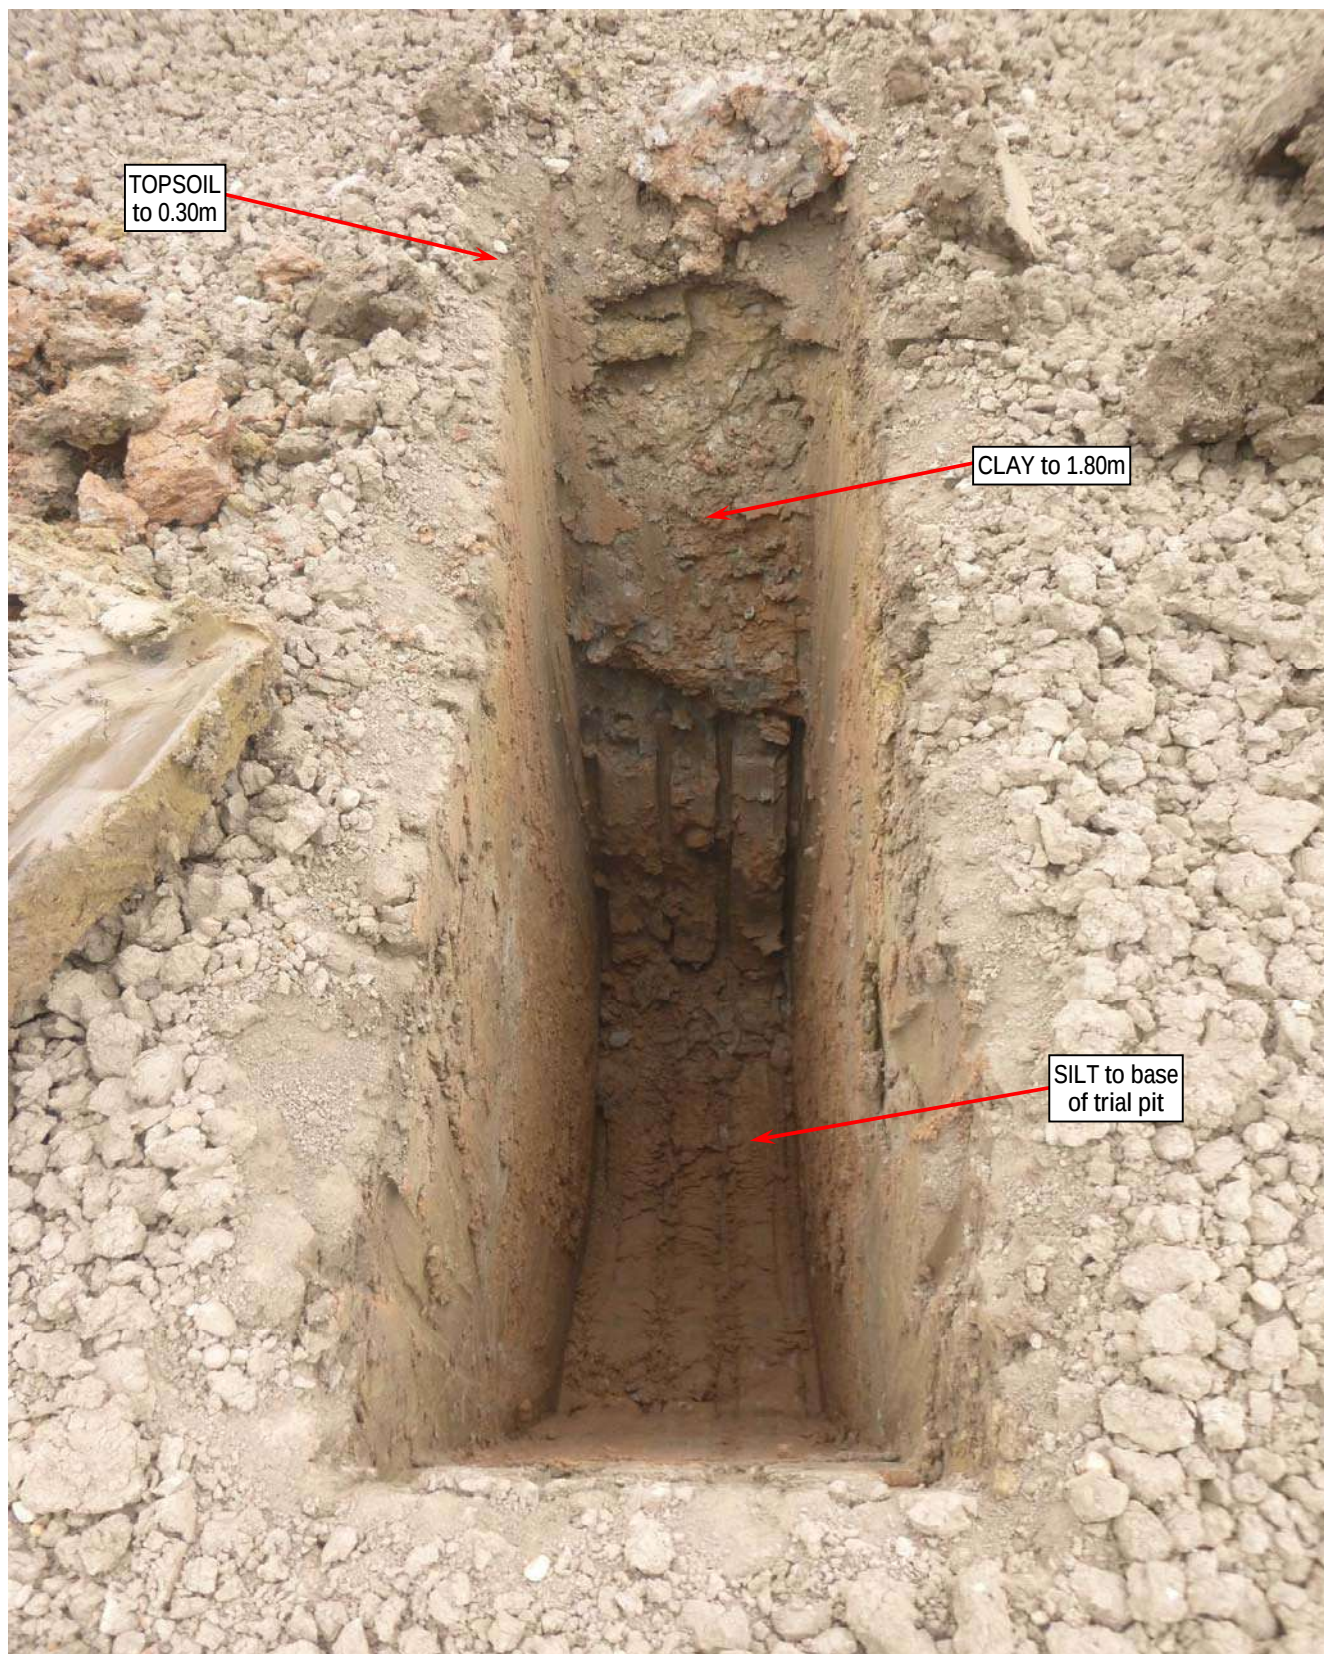
| Title | Completed Excavation (TP1) | Rev. | |

The sides of the trial pits were noted to remain generally stable during their excavation and for the short period of time they remained open following completion.

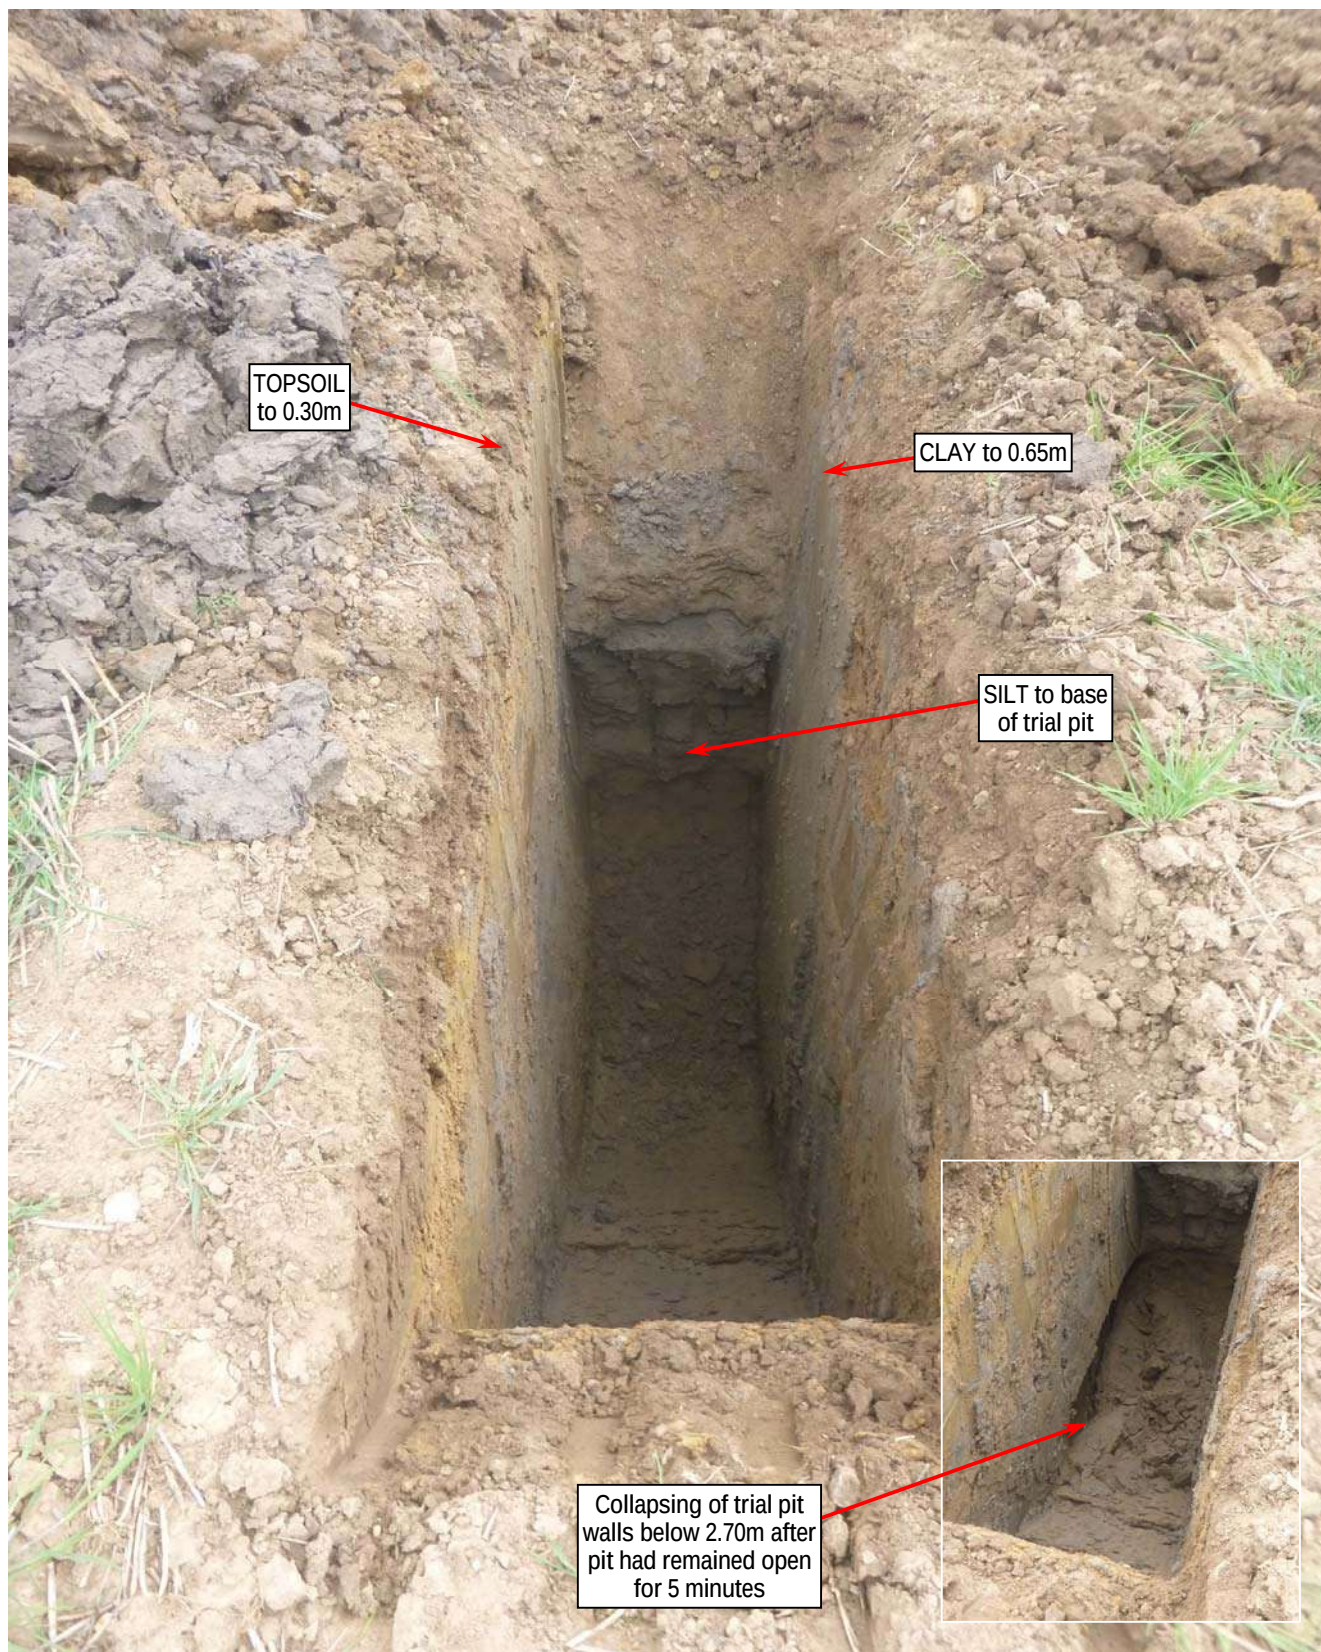
| Title | Completed Excavation (TP18) | Plate No. | 4 |

Collapsing of trial pit walls was only recorded in four locations, each time during excavations within the natural Silt strata. In TP18 and TP36 collapsing of the pit walls occurred after the pits had remained open for five minutes. Collapsing was recorded below a depth of 2.70m begl in TP18, and from between 1.50m and 2.80m begl in TP36. In TP18 the collapsing caused the undermining of shallower strata. In TP33 and TP35 collapsing occurred as the pits were being excavated; collapsing was recorded at depths in excess of 2.30m begl and in both cases caused the undermining of shallower strata. In TP18, TP33 and TP35, the collapsing appeared to be associated with groundwater seepages.

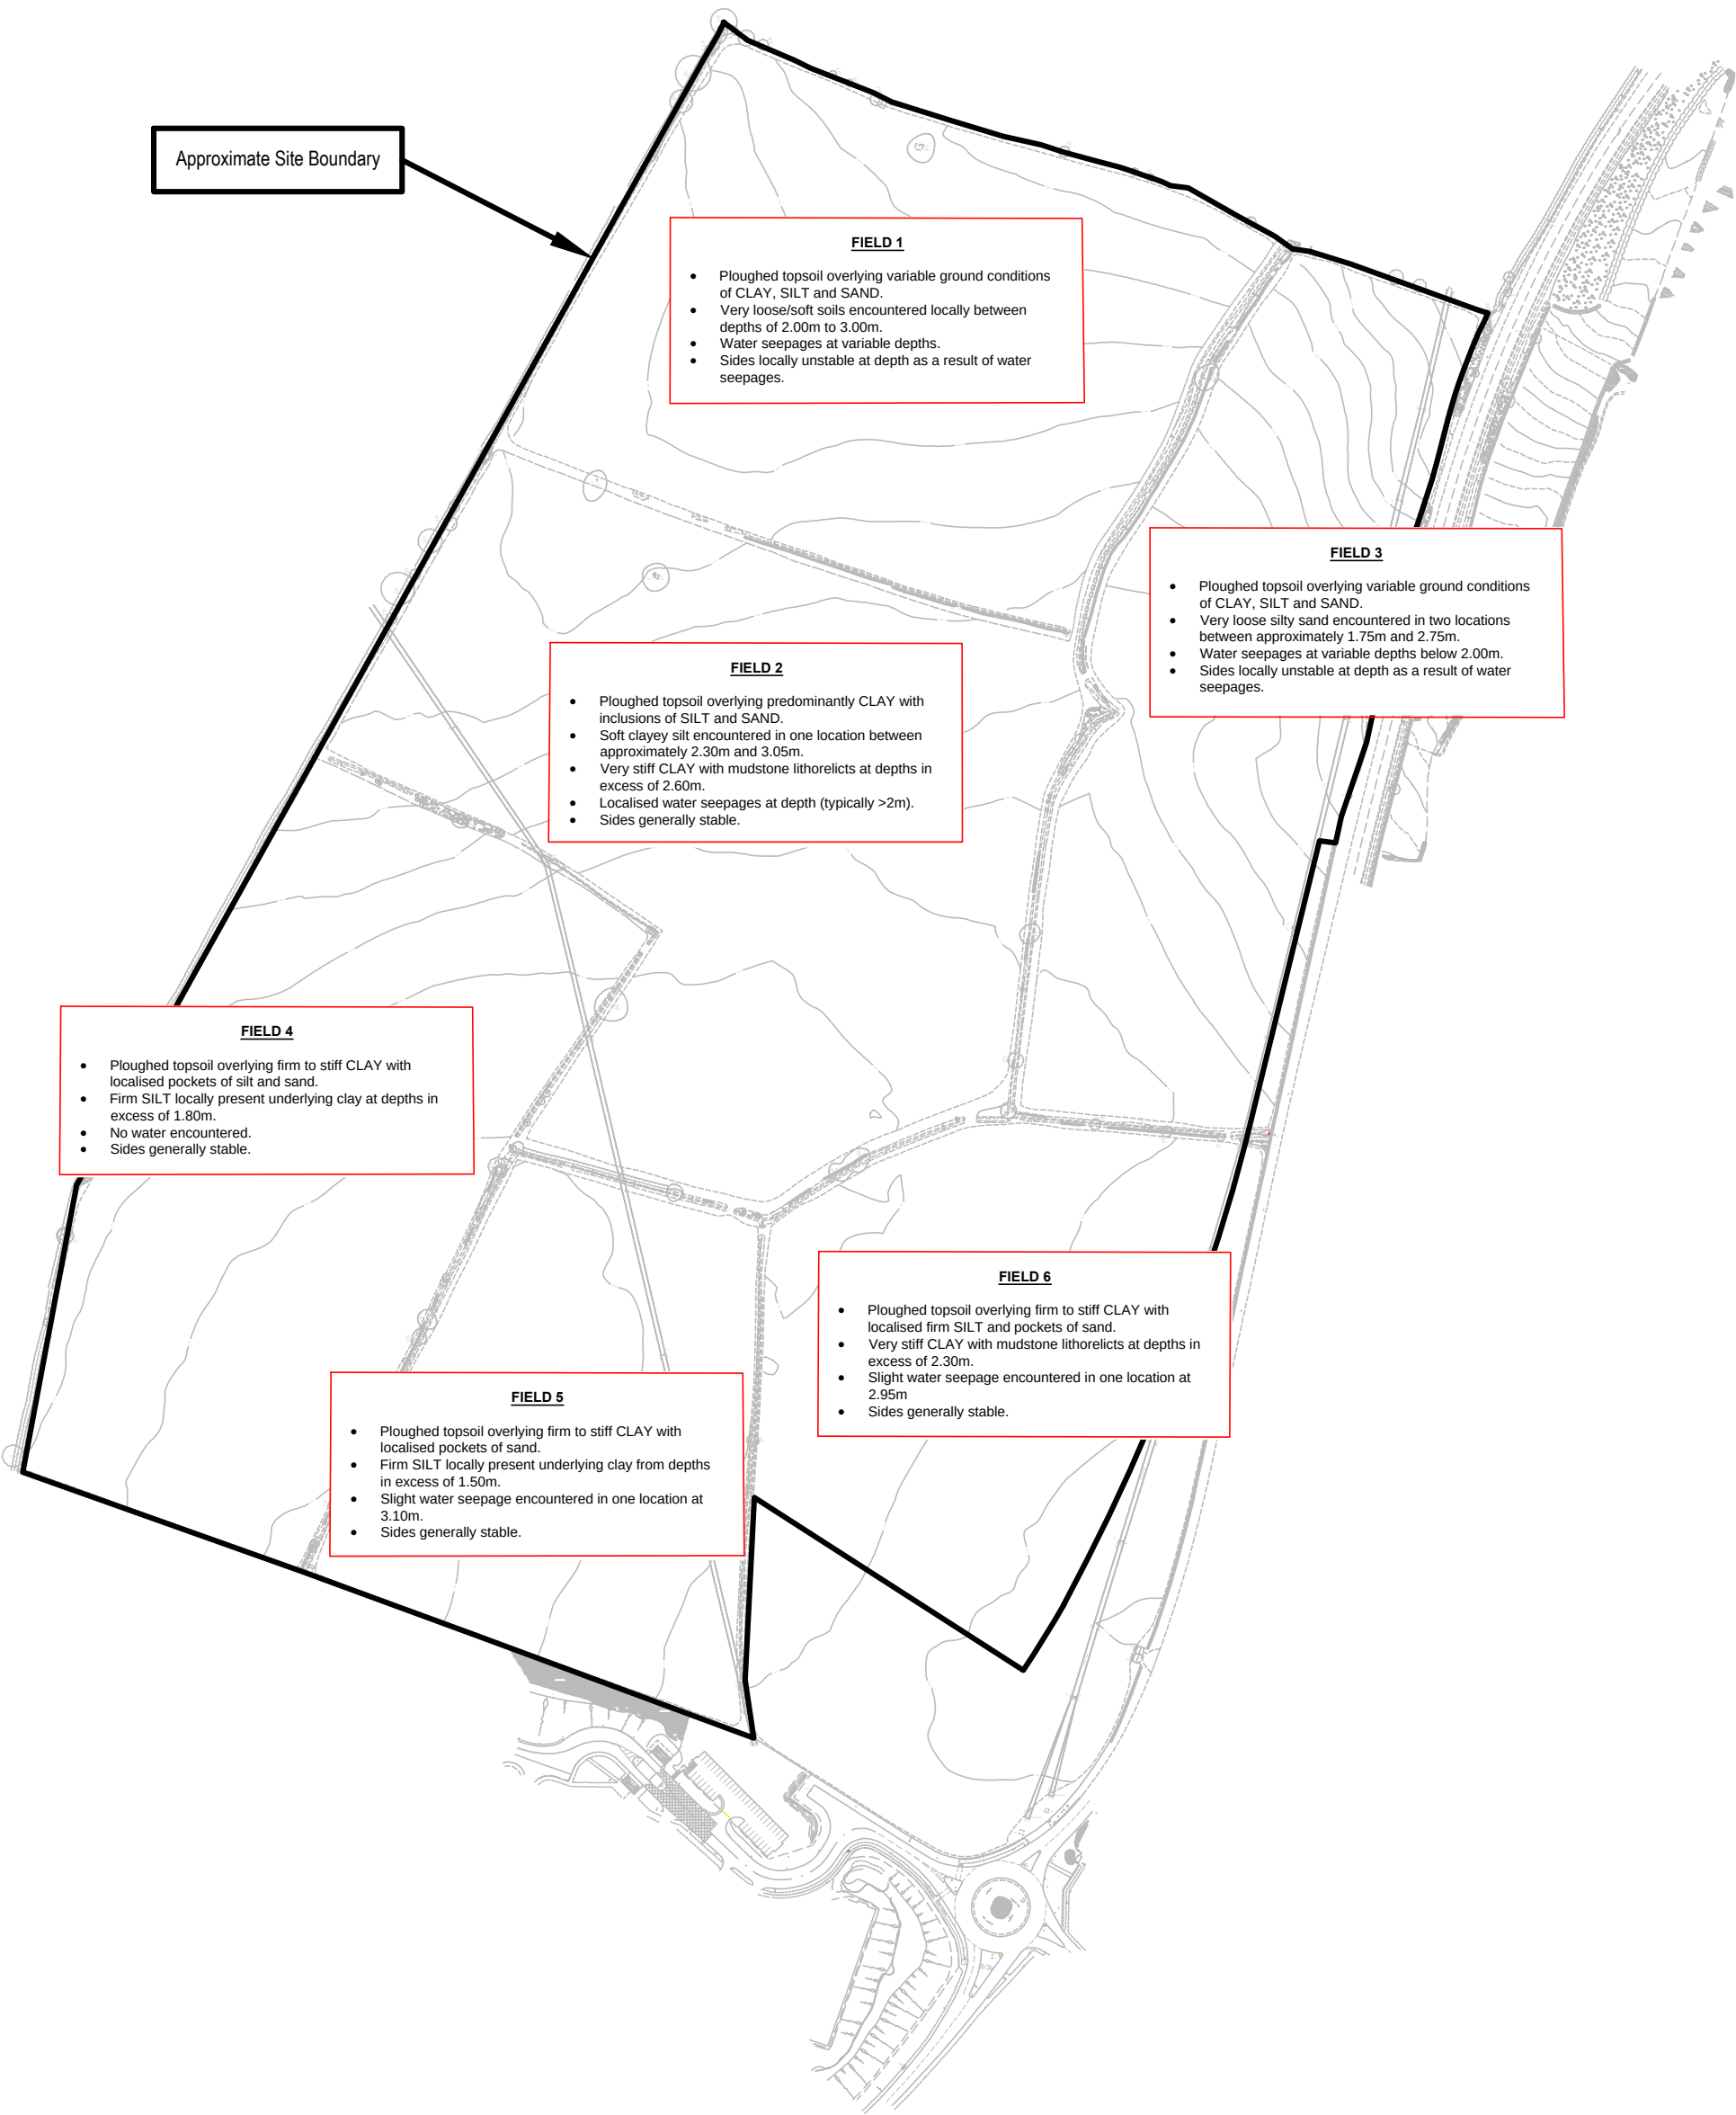
**Ground Conditions Plan  
(Figure No. D36147/06)**

| Ground Conditions | Reference should be made to the Ground Conditions Plan (Figure No. D36147/06), which is presented in Appendix XI of this report and summarises the ground conditions on a field by field basis. |

Reference should be made to the Ground Conditions Plan (Figure No. D36147/06), which is presented in Appendix XI of this report and summarises the ground conditions on a field by field basis.

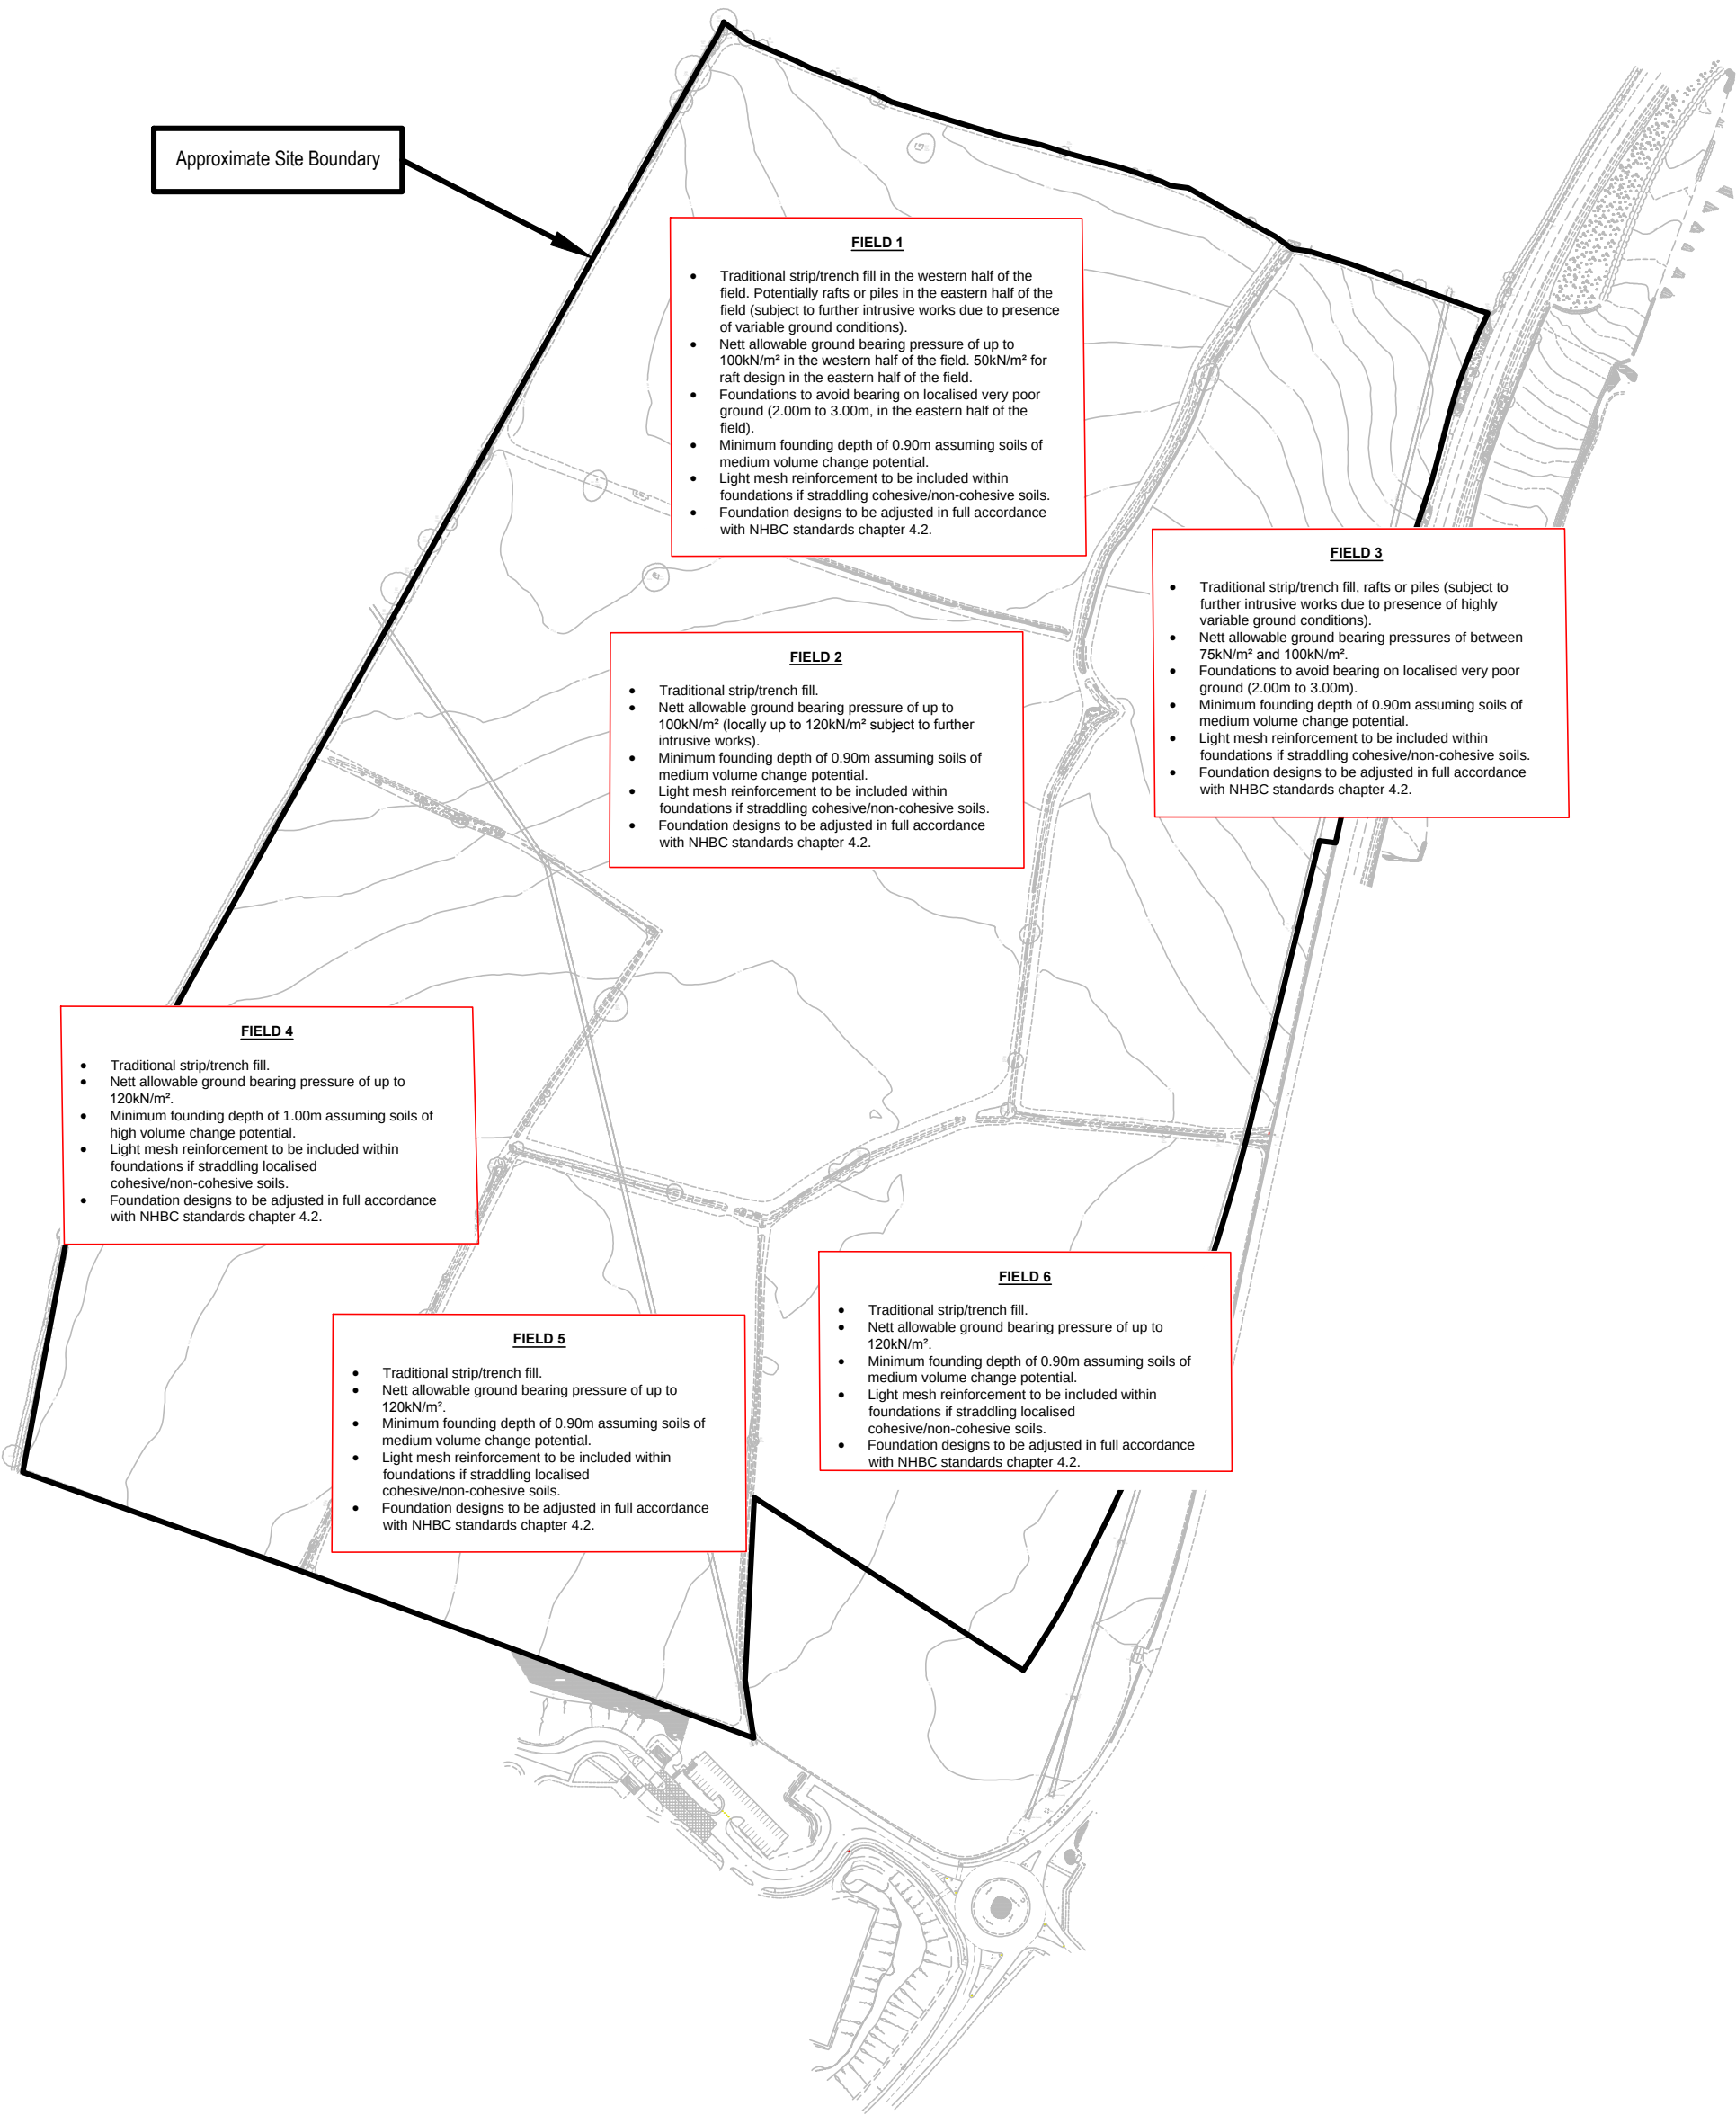
**Foundation Summary Plan  
(Figure No. D36147/07)**

| Foundation Design | A Foundation Summary Plan (Figure No. D36147/07), which summarises the foundation recommendations on a field by field basis, is presented in Appendix XII. |

The following foundation design recommendations comprise general advice for the entire site area. Based on the large size of the site (approximately 45Ha), a prudent developer may wish to commission parcel specific trial pitting and reports once the layout/development proposals, including levels, have been confirmed. In addition to the advice given below, a Foundation Summary Plan (Figure No. D36147/07), which summarises the foundation recommendations on a field by field basis, is presented in Appendix XII.

Foundations within cohesive soils may require localised deepening due to the influence of trees and hedgerows.
