Project Mira Technology Park

Title Cut & Fill Part 1 of 2

## **Factual Geotechnical Investigation Report**

**Reference: 20188/FGIR Rev1.0**

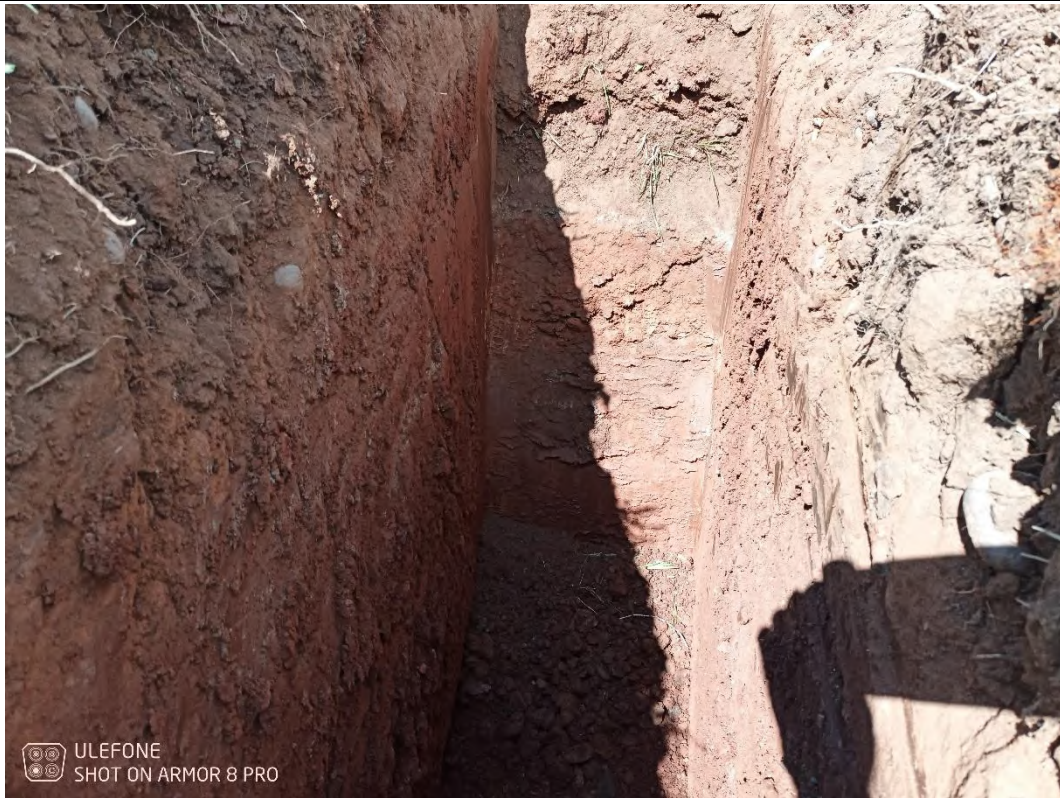
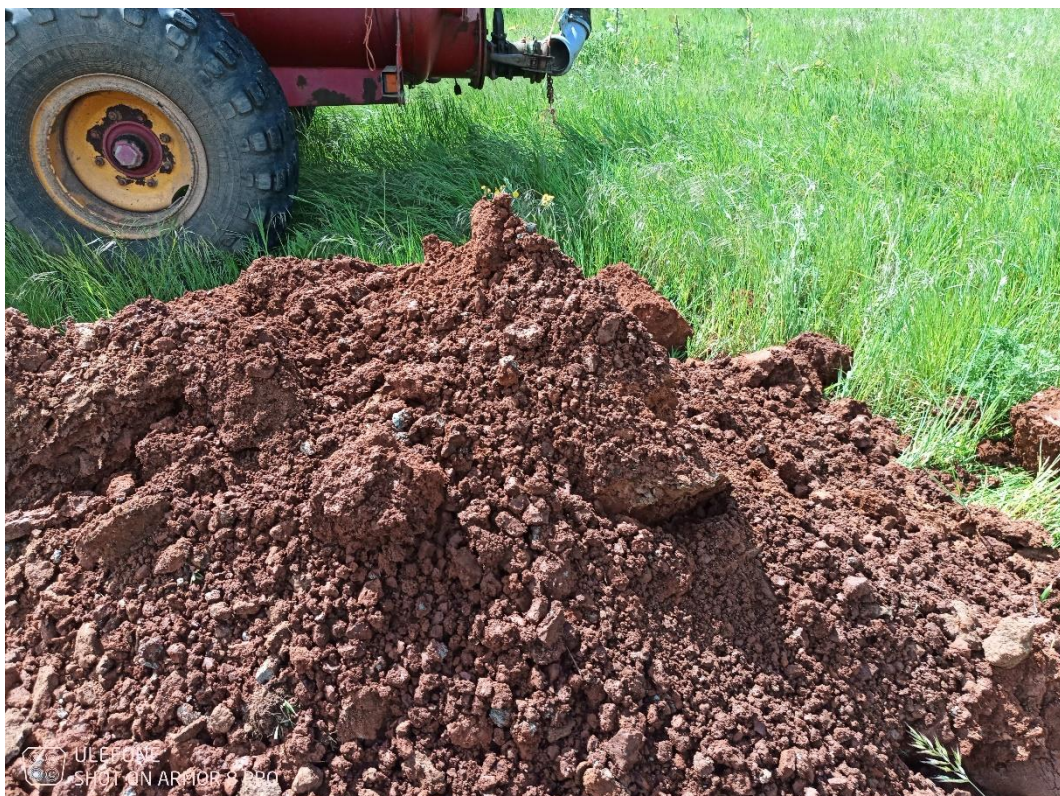
**Trial Pit Photographic Log**

| <b>Hole No:</b> SA1 | <b>Project:</b> MIRA, Nuneaton<br><b>Project No:</b> 20188<br><b>Date of Excavation:</b> 24/05/22<br><b>Location Coordinates:</b> 436584.531, 295401.981<br><b>Termination Depth:</b> 1.50m<br><b>Method:</b> Machine excavation |

Infiltration testing was undertaken in SA1, SA2, SA4 and SA6A following the principles of BRE Digest 365 Soakaway design: 1991. BRE 365 states that for an accurate infiltration rate to be obtained a soakage pit needs to be filled three times in quick succession. Each test can only be ended once 75% of the water present has drained away.

A single test was carried out at each location, with insufficient soakage recorded to allow calculation of an infiltration rate. The infiltration test data for each location is presented in Appendix C.2.

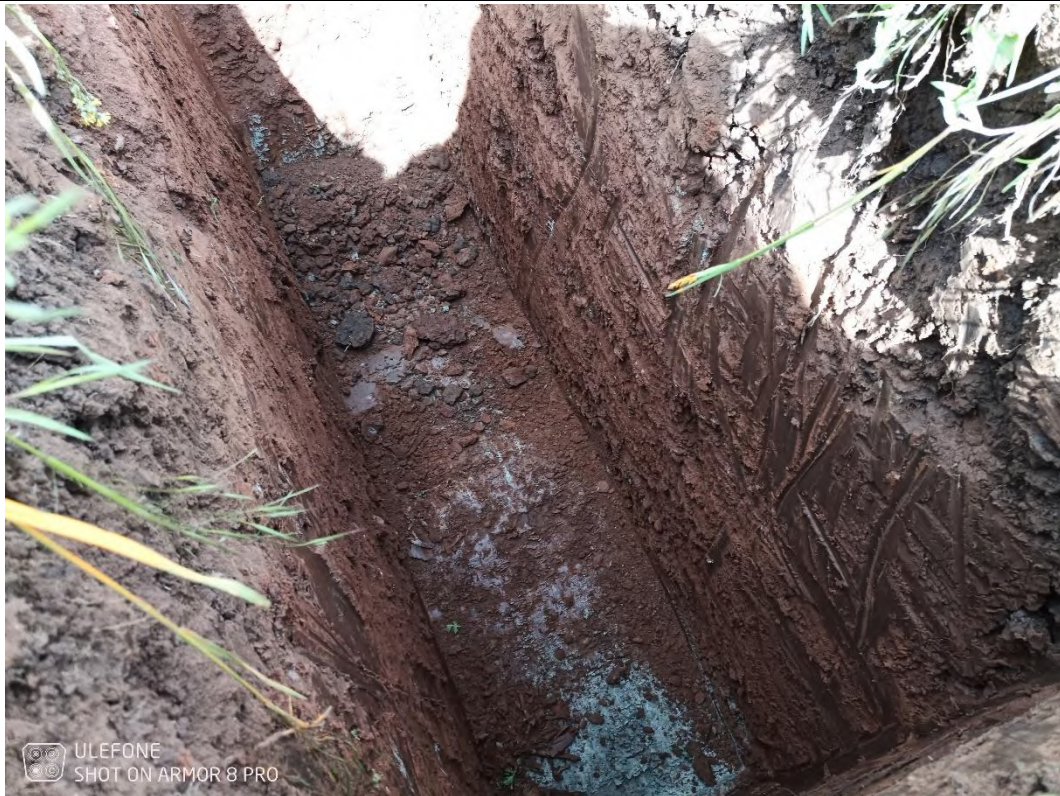
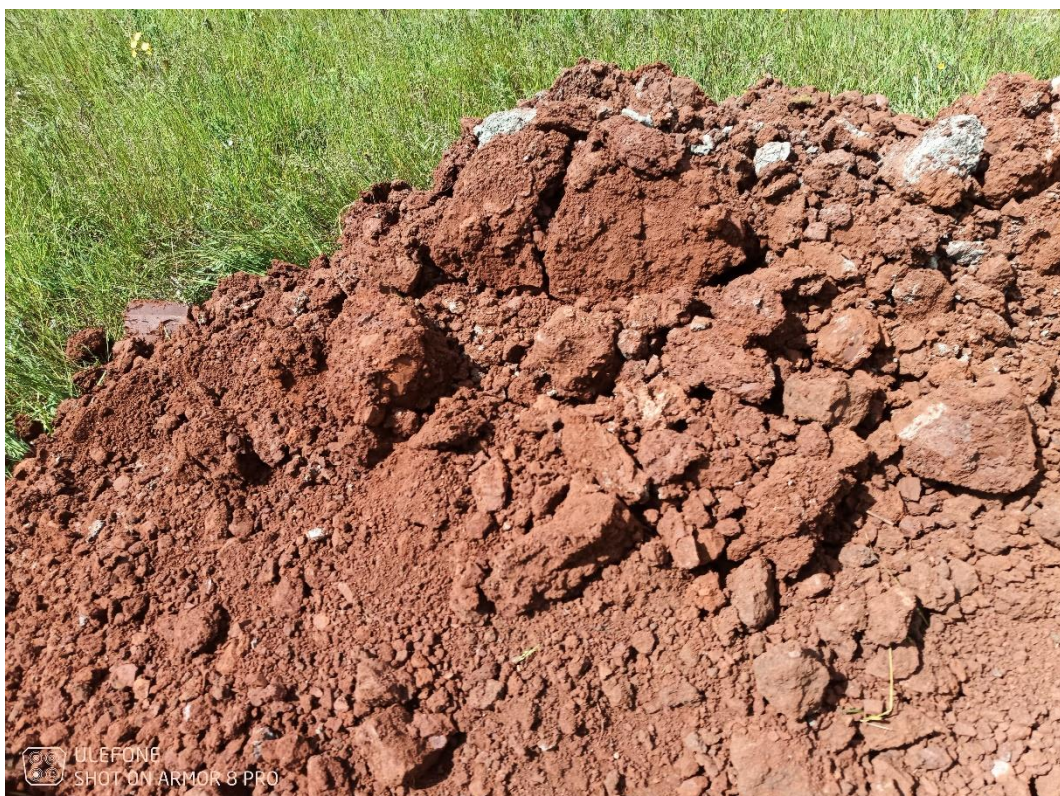
**Trial Pit Photographic Log**

| <b>Hole No:</b> SA2 | <b>Project:</b> MIRA, Nuneaton<br><b>Project No:</b> 20188<br><b>Date of Excavation:</b> 24/05/22<br><b>Location Coordinates:</b> 436495.680, 295469.828<br><b>Termination Depth:</b> 1.50m<br><b>Method:</b> Machine excavation |

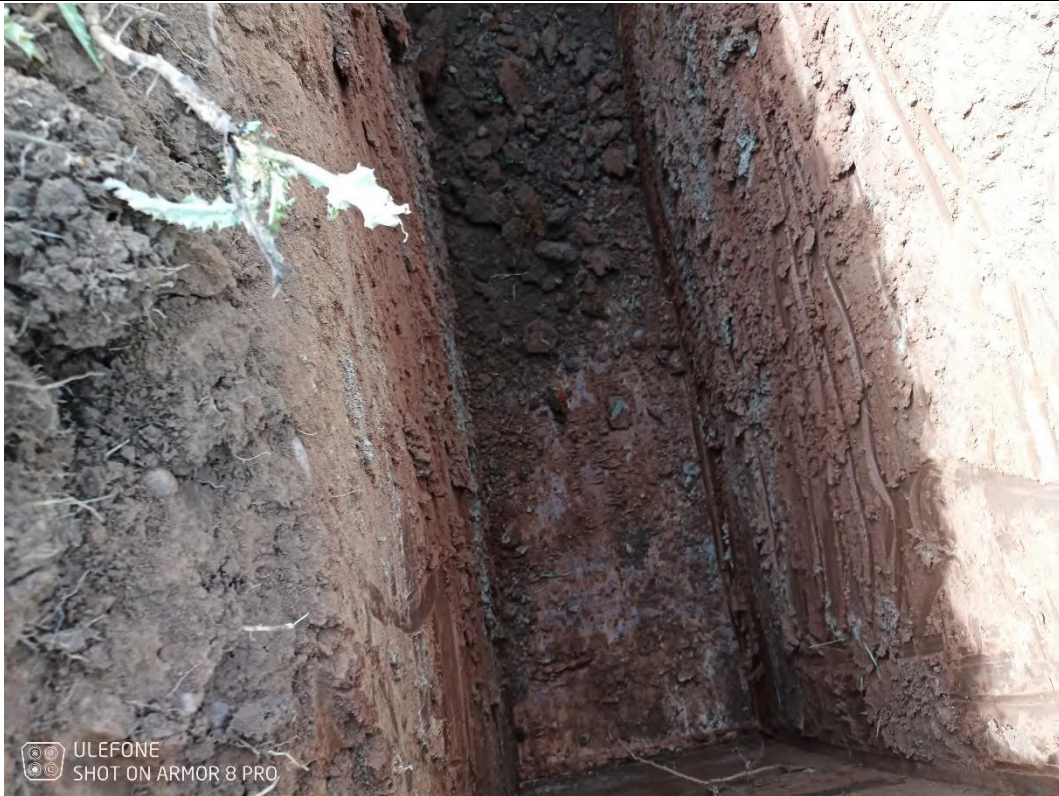
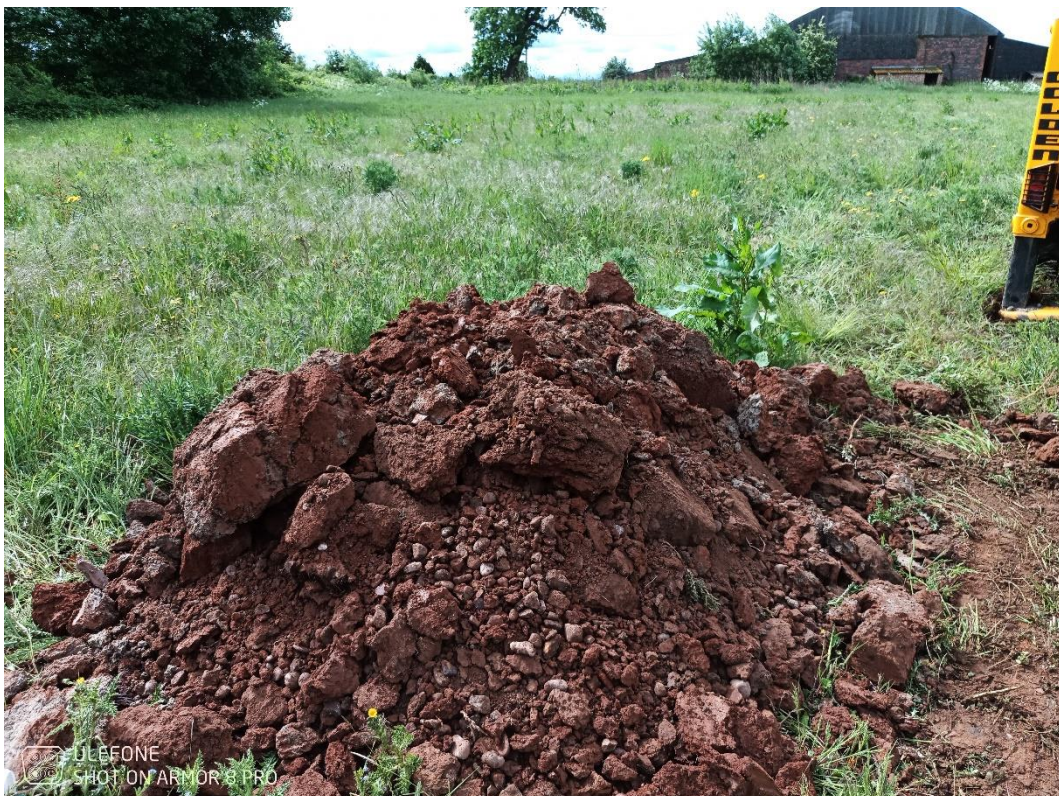
**Trial Pit Photographic Log**

| <b>Hole No:</b> SA4 | <b>Project:</b> MIRA, Nuneaton<br><b>Project No:</b> 20188<br><b>Date of Excavation:</b> 24/05/22<br><b>Location Coordinates:</b> 436574.788, 295597.740<br><b>Termination Depth:</b> 1.50m<br><b>Method:</b> Machine excavation |

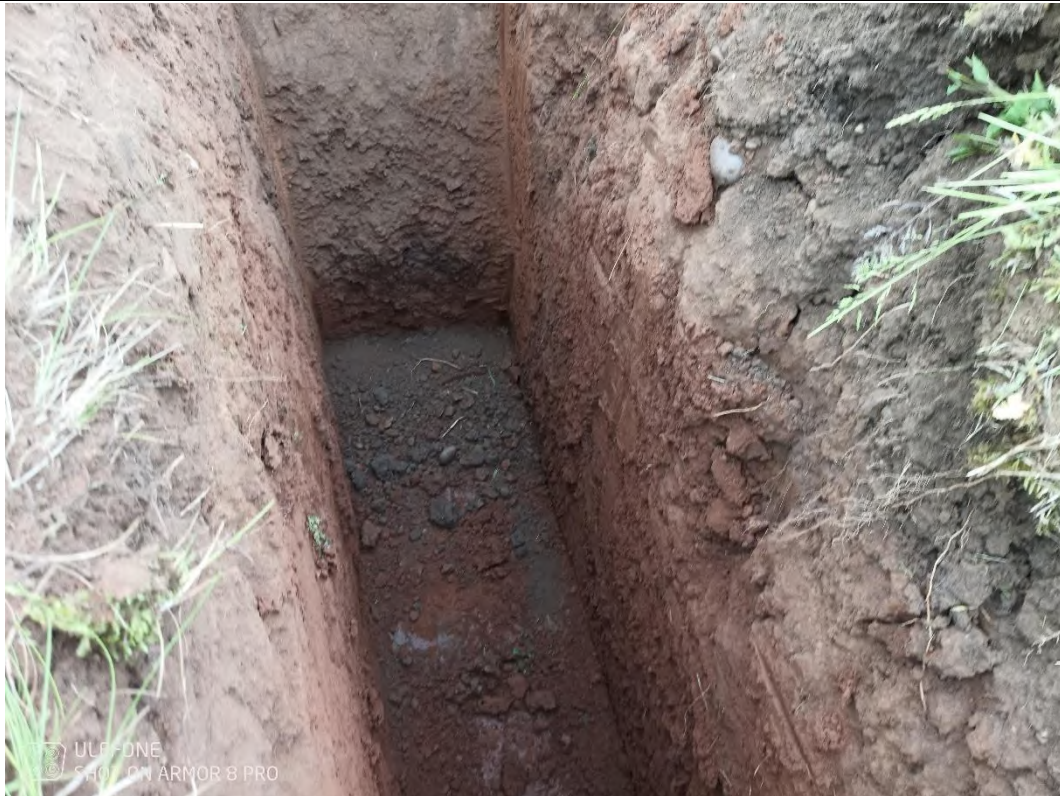
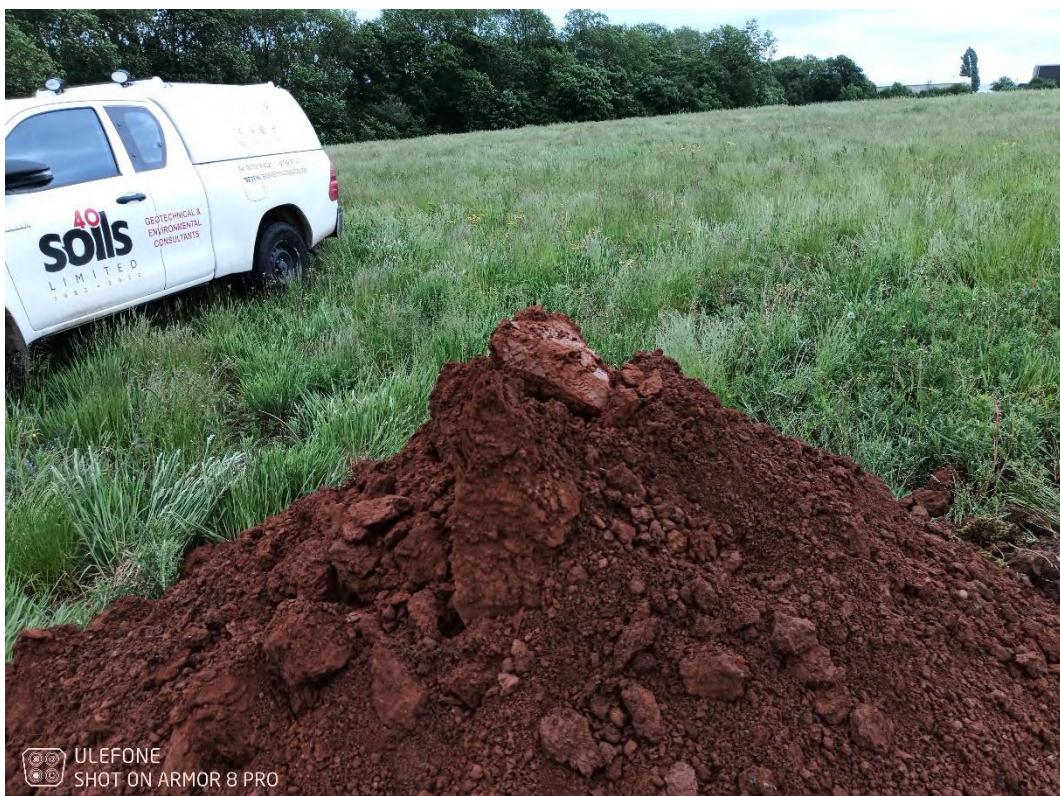
**Trial Pit Photographic Log**

| <b>Hole No:</b> SA6 | <b>Project:</b> MIRA, Nuneaton<br><b>Project No:</b> 20188<br><b>Date of Excavation:</b> 25/05/22<br><b>Location Coordinates:</b> 436319.909, 295654.294<br><b>Termination Depth:</b> 1.50m<br><b>Method:</b> Machine excavation |

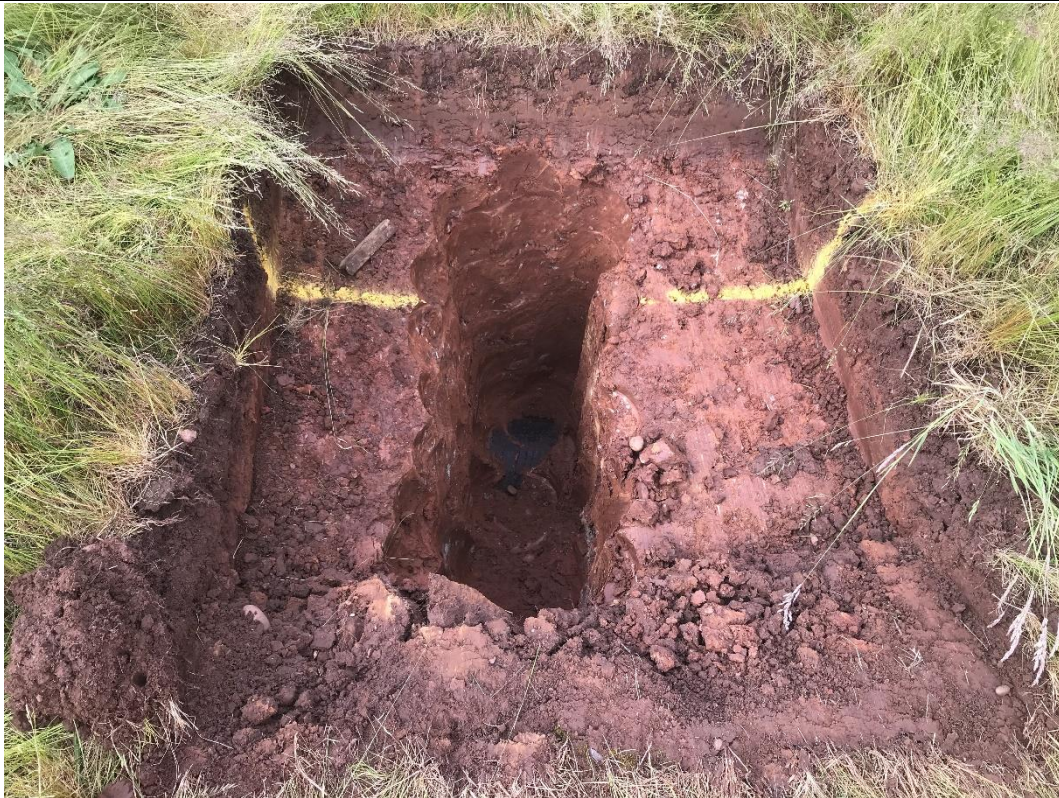
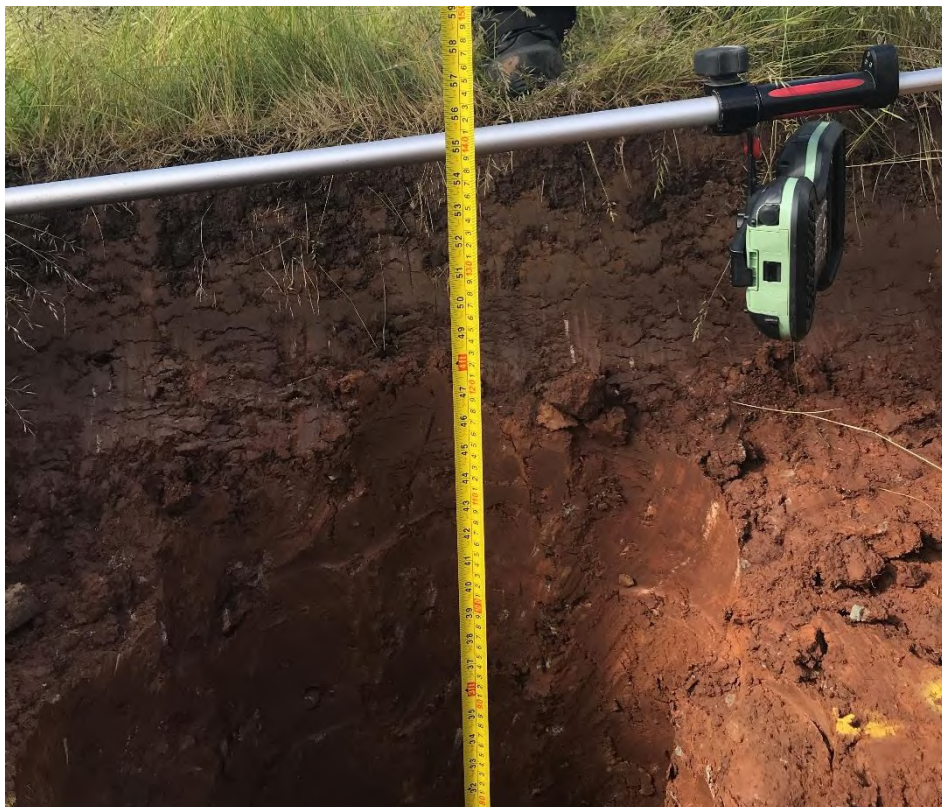
**Trial Pit Photographic Log**

| <b>Hole No:</b> TP1 | <b>Project:</b> MIRA, Nuneaton<br><b>Project No:</b> 20188<br><b>Date of Excavation:</b> 08/06/22<br><b>Location Coordinates:</b> 436473.387, 295434.195<br><b>Termination Depth:</b> 1.34m<br><b>Method:</b> Vacuum excavation |

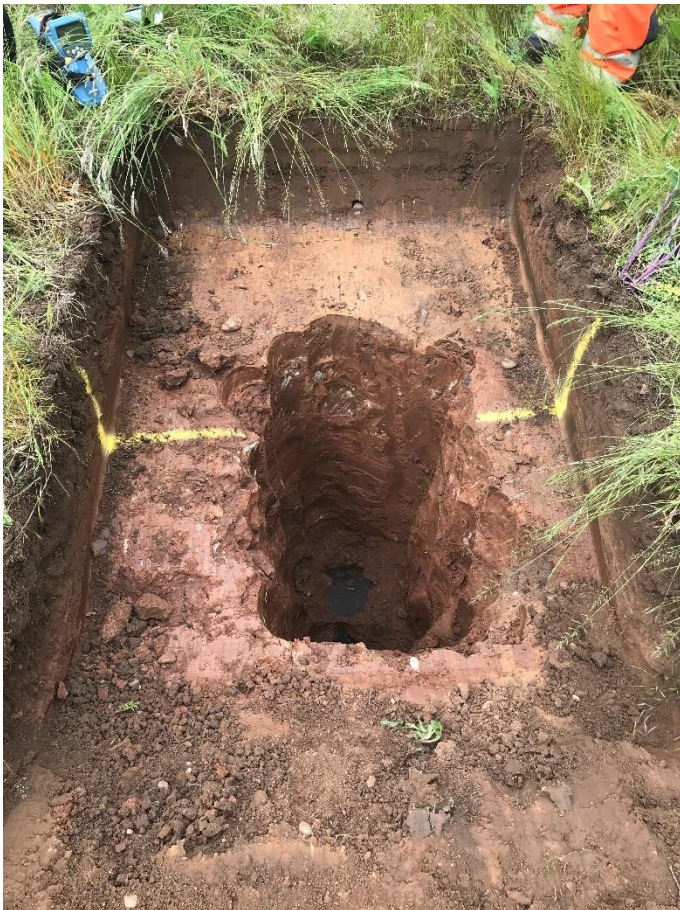
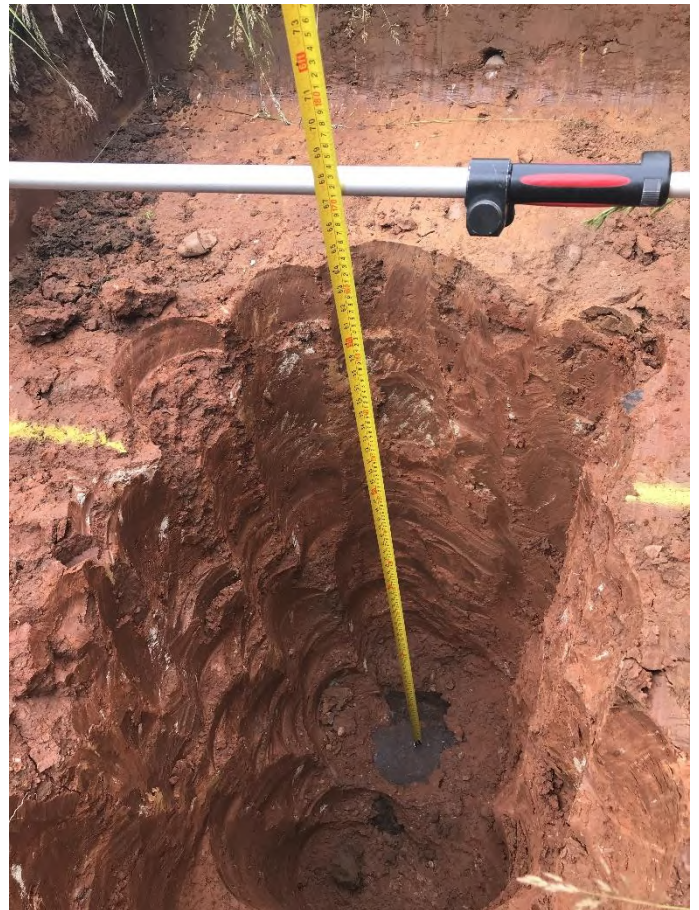
**Trial Pit Photographic Log**

| <b>Hole No:</b> TP2 | <b>Project:</b> MIRA, Nuneaton<br><b>Project No:</b> 20188<br><b>Date of Excavation:</b> 08/06/2022<br><b>Location Coordinates:</b> 436348.901, 295534.995<br><b>Termination Depth:</b> 1.70m<br><b>Method:</b> Vacuum excavation |

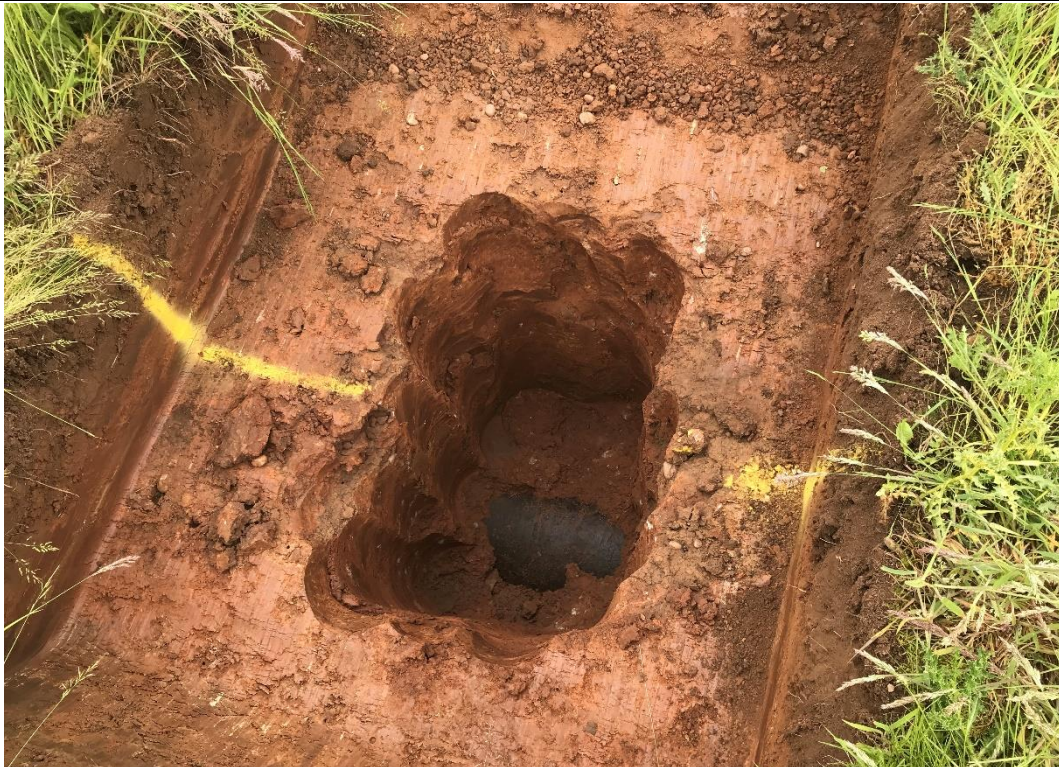
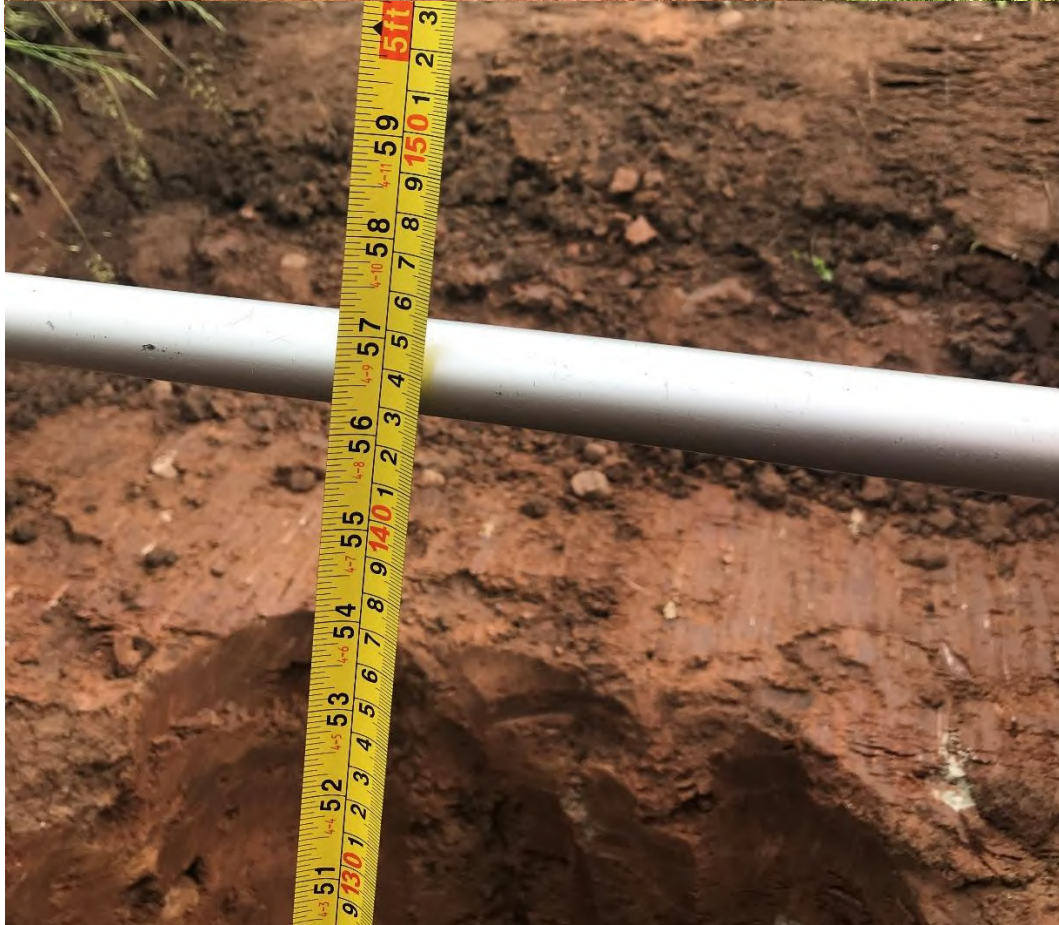
**Hole No:** TP3A

**Termination Depth:** 1.45m

**Method:** Vacuum excavation

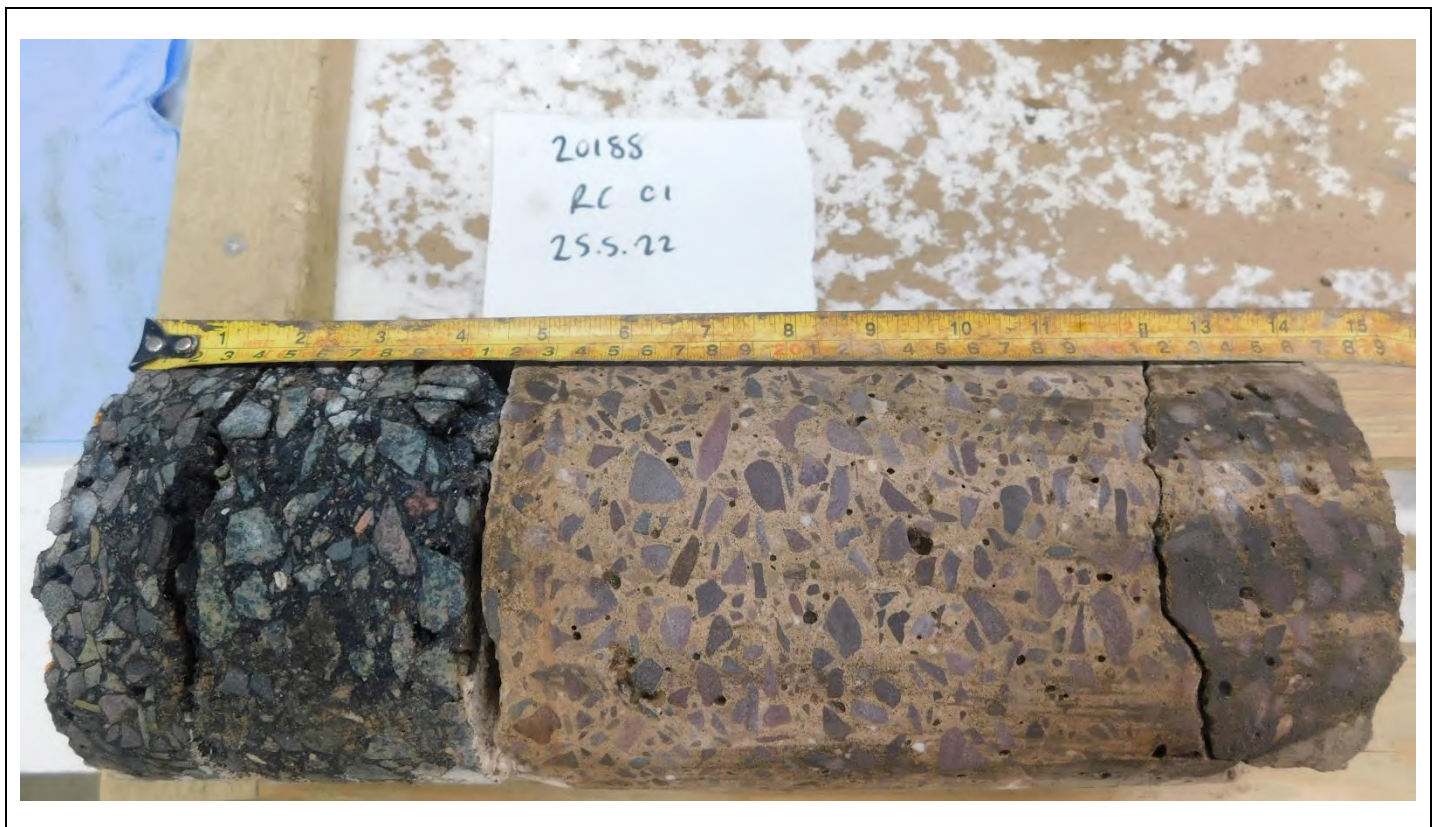
| Layer No. | Depth (m) | | Thickness (mm) | Material Description |
|---|---|---|---|---|
| 1 | 0.000 | 0.110 | 110 | Asphalt |
| 2 | 0.110 | 0.370 | 150 | Concrete |

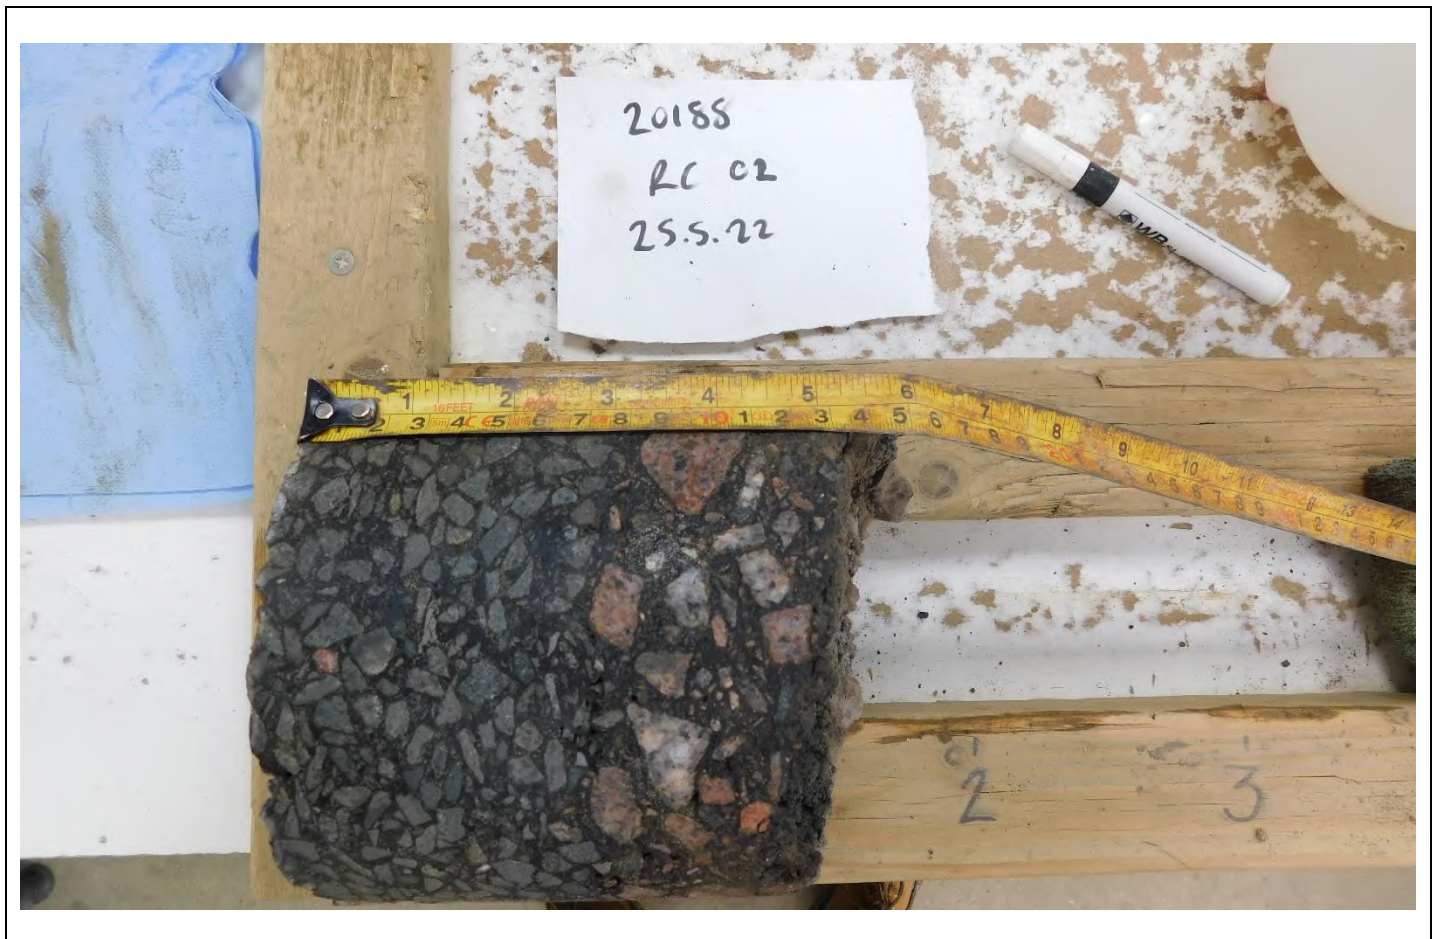
| <b>Pavement Core Number:</b> RC2 | <b>Project:</b> MIRA, Nuneaton<br><b>Project No:</b> 20188<br><b>Date of Coring:</b> 25/05/22<br><b>Location Coordinates:</b> 436744.760, 295396.415<br><b>Diameter:</b> 150mm |

| Layer No. | Depth (m) | | Thickness (mm) | Material Description |
|---|---|---|---|---|
| I | 0.000 | 0.130 | 130 | Asphalt |

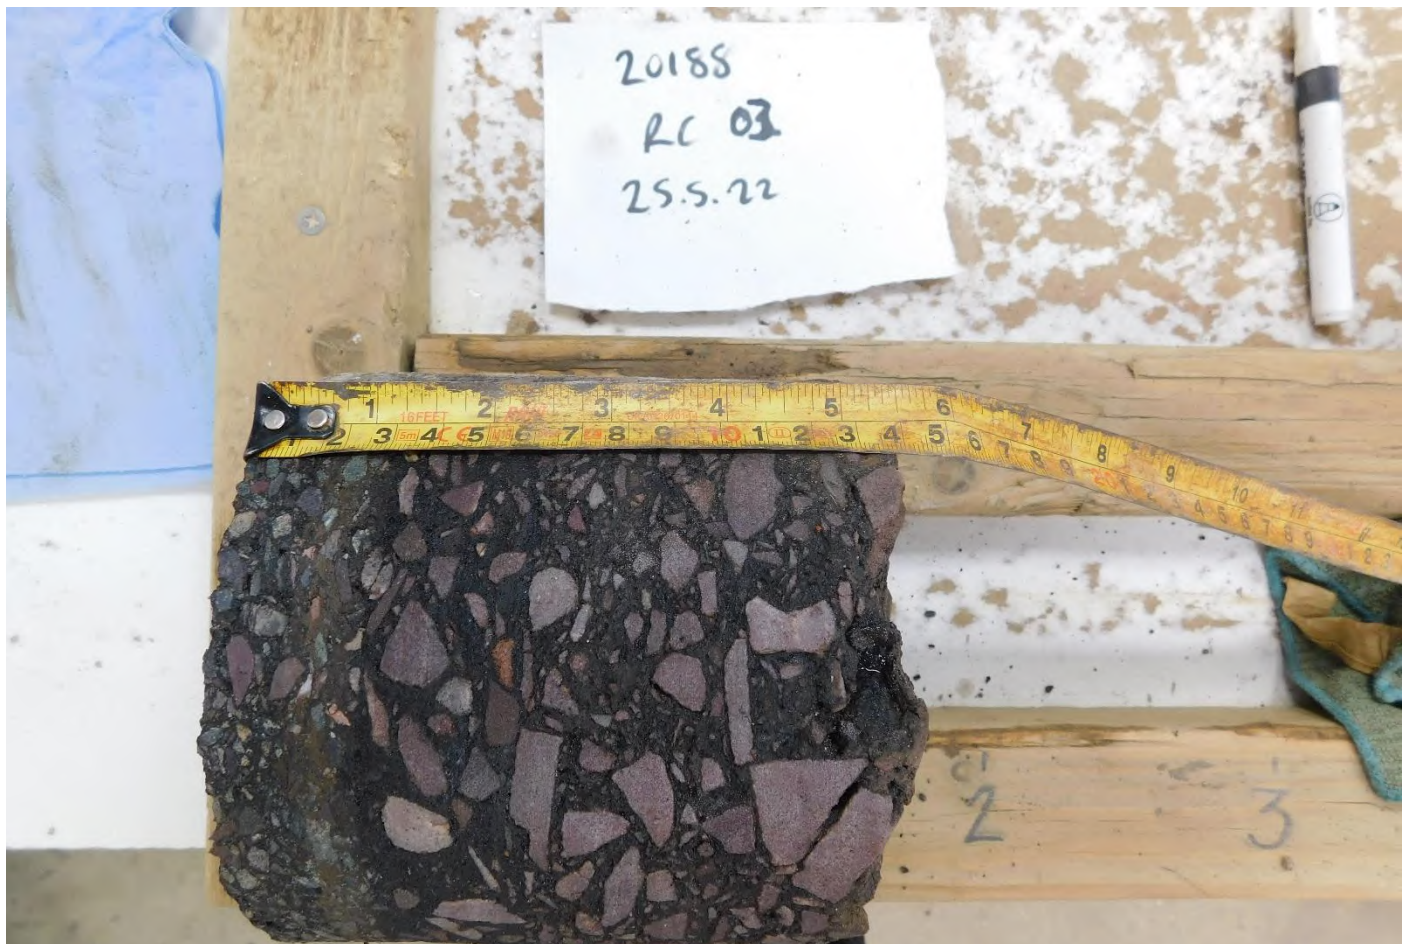
| <b>Pavement Core Number:</b> RC3 | <b>Project:</b> MIRA, Nuneaton<br><b>Project No:</b> 20188<br><b>Date of Coring:</b> 25/05/22<br><b>Location Coordinates:</b> 436769.953, 295405.683<br><b>Diameter:</b> 150mm |

| Layer No. | Depth (m) | | Thickness (mm) | Material Description |
|---|---|---|---|---|
| I | 0.000 | 0.140 | 140 | Asphalt |

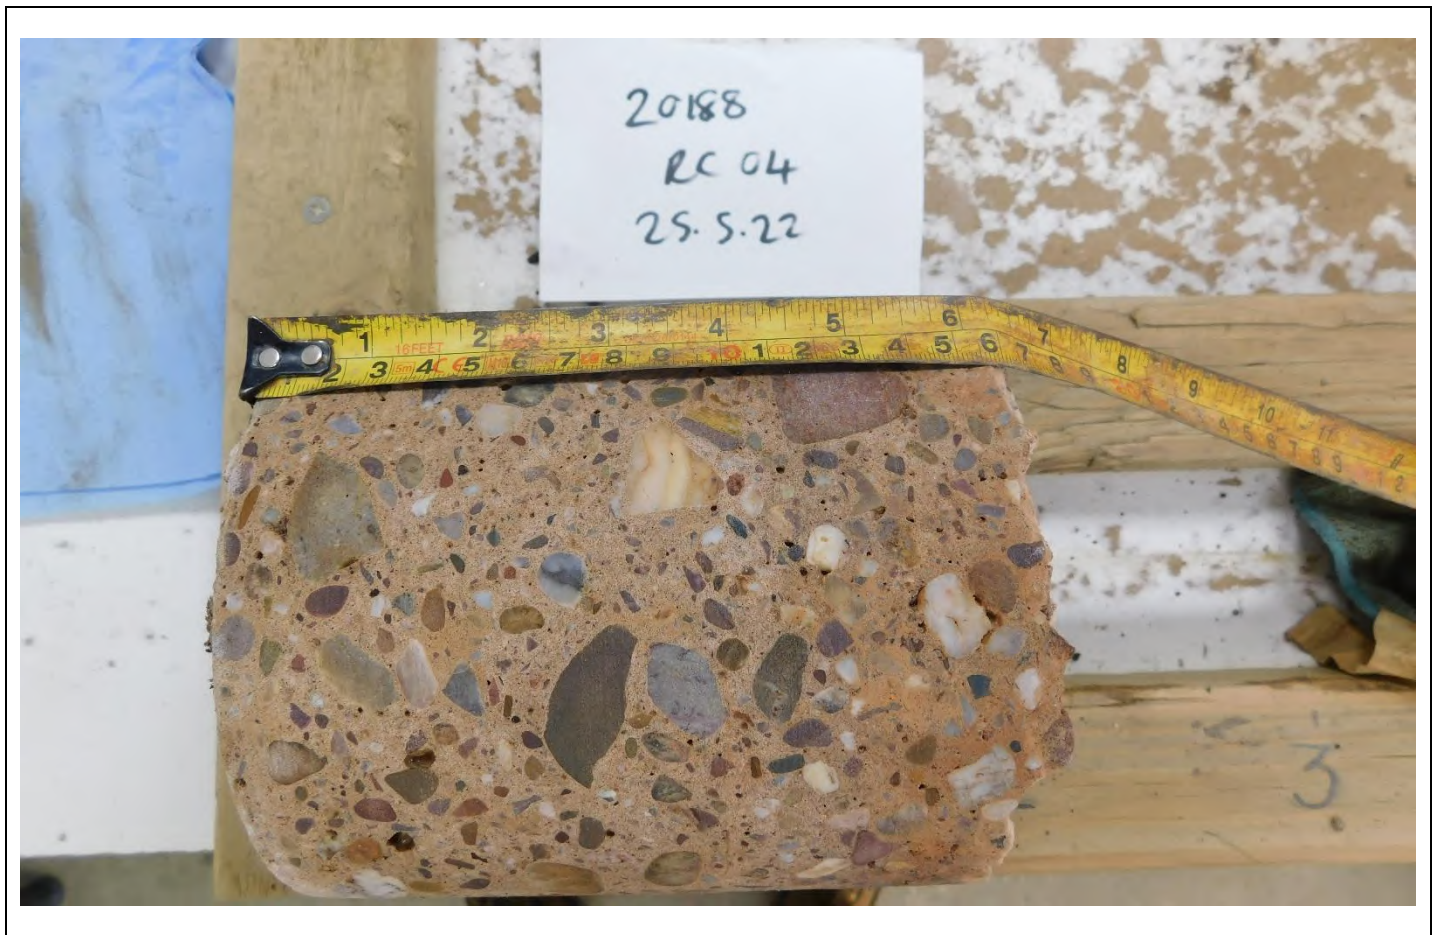
| <b>Pavement Core Number:</b> RC4 | <b>Project:</b> MIRA, Nuneaton<br><b>Project No:</b> 20188<br><b>Date of Coring:</b> 25/05/22<br><b>Location Coordinates:</b> 436643.316, 295525.746<br><b>Diameter:</b> 150mm |

| Layer No. | Depth (m) | | Thickness (mm) | Material Description |
|---|---|---|---|---|
| I | 0.000 | 0.160 | 160 | Concrete |
