**Re: MIRA, Watling Street, Nuneaton, CV10 0TU**

Following the completion of the site works, we write to update you on the findings to date, please find the attached the preliminary trial hole logs and data are given in the following appendices: Appendix A (WS Boreholes-Unlogged, DP and Trial Pits) and Appendix B (Infiltration Soakage).

## MIRA NORTH SITE - CONDITIONS TRACKER – 01/01/23

# **GEOPHYSICAL SURVEY REPORT**

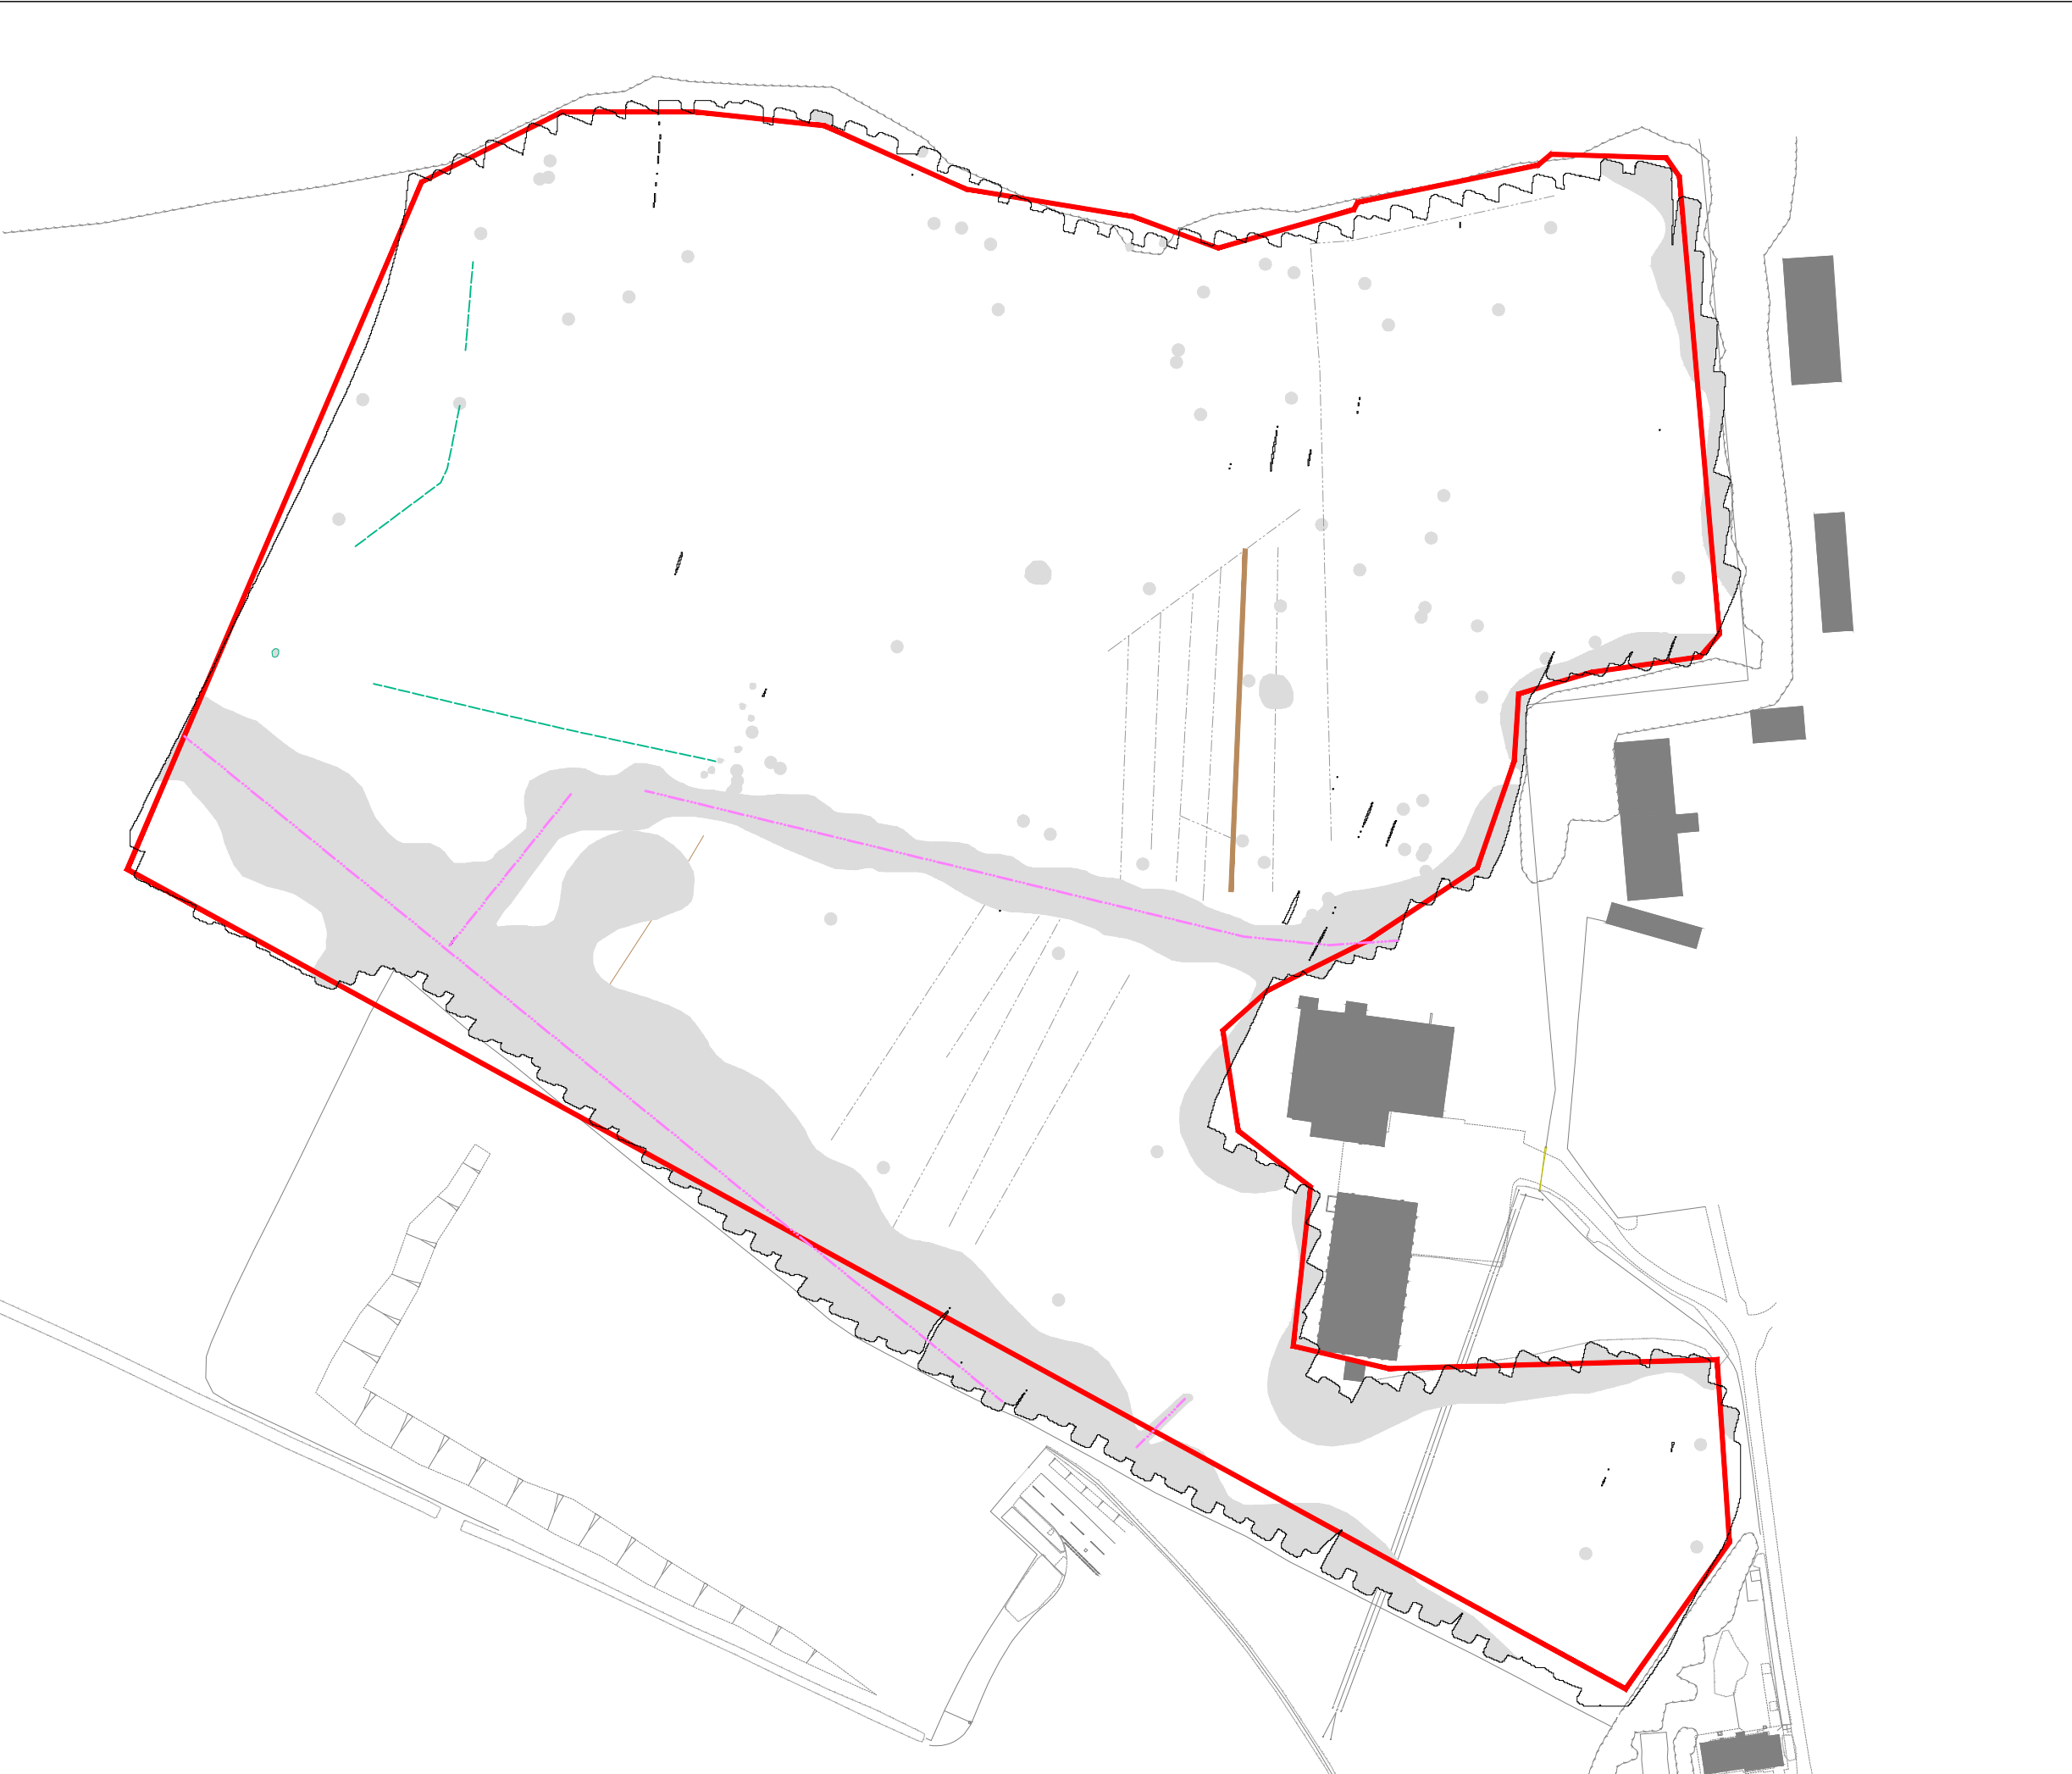
| Scale:<br>0 75<br>metres<br>1:1500 @ A3 | Fig No:<br>04 |

KEY

| | Former field boundary (corroborated) |

#### 6.3 ***Former Field Boundary – Corroborated***

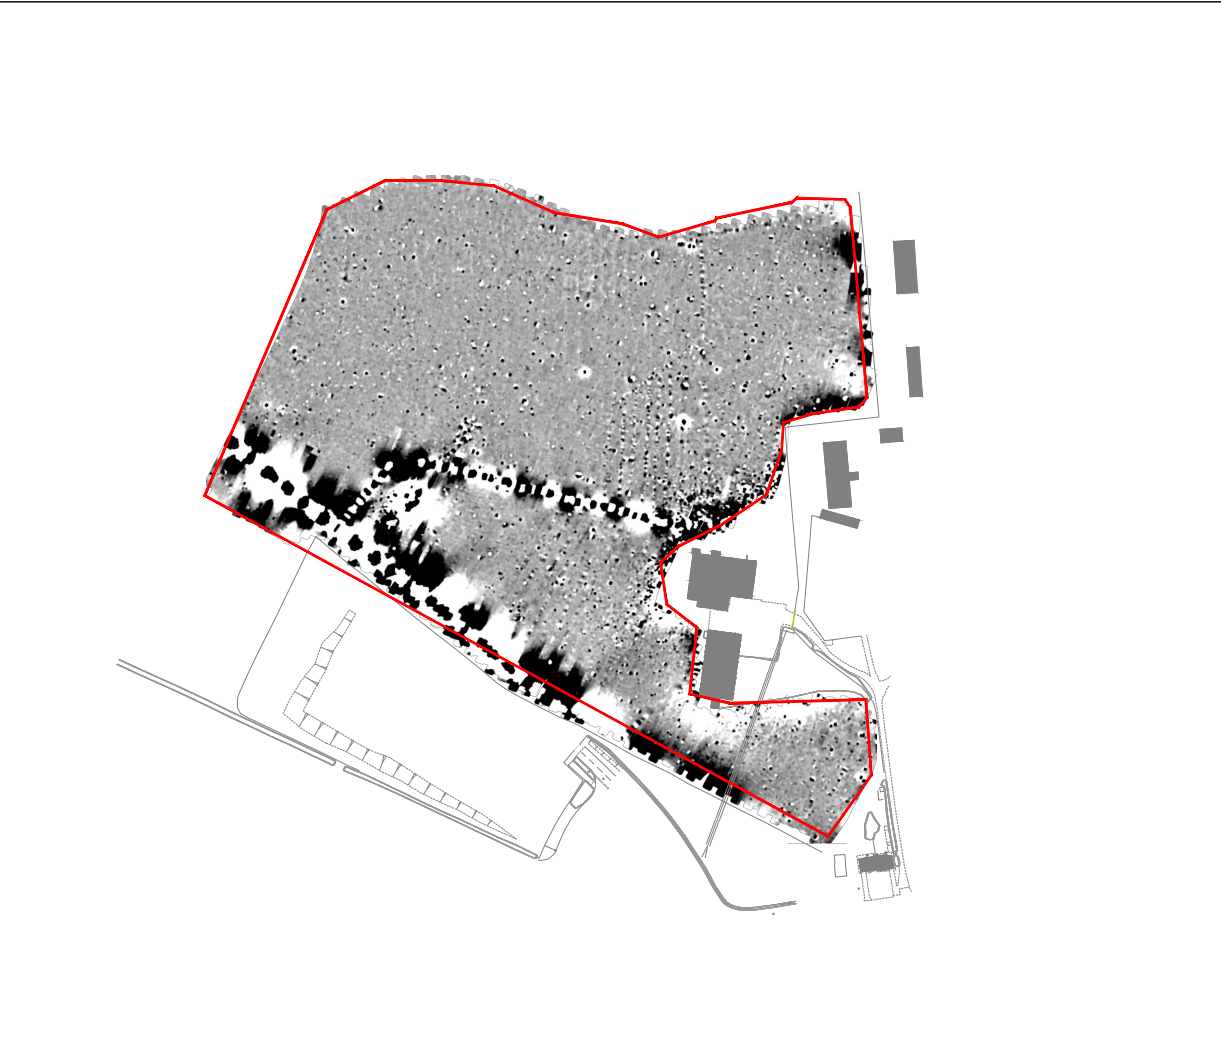
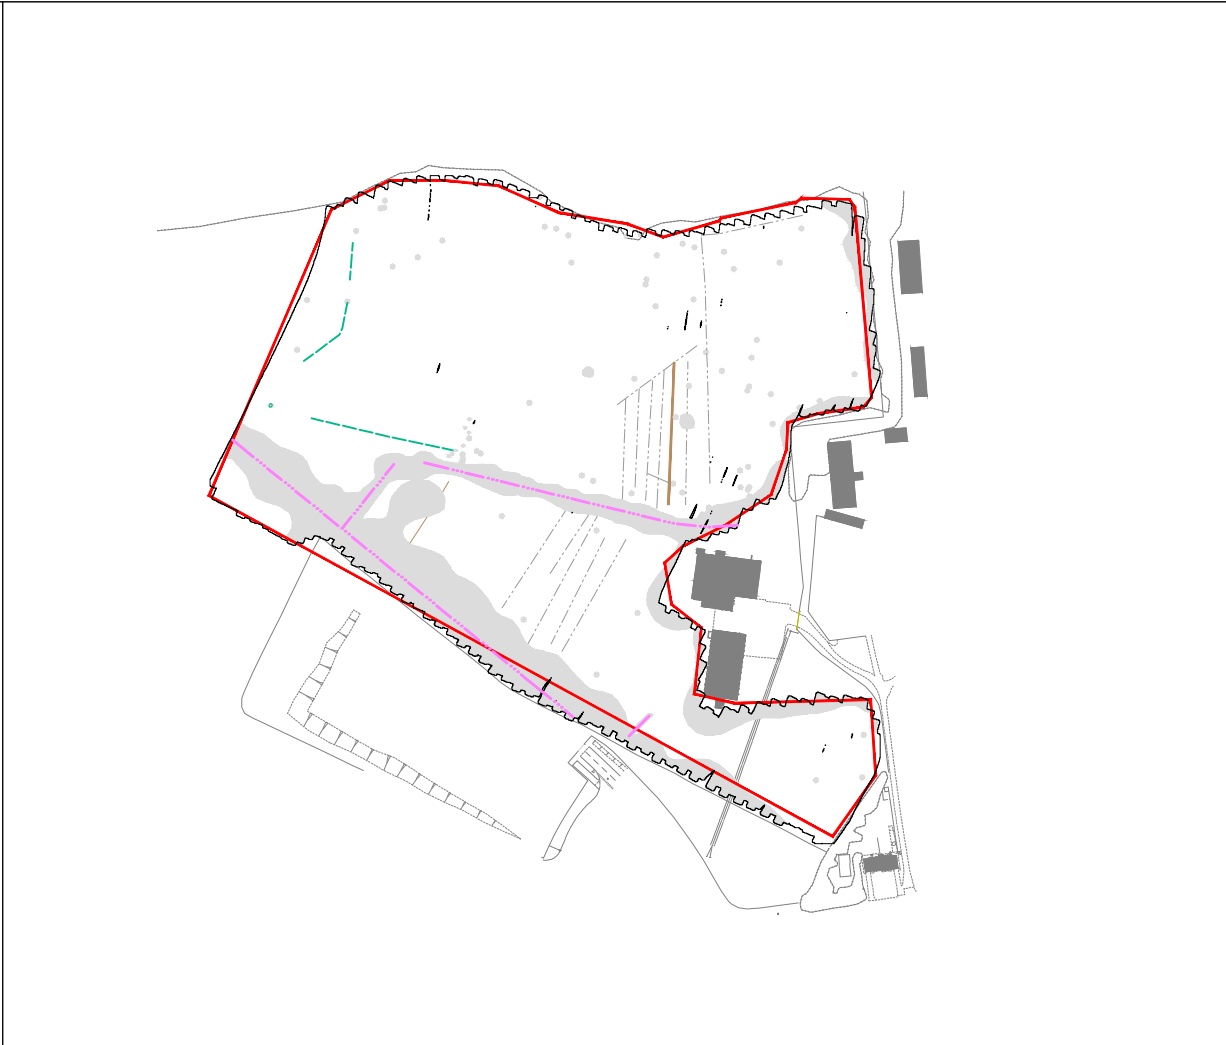
KEY

| | Former field boundary (corroborated) |

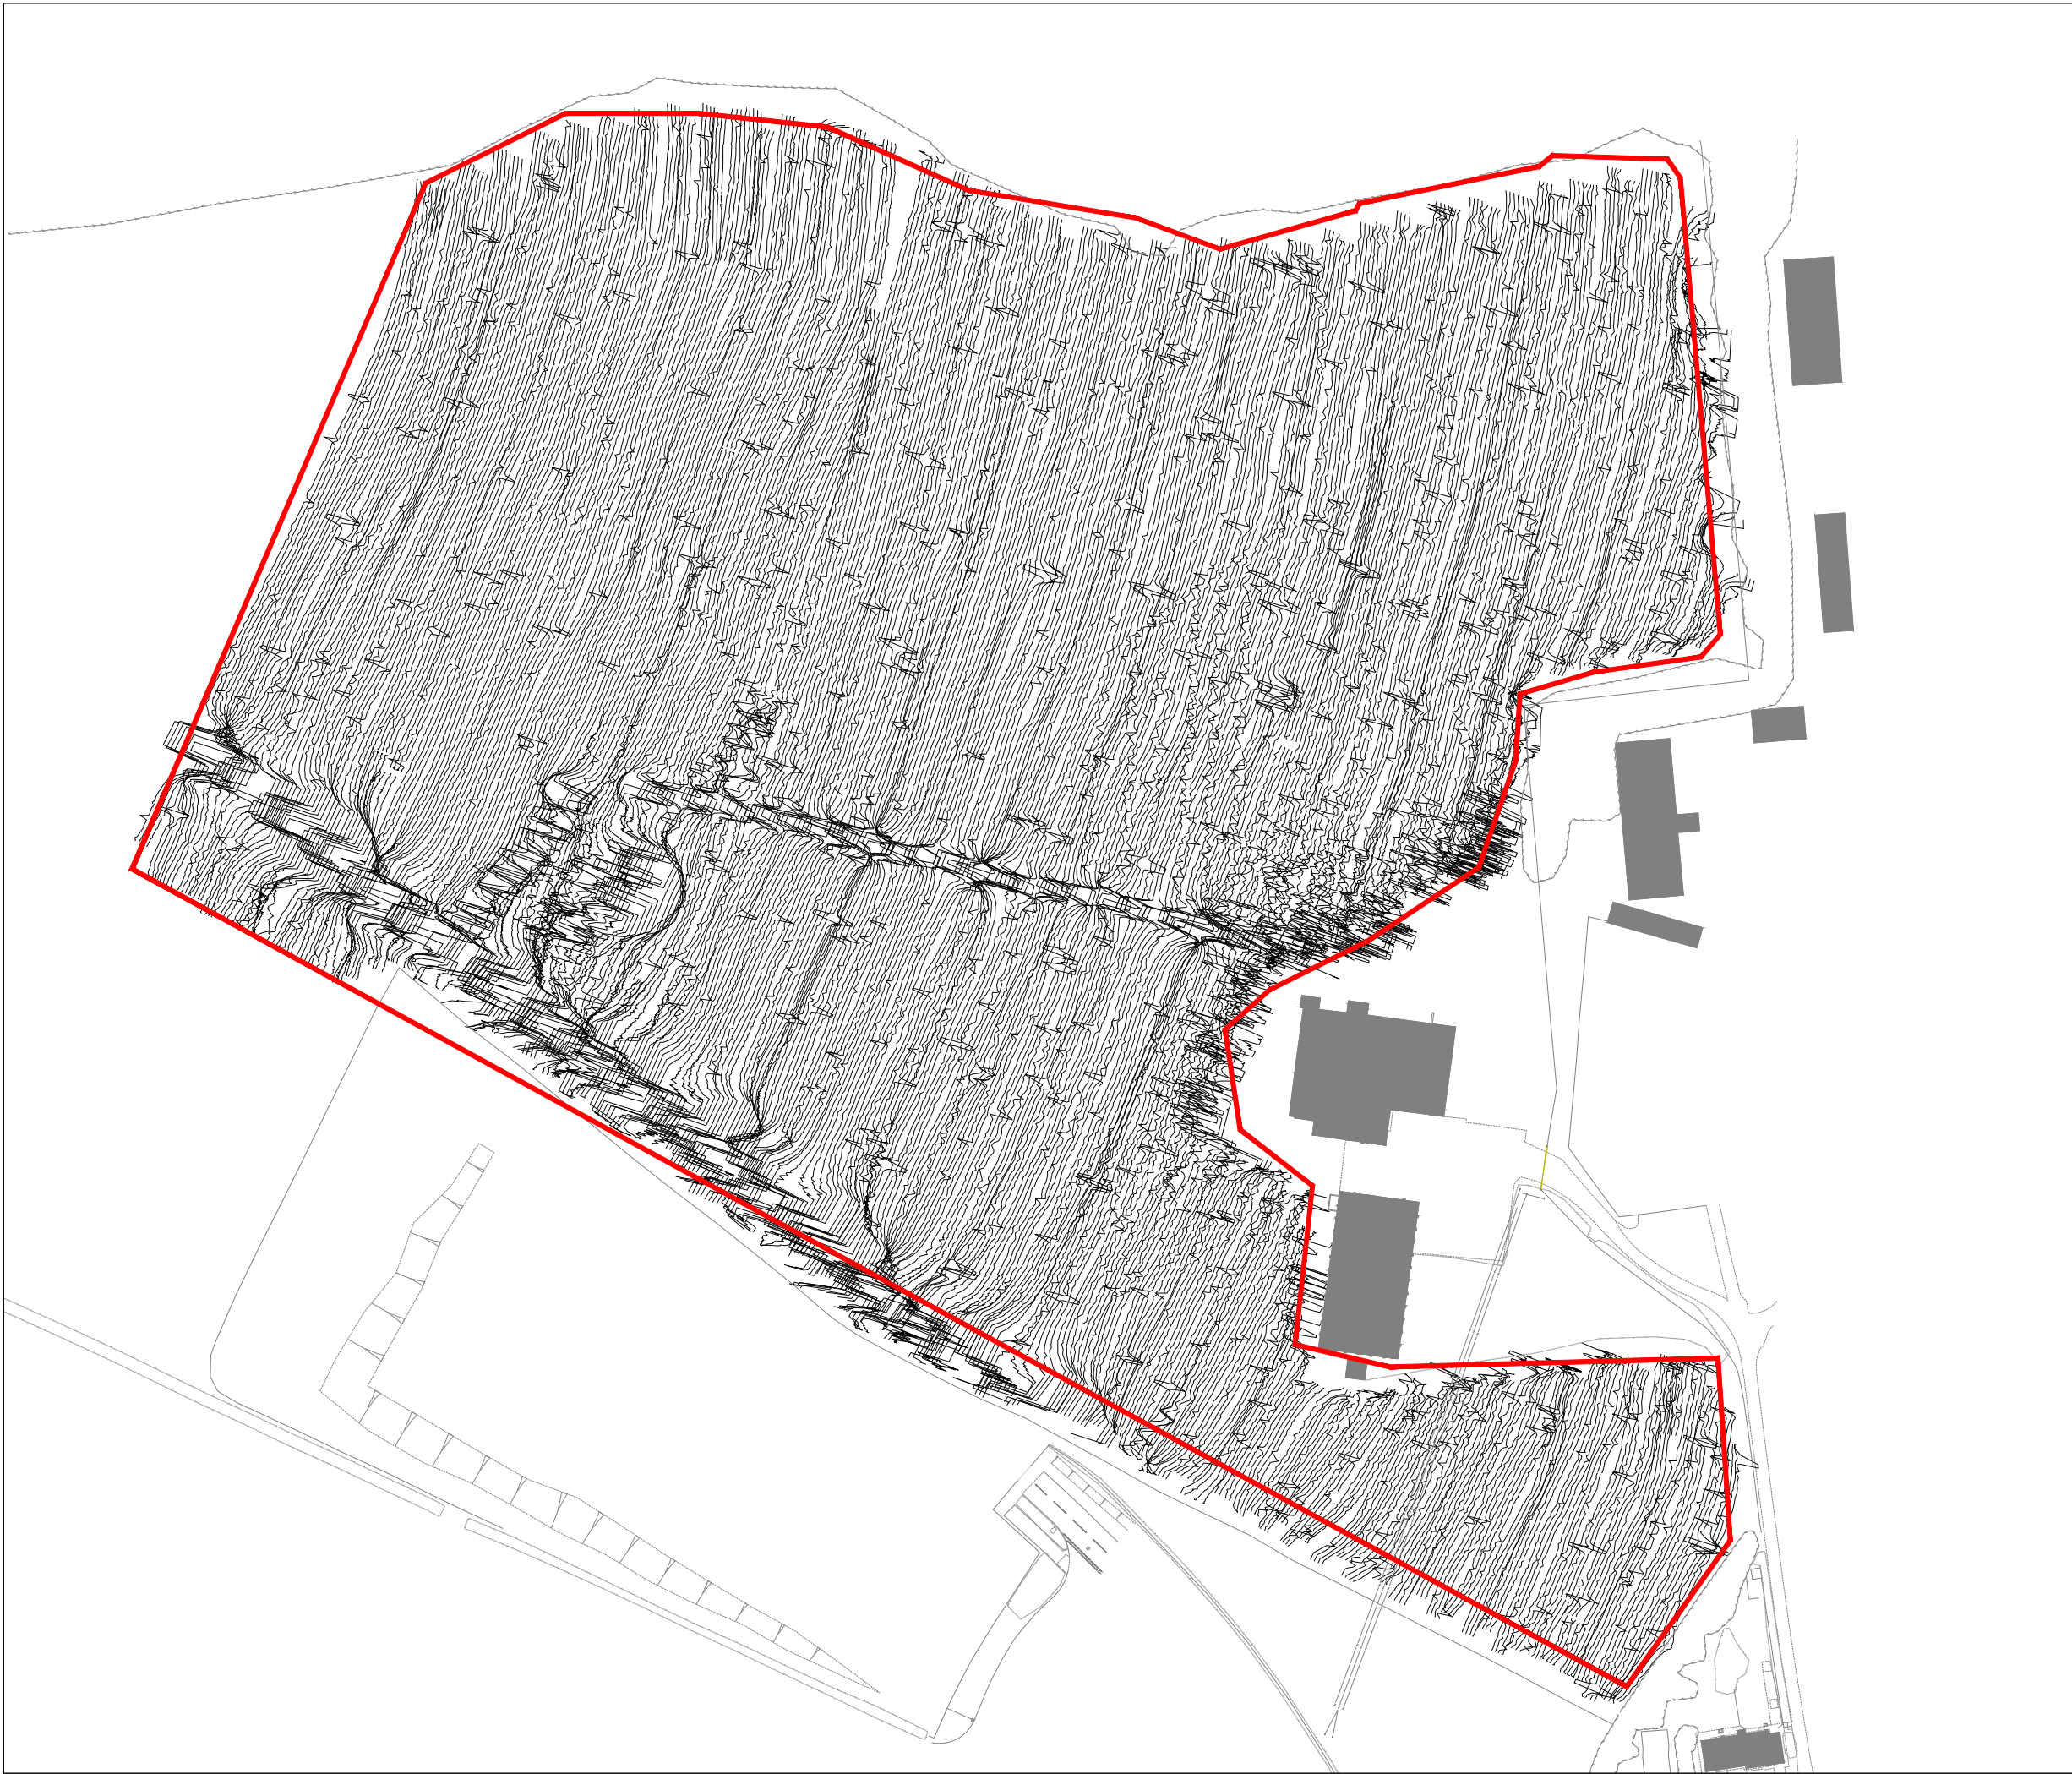
| Title:<br>XY Trace Plots (clipped at +/-15nT) | |

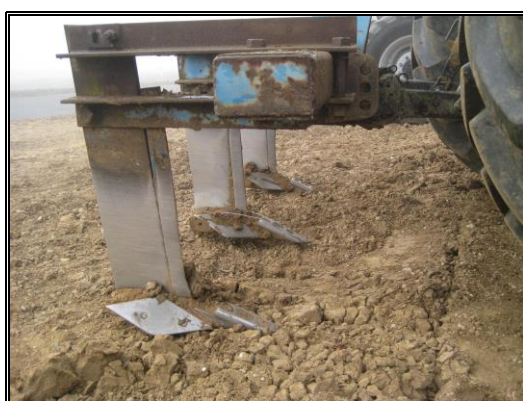
5.14.1 On the larger areas a wing-tined subsoiler mounted on either a tracked dozer or large tractor should be used.

Plate 1 : Wing-tined subsoiler

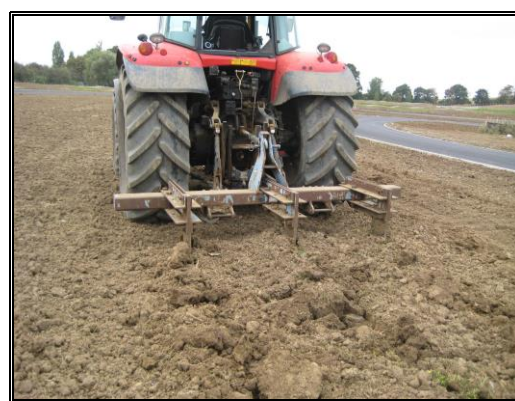
Plate 2 : Tractor drawn subsoiler

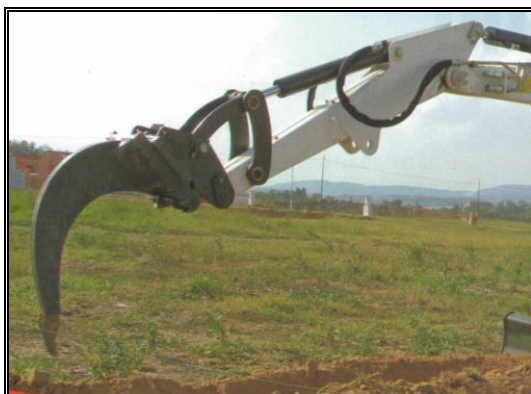
5.14.2 A suitably-sized tracked excavator fitted with a single rigid tine should be used to loosen the soil profile in smaller inaccessible areas, such as field boundaries, corners of the site, steep slopes or adjacent to roads and pathways.

**Plate 3: Tracked excavator with single rigid tine**

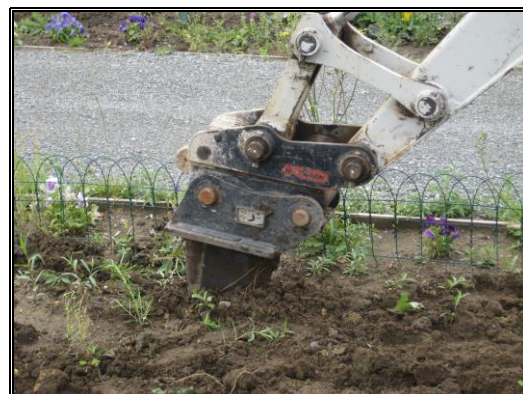
**Plate 4 : Single rigid tine in use**

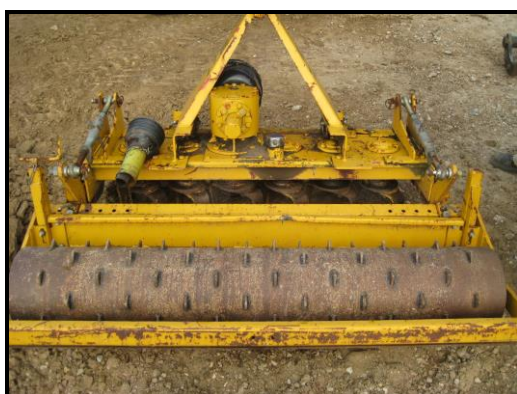
5.15.1 After respreading topsoil, any large, compacted lumps should be broken down using suitable tillage equipment (e.g. shakaerator, power harrow or set of discs) to break down larger clods and produce a fine tilth suitable for planting (<40mm), turfing and seeding (<10mm).

**Plate 5: Example of power harrow**

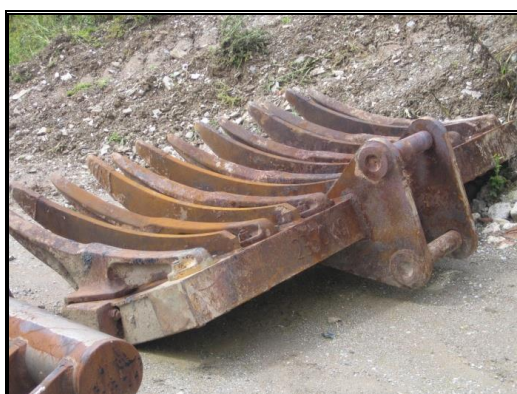
5.15.2 Small less accessible areas should be cultivated by hydraulic excavator fitted with a landscape rake attachment or similar and approved.

**Plate 7: Example of landscape rake (1)**

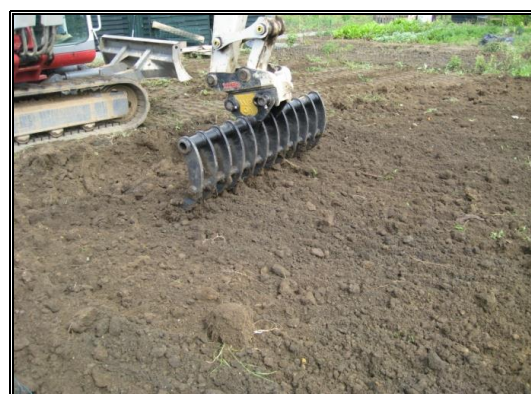
**Plate 8 : Example of landscape rake (2)**

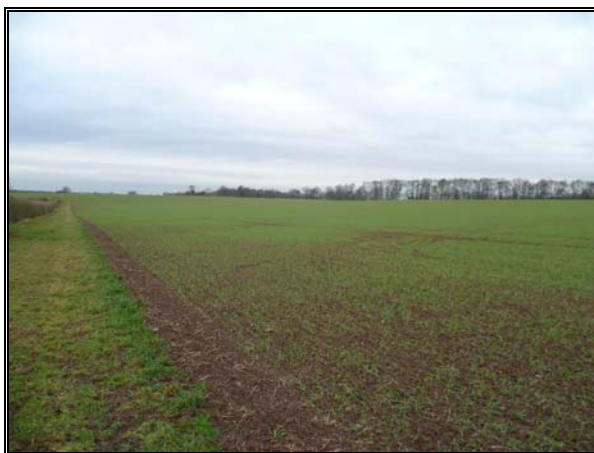
Plate 1 : Area 1 – agricultural land adjacent to A5

Area 3 – agricultural land and paddocks, north of Lindley. This roughly square area is divided into agricultural fields and number of horse paddocks, bounded by fences. This area was generally level and had been sown with a winter cereal (fields) or was vegetated with a short grass sward (paddocks).

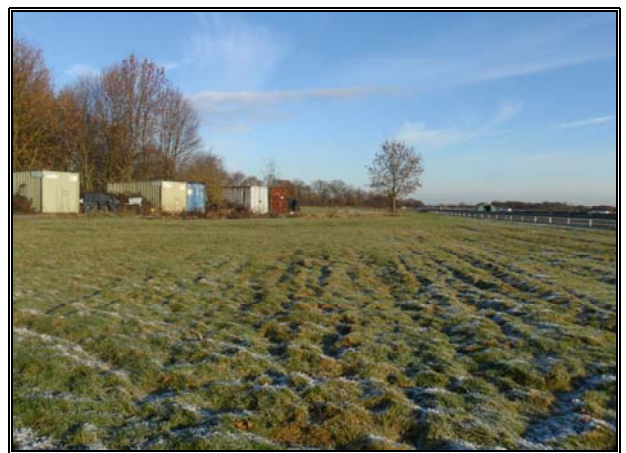
Plate 2 : Area 2 Soft landscape next to Track 1

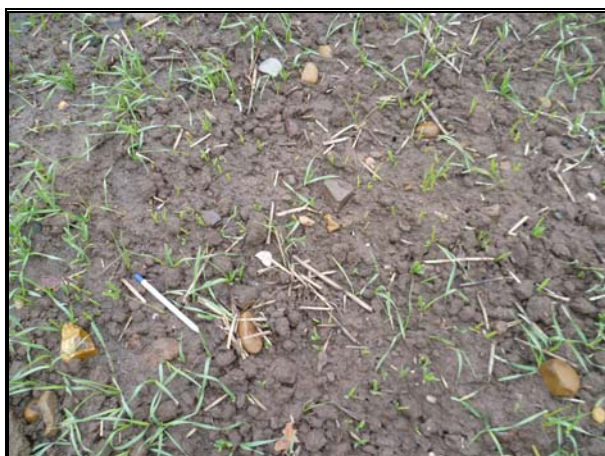
Plate 3 : Area 1 – Occasional stones at surface

| <b>Topsoil</b><br>GL – 210/410mm<br>Average depth :<br>320mm | Brown to dark reddish brown (Munsell Colour 7.5YR 4/2 to 7.5YR 3/2) moist to wet, plastic HEAVY CLAY LOAM to CLAY, with a moderately developed, granular and blocky structure. Slightly stony with occasional rounded to subangular stones (up to 60mm). No observable deleterious materials.<br><br>Rusty root mottles were frequently observed at the topsoil/subsoil interface. |

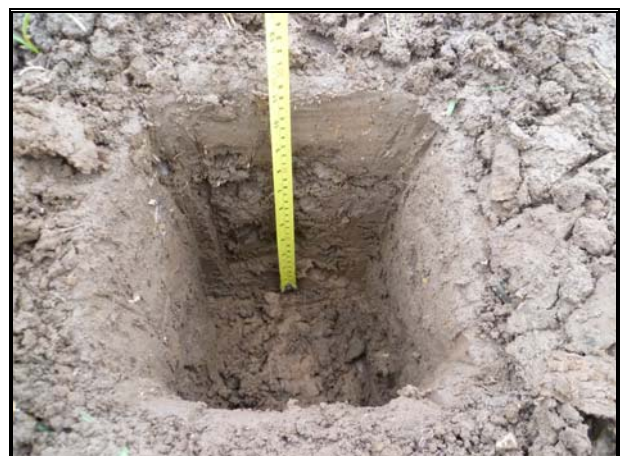
| <b>Subsoil</b><br>210/410mm – 1200mm | Brown to yellowish red to reddish brown (Munsell Colour 7.5YR 4/2 to 5YR 5/6 to 2.5YR 4/4) moist, plastic CLAY with a moderately developed, granular and blocky structure to poorly developed columnar structure becoming massive (structureless). Stoneless to virtually stone-free and no observable deleterious materials.<br><br>Manganese concretions and prominent reddish grey mottles were frequently observed within the subsoil. |

Plate 4 : Area 1 - Typical soil profile (TH1)

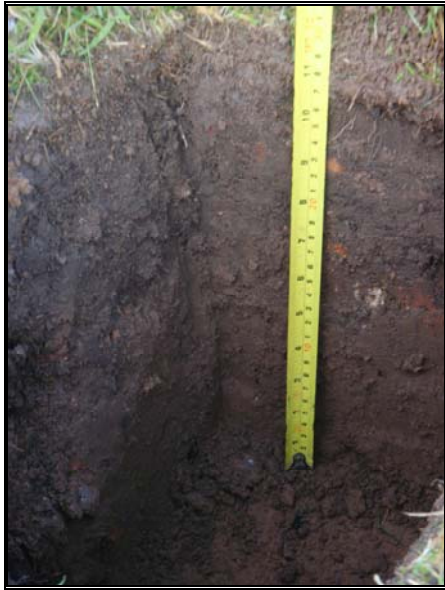
Plate 5 : Area 2 Typical soil profile (TH30)

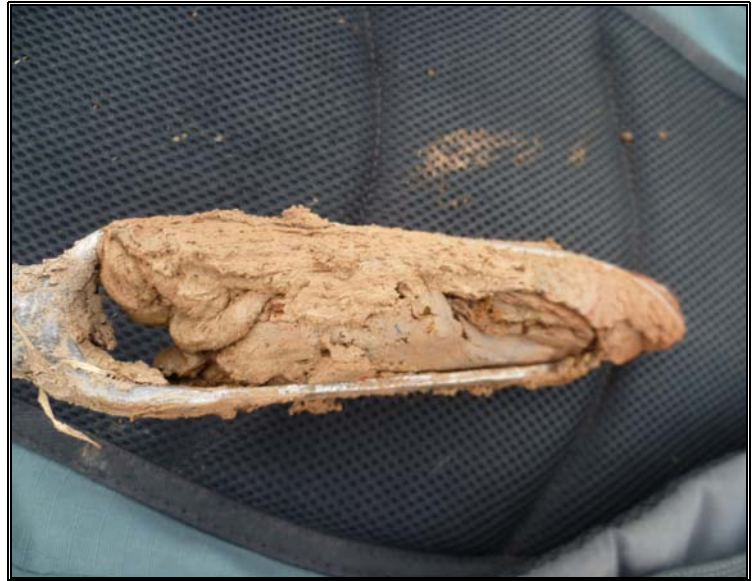
Plate 6 : Subsoil
