**Preliminary Bat Roost Assessment and Bird  
Survey for,  
Mr. and Mrs. M. Burgess.  
Building at,  
Lodge Farm,  
Market Bosworth Road,  
DADLINGTON,  
CV13 6DH.**

**Map Ref SP 3973 9884  
29<sup>th</sup> May 2025.**

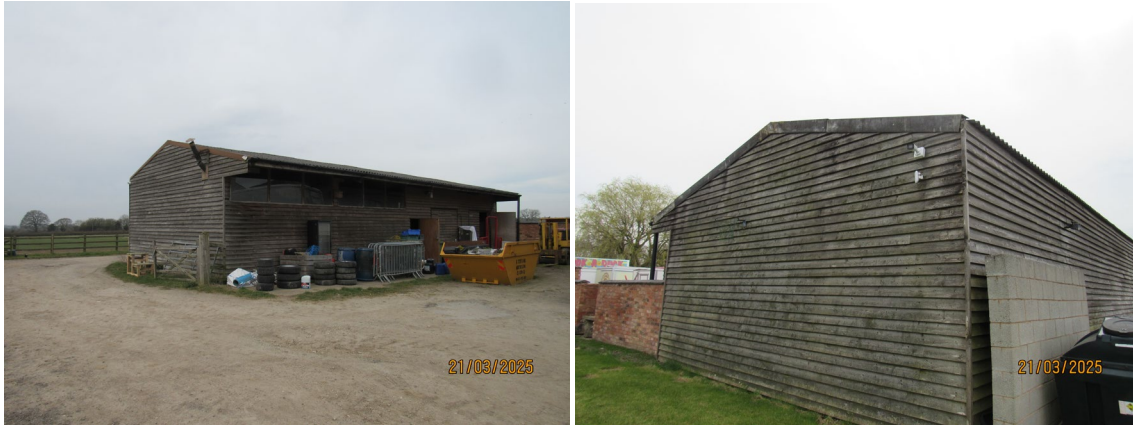
Block Plan  
Scale 1:500

The buildings to be surveyed consisted of a single storey steel portal framed building with a pitched roof covered with fibre cement sheets.

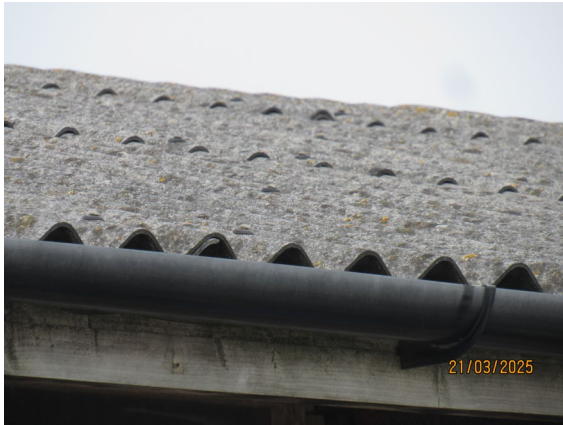
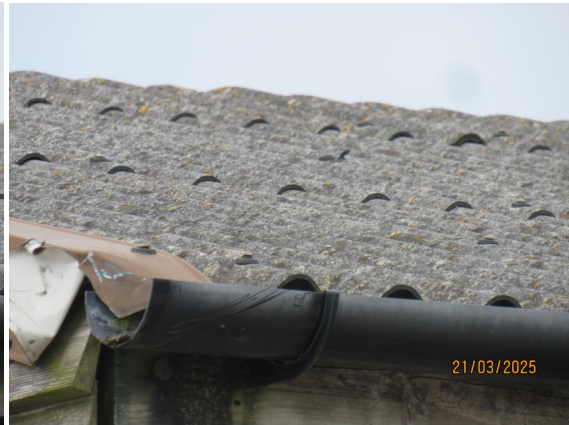
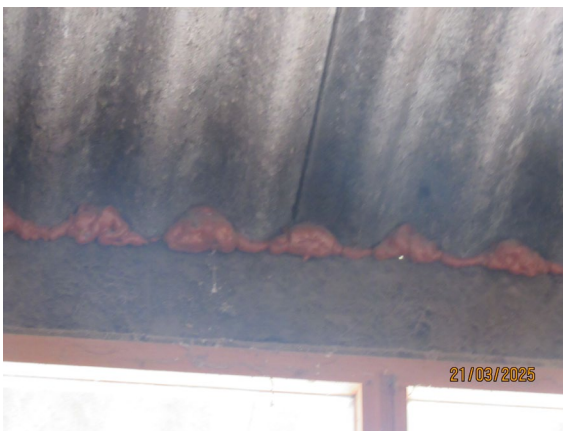
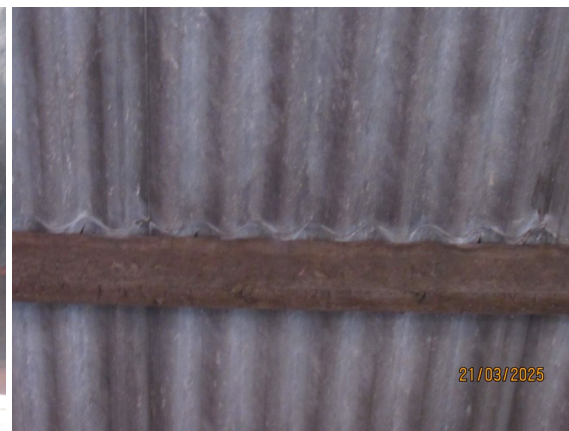
The building is a steel portal frame with fibre cement roof sheets. The building has one area that has the walls lined with plasterboard and insulated with fibre glass. There is one bay that has no liner and insulation. There is no access to the section of the building where there is insulation and plasterboard liner due to expanding foam at the eaves. There is access in one bay to the gap between the rear of the fibre cement roof sheet and the timber sheeting rail. This provides an exceptionally poor place of shelter for crevice dwelling bats and the likelihood of bats using the space can be managed by contractors following the method of working set out below.

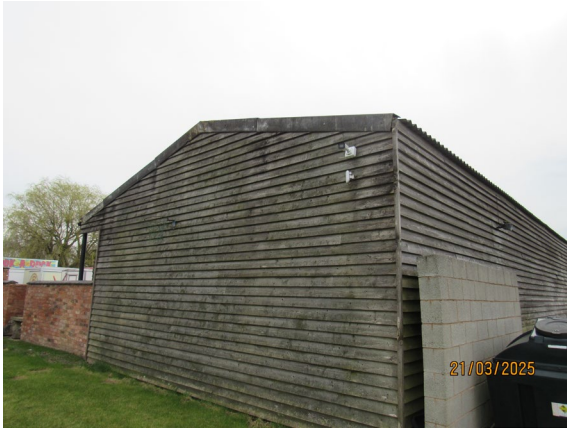
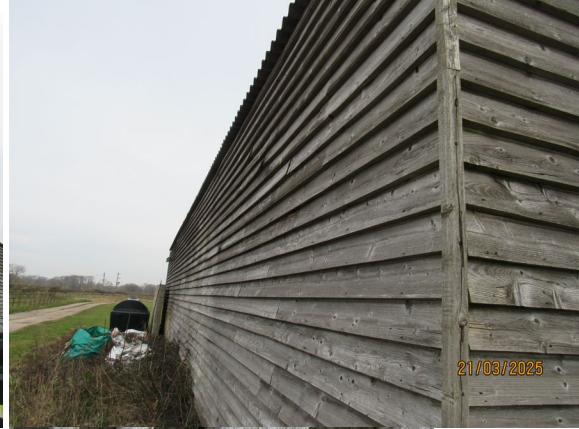
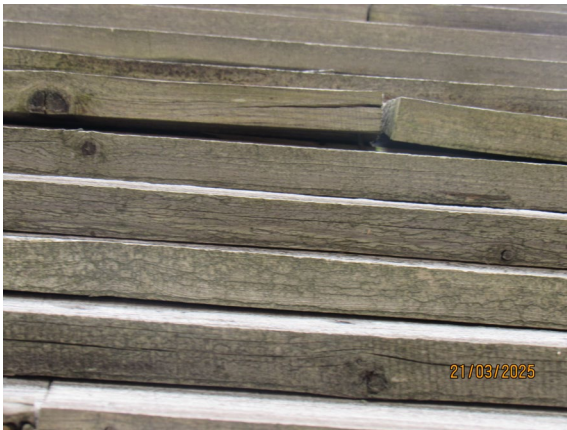
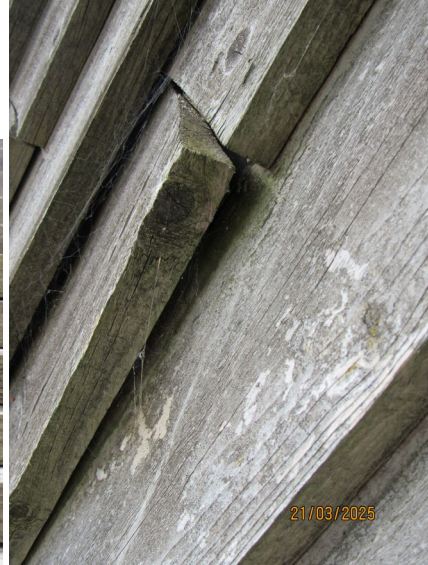
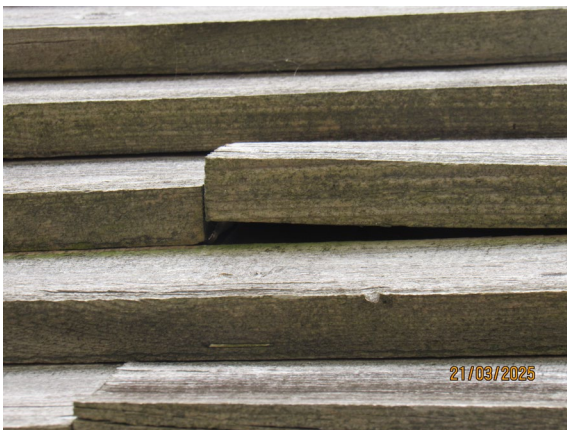
The walls of the building have a breathable roofing membrane with timber cladding. In one area on the western elevation and three areas on the southern gable the timber has warped and allows access to the rear of the timber cladding. These gaps provide a possible place of shelter for crevice dwelling bats. The likelihood of bats using this potential place of shelter is moderate and two emergence surveys are required to determine if bats are using them as a place of shelter.

These gaps were checked with an endoscope and there was no evidence of use by bats.

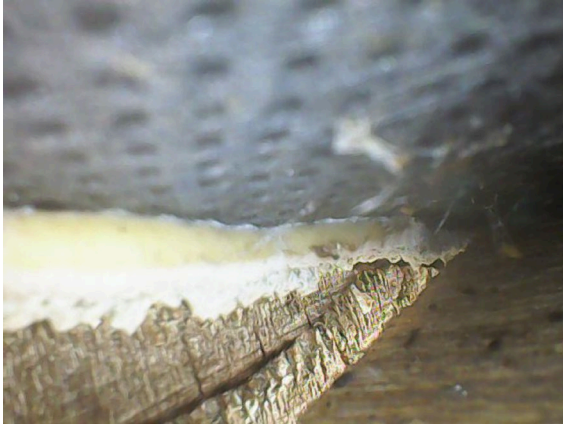
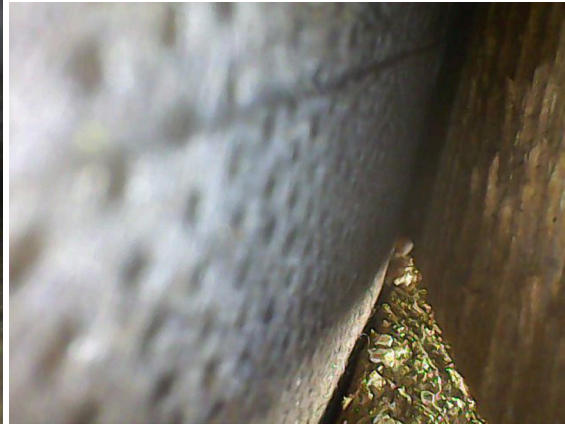
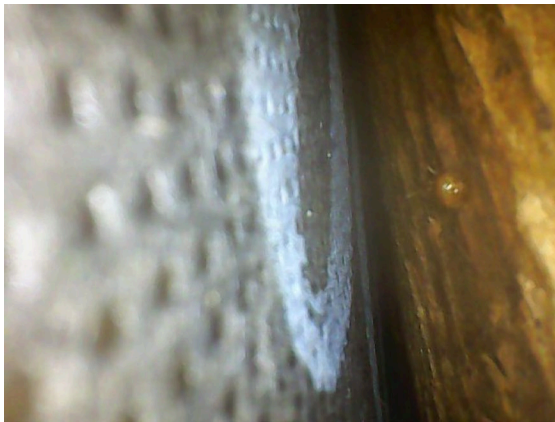
At the northern gable there is a fibre cement verge flashing that provides no places of shelter for bats as there is no crevice for bats at the rear

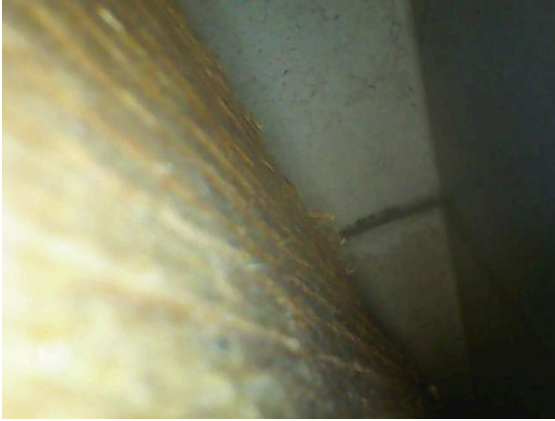
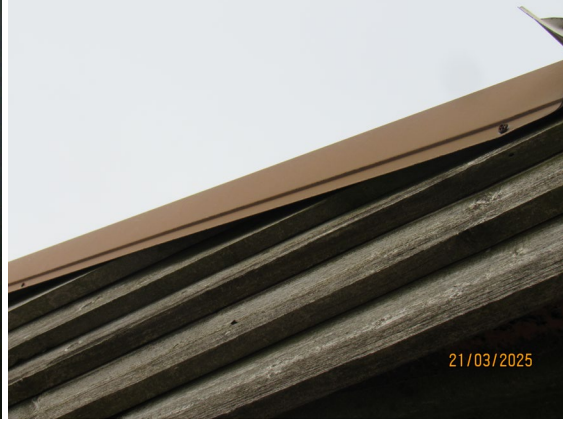
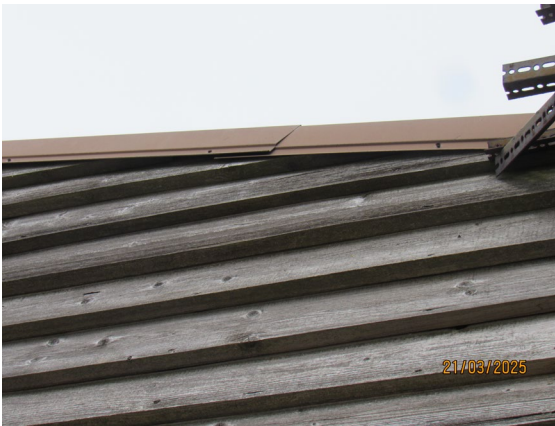
On the southern elevation there is a pressed steel verge flashing which has gaps under the pressed metal where it covers the timber cladding. This provides a poor place of shelter for individual crevice dwelling bats but the likelihood of use is exceptionally small due to the rapid heating and cooling of the pressed metal.

**Bat roosting opportunities for individual bats; Moderate.**

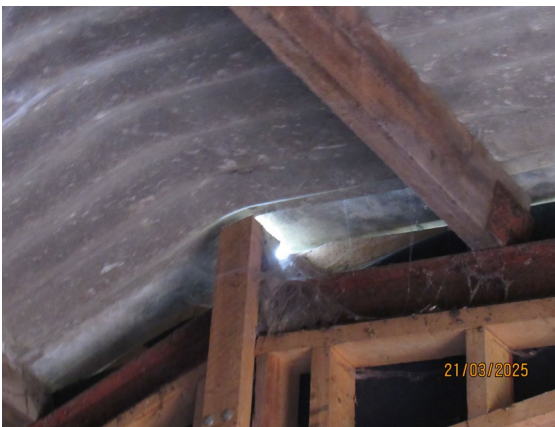
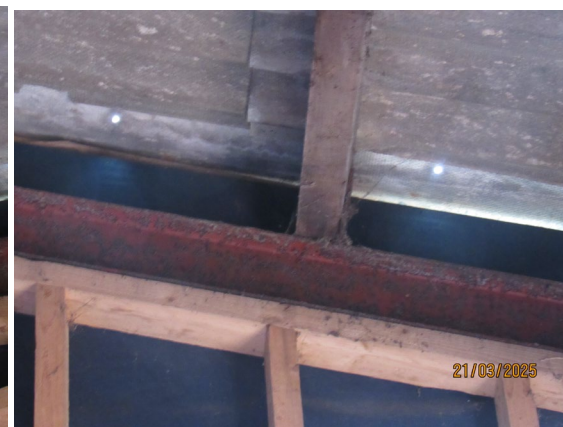
There are no bird nesting opportunities in the lined area of the building but there are nesting opportunities on the steel frame of the unlined bay.

If birds begin to nest in any of the areas being developed between the beginning of March and the end of August in any year then work must stop until the young have fledged.

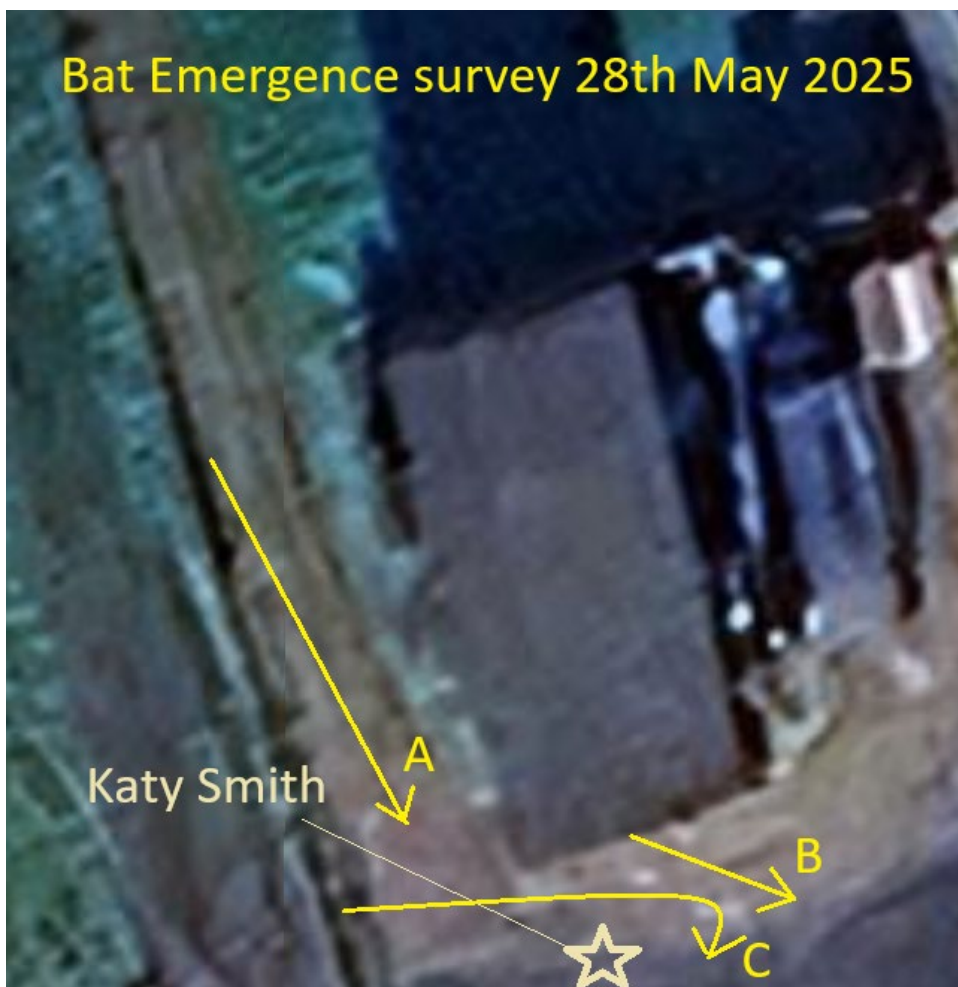
## Bat Emergence survey 28th May 2025

An emergence survey has revealed two Common pipistrelle bats emerging from behind the pressed metal verge flashing at 21.38.

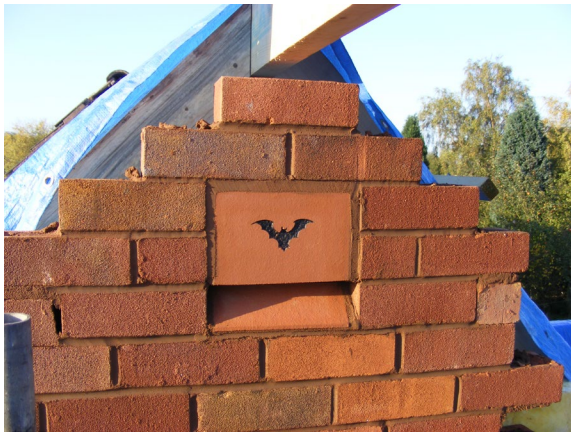
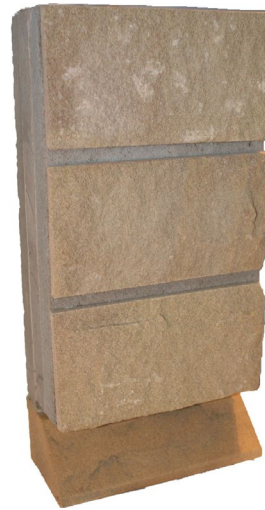
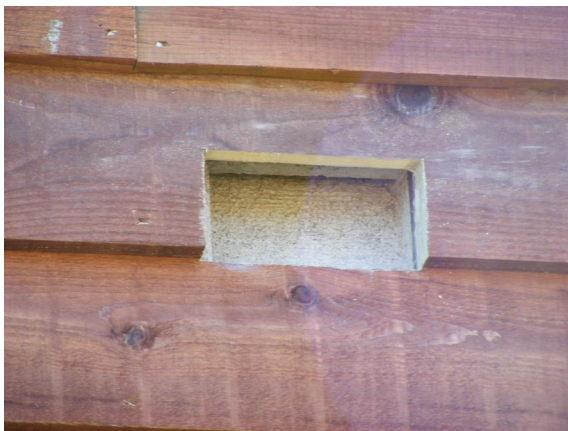
An integrated bat box can be installed at the gable apex of northern and southern elevation of the replacement dwelling, should planning permission be granted. These are constructed from brick or concrete blocks and are built into the outer leaf of brickwork. They can have facing bricks, can be rendered or built behind the timber cladding with a suitable access slot for bats. They provide no access to the cavity wall.

They are made by a number of companies including Wienerberger, Ibstock Brick, Habibat and Schwegler.
