## Preliminary Roost Assessment

6 Chapel Street, Stapleton, Leicester, Leicestershire, LE9 8JH

This report is prepared to inform a planning application with Hinkley and Bosworth Borough Council. The proposal is described as: Single storey side and rear extension with new front porch.

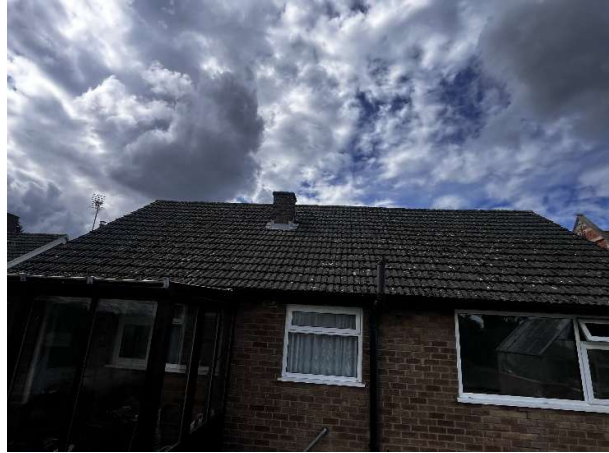
| <p><i>Summary</i></p> <p>B1 is a bungalow with brick walls and concrete roofing tiles. The interior of the roof has been lined with bitumen felt. The building will be subject to an extension which will impact the roof.</p> <p>A small number of droppings (&gt;5) were found within the loft space near to the loft hatch.</p> <p>The building has <b>high habitat value</b>.</p> | | | |

| <i>Recommendations</i> | <p><b>Roosting habitat [Buildings]</b><br/>Three bat emergence/re-entry surveys are required on B1 during the active bat season (May – September) to confirm presence/likely-absence of bats roosting in or on the building.<br/>These survey visits should be completed during the optimal survey period mid-May to August inclusive. The survey visits should be at least three weeks apart.<br/>Sub-optimal: early May and September. Would require greater justification of timing e.g., weather conditions, known local bat activity.<br/>One of the surveys could be a dawn re-entry survey, or all three can be at dusk if supported by night vision aids (NVA).<br/>Four surveyors are required to provide full coverage of the building's elevations to look for emerging/re-entering bats. An infrared camera should also be employed as part of the survey to see where any specific roost locations are located.<br/>Lighting mitigation may be required based on the outcome of the night bat survey(s).<br/>If any bat roosts are confirmed from this survey schedule, a bat licence would be required to demolish the buildings as it would involve the destruction of roosts. This is applied for with the help of a class 2 licensed bat ecologist after planning permission is granted, but before commencement of works.</p> <p><b>Roosting habitat [Trees]</b><br/>Any trees on site are to be retained.</p> <p><b>Foraging and commuting habitat</b><br/>No further surveys are required.</p> <p><b>Artificial lighting</b><br/>A low impact lighting strategy will be adopted for the site during post-development which outlines the areas of the site that will be retained as dark corridors. Parameters can be found on the Bat Conservation Trust website: <a href="https://www.bats.org.uk/our-work/buildings-planning-and-development/lighting-2">https://www.bats.org.uk/our-work/buildings-planning-and-development/lighting-2</a></p> <p><b>Suggested biodiversity enhancements</b></p> |

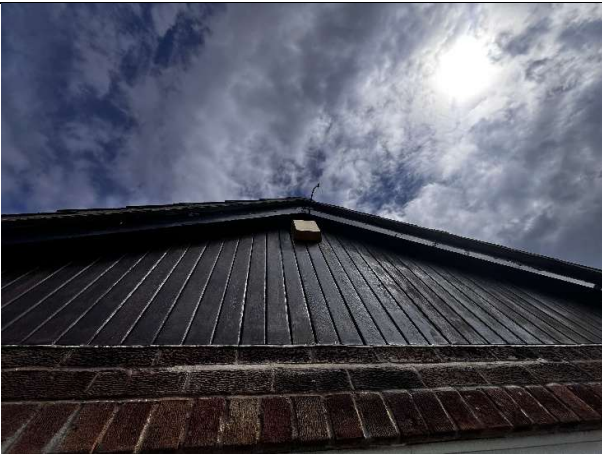
| Walls | Brick and mortar and timber cladding on the southwest gable end | <p><b>Condition/description</b></p> <p>Brick and mortar are in good condition with no missing bricks or gaps present.</p> <p>Timbers are flush and provide no gaps or crevices.</p> <p><b>Suitability/access/evidence of bats</b></p> <p>No suitability for roosting bats due to lack of access to internal structures.</p> | |

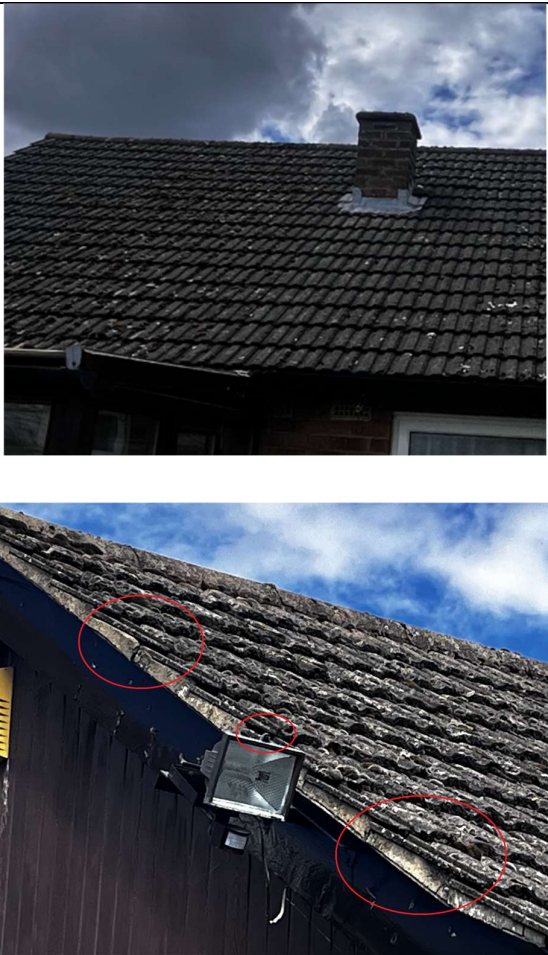
| Roof | Concrete | <p><b>Condition/description</b></p> <p>Gabled roof. Slightly raised tiles present throughout with two prominent areas of lifted tiles along the edge of the southwest gable end.</p> <p><b>Suitability/access/evidence of bats</b></p> <p>Space under tiles could accommodate crevice dwelling bats. Due to the size of the roof and the sheer volume of available habitat, this is suitable to support maternity roosts of crevice dwelling bats. No evidence found but recent and current rain would wash this away externally</p> | <div>0</div> <div></div> |

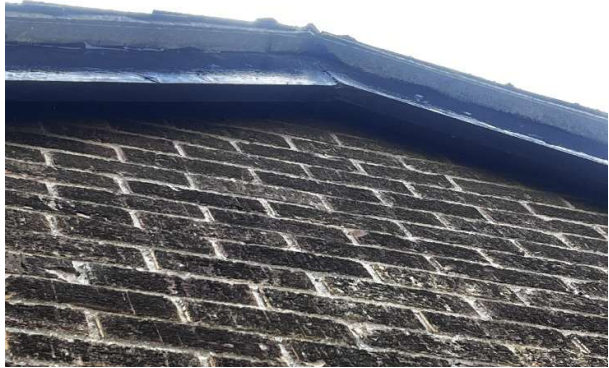
| Eaves | Overhanging | <b>Condition/description</b><br>Gaps/crevices on wall tops.<br><b>Suitability/access/evidence of bats</b><br>Provides possible bat access into internal void and crevices on wall tops. No evidence found but recent and current rain would wash this away externally. Could support maternity roosts of crevice dwelling bats. | |

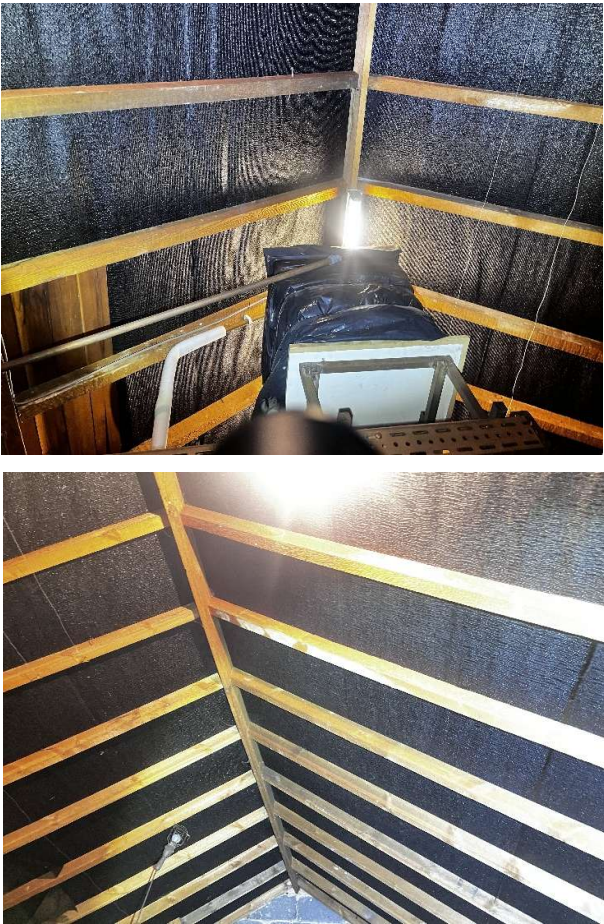
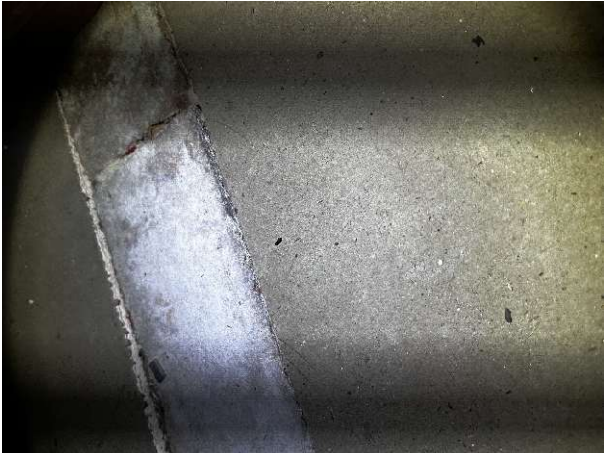
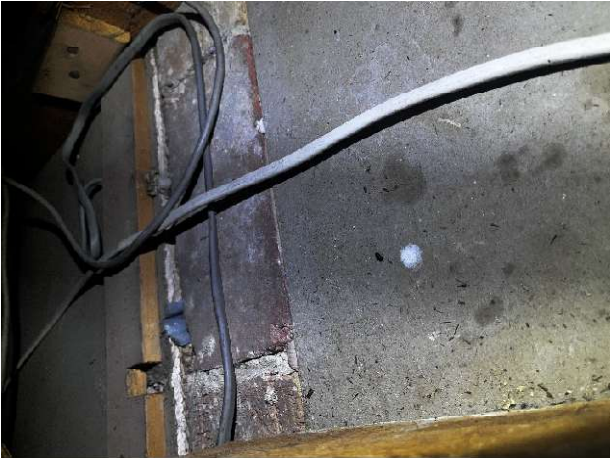
| Internal voids | Timber rafters and ridge beam.<br>Bitumen lining. | <p><b>Condition/description</b></p> <p>Internal space measures approx. 10m long, 5m wide, floor to ridge height approx. 1.5m.</p> <p>The internal timbers appear to be original, but no not have any cracks or crevices within the timbers. There are gaps between the timber and bitumen lining.</p> <p>The bitumen lining is in good condition but there are gaps where the sheets overlap.</p> <p>Temperature: 19°C</p> <p>Humidity: 60%</p> <p><b>Suitability/access/evidence of bats</b></p> <p>Low numbers (&lt;5) bat droppings were found on floorboards of the loft void of the building. Samples were collected for DNA analysis.</p> <p>Droppings are from common pipistrelle and brown long eared bats. Bat dropping locations shown in appendix 1 and bat DNA analysis is shown in appendix 4.</p> | |
