Land to rear of
Sherwood, Nutts Lane,
Hinckley

**PRELIMINARY ROOST
ASSESSMENT FOR BATS
AND BARN OWL SURVEY**

Report No. 20636.PRA.BO.V1

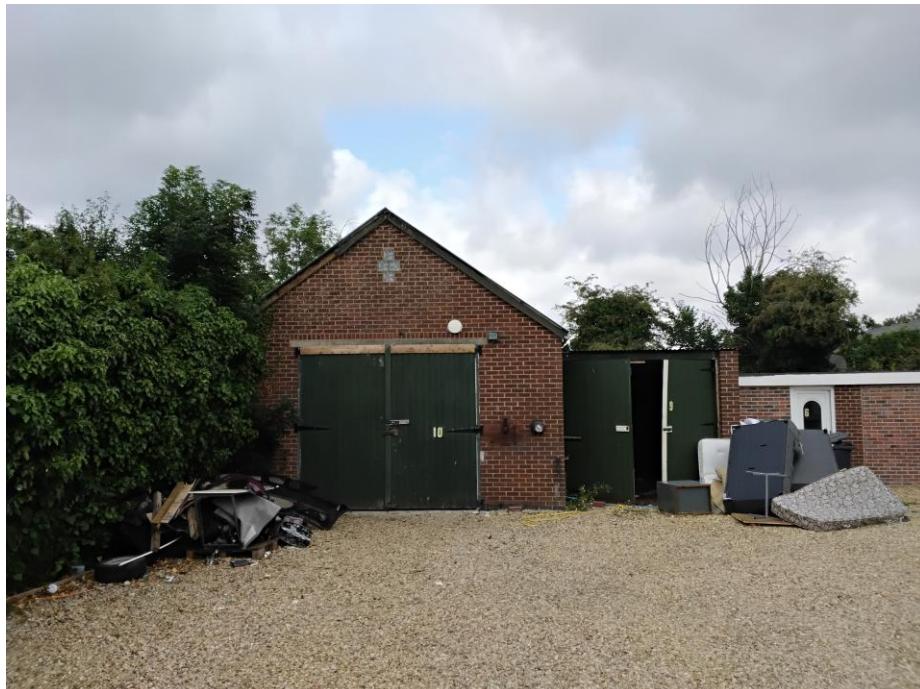
The Site comprised a shingled yard, at the western end of which was a building comprising a single storey gabled garage (Photo 1) from which flat roofed extensions extended to the northern boundary (Photo 2). Four mobile homes were also present on the Site.

The main garage comprised a gabled brick structure, with single skin walls and as such no cavity present. A tightly sealed glass window was present on the northern gable. Wooden fascia and barge boards were present, though on the southern gable end there was evidence that ivy had been growing under the barge board and had been removed. Ivy stems filled the gaps along much of the length, with the rest of the gap between the board and brickwork appearing cobwebbed. The roof comprised corrugated metal panels lined with MDF boarding supported

Photo 1: Main garage of the Site, with extensions on the northern elevation

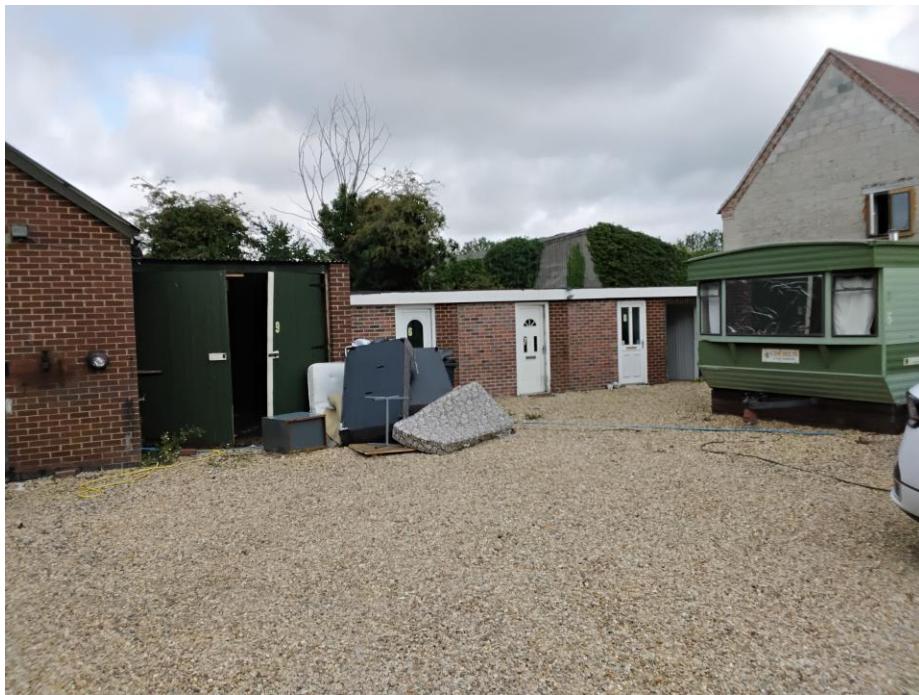
A single record of barn owl was returned, dating from 2021 and nesting within a barn owl box in a farm barn 10m west of the Site. No access was available to this barn, though the record is believed to be associated with the metal framed and ivy covered barn which can be seen in the rear of Photo 2.

An additional single storey section, comprising brick walls and a flat felt roof, extended to the north. This comprised four rooms, three as bedsits and a fourth storage room. No loft space was present within this section. A uPVC fascia board was present on the eastern elevation, with small gaps noted along its length which could provide an access point for bats, however, no evidence of bats were noted around these features.

Photo 2: Flat roofed section at the north, with mobile home typical of the Site also visible to the right of shot.

A nearby record of nesting barn owl was identified within a barn owl box in a barn in the field, located approximately 10m west of the Site boundary. This barn can be seen in the rear of Photo 2 and west of the Site on Figure 2. No access was available to this land parcel or the barn within which the barn owl had been recorded; though based on the appearance of the barn and the immediate surroundings it was considered that barn owls using the structure would exit the barn to the north or west to forage over the open field in that direction; rather than flying to the urban areas to the south and east.

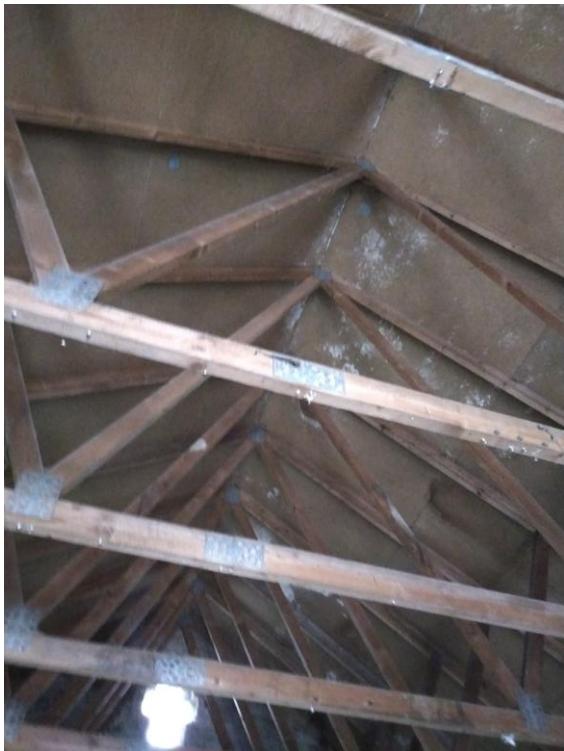
by a prefabricated wooden truss. No ridgeboard was present. Gaps at the eaves and behind the soffit provided access into the gap between the roof panels and the MDF lining; however, the metal roof would experience thermal fluctuations with weather that was considered to reduce its suitability for roosting bats. Evidence of damp was present across the internal roof and was considered such that any roosting potential would be reduced, and the trusses were cobwebbed.

Left: Photo 3 – Roof void of the main garage. The roof was lined with MDF boarding, with evidence of damp throughout.

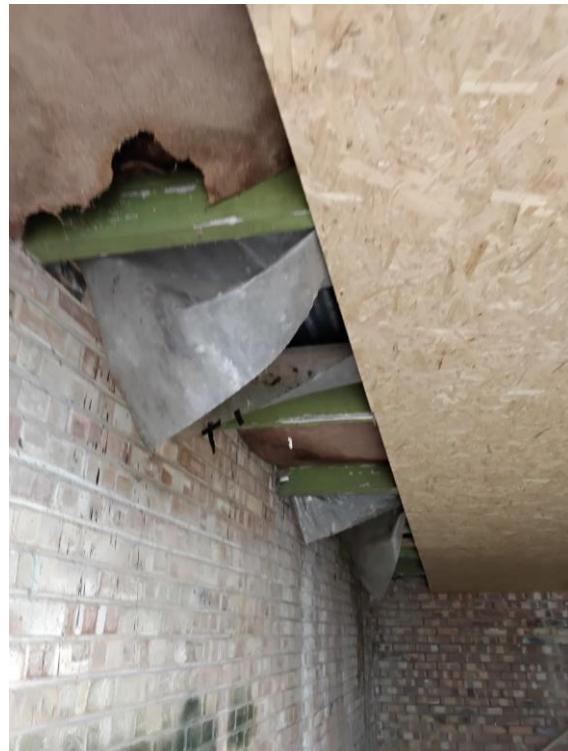
Another garage adjoined the northern wall of the main section. This was a brick structure with a roof of corrugated metal panels. An MDF ceiling was attached to the roof joists, creating a gap approximately 10cm high between the ceiling and the roof panels. No evidence of bats was identified within this section of the building.

Right: Photo 4 – Interior of flat roofed garage showing the void between ceiling and roof panels.

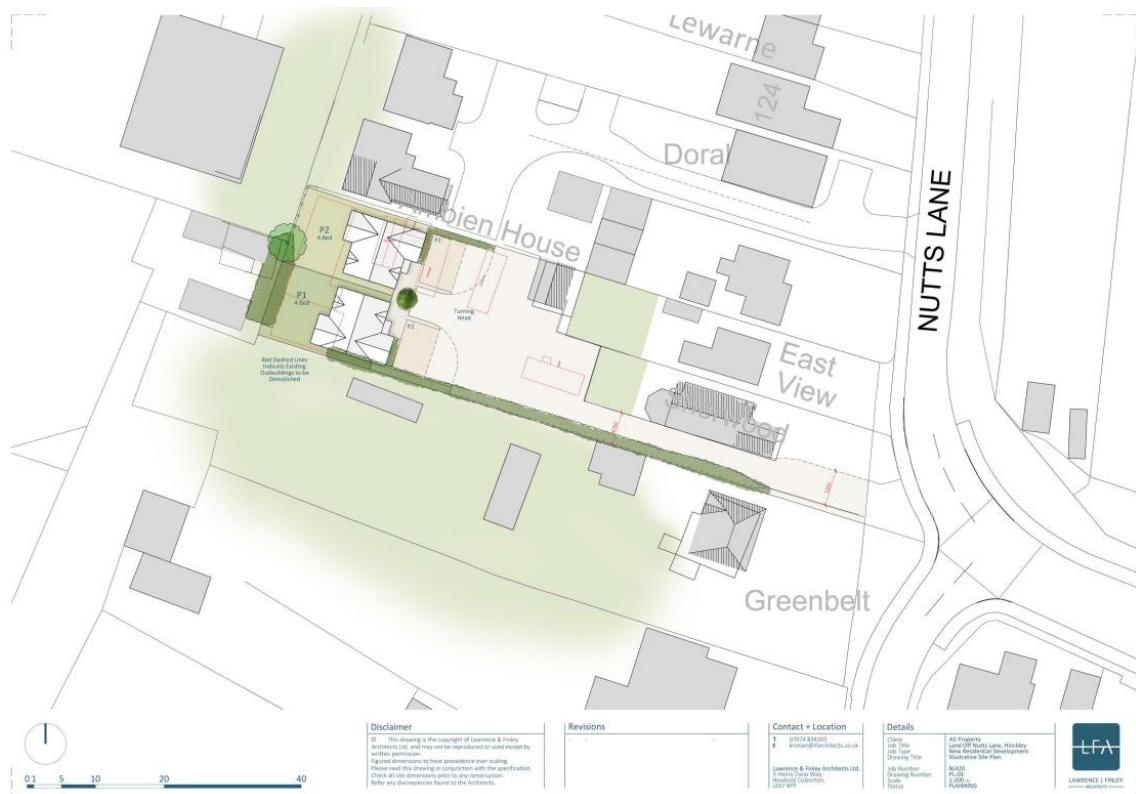
The proposals involve the demolition of the existing buildings and removal of the static caravans to facilitate the construction of two residential properties and associated gardens at the Site. For the purposes of this report, Lawrence Finley Architects drawing NJ420_PL-03_Illustrative Site Plan has been used to assess the impacts of the proposed design.

Figure 2: Proposed Site plans
