# GeoShield Verification Report

PROJECT REFERENCE: GEO103990

PROJECT: Aldi Bardon

SPECIFICATION: Verified in accordance with CIRIA 735.

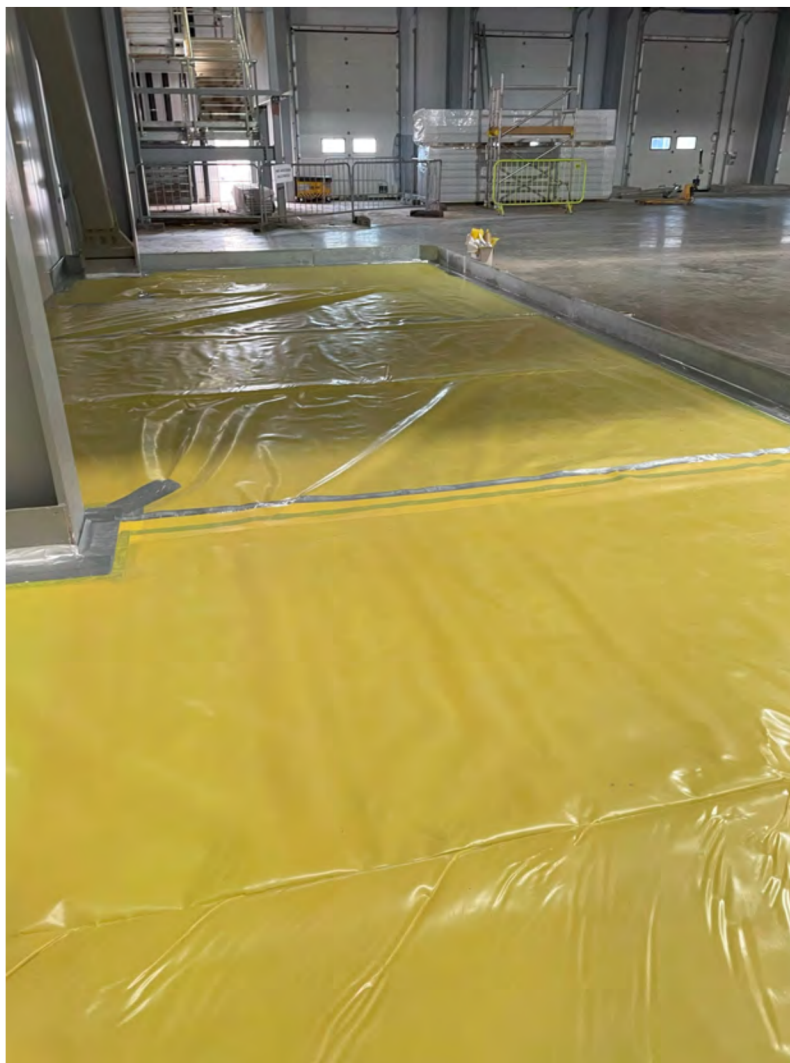
## OVERVIEW PHOTOGRAPHS

Overview of an area of installation

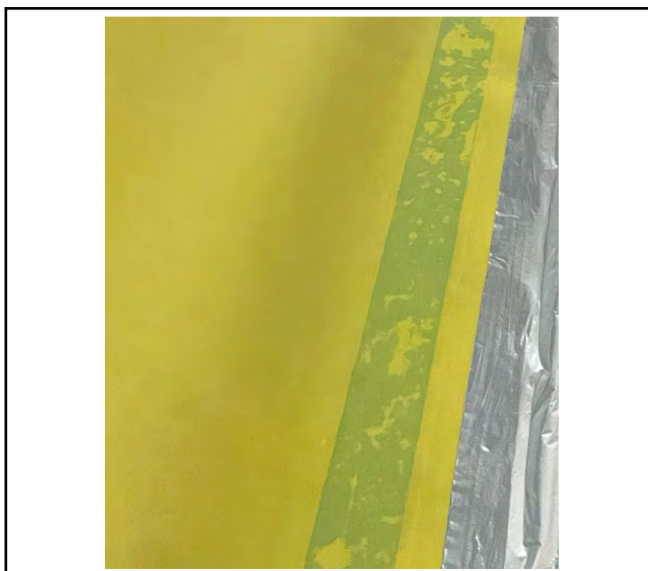
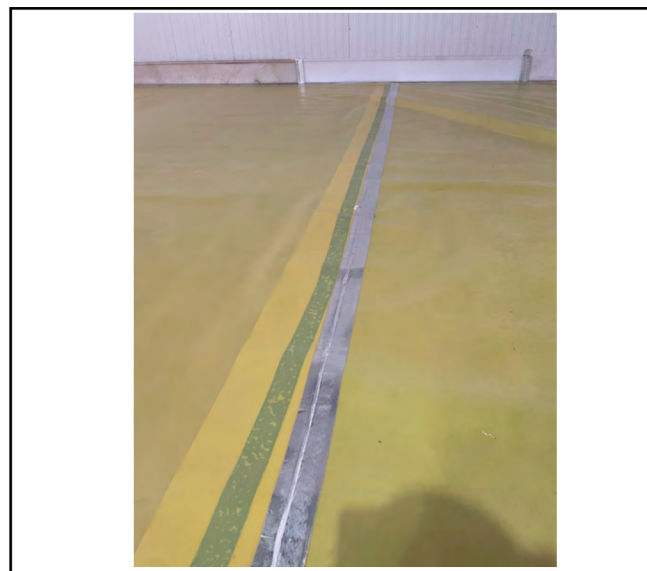
## VERIFICATION ITEM TWO

NOTES: Visqueen Low Permeability Membrane - Lap Joints

The Visqueen Low Permeability Membrane has been taped with a combined system

Using Visqueen Double Sided Butyl Tape (the initial seal) and a second seal using the

Visqueen ProDetailing Tape. As can be seen the double sided butyl tape has been

used to seal the lap between the two adjacent sheets of the Visqueen low

Permeability Membrane ensuring the continuity of the membrane as per the

manufacturer's specifications.

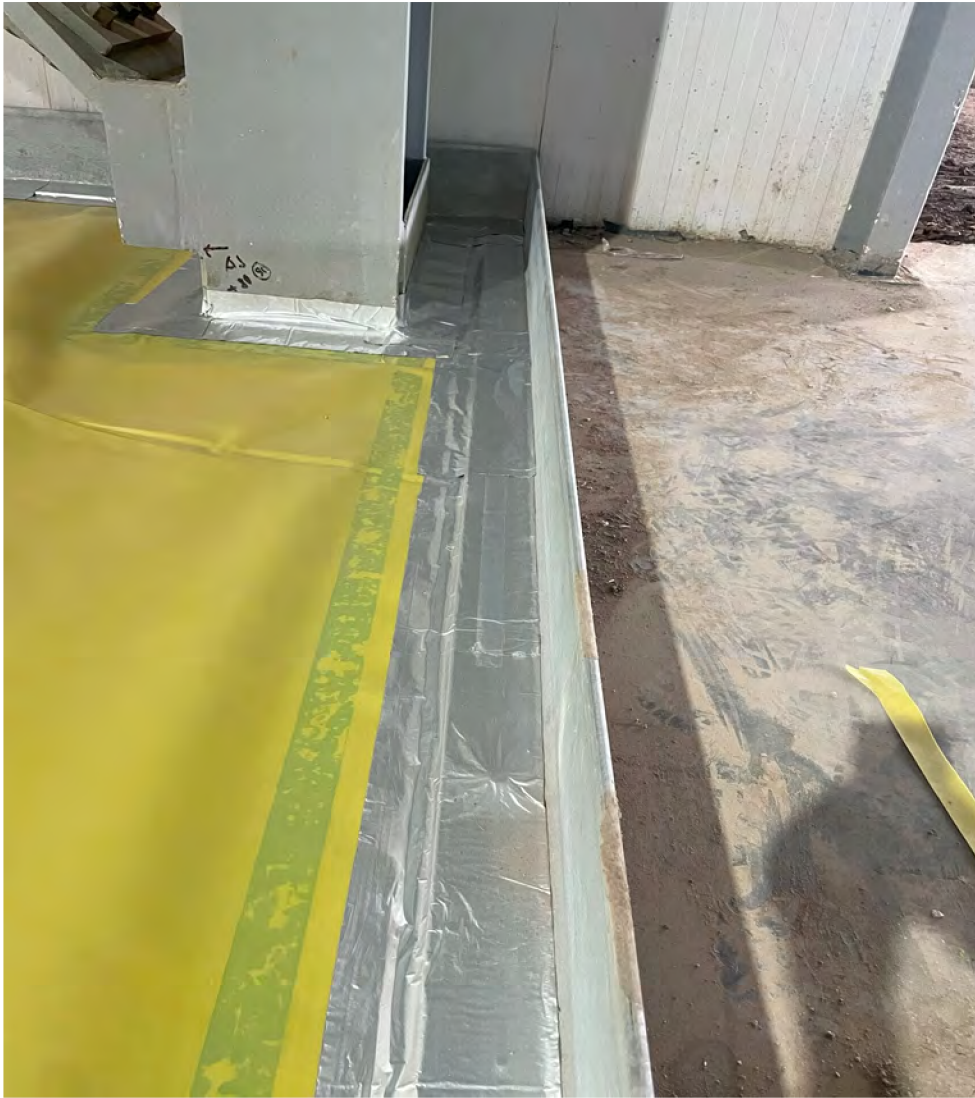
## VERIFICATION ITEM TWO

As can be seen from the above image all detailing has been carried out using the Visqueen detailings strip, heat has been applied to ensure a strong and robust seal has been achieved.
