Preliminary Bat Roost Assessment (PRA)  
and Barn Owl Presence / Absence Survey

**The Barn at Willow Farm**

April 2023

| <b>Report Reference</b> | 23121 – Bat and Barn Owl Survey Report |

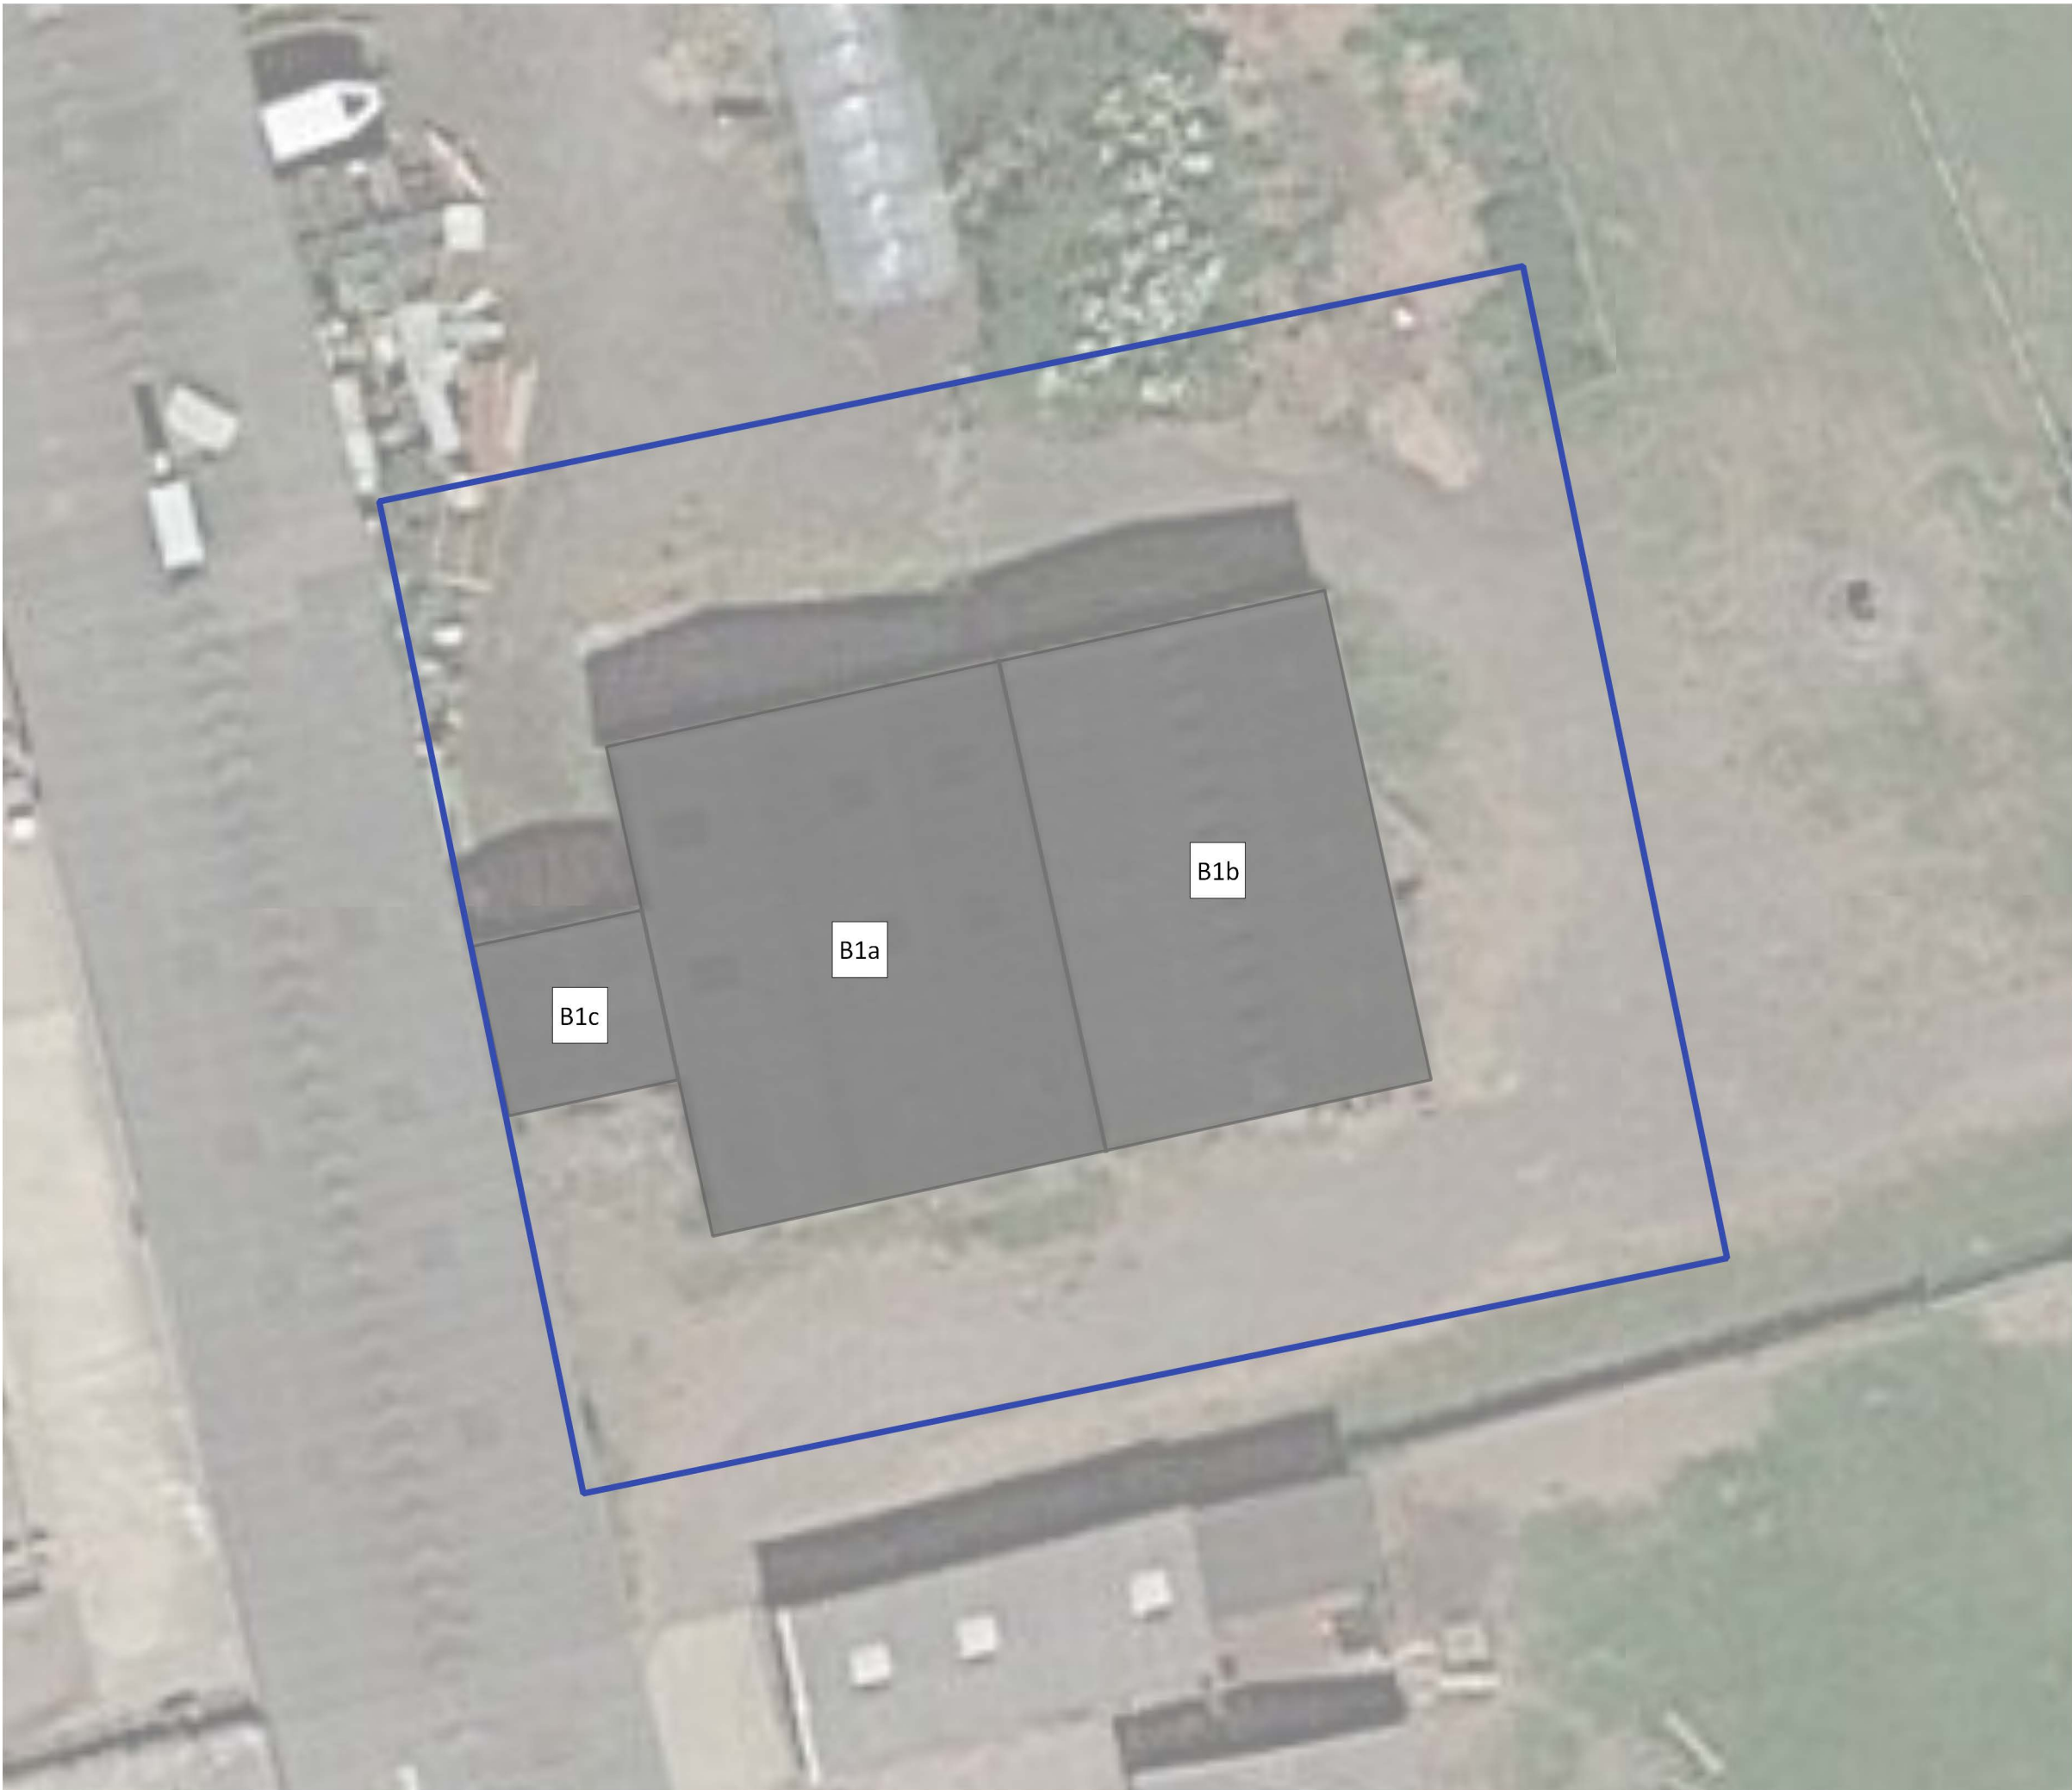
# **Plan 23121-PRA1**

Preliminary Roost Assessment and  
Barn Owl Presence / Absence Survey Results

Building with 'Negligible' Bat Roosting Potential

\* No evidence of bats was recorded within the building, with all minor accessible features able to be inspected by torchlight and / or endoscopic inspection.

No evidence of Barn Owl activity, or Barn Owl perching / roosting, was recorded within the building, with all internal and external areas able to be inspected.

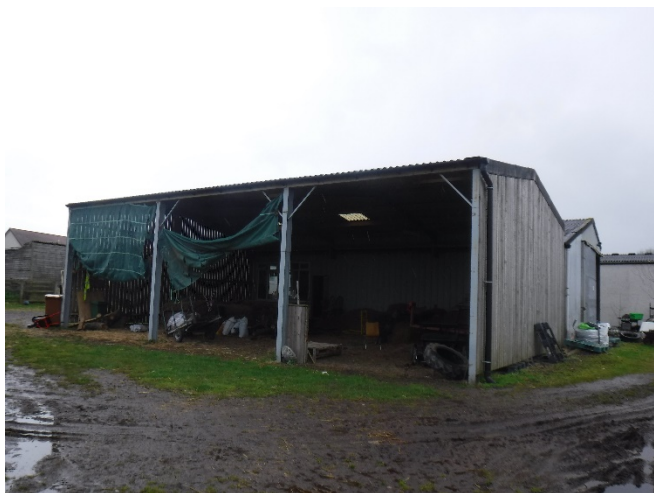
- 4.2.3. The eastern section, **B1b**, is largely steel frame and modern timber beam construction with 'hit and miss' vertical wooden cladding and supports a corrugated concrete (likely asbestos) roof, with skylights. The barn is open sided on its eastern aspect and was found to be light and draughty with negligible roosting opportunities for bats. No enclosed roof void or basements are present.

Photo 1. Section B1b – external, eastern elevation.

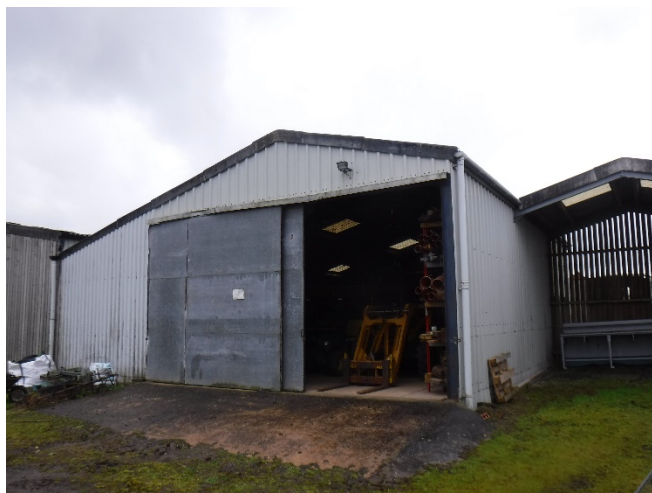
- 4.2.2. **Building B1.** A two-storey modern agricultural barn which is divided into three distinct sections, referred to as B1a-B1c on Plan 23121-PRA1. The central section, **B1a**, is largely steel frame and modern timber beam construction with corrugated metal walls and corrugated concrete (likely asbestos) roof, with skylights. B1a is in active use for storage and as a lambing shed and was found to be light and draughty with negligible roosting opportunities for bats. No enclosed roof void or basements are present.

Photo 2. Section B1a – external, northern elevation.

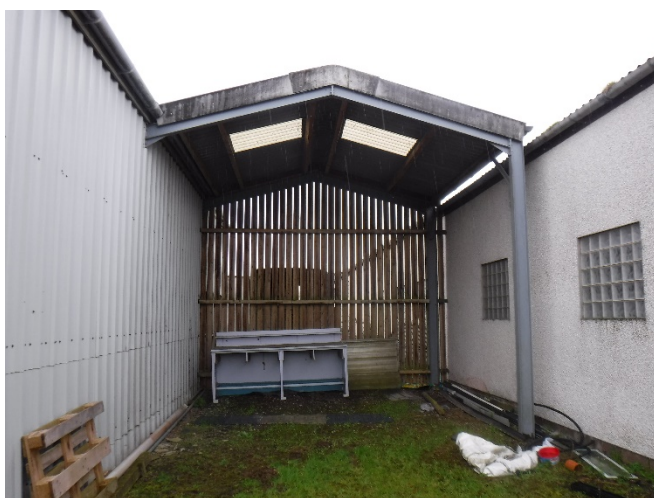
- 4.2.4. The western section, **B1c**, is largely steel frame and modern timber beam construction with 'hit and miss' vertical wooden cladding and supports a corrugated concrete (likely asbestos) roof, with skylights. The barn is open sided on its northern aspect and was found to be light and draughty with negligible roosting opportunities for bats. No enclosed roof void or basements are present.

Photo 3. Section B1c – northern elevation.

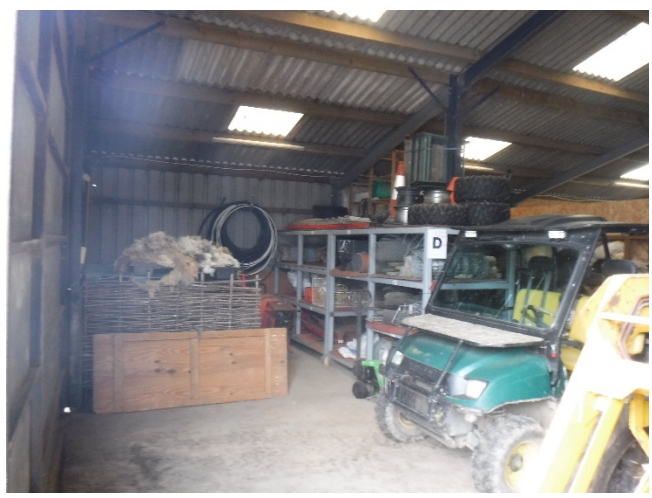
Photo 4. Section B1a – internal, machinery storage.

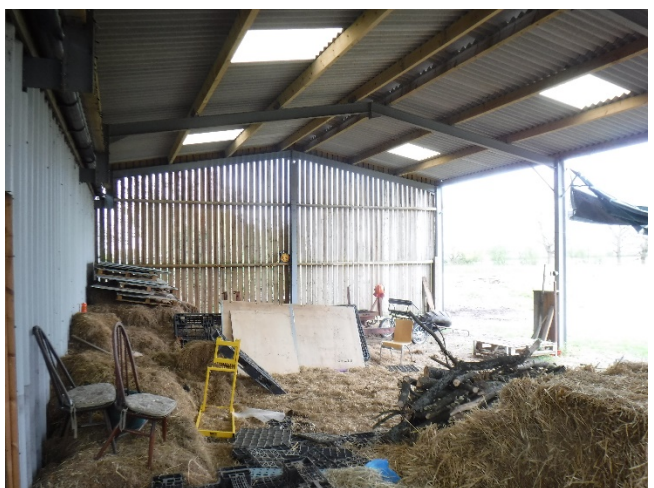
Photo 5. Section B1b – internal.

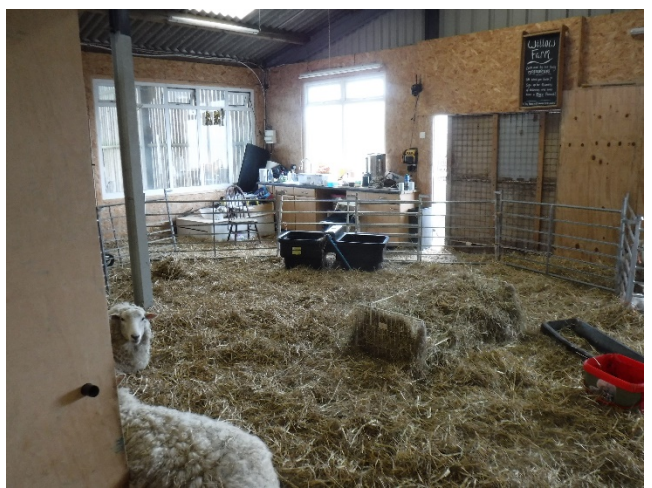
Photo 6. Section B1a – internal, lambing area.
