# Holywell Farm, Ratby

## PRELIMINARY ROOST ASSESSMENT & BAT EMERGENCE SURVEY REPORT

Report No. 250227.PRA.BES.V2

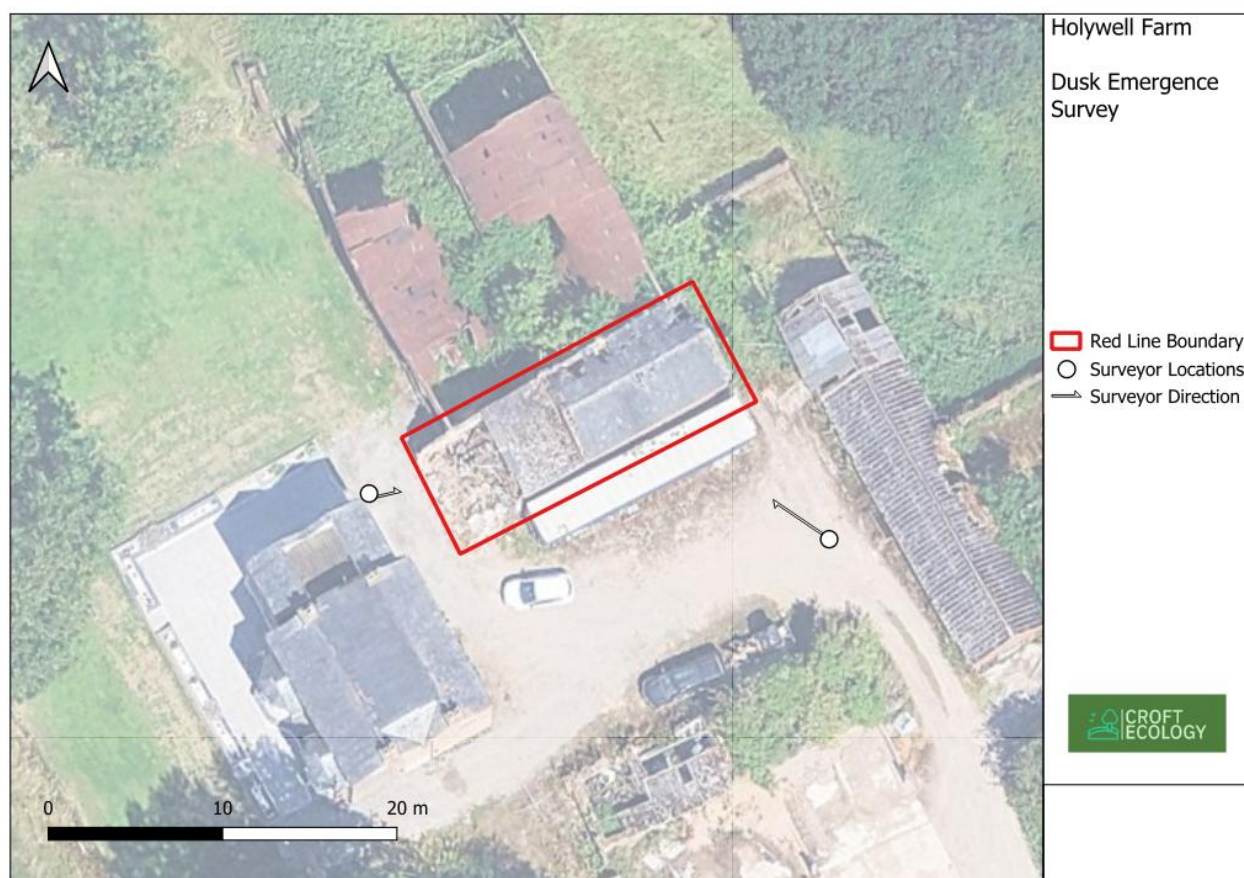
Figure 2. Surveyor and NVA positions during the bat emergence surveys

Two surveyors, equipped with EMT2 Pro bat detectors and Nightfox Whisker infrared cameras and additional infrared floodlights made observations of any bat activity or bat emergence both from and around the existing building, focusing on areas with potential roosting features. Echolocation calls were analysed with Kaleidoscope when required. An additional camera was positioned inside the eastern doorway of the upper floor to capture any bat activity within the upper floor of the building.

Surveyor and camera locations are illustrated in Figure 2, below.

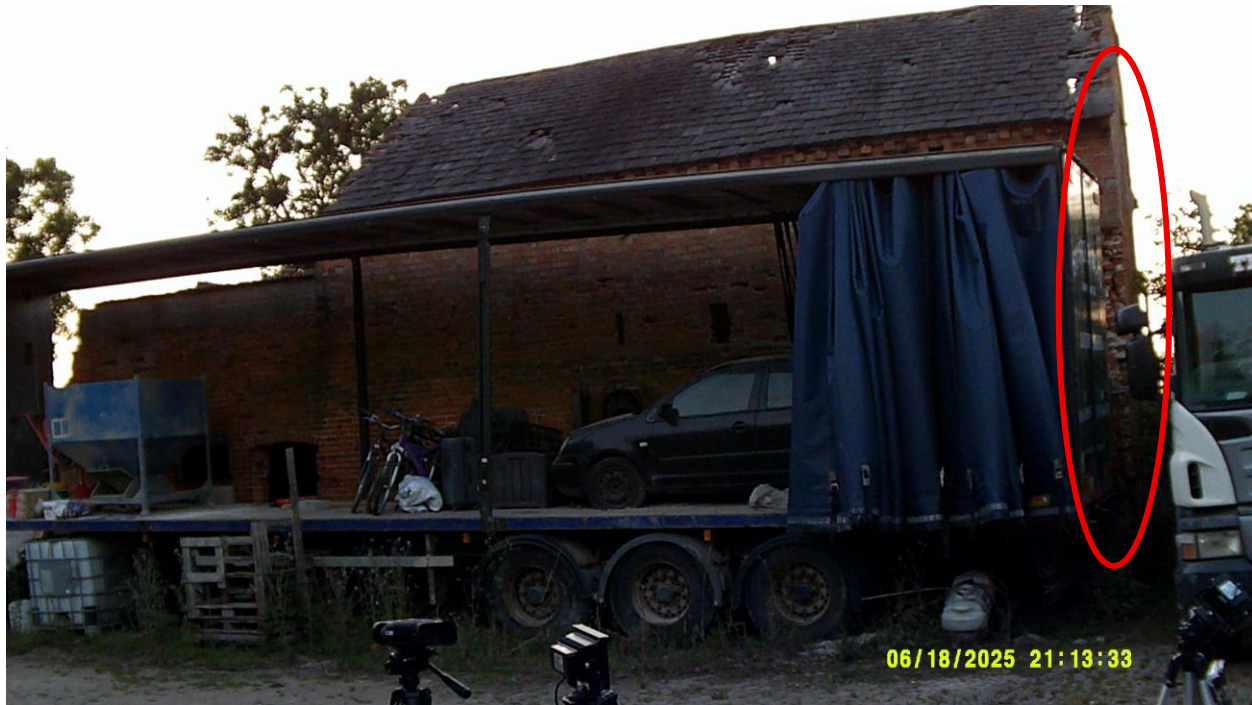
The Site comprised a gabled two-storey brick barn with a slate tiled roof (Photo 1). An articulated lorry trailer was parked in front of the southern elevation, limiting the ability of the surveyor to fully assess the front of the building. The barn was in a dilapidated state, with a large section of roof slates missing, in particular on the northern (rear) elevation, and the western end was partially collapsed (Photo 2). Access to the interior of the building was readily available via open doorways across the building, ventilation gaps in the bricks, and missing roof slates. Gaps in the brickwork were present at various locations around the building, with potential roosting locations

on top of the walls, at the eastern gable verge and apex and in a vertical fissure at the southeastern corner of the building where missing brickwork provided access to the gap between the two skins of brick forming the walls.

*Photo 1: Southern elevation of the building, with fissure at the eastern end visible at the right end of the trailer (circled), and light visible through the roof gaps.*

- Installation of exclusion devices, particularly within the southeastern fissure, and at a gap in the brickwork above the western doorway on the southern elevation, will be undertaken at least 7 days prior to the commencement of building works. These exclusion devices will ensure that bats which leave the roost location cannot re-enter. Devices must be in place for at least 7 days of good weather for bat activity (temperatures above 9°C at sunset and with no prolonged heavy rain or wind) prior to works commencing so that any bats roosting within the building have left. After a period of 7 days, if the remaining works are not ready to proceed, the exclusion devices can be carefully removed, inspected with an endoscope by a qualified ecologist and subsequently filled with expanding foam/insulation or similar to ensure no roosting opportunity remains.

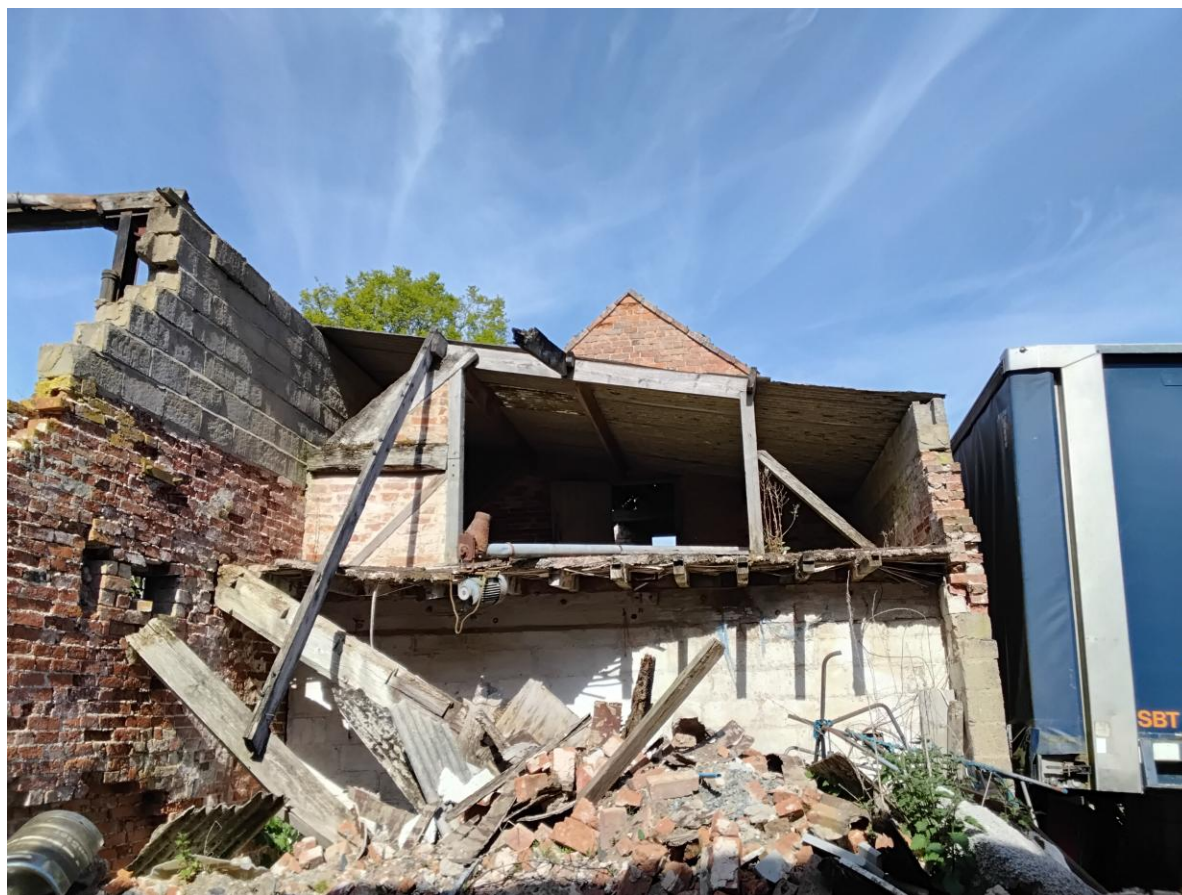
*Photo 2: Partially collapsed western end of the building.*

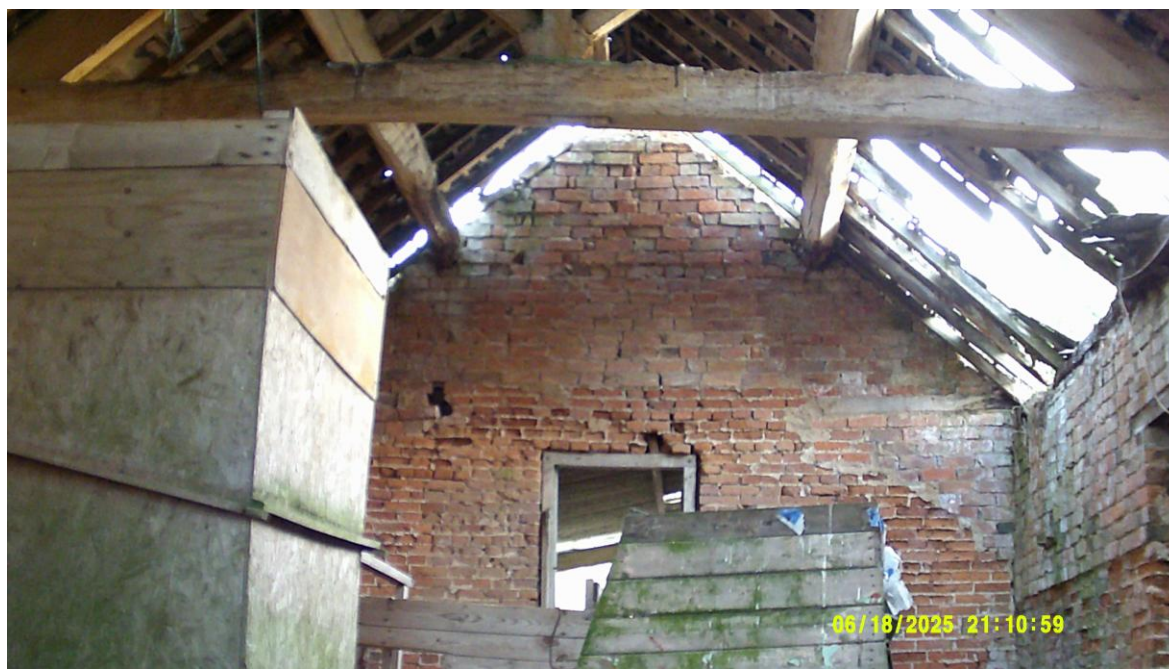
Internally the upper floor was vaulted (Photo 3), with the unlined roof slates supported by a wooden ridgeboard, battens, rafters, purlins and a king post truss. The large gaps in the roof and doorways at both gables created a light and draughty room. Two ground floor rooms were present. The eastern of these was inaccessible, while the western comprised a former stable with whitewashed brickwork and thick timbers forming the ceiling joists. Gaps were noted in the brickwork of the walls and where the joists met the brickwork, though these were largely heavily cobwebbed. A window in the northern wall allowed flighted access to the roof along with the open doorway on the southern elevation.

*Photo 3: Internal view of the upper floor*

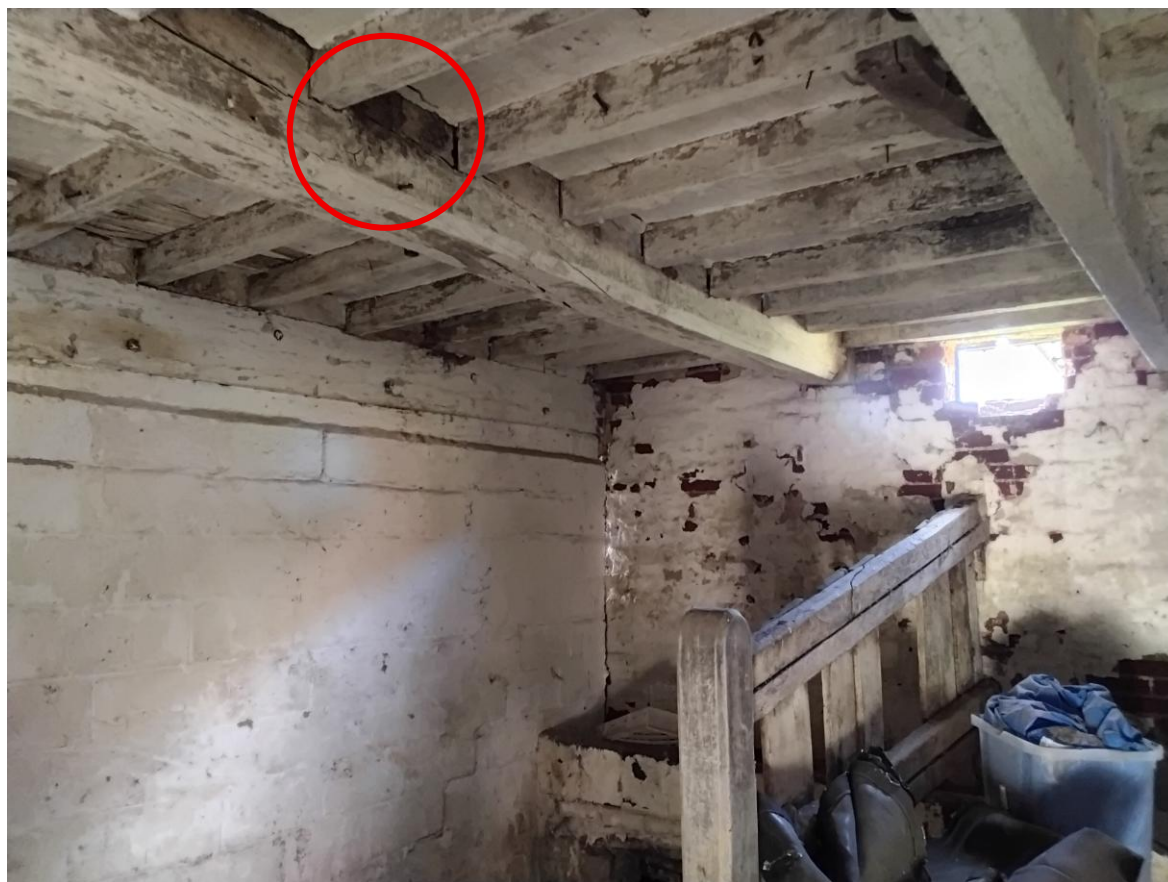
Bird nests were present, with swallow *Hirundo rustica* nests noted on the beams of the building and a wren *Troglodytes troglodytes* nesting in the hole of a missing brick (Photos 4 and 5).

*Photo 4: Western ground floor room, with birds' nest on the joist (circled).*

- Nest boxes for birds should be installed at the Site to compensate for the loss of the nesting locations within the building. For wren, this should take the form of an open fronted box installed in retained vegetation. To compensate for the loss of the swallow nesting opportunities, swallow cups should be installed inside a building or lean to at the Site. Further details on box type and location should be discussed and agreed with the architect and ecologist as proposals for the Site develop.

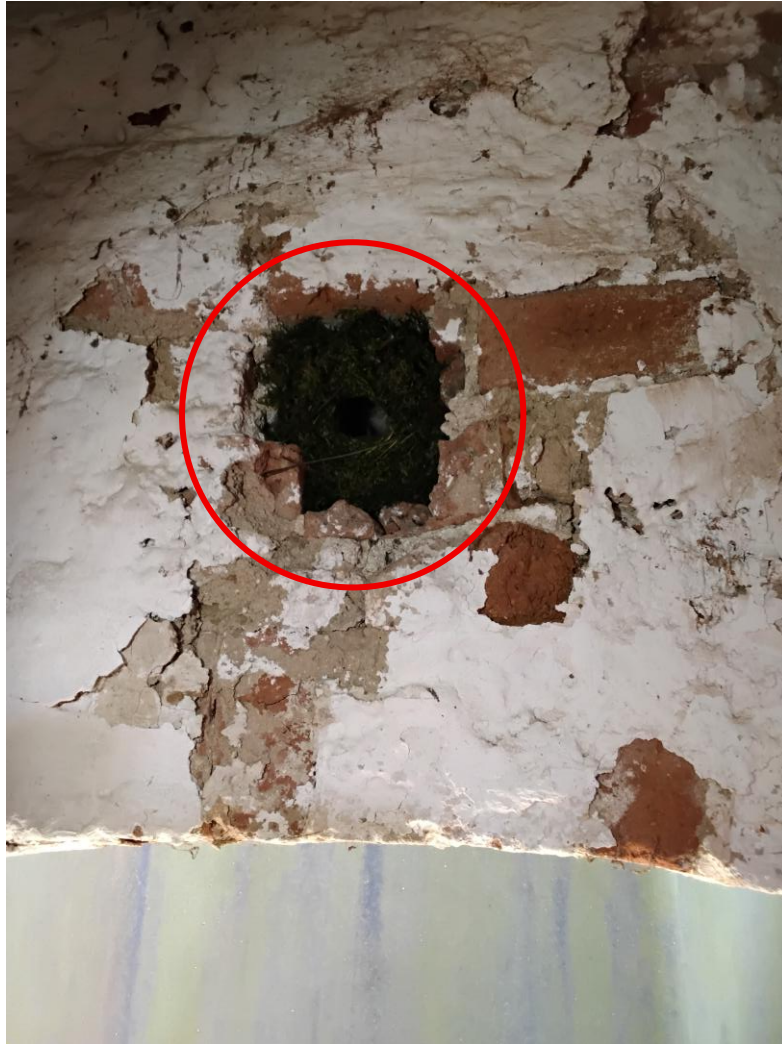
*Photo 5: Nest in brickwork above door on the southern elevation*
