**Preliminary Bat Roost Assessment and Bird  
Survey for,  
Mr. A. Angrave of Markfield Equestrian Centre.  
Buildings at,  
Markfield Equestrian Centre,  
Stanton Lane,  
Markfield,  
LEICESTERSHIRE,  
LE67 9TT.**

**Map Ref SK 4714 1127  
9<sup>th</sup> May 2024.**

**S. Christopher Smith MRICS MSc CEnv.**

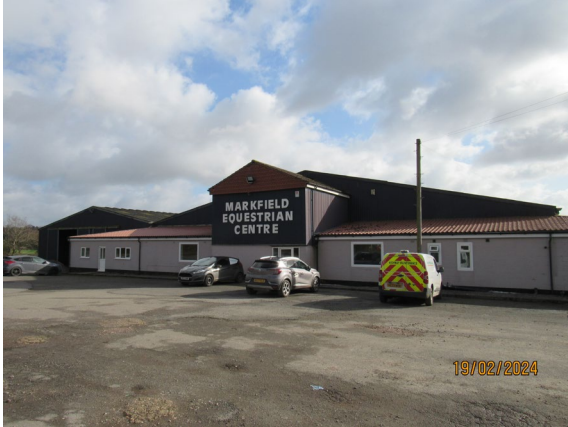
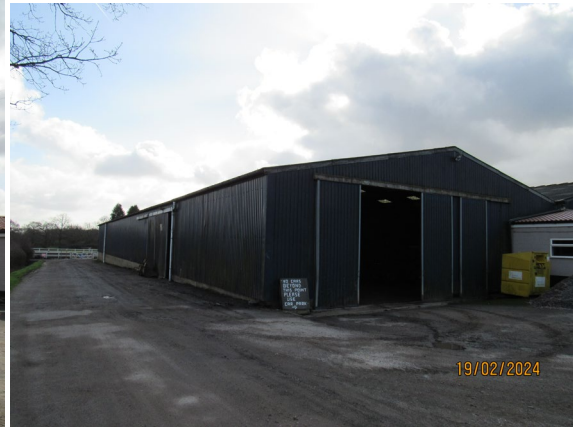
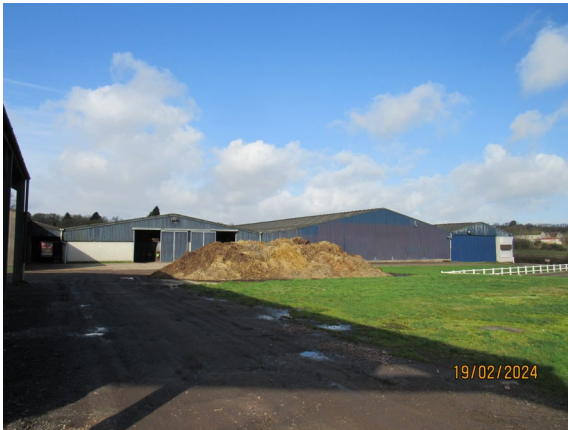
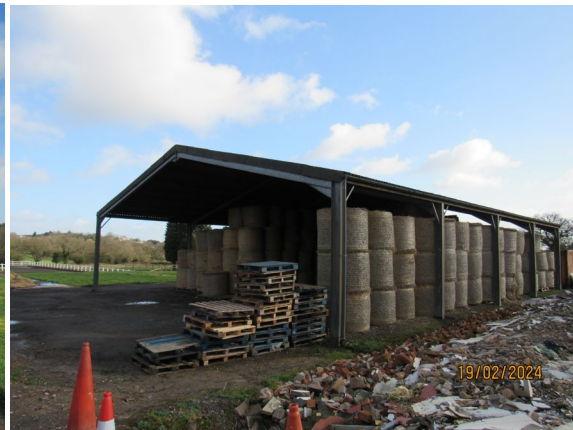
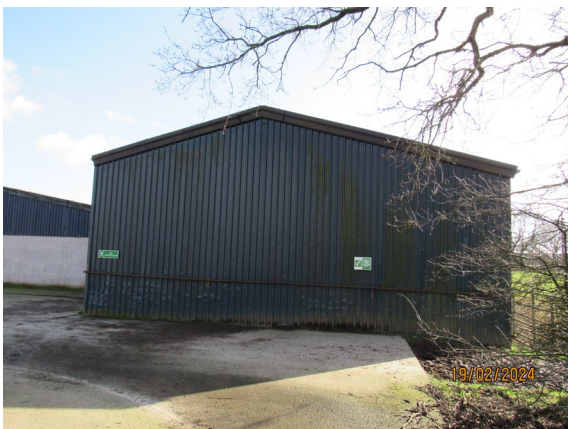
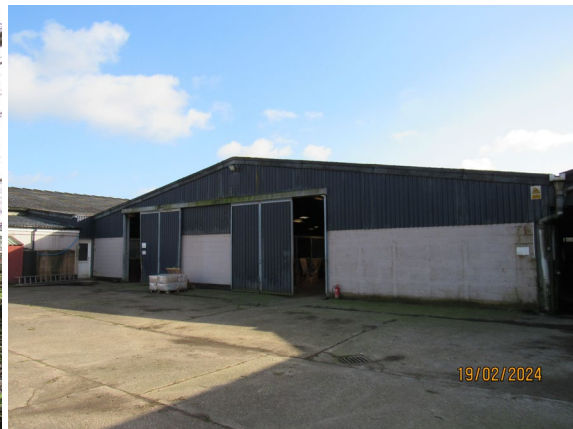
The buildings to be surveyed consisted of a group of steel portal framed buildings with a pitched roof covered with fibre cement sheets.

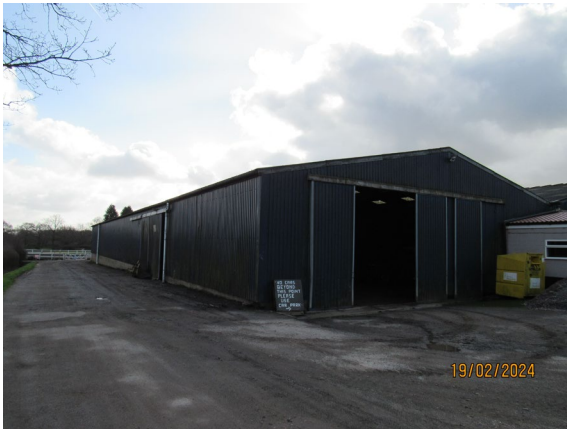
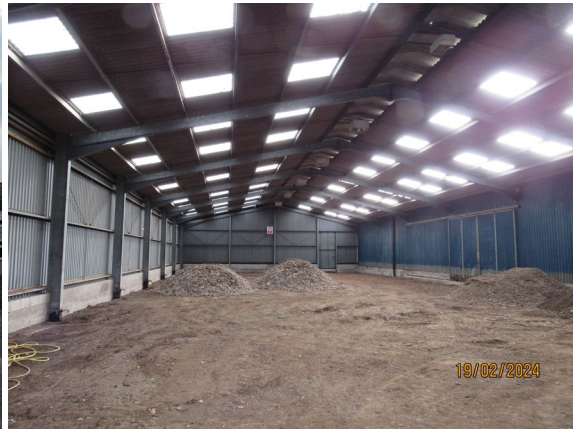
#### **Building 1.**

The building is a steel portal framed building with a pitched roof.

The roof is supported on Z section galvanized sheeting rails which offer no opportunity for bats to roost in the space between the rear of the roof sheets and the sheeting rails.

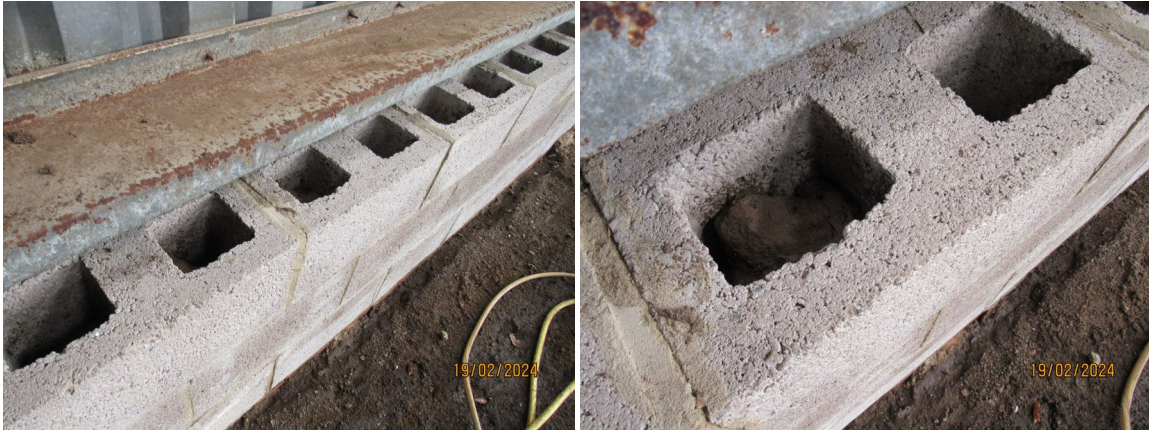
The roof is supported on Z section galvanized sheeting rails which offer no opportunity for bats to roost in the space between the rear of the roof sheets and the sheeting rails.

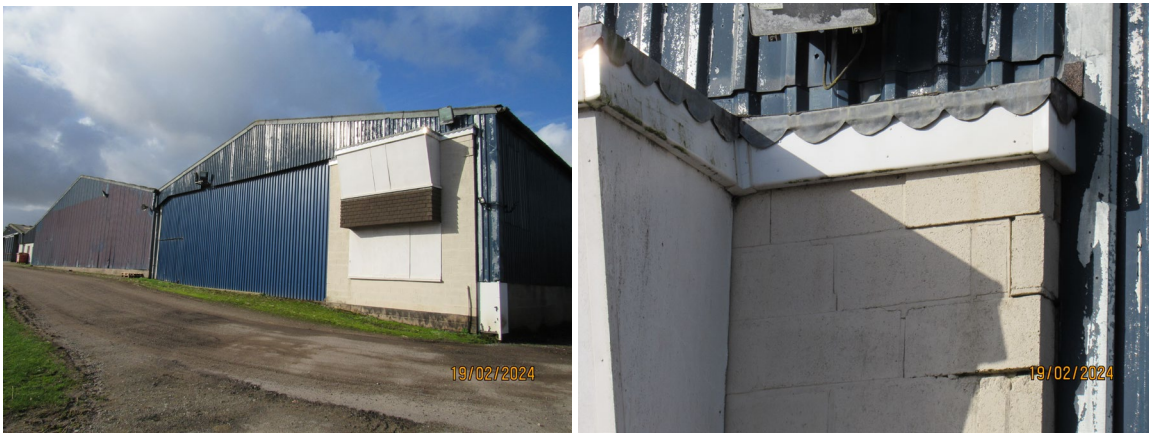
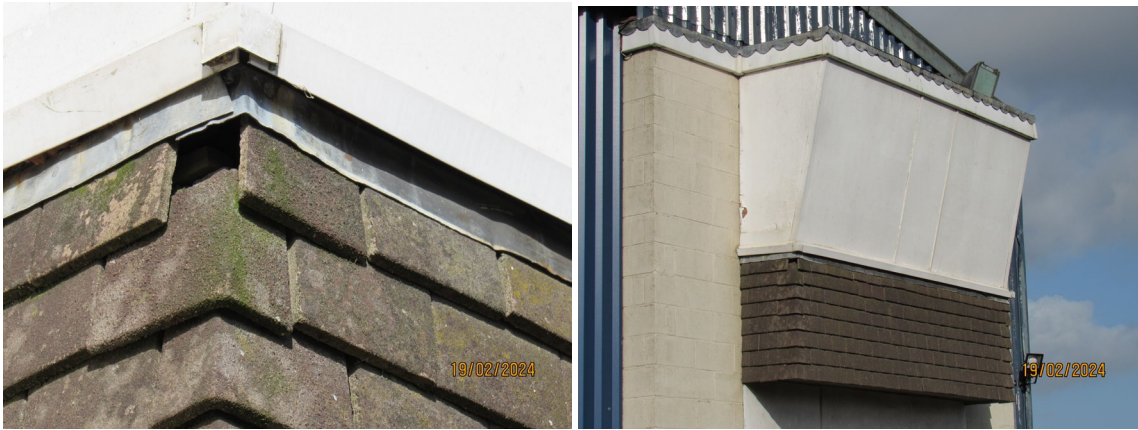
On the rear elevation there is a small office overlooking the menage. This has a mineral felt roof covering and hanging tiles. There are no bat roosting opportunities under the mineral felt roof or the uPVC fascia boards.

There is one broken hanging tiles which offers a place of shelter for bats in the rear of the hanging tiles. Emergence surveys are necessary to determine if this area is being used by bats..

Bat roosting opportunities; Possible.

Two emergence surveys of each area are required to determine if bats are using these areas as a place of shelter.

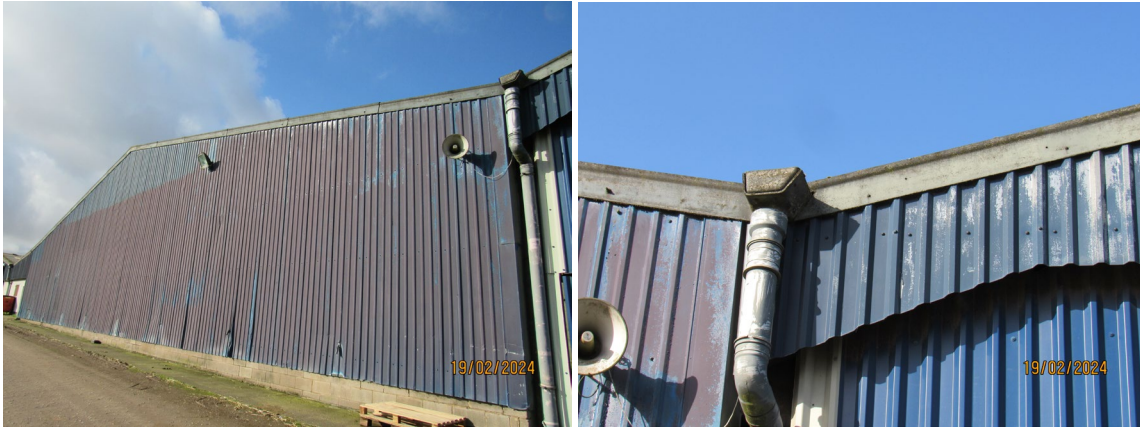
The building is a steel portal framed building with an internal menage.

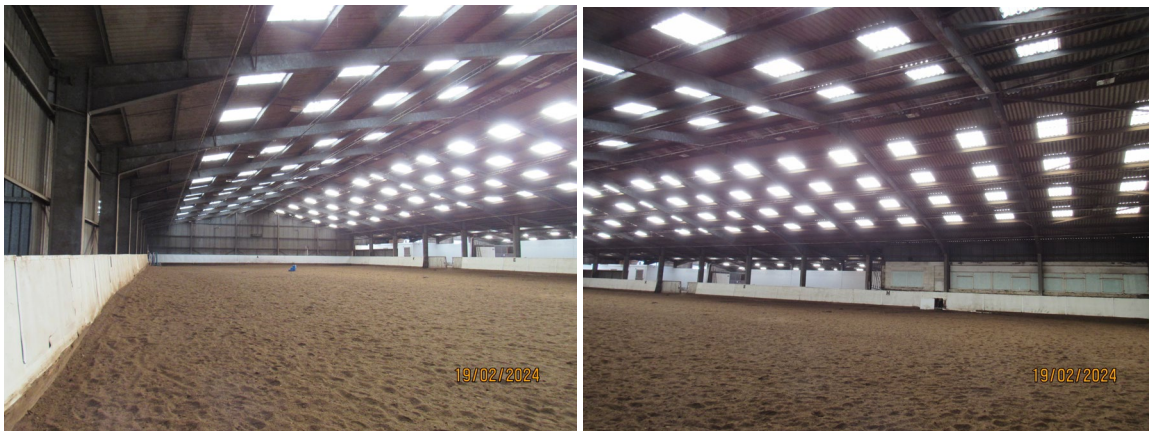
The fibre cement roof sheets are supported on Z section galvanized sheeting rails which offer no opportunity for bats to roost in the space between the rear of the roof sheets and the sheeting rails.

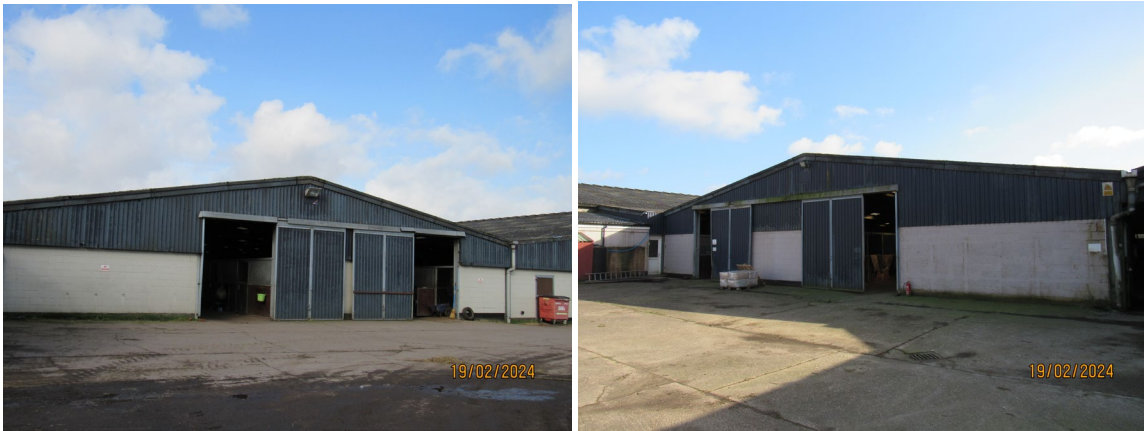
The building is a steel portal frame with an extension that adjoins Building 2.

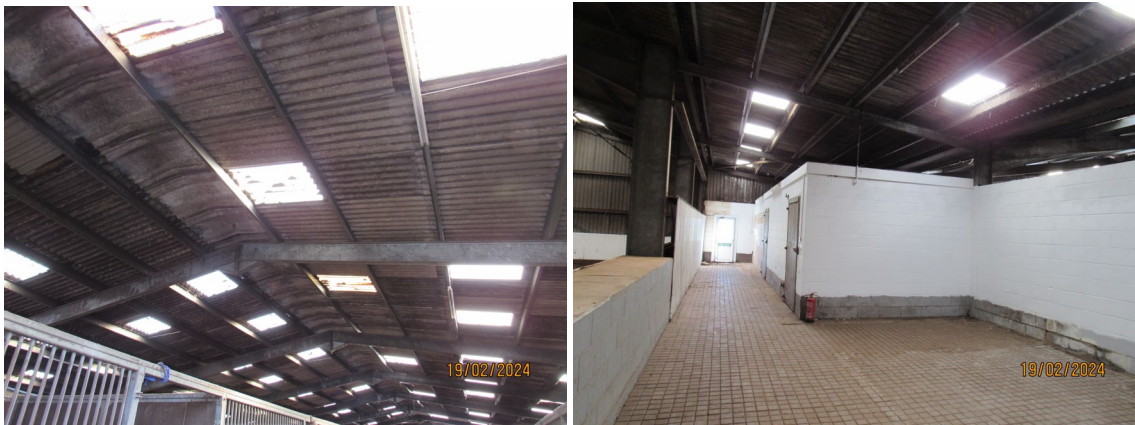
The fibre cement roof sheets are supported on Z section galvanized sheeting rails which offer no opportunity for bats to roost in the space between the rear of the roof sheets and the sheeting rails.

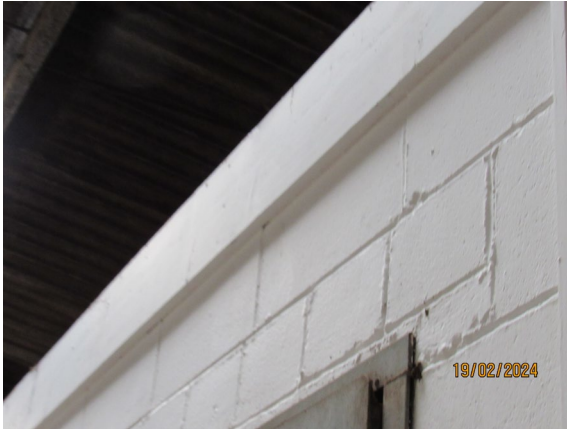
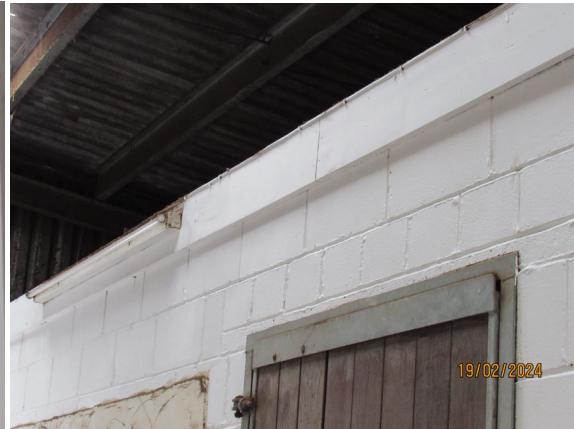
The roof is supported on Z section galvanized sheeting rails which offer no opportunity for bats to roost in the space between the rear of the roof sheets and the sheeting rails.

There is a single storey flat roofed building within the steel frame. This has a chipboard flat roof on timber joists with uPVC fascia boards. There are no bat roosting opportunities in the building.

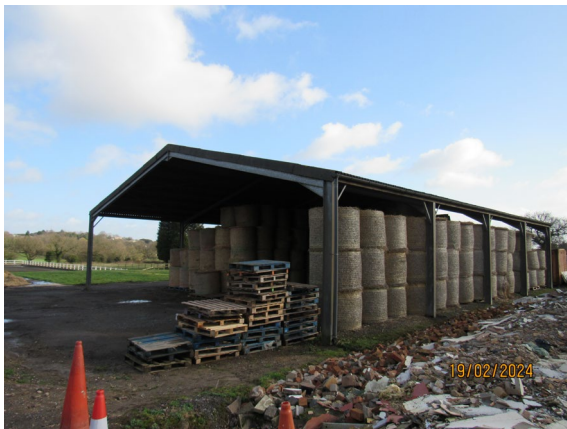
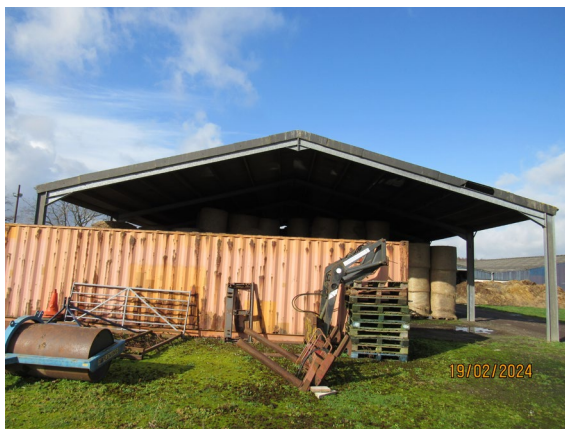
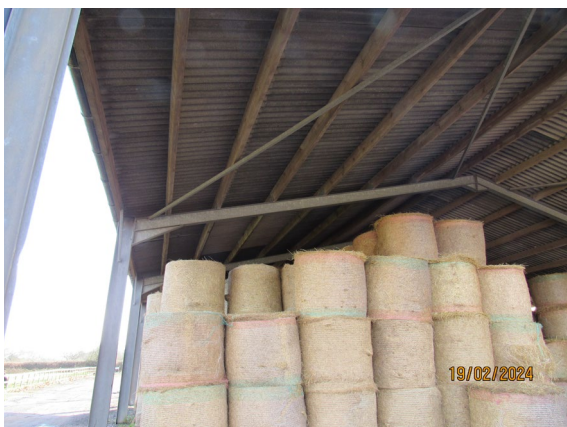
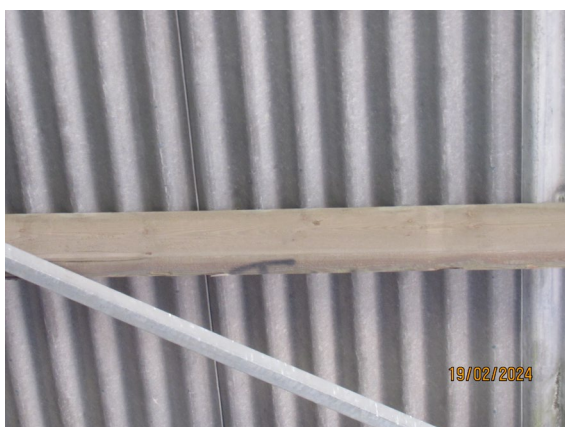
The building is a steel portal frame open sided hay store with a pitched roof. The roof is covered with fibre cement sheets supported on timber sheeting rails. There is an exceptionally poor place of shelter for individual bats between the rear of the fibre cement roof sheets and the timber sheeting rail. The likelihood of this is exceptionally small and can be managed by contractors following the method of working set out below.

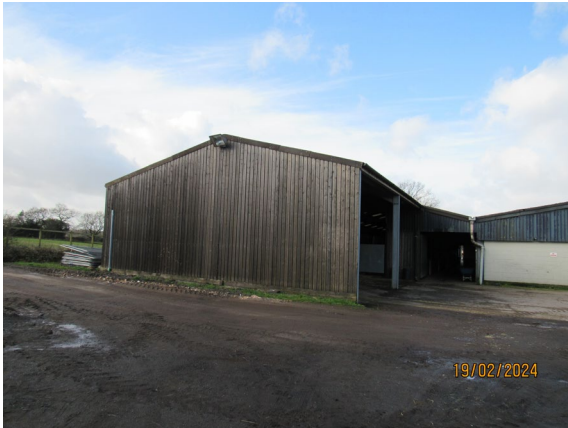
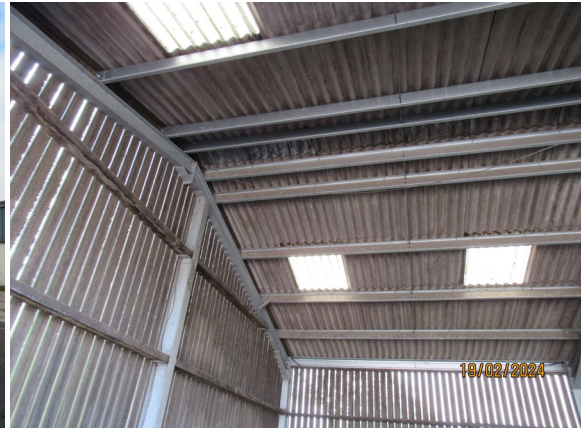
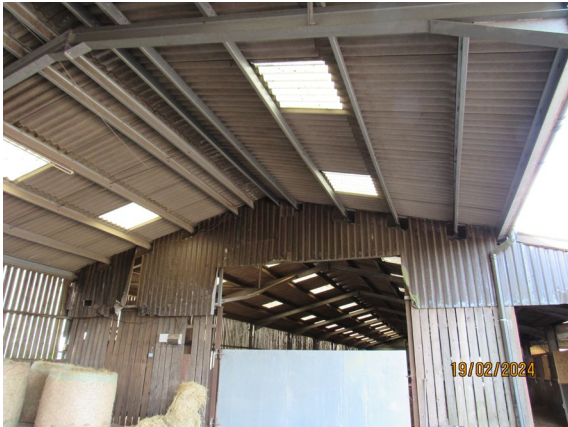
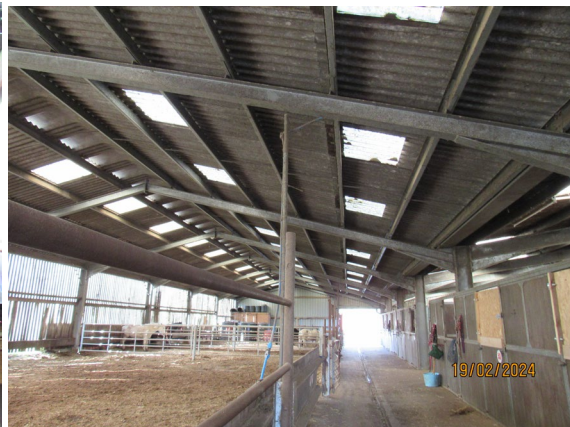
The building is a steel portal framed building with some stables and loose boxes. The roof is covered with fibre cement sheets supported on galvanized Z purlins/sheeting rails. There are no roosting opportunities for bats.

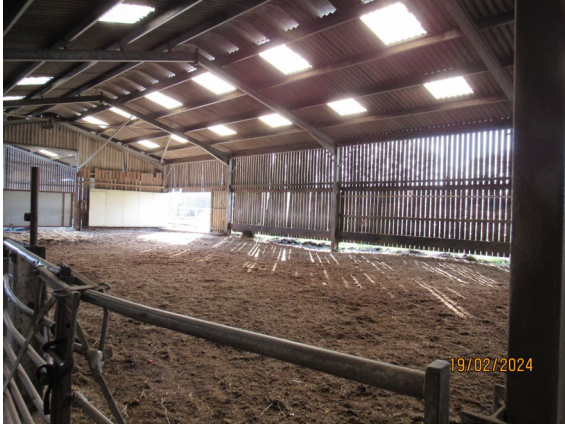
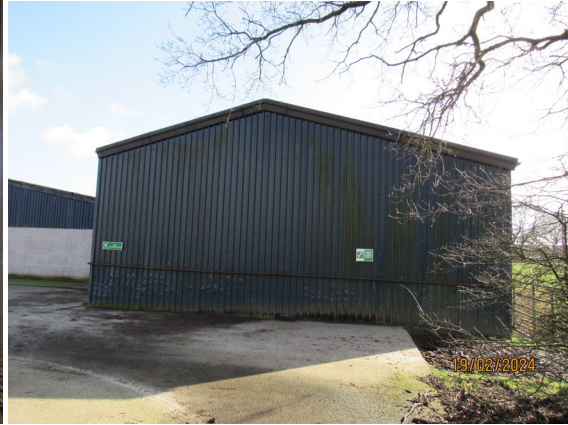
The buildings has some vertical profile steel cladding and some hit and miss timber cladding with no places of shelter for bats.

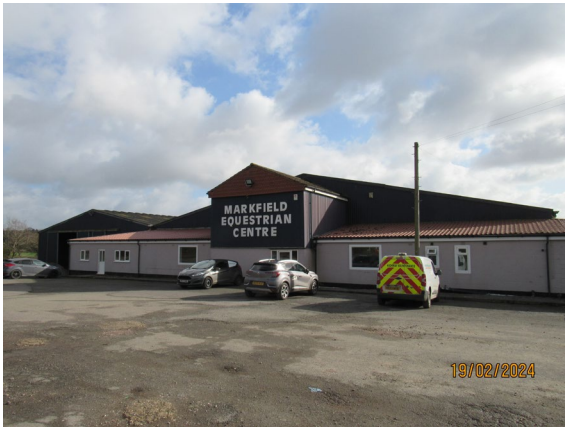
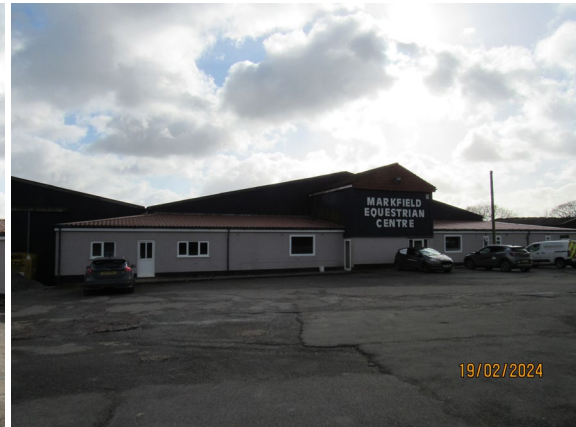
The building is an area of largely single storey rooms with a mono pitch roof. There is a two storey section with a pitched roof.

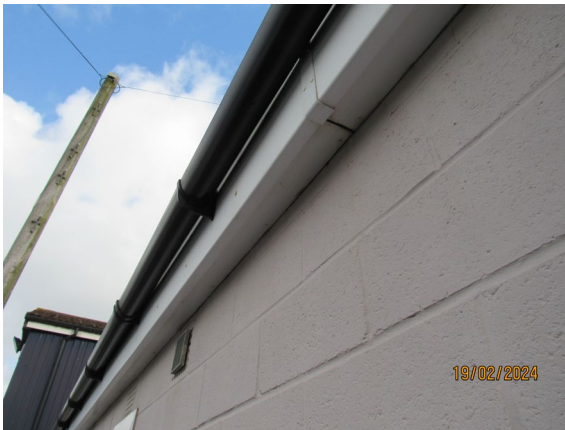
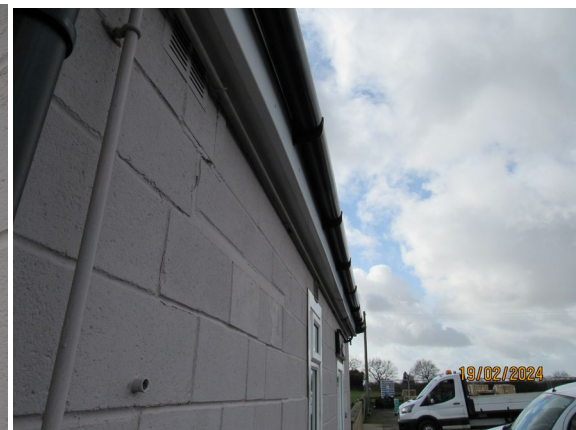
The walls are painted blockwork with uPVC fascia boards and soffits with no access for bats.

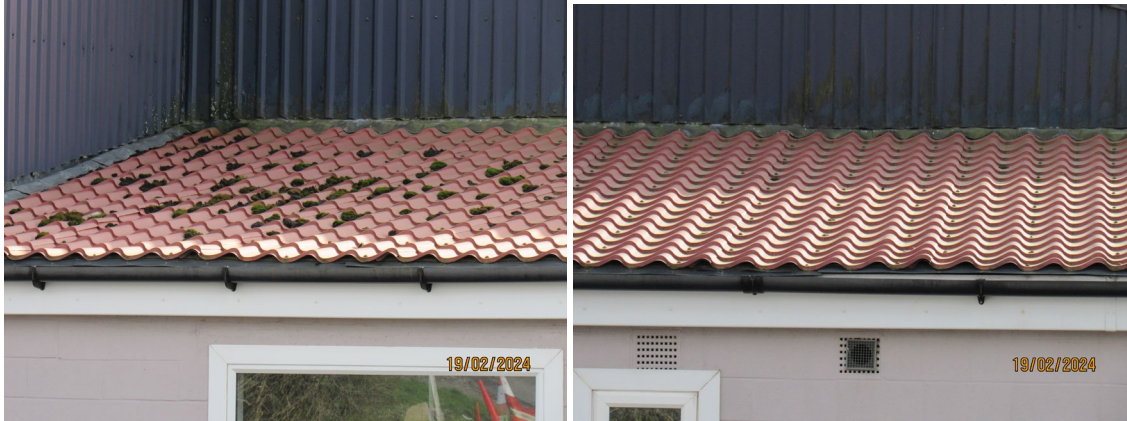
The single storey section of roof is pressed steel imitation pan tiles with no access for bats.

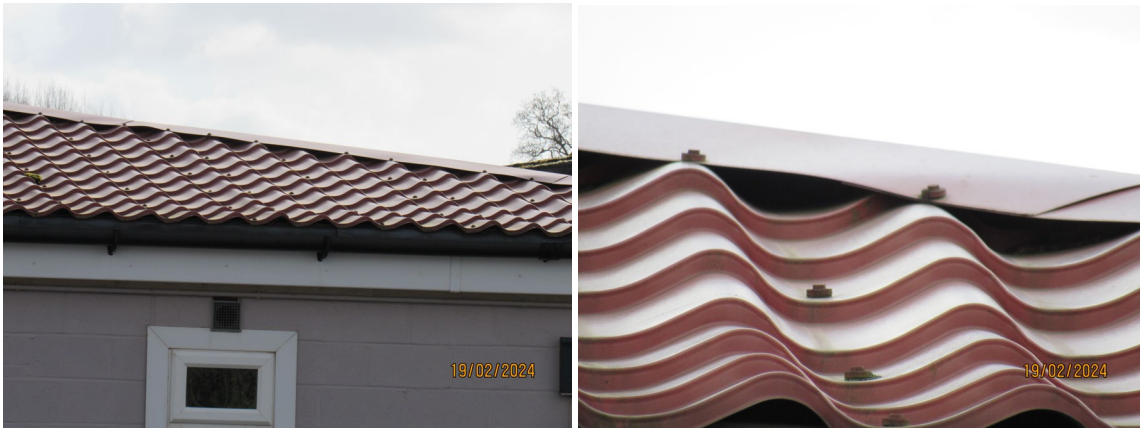
There are pressed metal flashings over the hips but there is little chance of bats moving across the surface of the pressed metal sheets so the likelihood of bats using this area is nil.

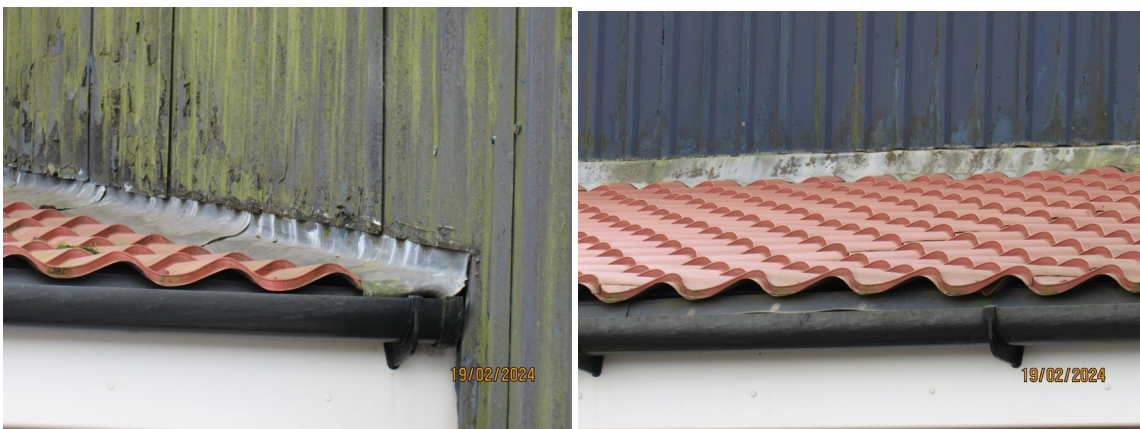
Where the monopitch roof adjoins the vertical profile steel cladding there are lead flashings. There is no access under the lead flashings for bats.

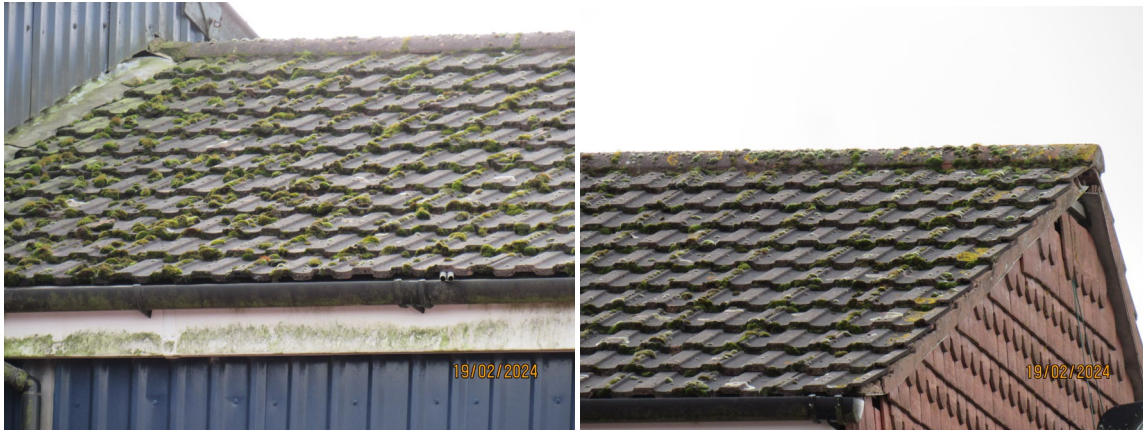
On the roof of the two storey section of Building 6 there are interlocking plain tiles over a bitumous underfelt.

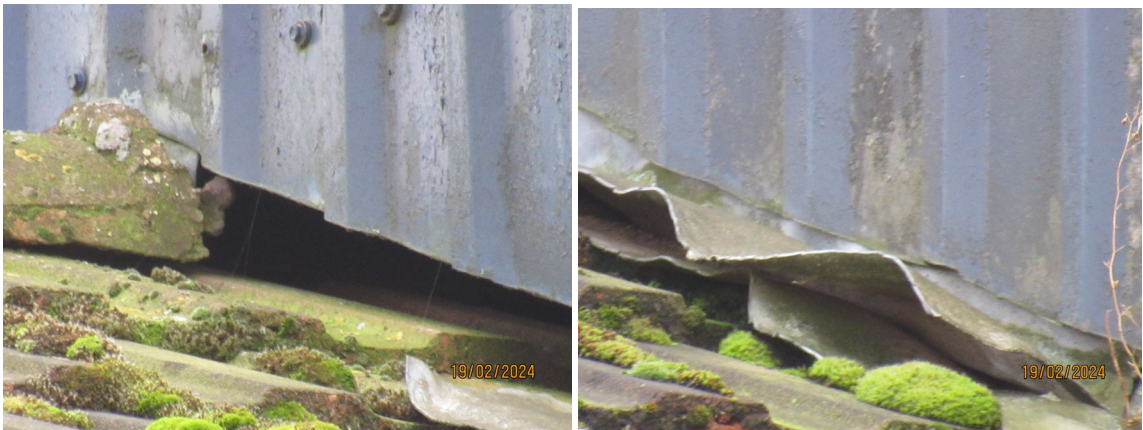
There is no access under the tiles except where the tiles go under the vertical profile steel cladding and the lead flashing has come away. This allows bats to crawl under the interlocking plain tiles to the space between the rear of the tiles and the bitumous underfelt.

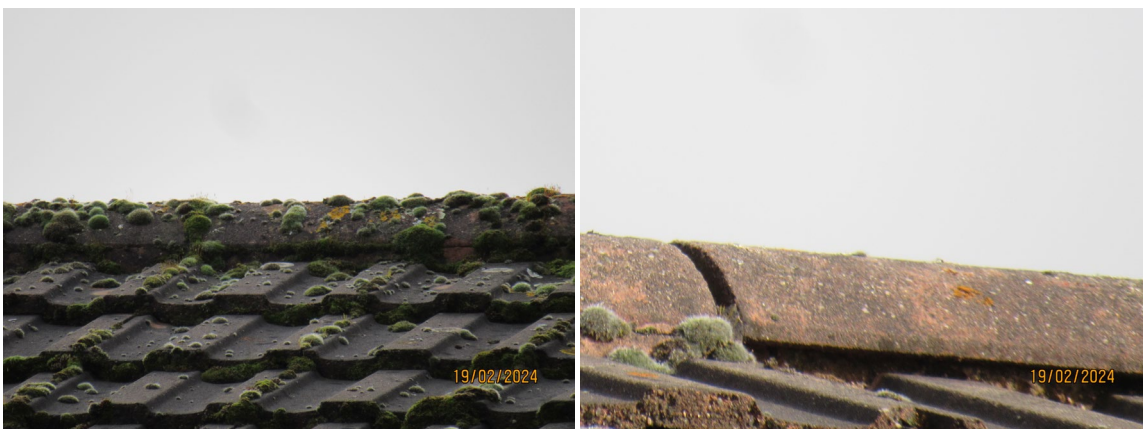
There are half round ridge tiles which have a number of gaps that give bats access to the space between the rear of the ridge tiles and the bitumous underfelt.

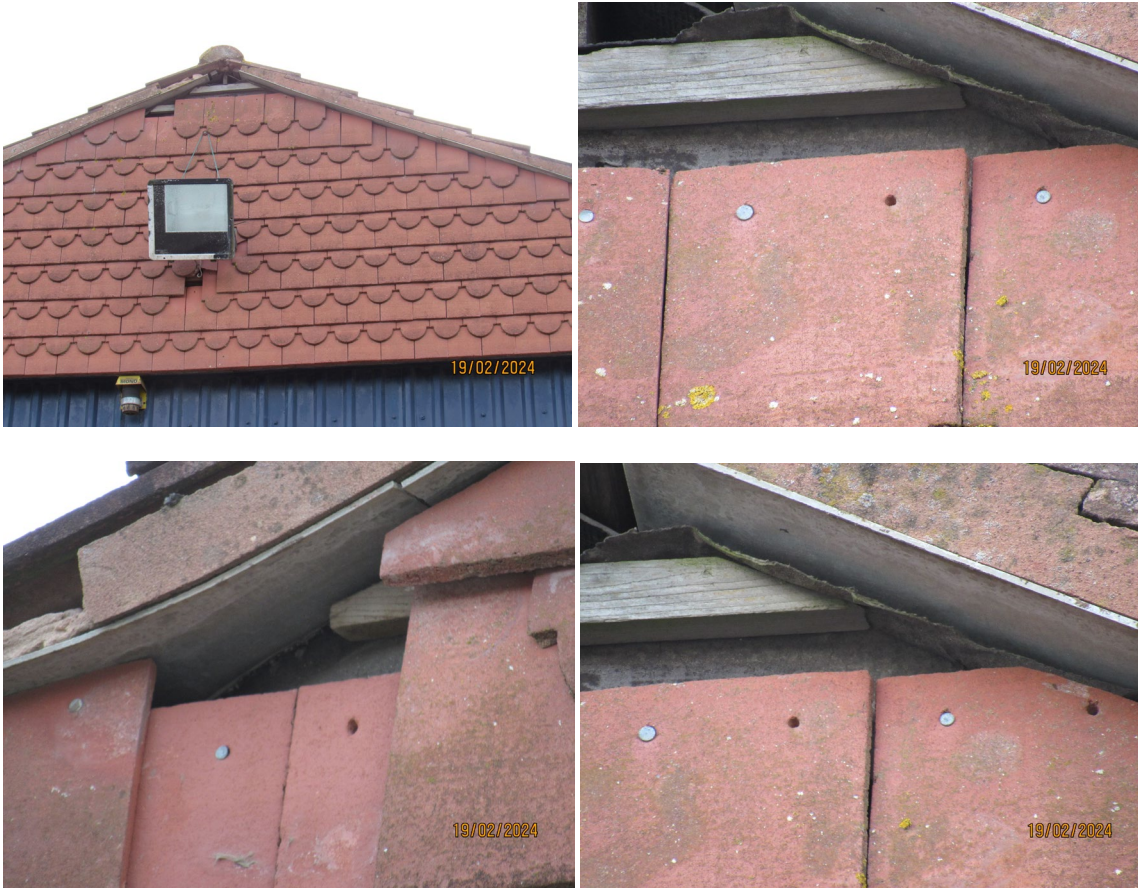
On the front elevation of the two storey section of the building there are hanging tiles.

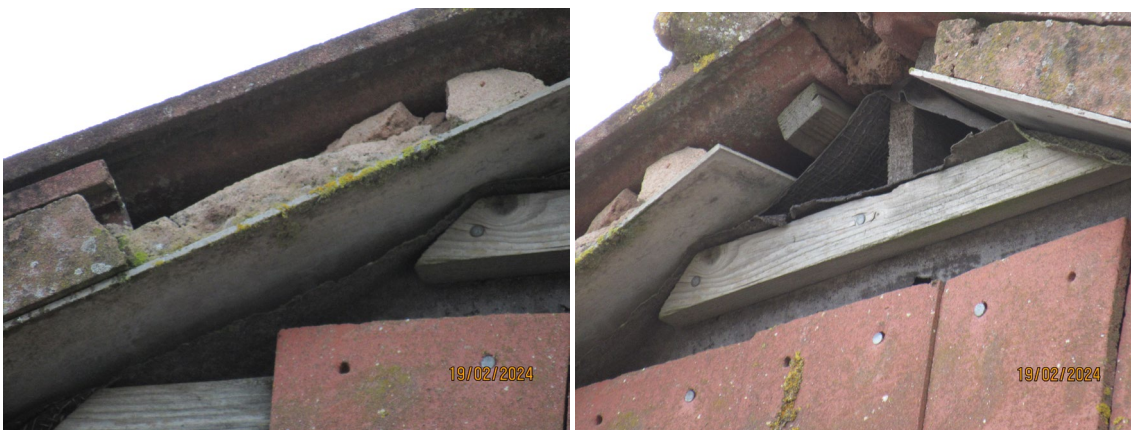
There are a number of missing hanging tiles that give bats access to the space between the rear of the plain tiles and the bitumous underfelt.

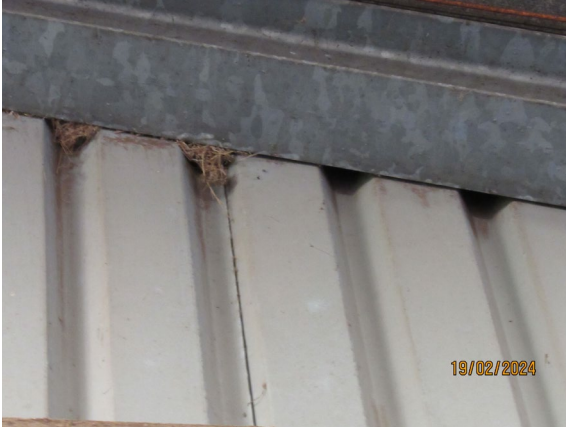
**Sparrow nesting between steel and vertical cladding.**

If birds begin to nest in any of the areas being developed between the beginning of March and the end of August in any year then work must stop until the young have fledged.

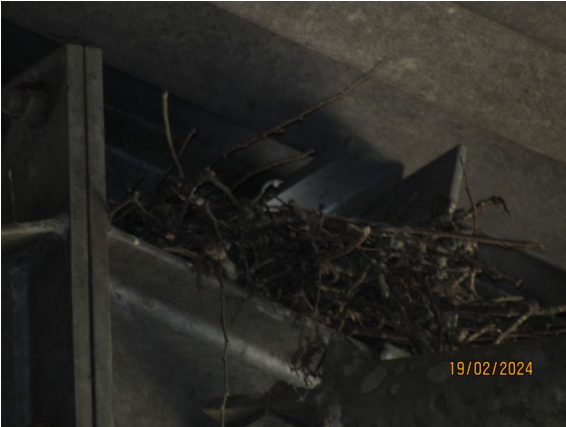
**Pigeon nesting.**
