**Preliminary Bat Roost Assessment and Bird  
Survey for the,  
Mr. D. Swift.  
Buildings at,  
Atherstone Hunt Kennels,  
Longford Lane,  
Witherley,  
ATHERSTONE,  
Warwickshire,  
CV9 3LJ.**

**Map Ref SP 3276 9727  
13<sup>th</sup> September 2022.**

**S. Christopher Smith MRICS MSc CEnv.  
The Hayloft,  
Farm Lane,  
Grendon,  
ATHERSTONE,  
Warwickshire.  
CV9 3DR  
01827 713324**

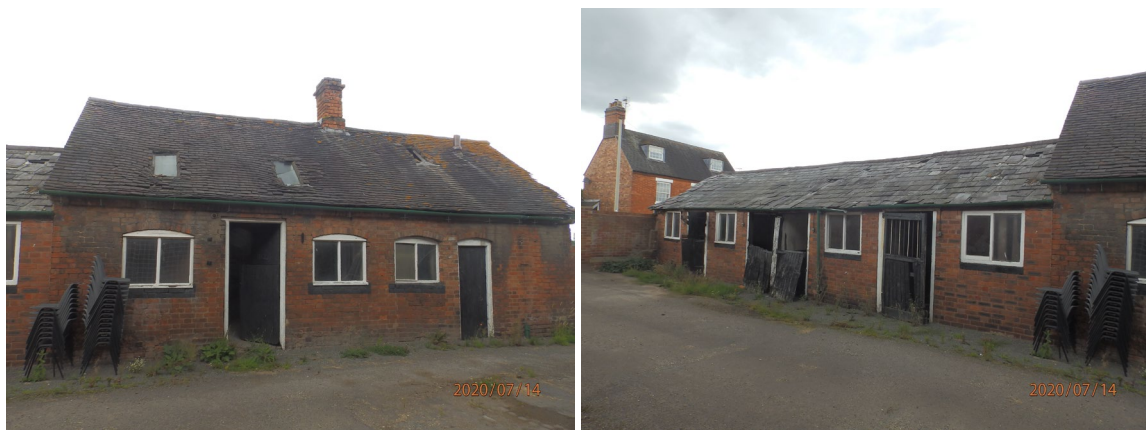
#### **Building 1.**

These are single storey solid brick stores and dog kennels with a pitched roof.

The roof is supported on timber rafters and purlins with slates above on the largest part of the building and plain tiles on one part of the building.

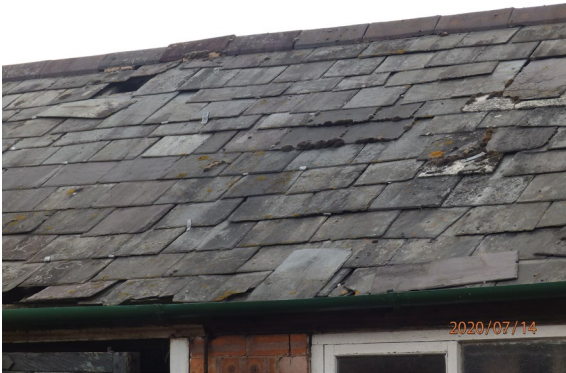
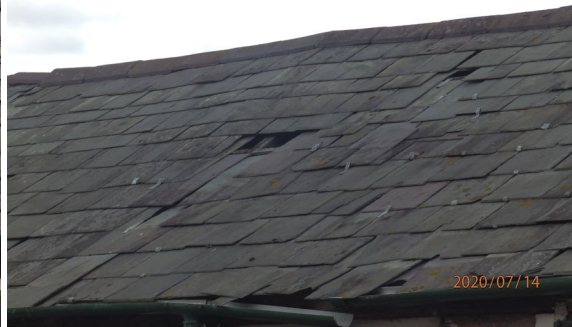
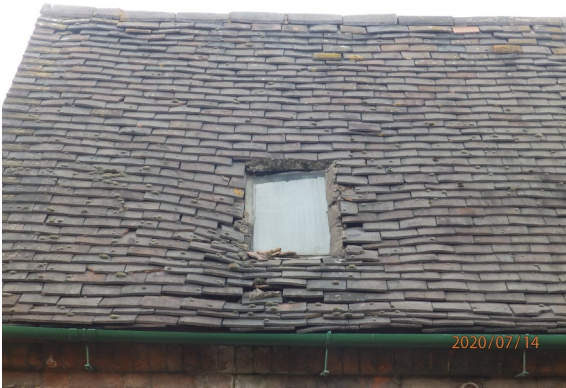
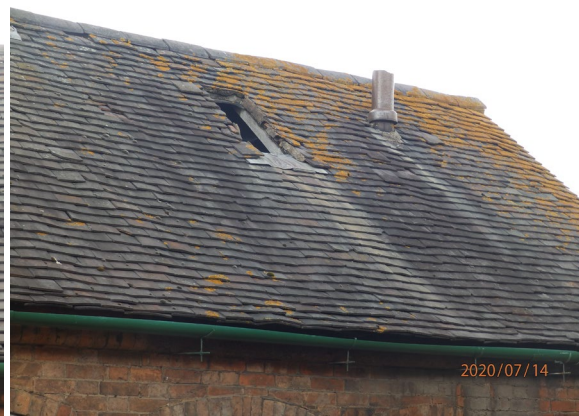
There are gaps in the slates and plain that allow bats to access the building but the only roosting for bats is against the ridge board or under the ridge tiles.

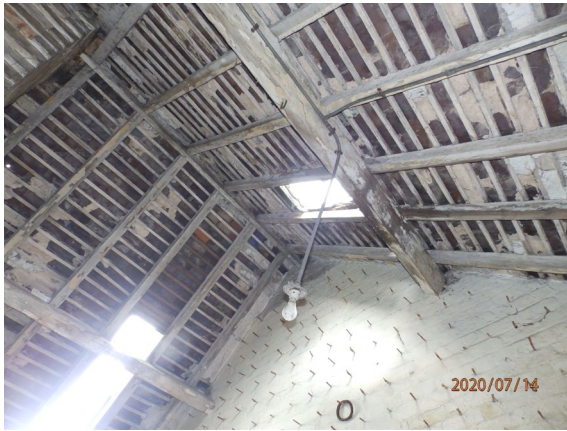
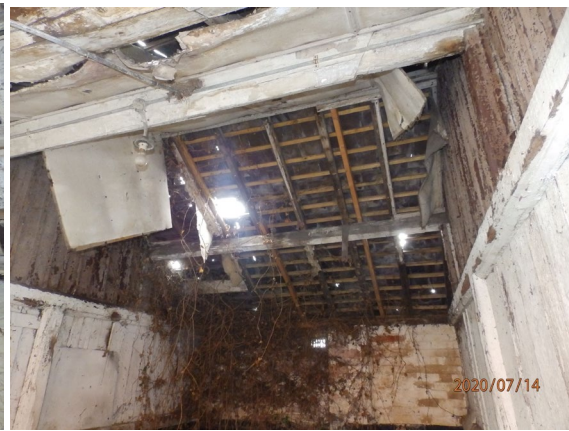
The holes in the roof allow weather penetration which makes any bat roosting poor.

**Bat roosting opportunities; Poor.**

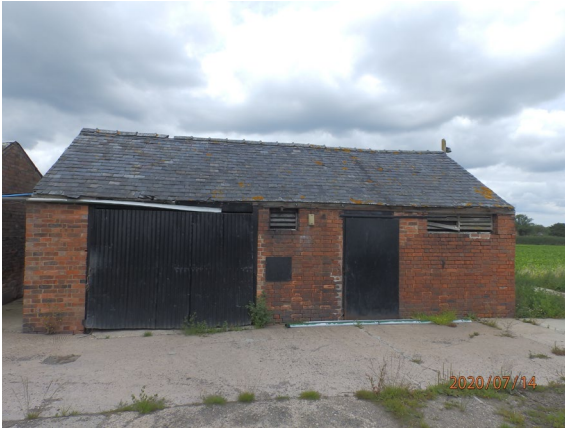
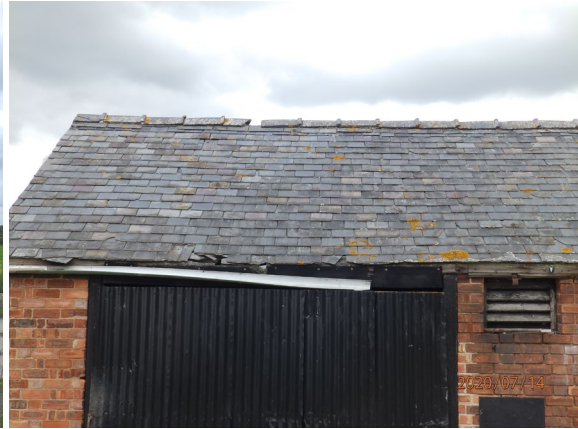
## Building 2.

These are solid brick stores with pitched roofs.

One building has corrugated iron roof sheets and offers no places of shelter for bats. The other building has slates on the roof over a bitumous underfelt.

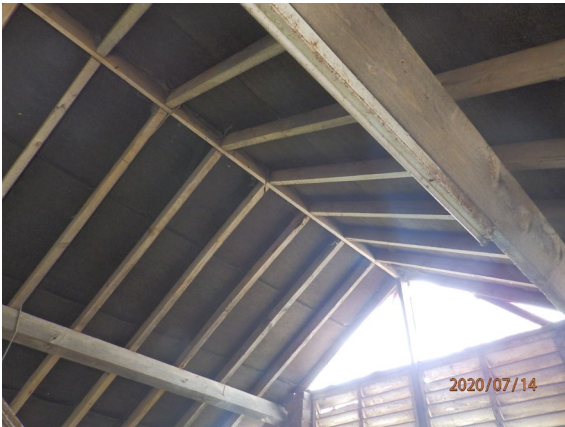
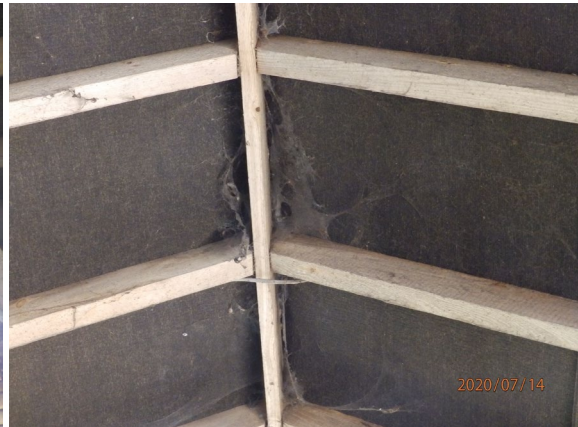
There is a broken ridge tile that allows access and roosting for bats.

There is access to the ridge board for bats to roost but the presence of cobwebs indicate no use by bats.

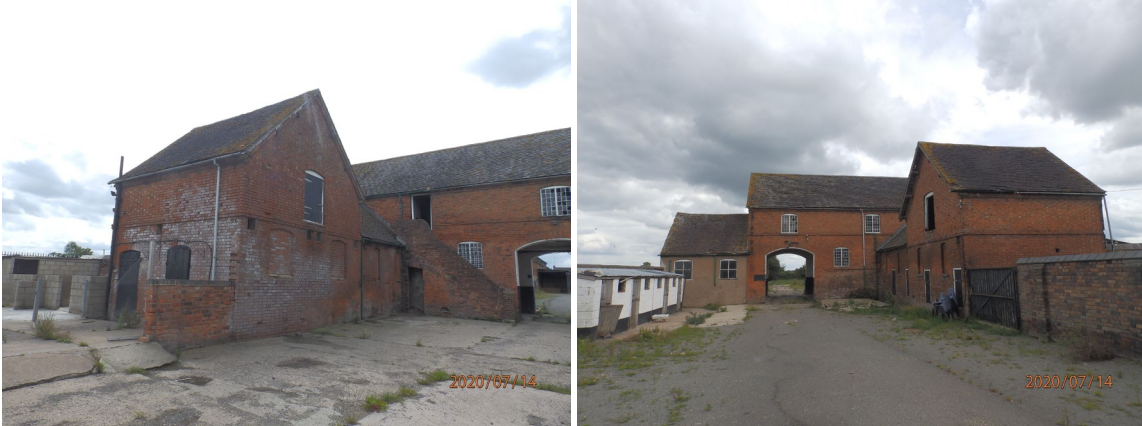
### **Buildings 3.**

This is a set of two storey solid brick stables, stores, and first floor accommodation.

There are pitched roofs with plain tiles on the roof. The roofs are supported on machine cut timber king post trusses and purlins. There have been repairs to the roofs in the past so that there are areas of bitumous underfelt beneath some of the plain tiles.

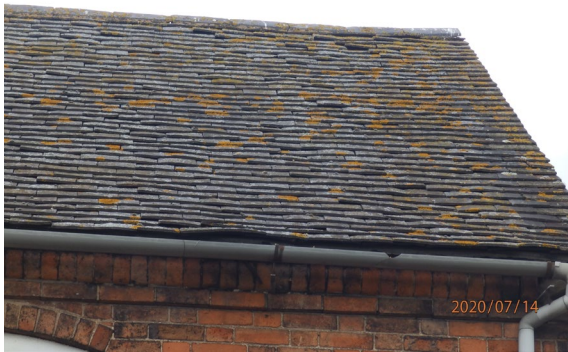
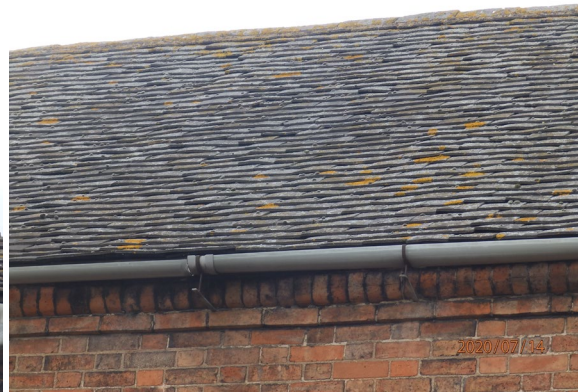
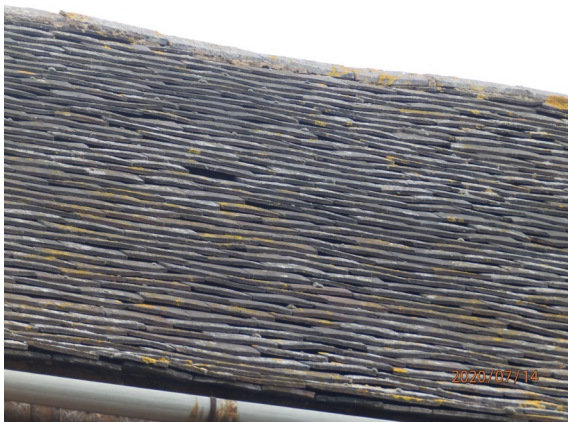
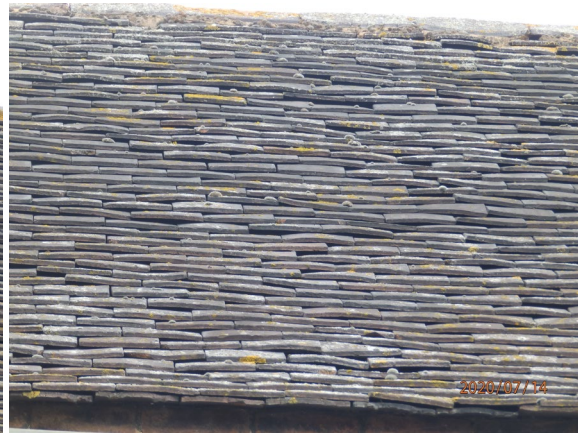
There is access to the ridge board for bats but the rear of the ridge tiles can be seen from within the building showing that there are no roosting opportunities for bats under the ridge tiles.

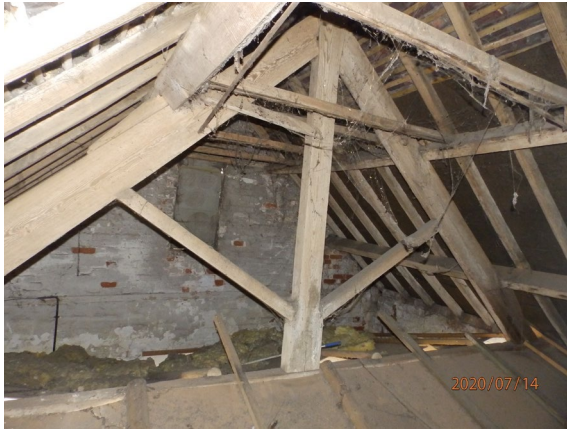
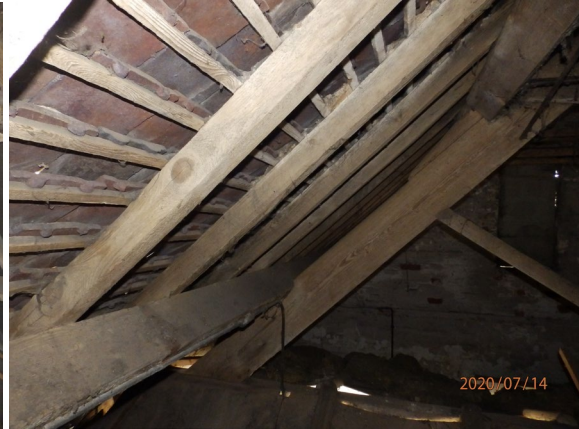
There was no evidence of bats using the roof space as a place of shelter.

The verge and barge boards are closed to bats but the timber battens that support the plain tiles can be seen and there are gaps between the battens that individual bats could use as a place of shelter.

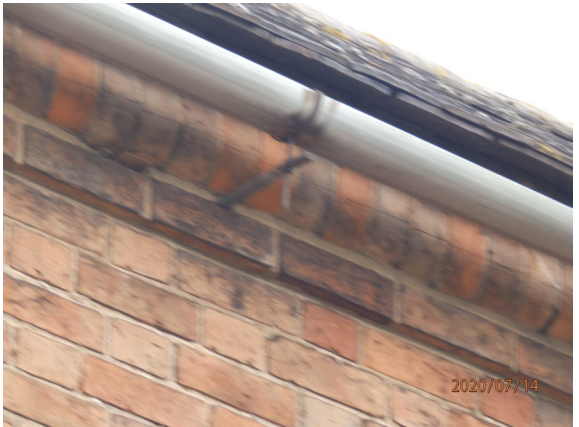
There are corbel brick eaves on the building with no access for bats.

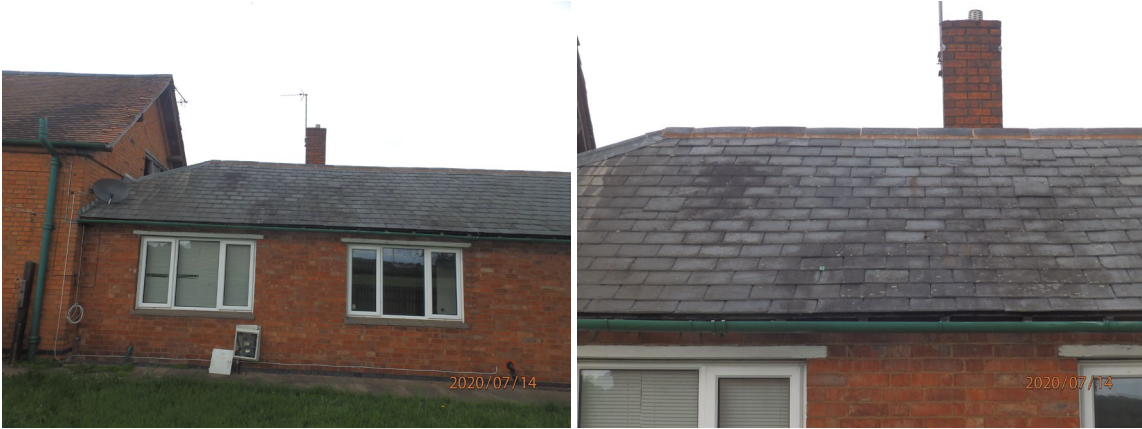
#### **Building 4.**

This is a solid brick single storey dwelling with a pitched roof.

There are slates on the roof with no access for bats and no access under the ridge tiles.

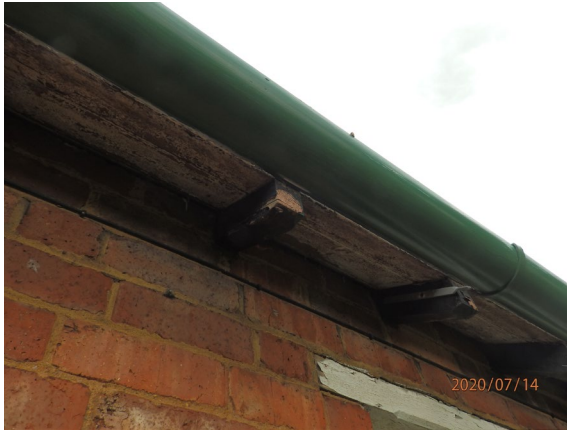
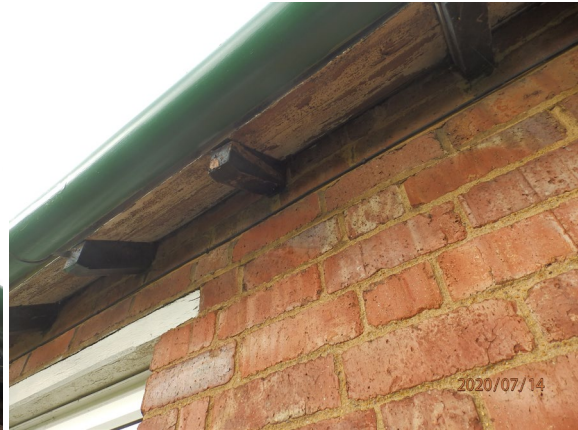
There are exposed rafter ends at the eaves with sarking board closures to the rear of the slates. There is no access for bats.

The building offers no places of shelter for bats.

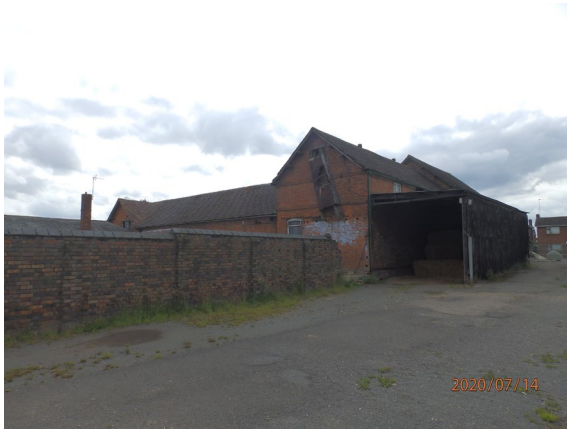
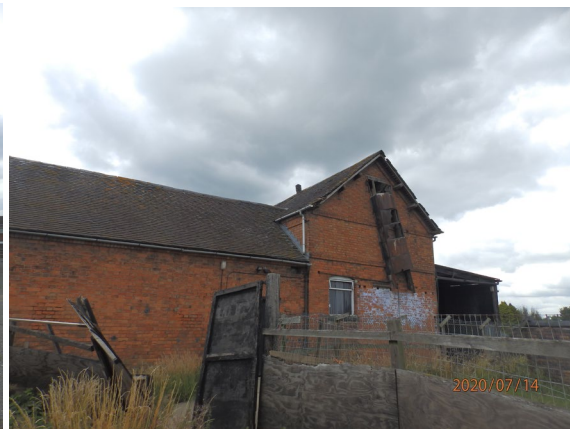
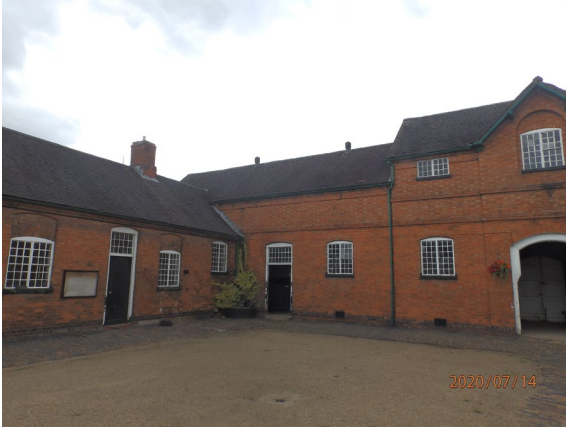
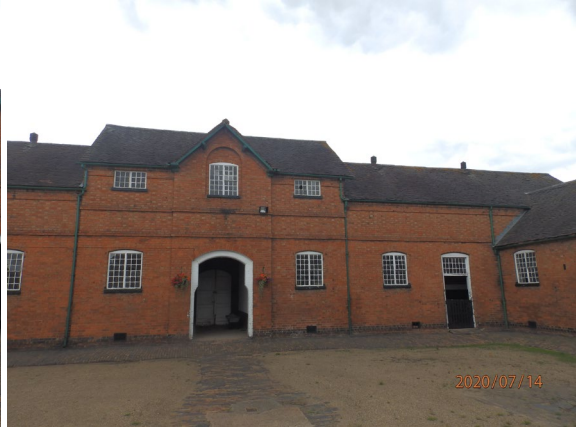
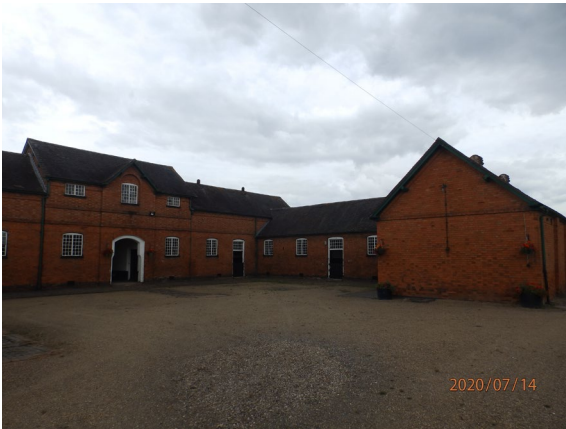
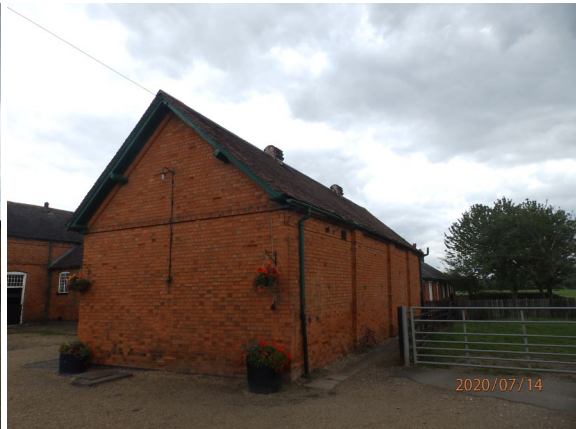
#### **Buildings 5.**

This is a set of two storey solid brick stables, stores, and first floor hayloft storage.

There are pitched roofs with plain tiles on the roof. The roofs are supported on machine cut timber king post trusses and purlins. There have been repairs to the roofs in the past so that there are areas of bitumous underfelt beneath some of the plain tiles.

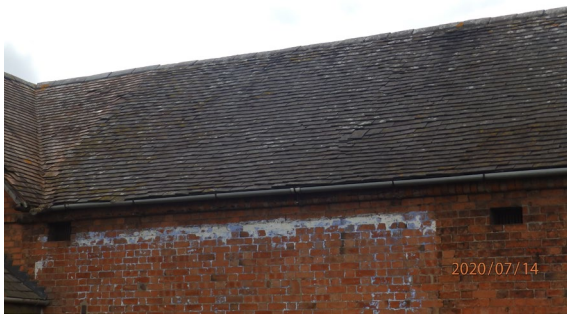
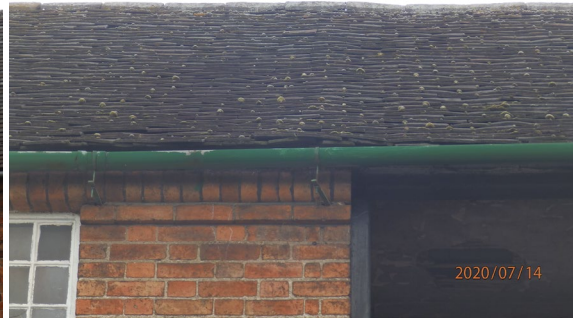
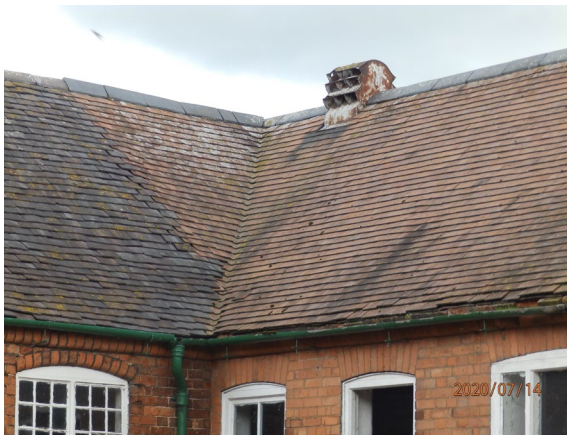
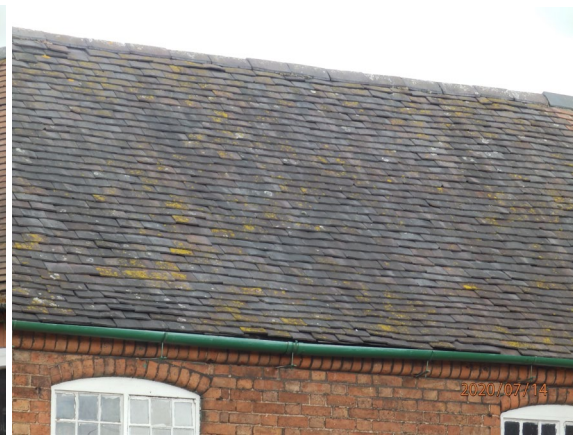
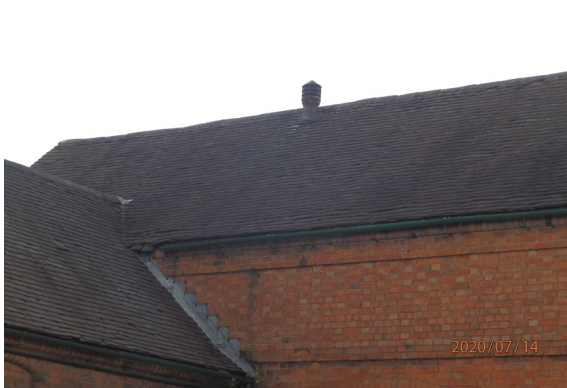
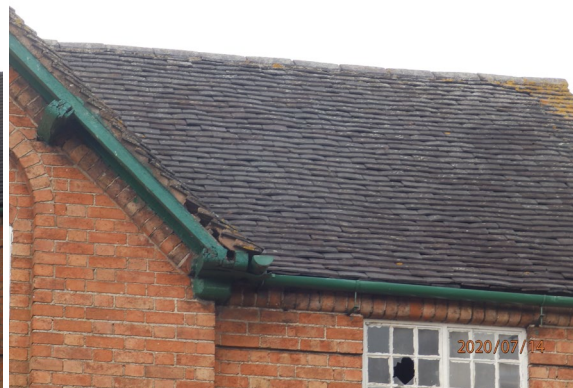
There is no access under the ridge tiles from the outside of the buildings.

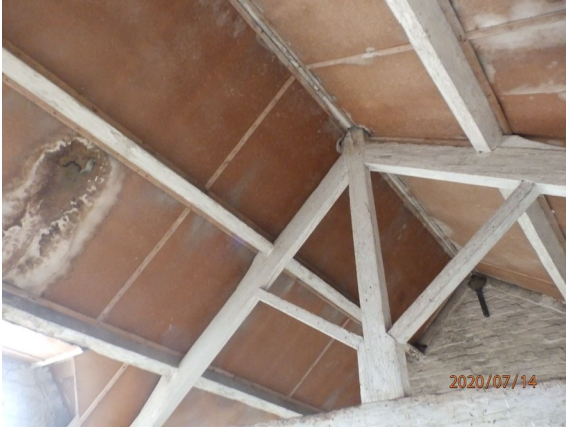
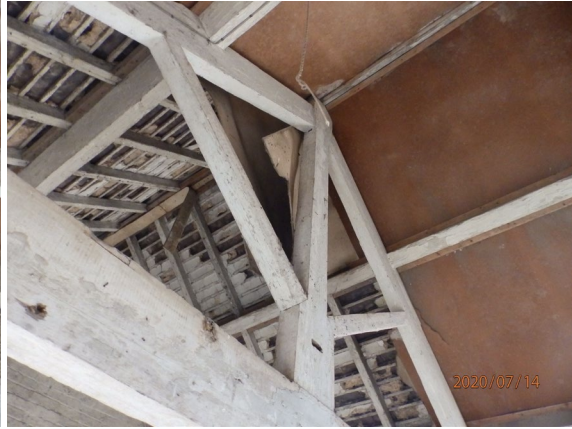
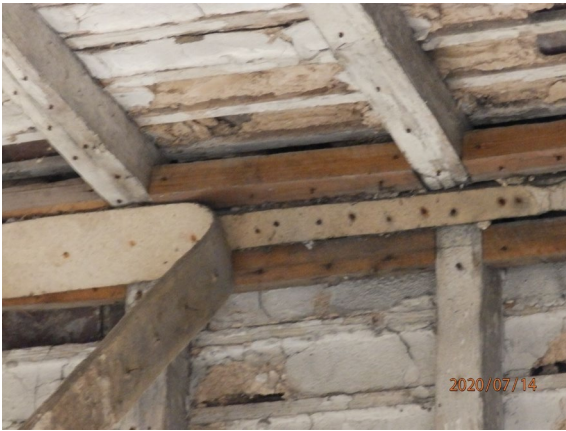
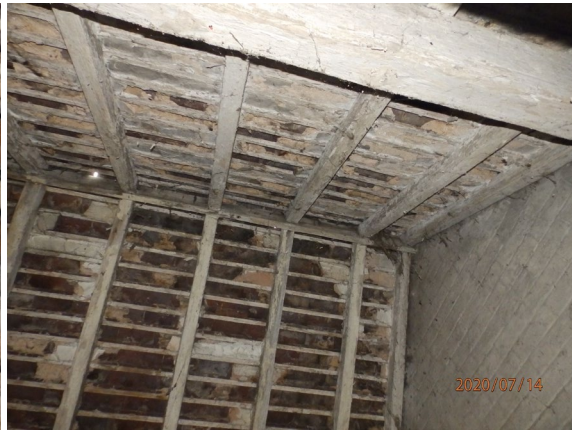
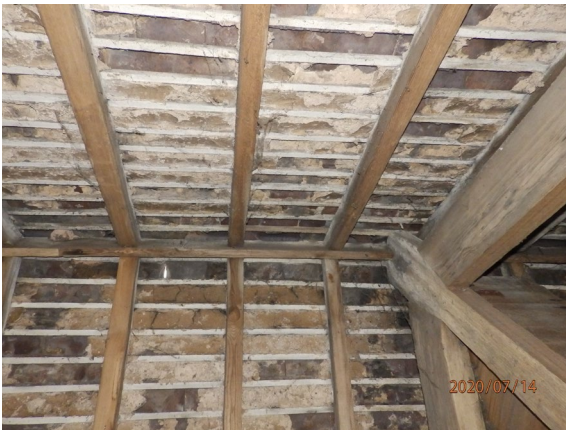
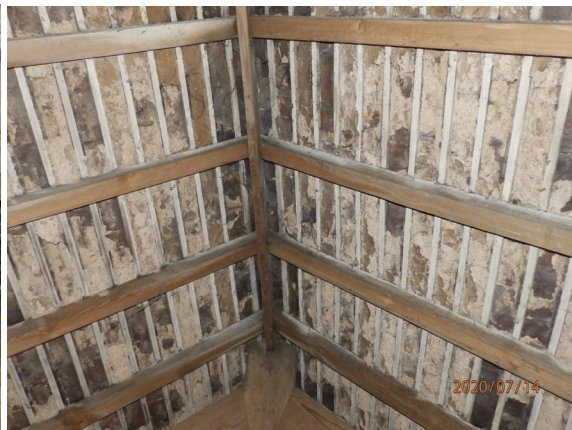
There is access to the ridge board for bats but the rear of the ridge tiles can be seen from within the building showing that there are no roosting opportunities for bats under the ridge tiles. There is boarding to the rear of the rafters in some of the roof spaces with no roosting for bats against the ridge board.

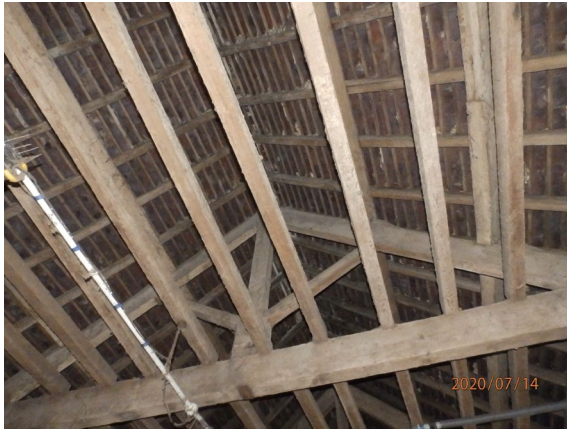
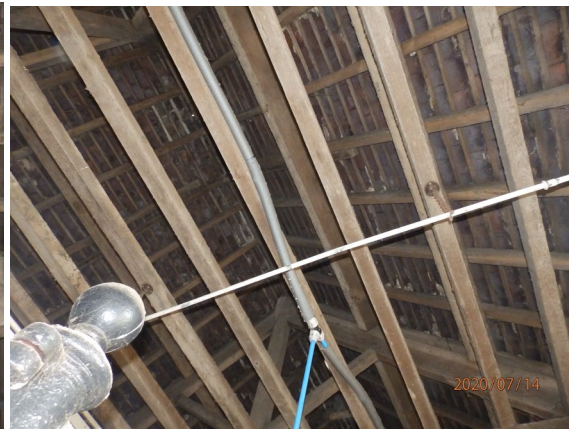
There was no evidence of bats using the roof space as a place of shelter.

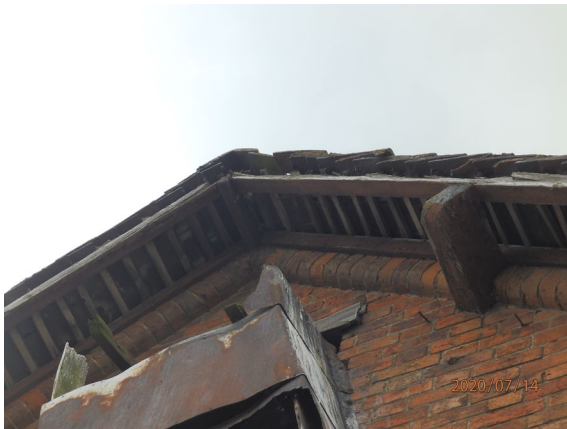
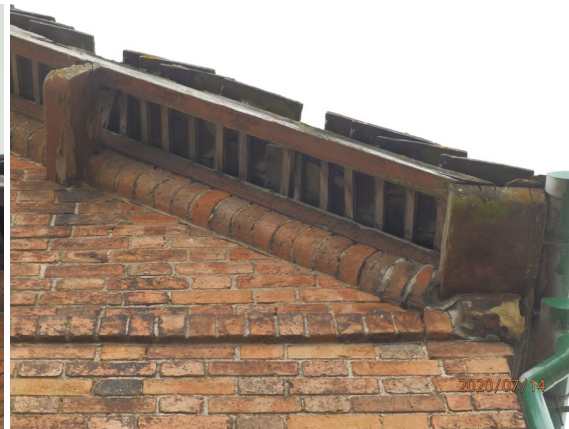
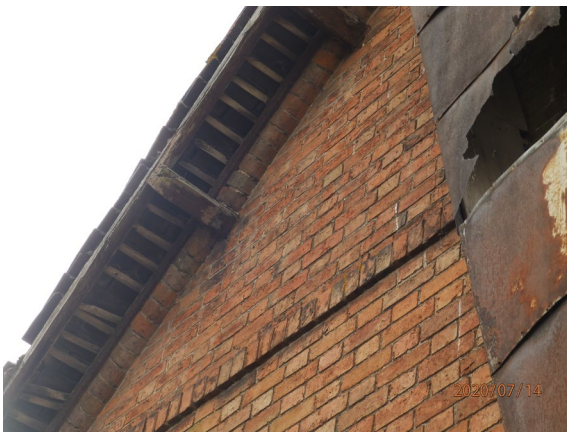
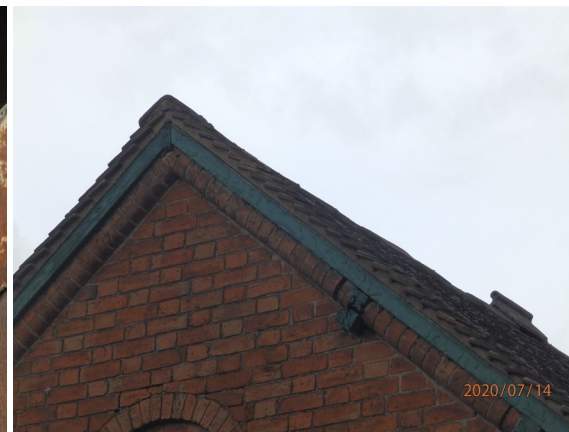
The verge and barge boards are closed to bats but the timber battens that support the plain tiles can be seen and there are gaps between the battens that individual bats could use as a place of shelter. On some parts of the building the barge board sits on corbel brickwork and there is no access for bats.

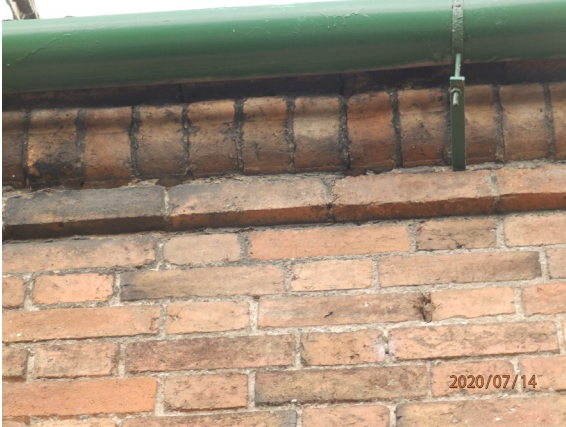
There are corbel brick eaves on the building with no access for bats.

**Bat roosting opportunities; Possible.**

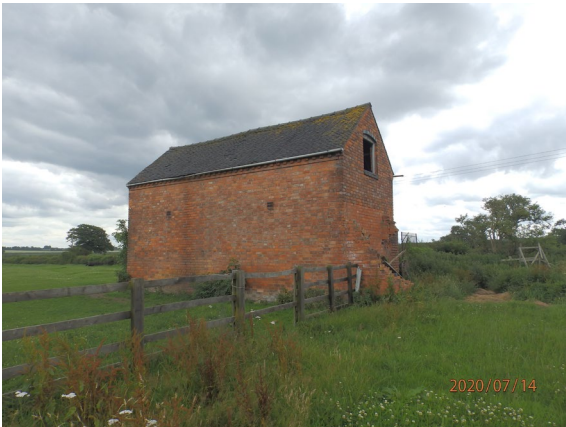
This is a solid brick building with a pitched roof covered with plain tiles.

There is no access at the verge or the eaves for bats.

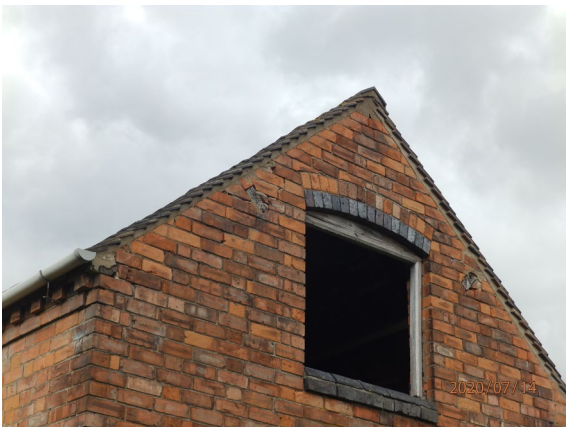
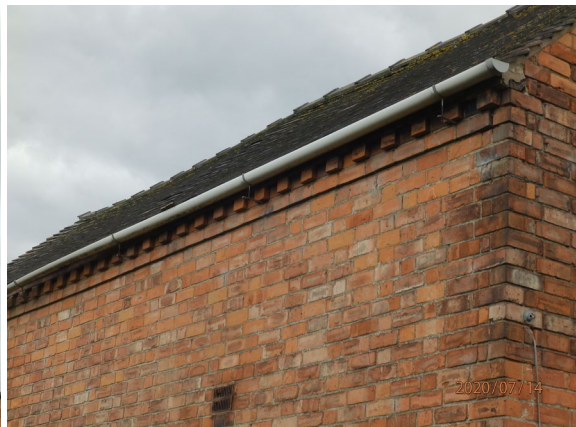
There are missing tiles that allow access to the roof space for bats but the 'torch on' mortar finish means there are no places of shelter for bats under the plain tiles. There is access at the ridge where there are missing plain tiles but the rear of the ridge tiles can be seen from within the roof space indicating that any roosting for crevice dwelling bats is exceptionally poor.

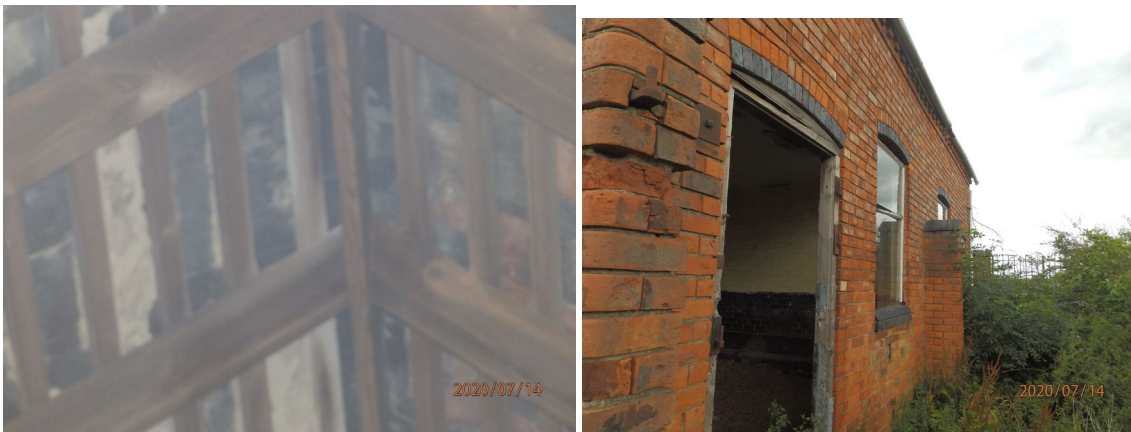
There is access to the ridge board for bats to roost against.

The building offers places of shelter for bats.
