Fisher German
Land at Barlestane Road,
Newbold Verdon

Heritage Statement

Land at Barlestone Road
Newbold Verdon

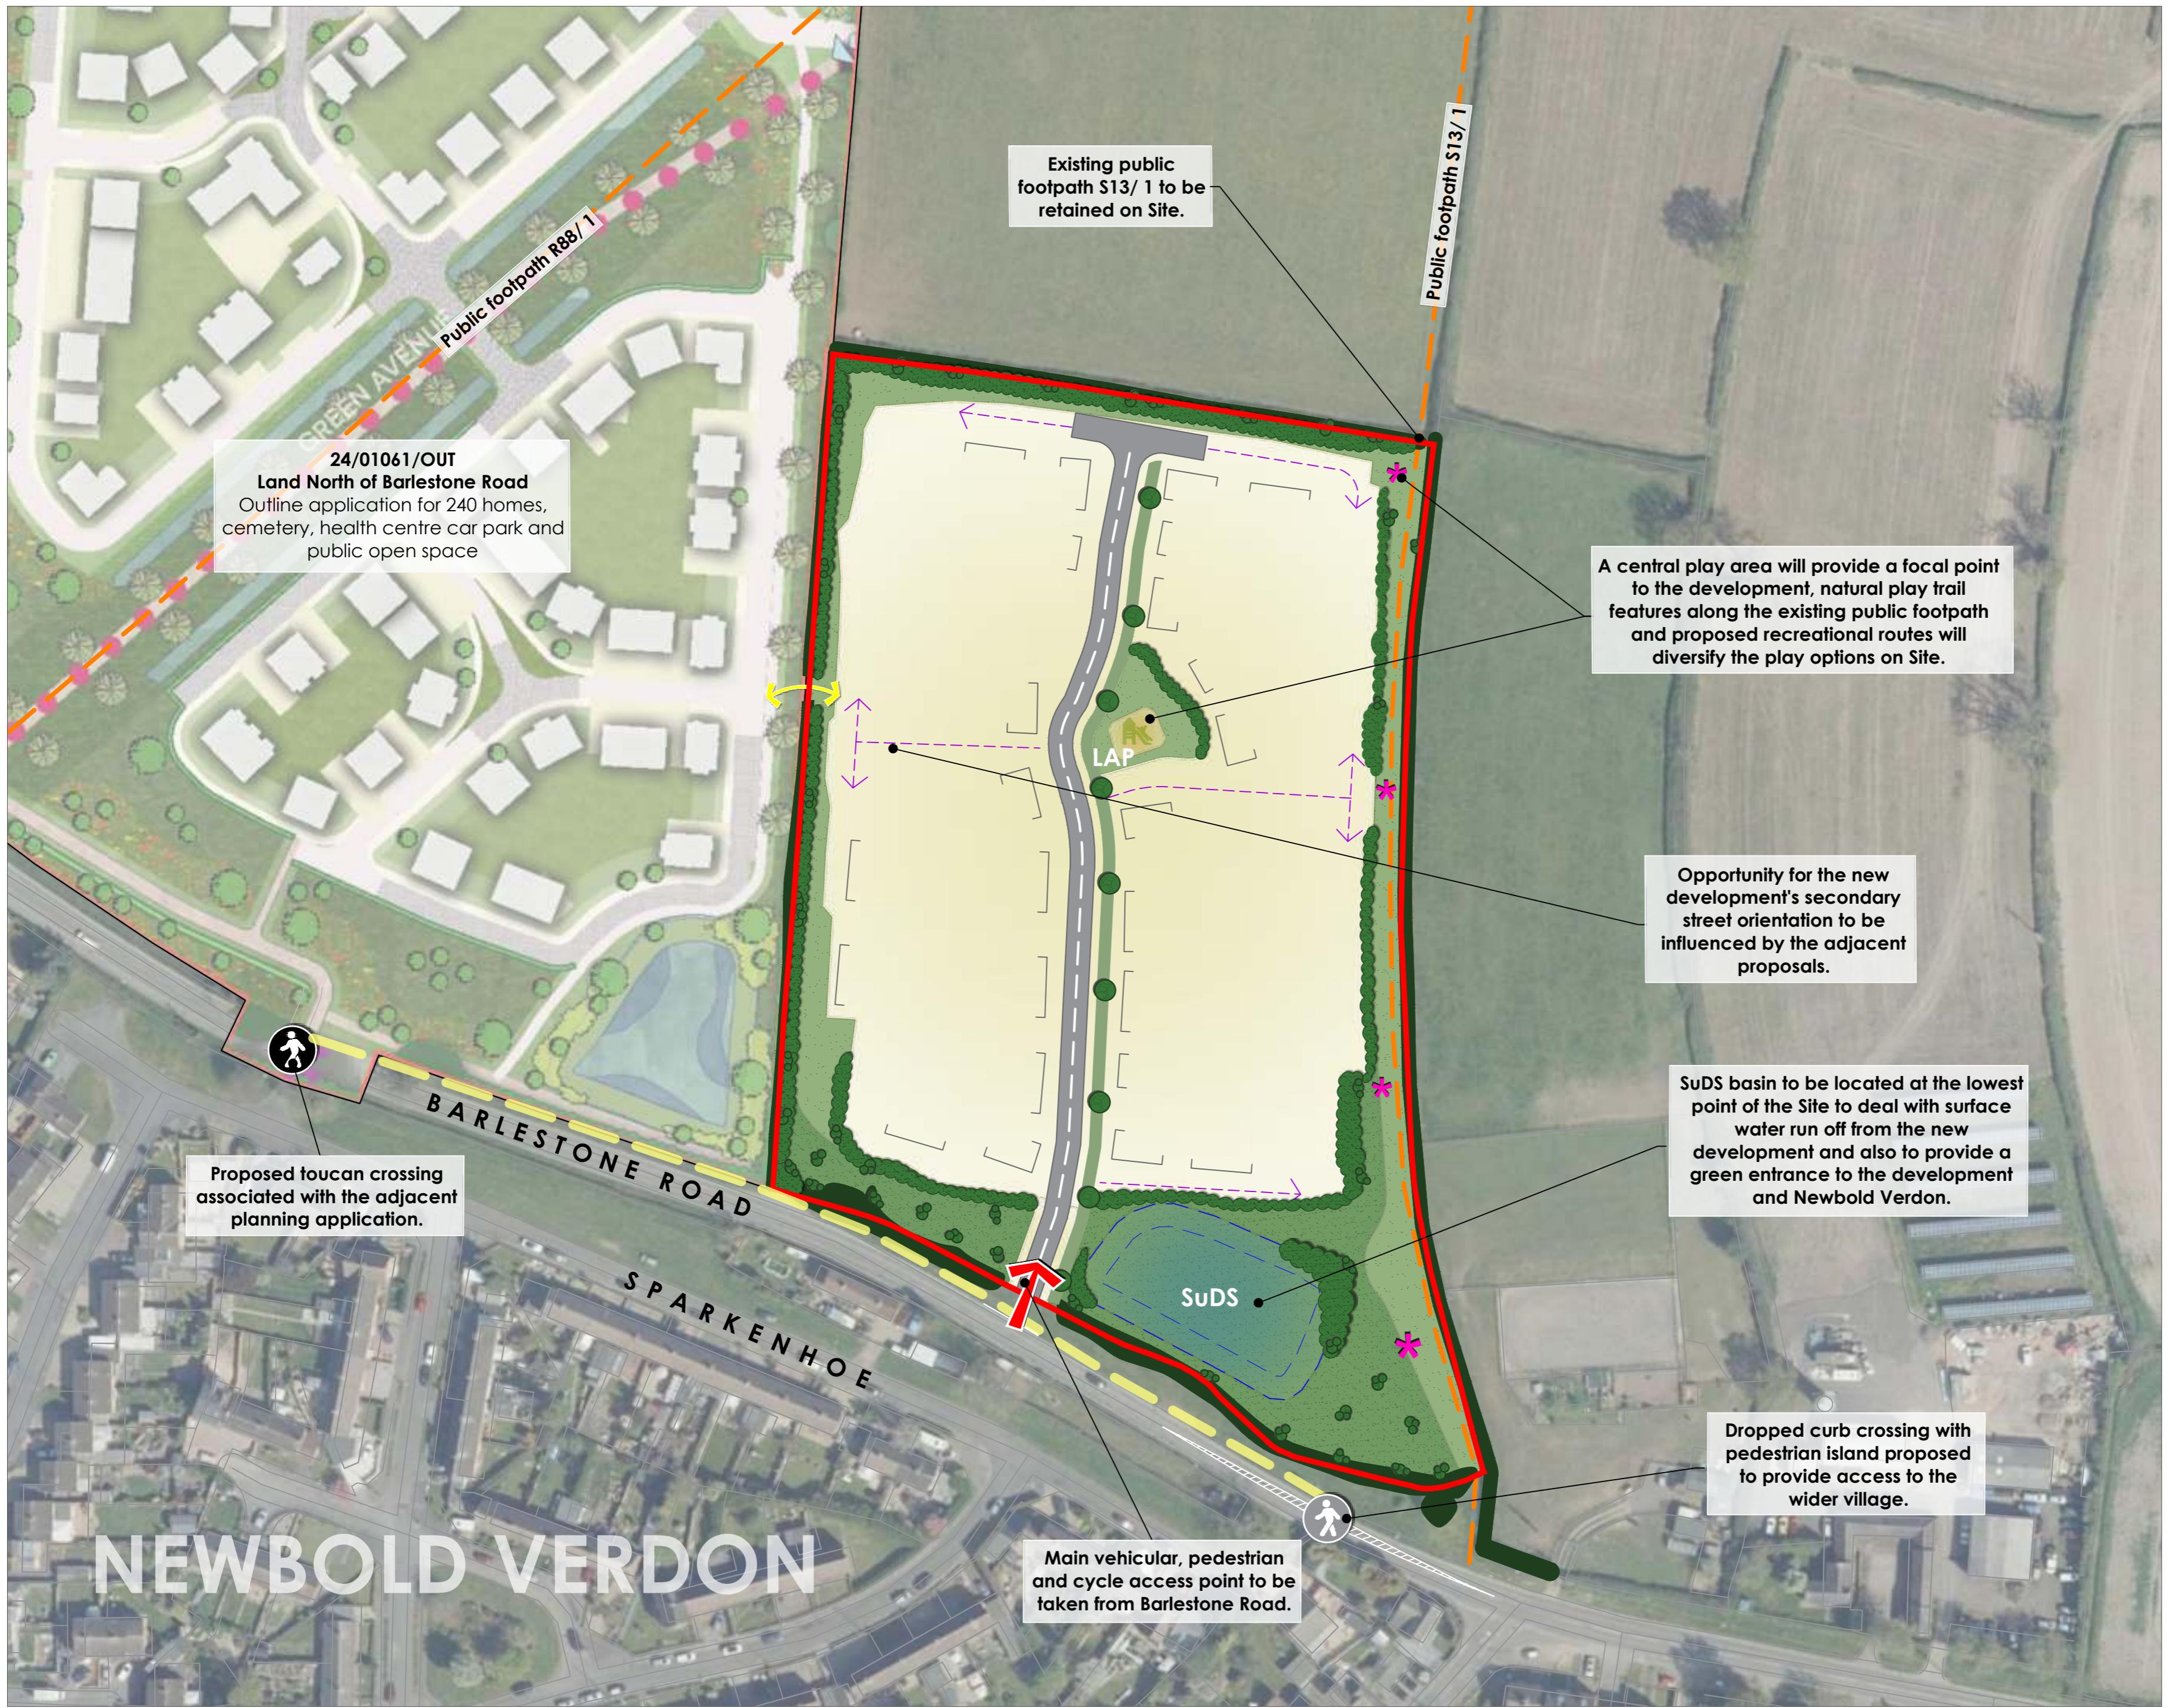
Drawing No.	CSA/7625/106	Rev	G

0	10	20	30	40	50 metres
N					
	Site boundary: Apx. 3.0ha				
	Developable area: 1.99ha (Up to 67 homes at 33.5 dph)				
	Indicative frontage orientation				
	Childrens play area (LAP)				
	Primary vehicular/pedestrian/cycle access				
	Tree lined primary street with green verge				
	Secondary streets				
	Potential pedestrian link				
	Existing public footpaths				
	Proposed drop curb crossing				
	Toucan crossing proposed by adjacent application (24/01061/OUT)				
	Proposed footway/cycleway				
	Proposed new grassland, wildflower, hedgerow and tree planting				
	Natural play trail features				
	Existing vegetation				
	Sustainable Drainage System (SuDS) basin				
G	28.10.25	DF	Highways updates		
F	27.10.25	DF	Boundary & highways updates		
E	17.10.25	DF	Highways updates		
D	09.10.25	DF	Natural play trail updates		
Rev	Date	By	Description		
CSA	environmental				
Dixies Barns, High Street, Ashwell, Hertfordshire SG7 5NT

t	01462 743647				
e	ashwell@csaenvironmental.co.uk				
w	csaenvironmental.co.uk				
Project	Land North of Barlestorne Road, NEWBOLD VERDON				
Title	Development Framework Plan				
Client	Wheeldon 1867				
Scale	1:1000 @ A2	Drawn	DF		
Date	August 2025	Checked	RR

1.7 The depth of any basement levels and depth and type of foundations are currently not known. Plans for the Proposed Development are included as **Appendix 1** (CSA/7625/106).

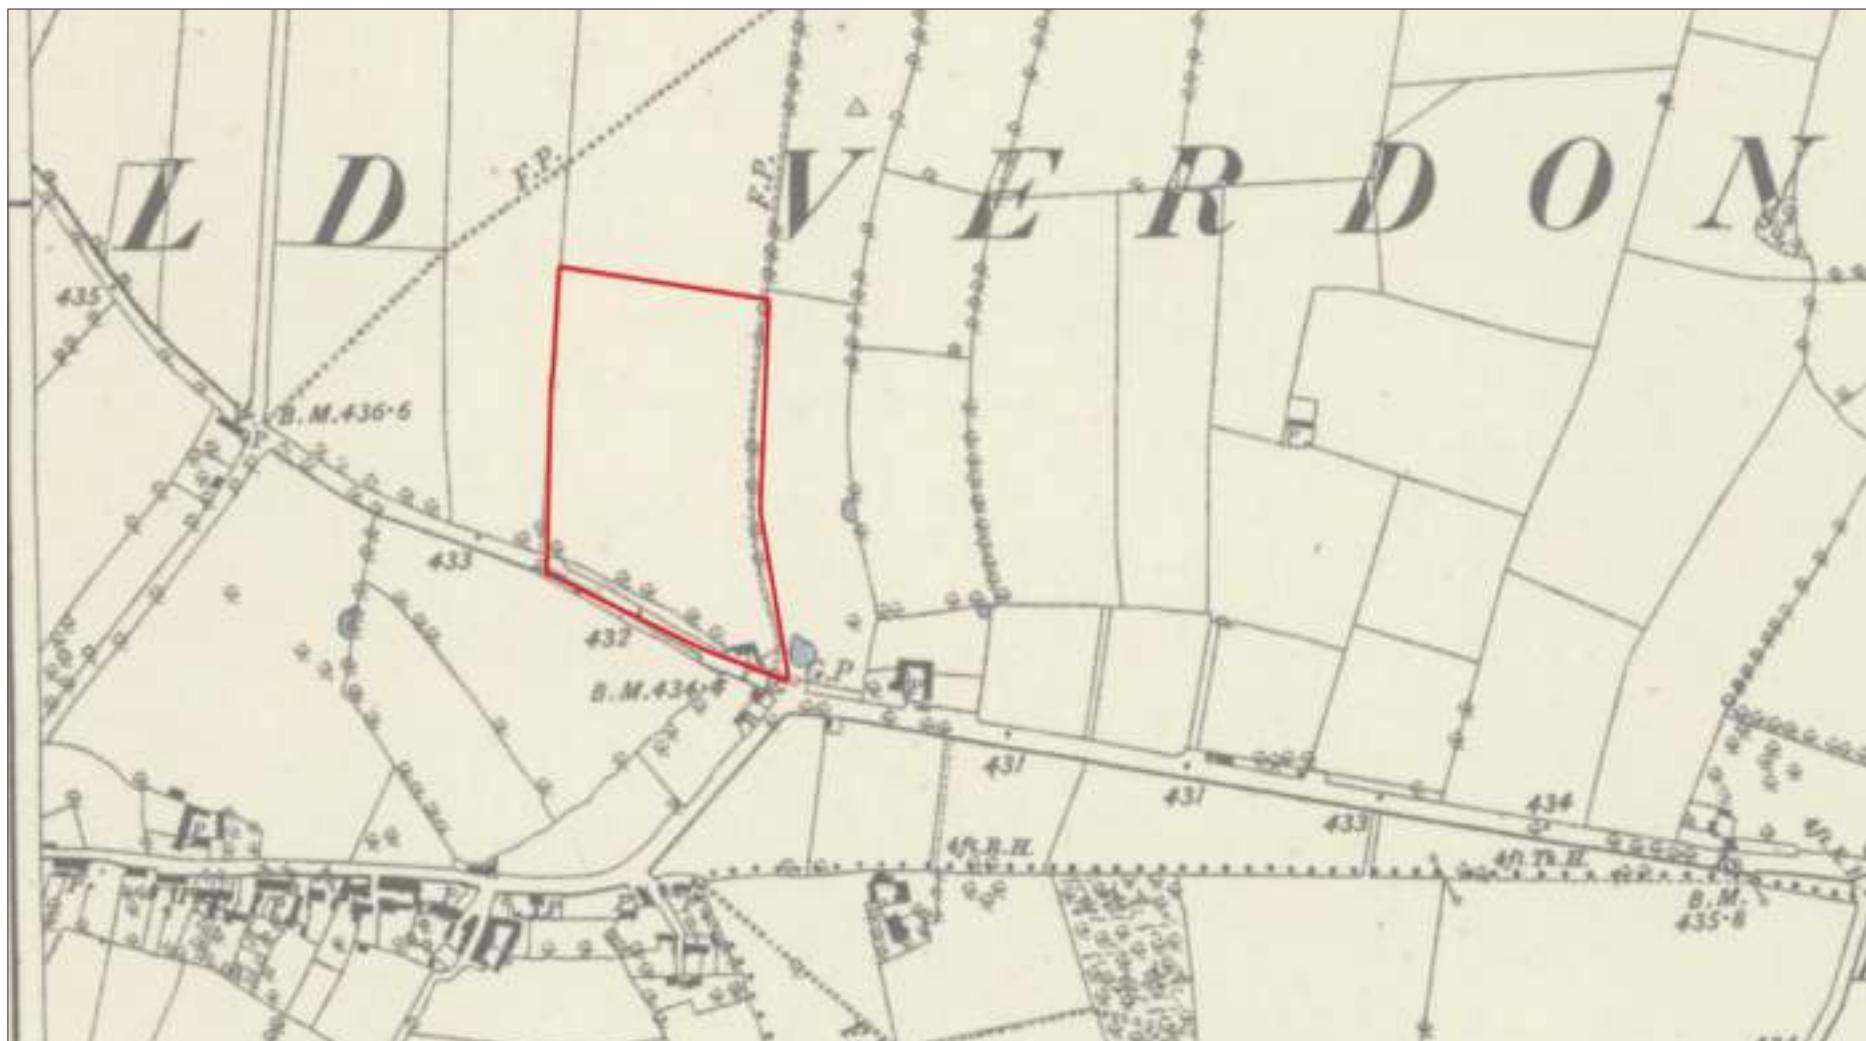
Figure 6: Leicestershire Sheet XXX.SW. Surveyed: 1885, Published: 1885. Reproduced with the permission of the National Library of Scotland.

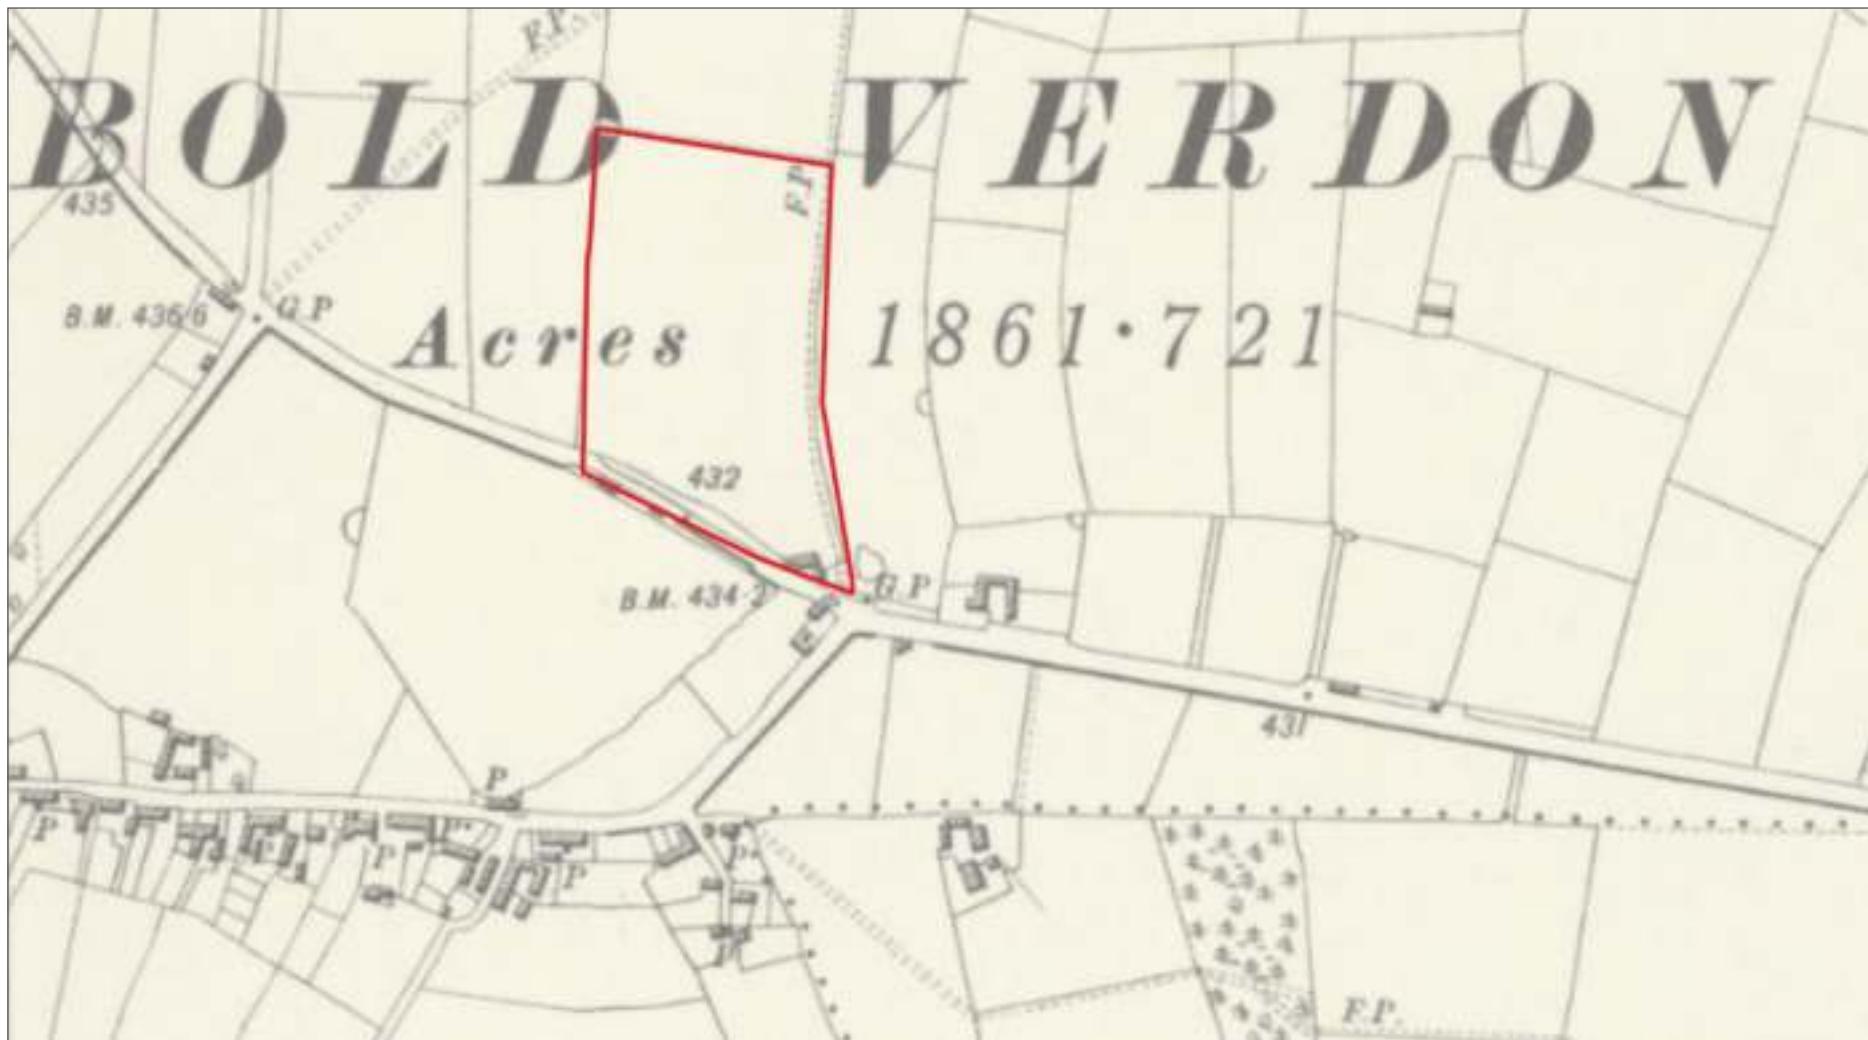
Figure 7: Parish of Little Dawley Tithe Map, Published: 1839. Reproduced with the permission of the Genealogist.

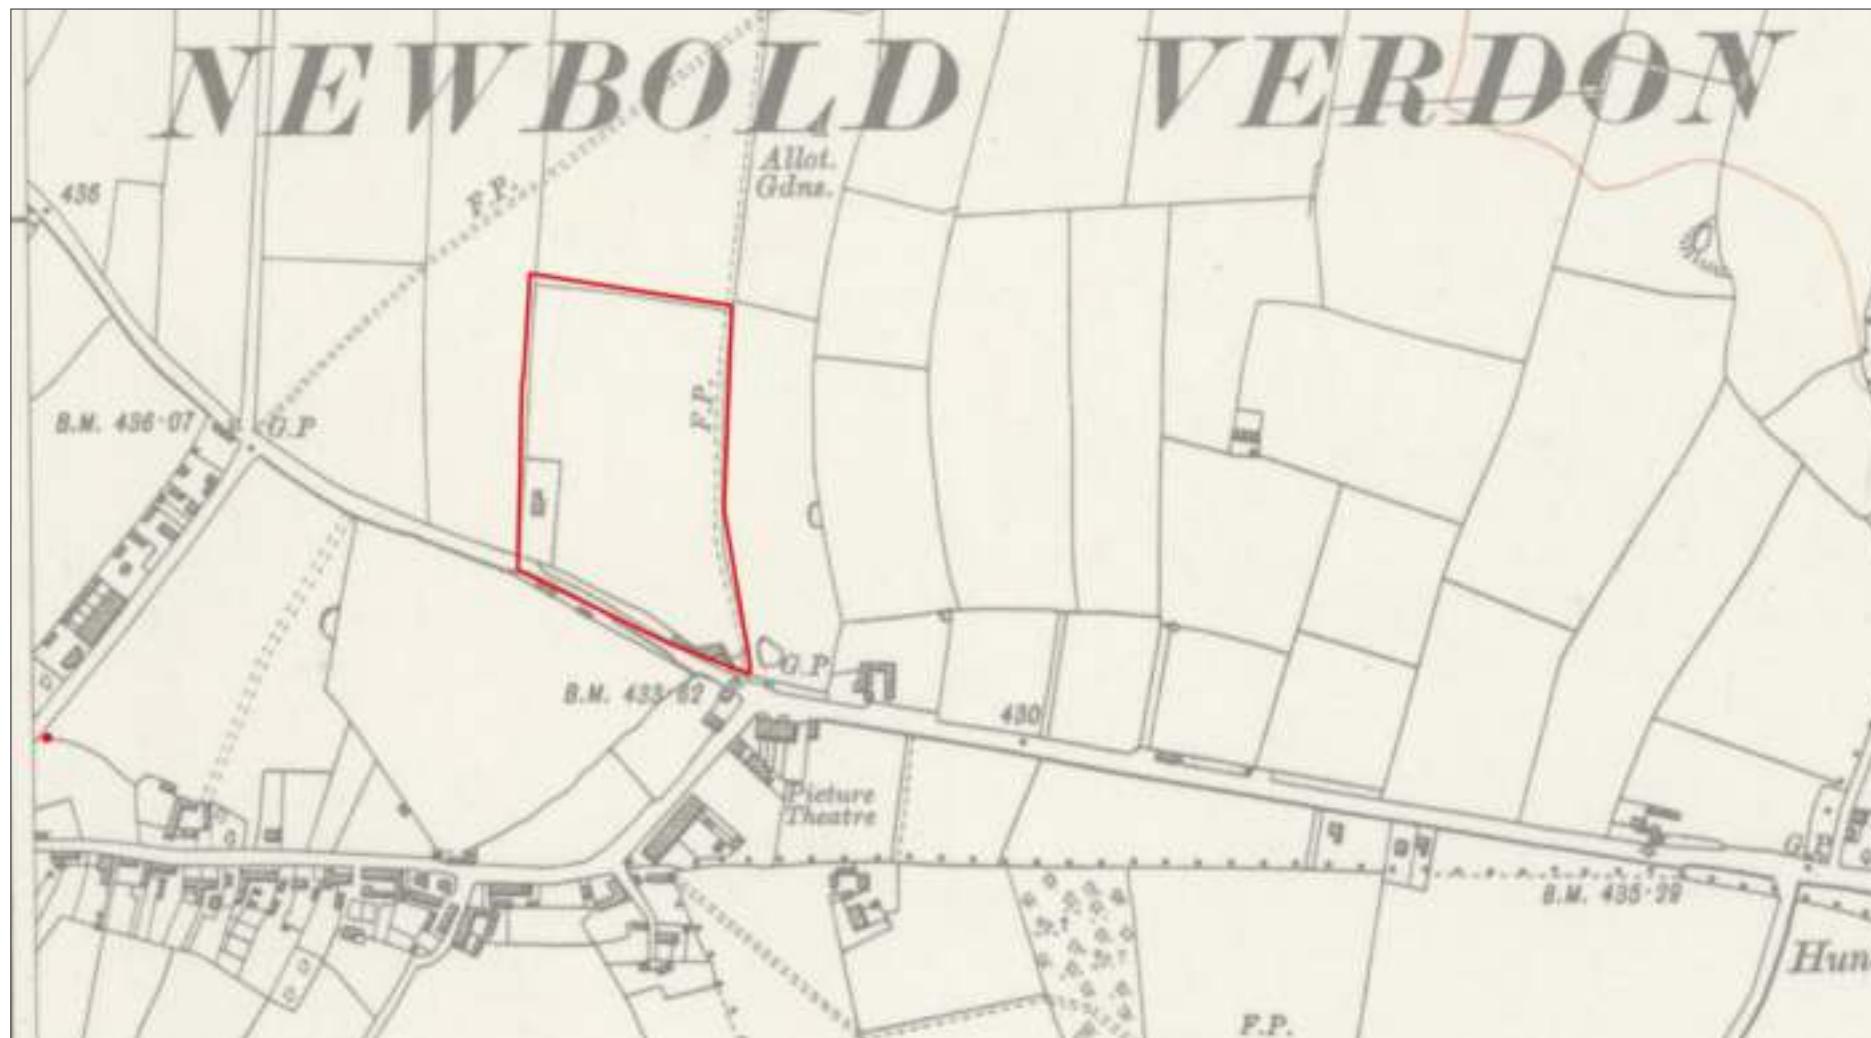
Figure 8: Leicestershire Sheet XXX.SW. Surveyed: 1928. Published, 1931. Reproduced with the permission of the National Library of Scotland.

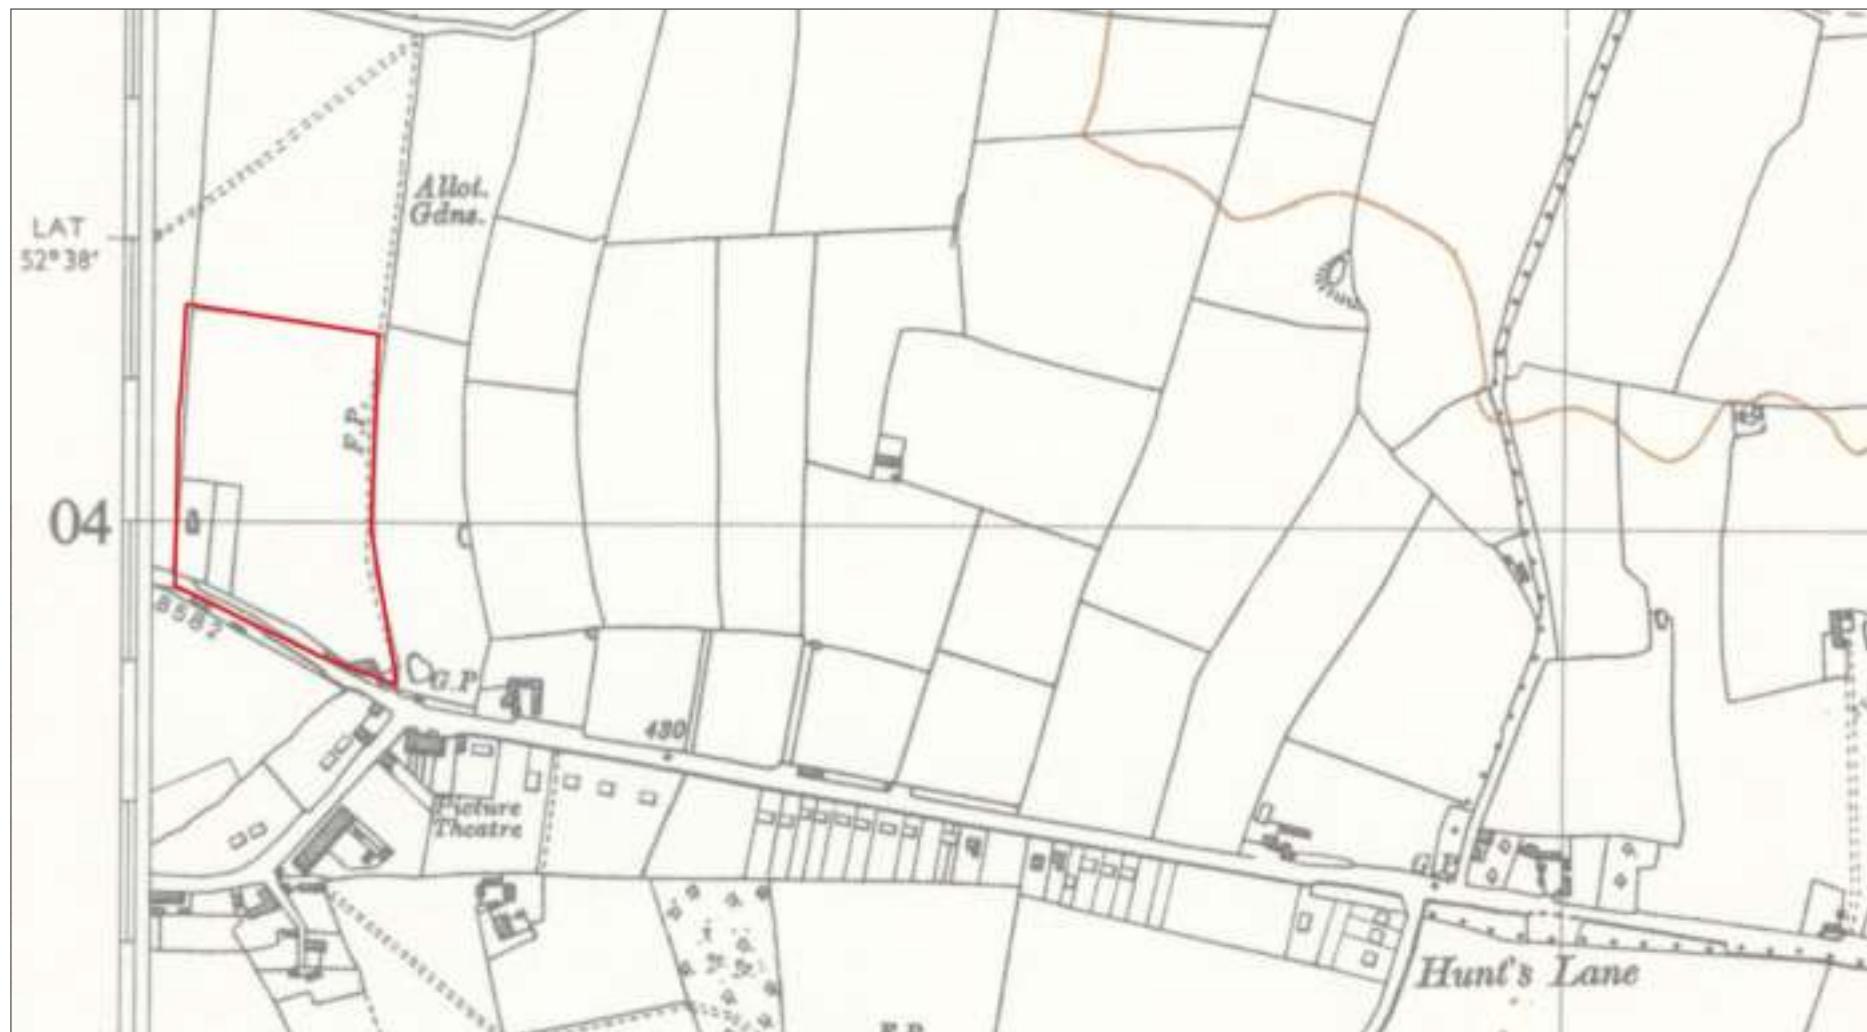
Figure 9: SK40SE - A. Surveyed: 1930. Published, 1955. Reproduced with the permission of the National Library of Scotland.

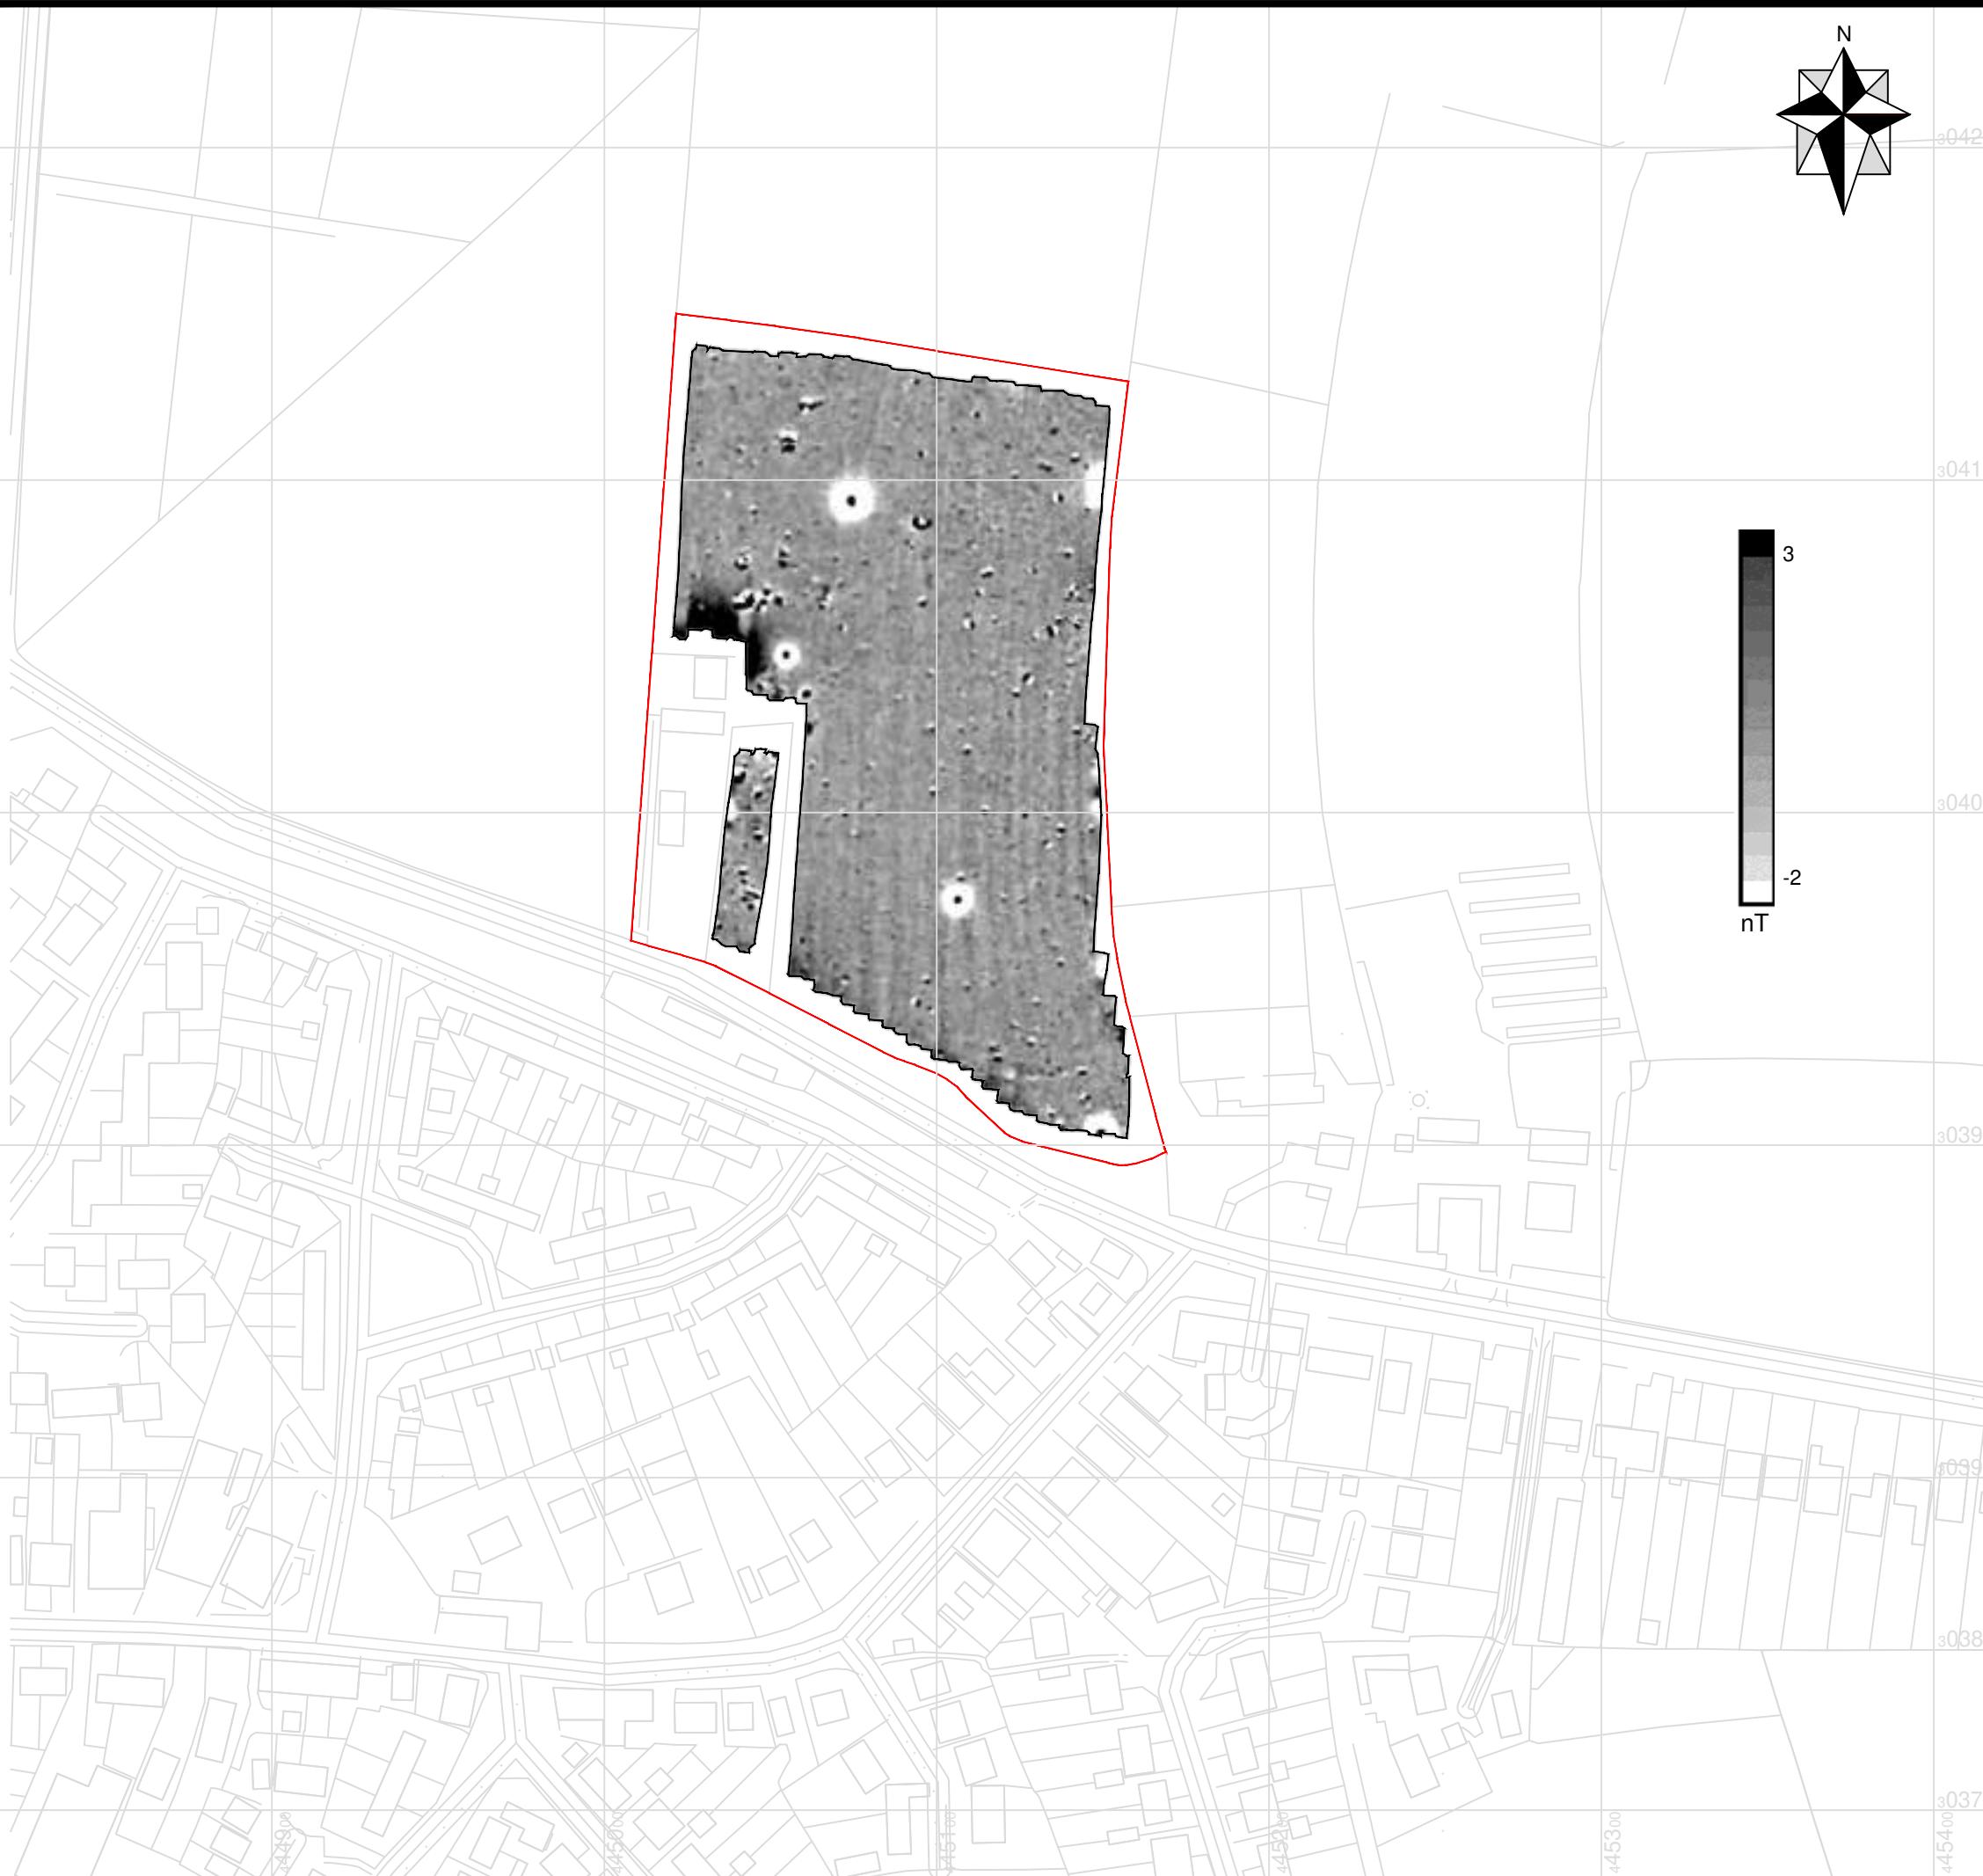
ANOMALY TYPE	INTERPRETATION
LINEAR / CURVI-LINEAR TREND (WEAK / DIFFUSE / FRAGMENTED RESPONSE)	UNCERTAIN ORIGIN. POSSIBLE AGRICULTURAL OR OTHER MODERN FEATURE. BUT COULD BE NATURAL OR REMNANT OF OTHER INFILLED FEATURE
ISOLATED POSITIVE RESPONSE	PROBABLE BURIED MODERN FERROUS / FIRED MATERIAL OR NATURAL VARIATION. BUT SOME COULD BE RELATED TO SUB-SURFACE FEATURES
APPROXIMATE ORIENTATION OF WEAK, BROADLY PARALLEL POSITIVE LINES	AGRICULTURAL ACTIVITY. POSSIBLE REMNANTS OF RIDGE AND FURROW BUT COULD BE RELATED TO LATER AGRICULTURAL ACTIVITY
AREA OF STRONG DIPOLEAR / BIPOLAR RESPONSES (MAGNETIC DISTURBANCE)	SURFACE / NEAR-SURFACE FERROUS OR FIRED MATERIAL (PROBABLE MODERN)
LIMIT OF VERY STRONG RESPONSE	INTERFERENCE CAUSED BY MODERN MAGNETIC FEATURE (FEATURE MAY BE LOCATED BEYOND THE SURVEY AREA)
ISOLATED BIPOLAR / DIPOLEAR RESPONSE	SURFACE / NEAR-SURFACE FERROUS OR FIRED MATERIAL (PROBABLE MODERN)

The anomalies have been categorised based on the type of response that they exhibit and an interpretation as to the cause(s) or possible cause(s) of each anomaly type is also provided.

Anomalies B are broadly parallel with each other and could be related to agricultural activity but it is possible that some could have a different cause.

There are several **isolated positive responses** across the survey area, some of which are relatively large or strong. This type of anomaly can have a variety of causes including natural features / variations, deeper buried ferrous or fired material, accumulations of topsoil related to agricultural activity, infilled features or areas of burning. At this site it is possible that some of the isolated positive responses are caused by infilled discrete features but there is no obvious pattern or relationship to their distribution that would indicate an archaeological origin and it is considered more likely that they are caused by buried relatively modern, ferrous or fired material or natural variations.

There are numerous **isolated dipolar** responses (iron spikes) across the survey area. These contain a strong positive and negative component and are indicative of ferrous or fired material on or near to the surface. **Isolated bipolar** responses are also present. These have strong positive and negative components but are not technically magnetic dipoles. They tend to be caused by ferrous or fired material on or near to the surface and are usually produced from larger, or more strongly magnetic, objects (compared to dipolar anomalies) or a concentration of strongly magnetic smaller objects. In the large majority of cases these two types of isolated responses will be caused by modern material. Selected larger / stronger isolated dipolar and bipolar responses have been shown on the interpretation as these could be associated with more substantial sub-surface features or material (although in this instance they are not thought to be of archaeological interest).
