## Contamination Investigation Report

| <b>LOCATION</b> | The Barn, Claires Barn Farm, Twycross CV9 3PG |
| <b>OUR REF.</b> | G23127 |

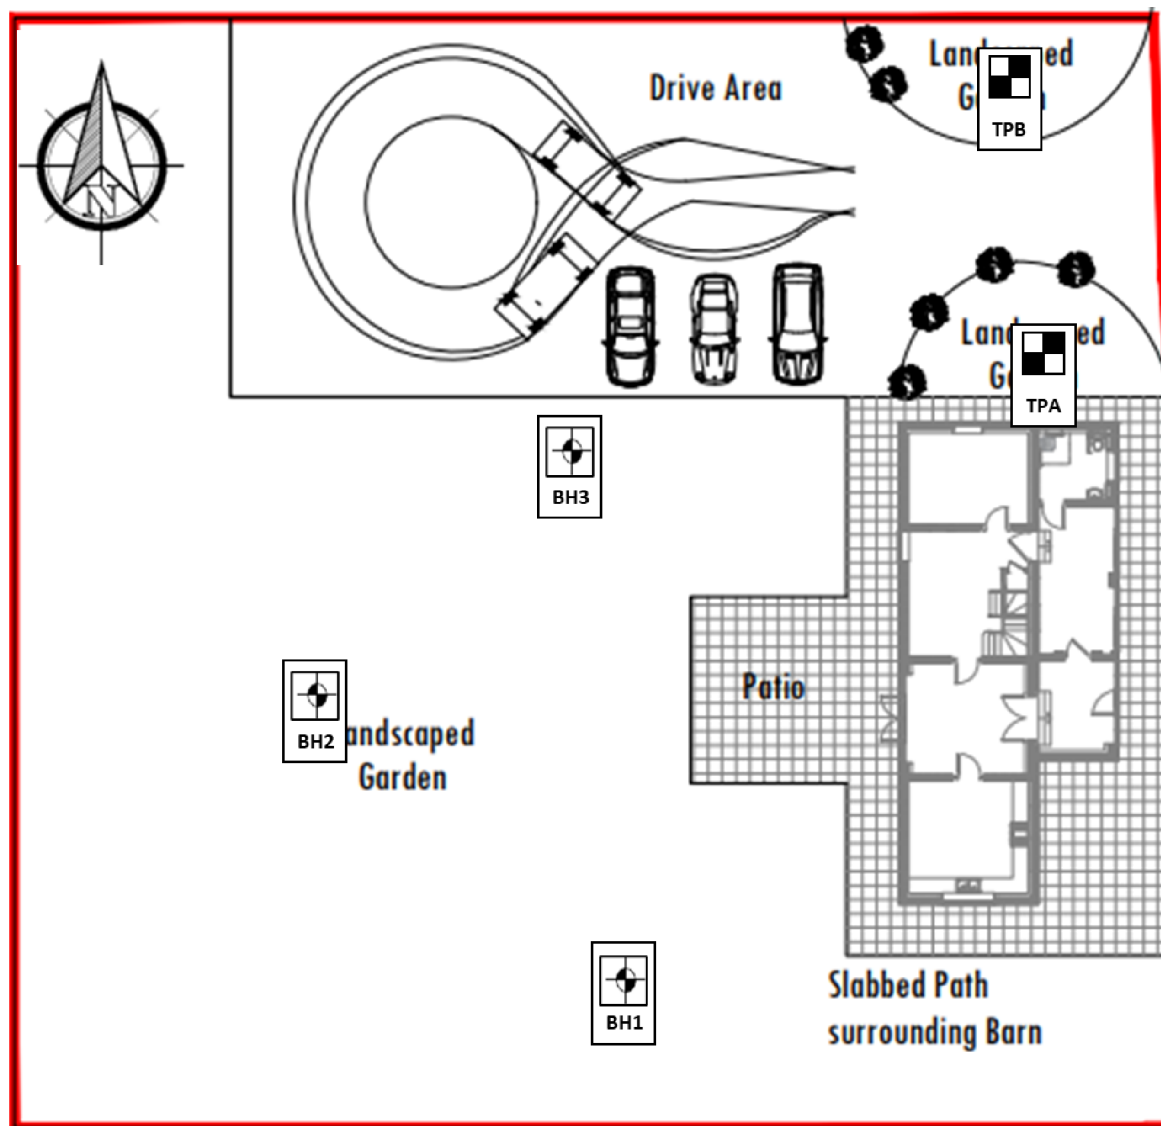
| OUR REF: G23127 | YOUR REF: | SITE PLAN (NOT TO SCALE) |

The trial pit and borehole positions are shown on the plan provided in Appendix 1.
