# Preliminary Roost Assessment

Of Pippin Cottage, Leicester Lane, Desford, LE9 9JJ

January 2026

Matthew Kirby  
OAK ECOLOGY

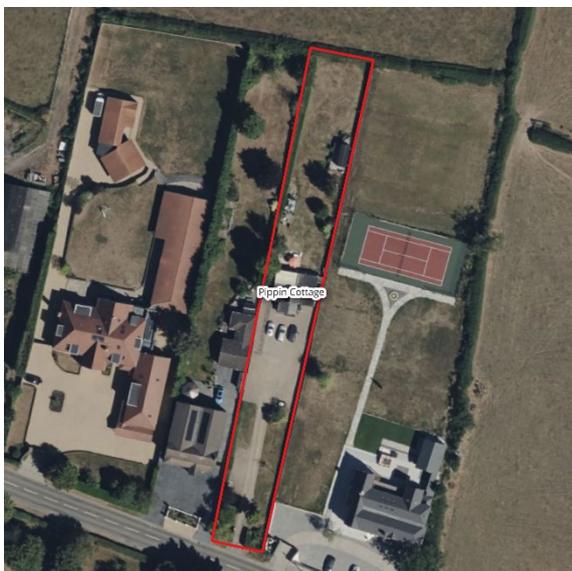
Figure 1: Red line boundary.

The site, centred at SK 49698 02542, consisted of a single-storey detached dwelling and associated landscaping. The surrounding landscape was primarily rural in all directions. Large expanses of arable fields, grasslands, and small wooded areas were identified. The proposed application is for the demolition of the existing building and creation of one new dwelling.

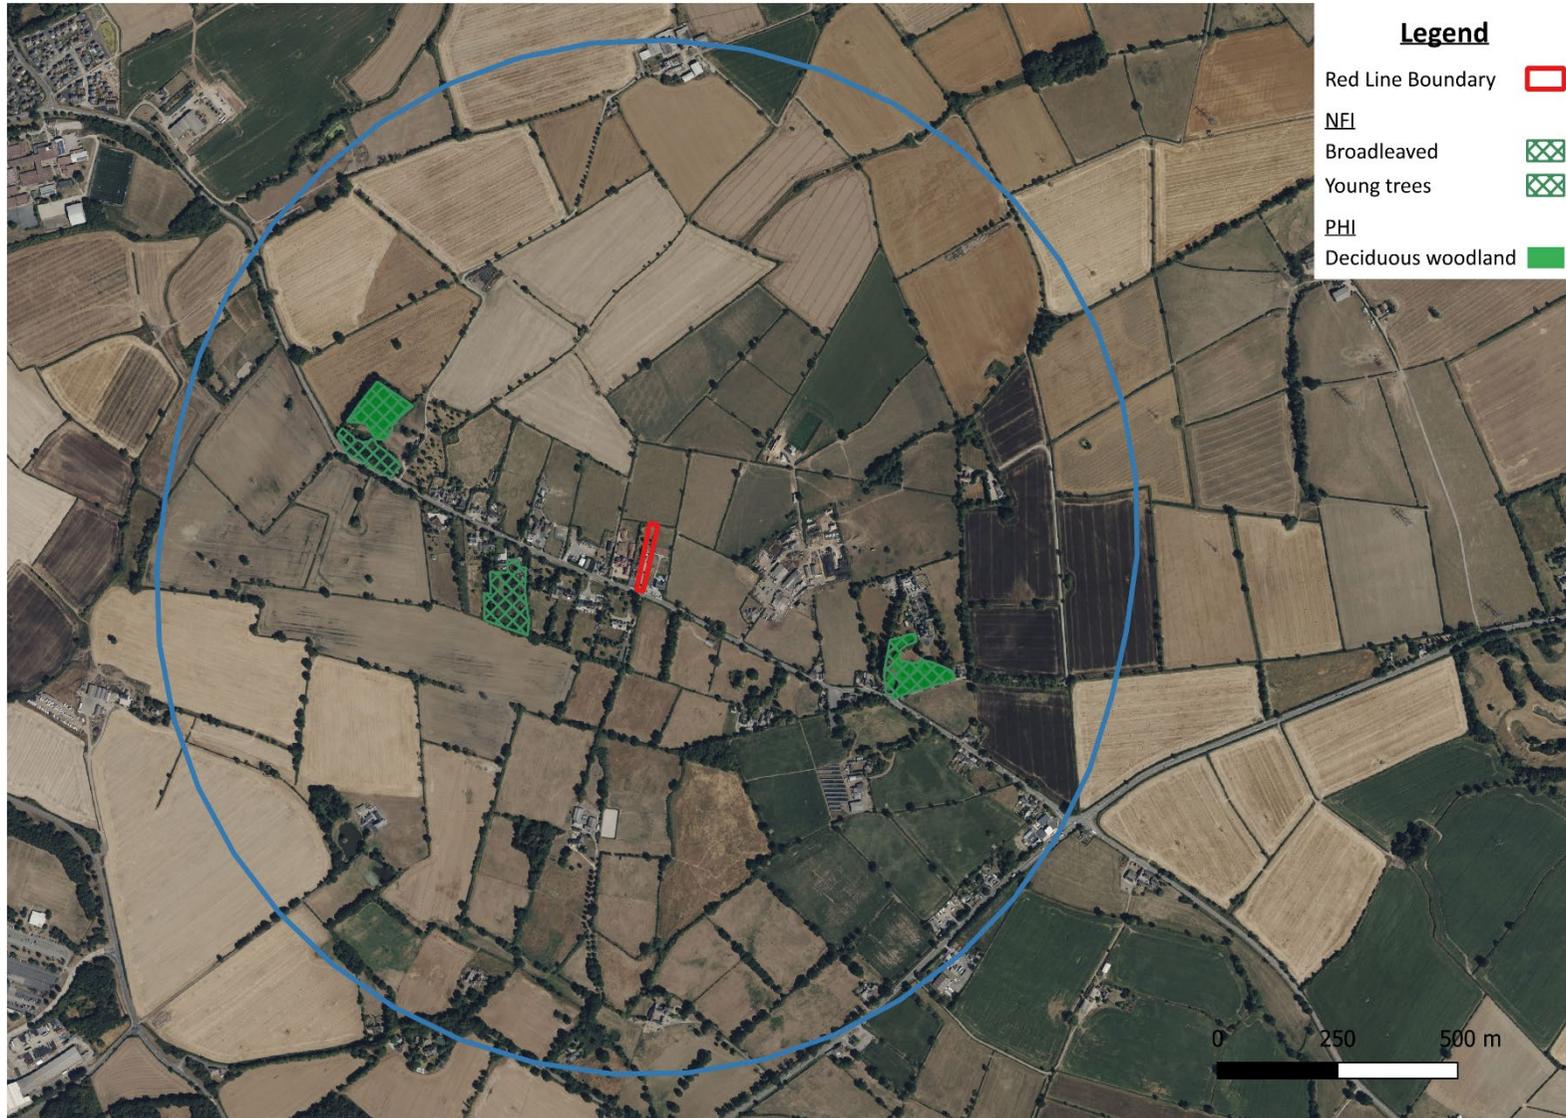
Figure 4: Wider landscape map.

The surrounding area had moderate potential to support bats, with good foraging habitats in the wider landscape. Connectivity to the wider landscape to more suitable habitats was good.

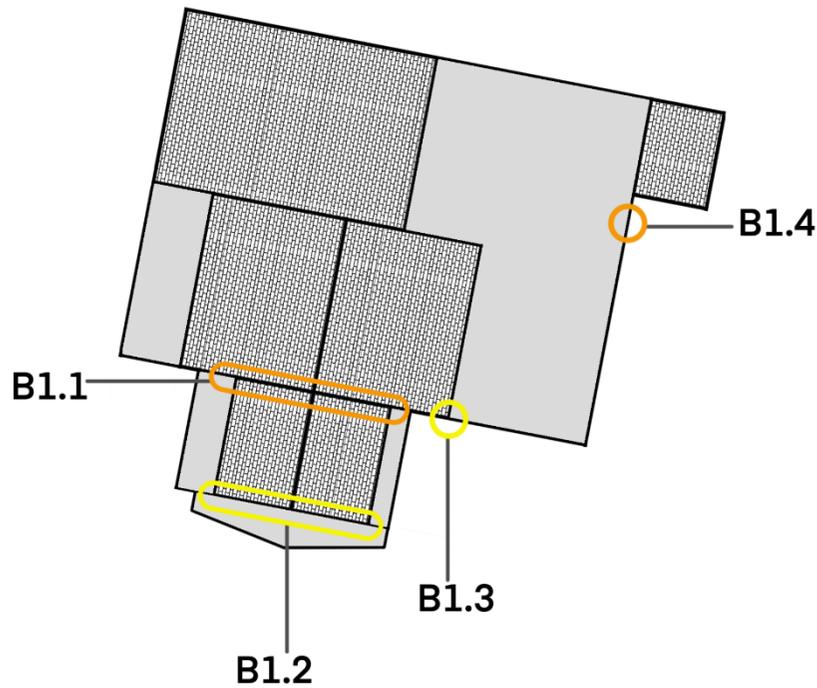
Figure 5: PRA map.

Feature ID	Type	Height/bearing	Notes	Potential
B1.1	Cladding	2.5-4m S	Wooden cladding that had lifted away providing a crevice. 5cm by 150cm opening.	Moderate
B1.2	Tiles	2-3m S	Gable edge of tiles with a small gap along the entire length of the gable end. 2cm by 400cm opening.	Low
B1.3	Fascia board	2.5m S	Loose boards with cavity extending up.	Low
B1.4	Wall cavity	2m E	Missing brick with exposed wire, providing access into the wall cavity, the full extent is unknown. Bird droppings identified on entrance. Partially cluttered but still feasible for bats.	Moderate

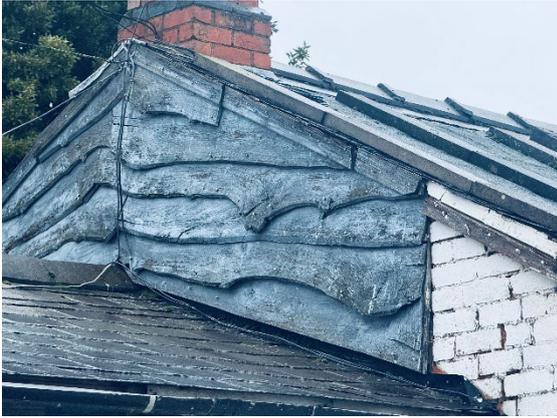
Figure 6: Feature B1.1.

Wooden cladding (B1.1) on the south aspect of the building had become raised providing shelter along the entire length. The cladding created a crevice type of cavity, similar to loose bark. The cladding was affixed to the exterior of the building and would not provide any access into the building.

As the development will result in the loss of PRF's bat boxes should be installed on the new building. Two moderate and two low potential features would be lost; therefore a minimum of two bat boxes should be installed for compensation.

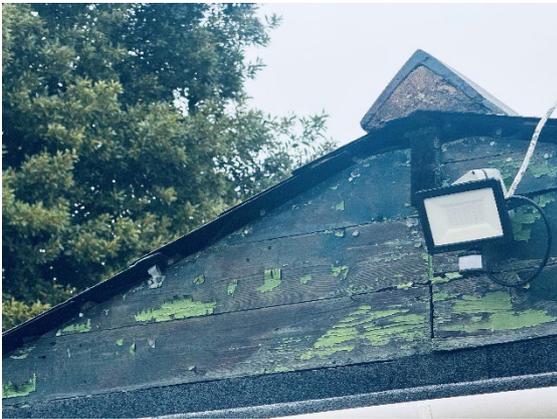
Figure 8: Feature B1.2.

The gable end verge (B1.2) did not have any edge covering or mortar, which provided access under the tiling. This would create a cavity between the tiles and the roofing membrane along the entire length of the battens. The tiles were thin slate which would be less likely to provide a stable environment all year-round.

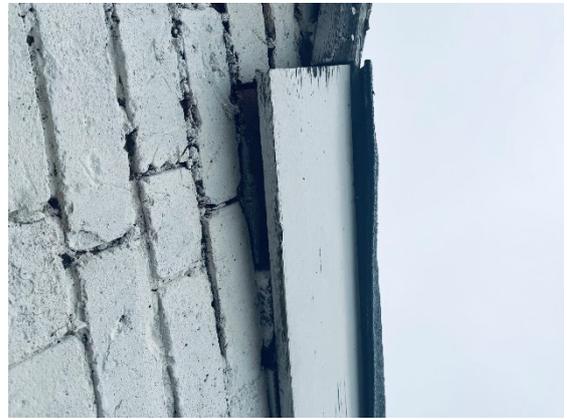
Figure 9: Feature B1.3.

The edge of the fascia board (B1.3) on the south aspect had lifted away the brickwork and extended up the board to the edge of the flat roof. It could not be determined if there was any access from this feature into a wall cavity.

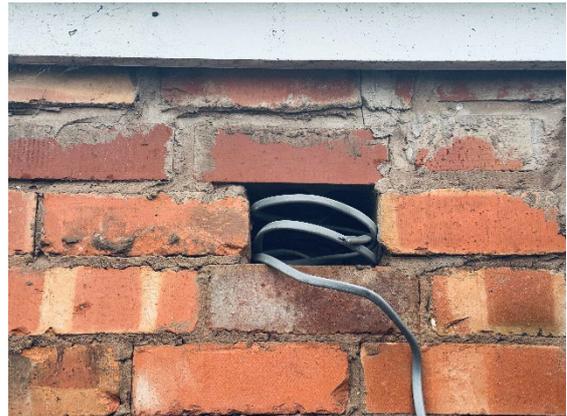
Figure 11: Feature B1.4.

A missing brick (B1.4) with exposed wiring was identified on the east aspect. The entrance was cluttered with wires, however there were bird droppings were present on the bricks. The hole allowed access into the wall cavity, therefore making it implausible to fully inspect without performing a destructive search. Depending on the level of insulation, this feature has the potential to provide a stable internal environment.

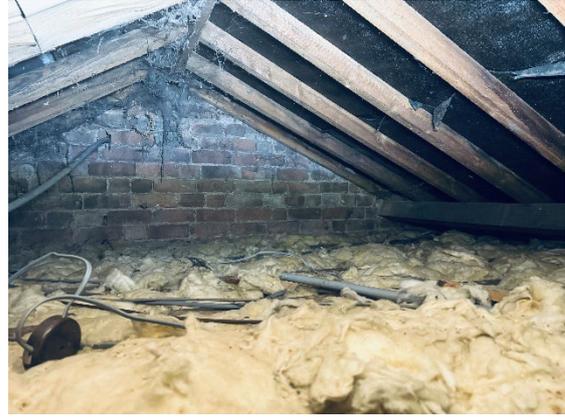
The loft space was approximately 1m tall at the apex and covered the length of building with ridged roofs. There was a roofing membrane and insulation but not boarded, making it unsafe/impractical to fully access all areas. No obvious damages were observed that would indicate access from the exterior for bats. However, there was a significant amount of mouse droppings throughout the loft, which was periodically checked to see if bat droppings were hidden amongst them. There was major cobwebbing and a thick layer of dust throughout the loft space indicating no recent bats flying inside. No significant damages or access points were identified. Overall, there was no evidence to suggest that bats have or could enter the internal space of the building.

Figure 13: Internal view of loft.

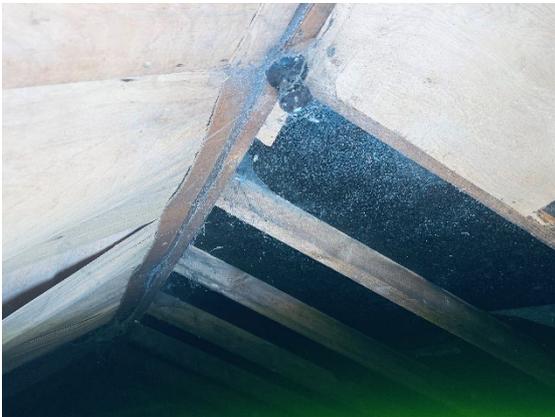
Figure 14: Internal view, showing ridge beam.

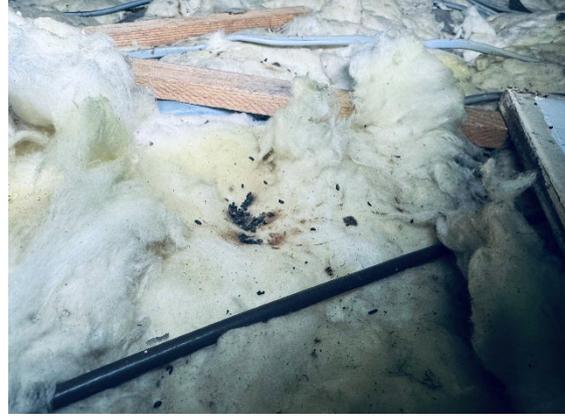
Figure 15: Mouse droppings identified within loft.

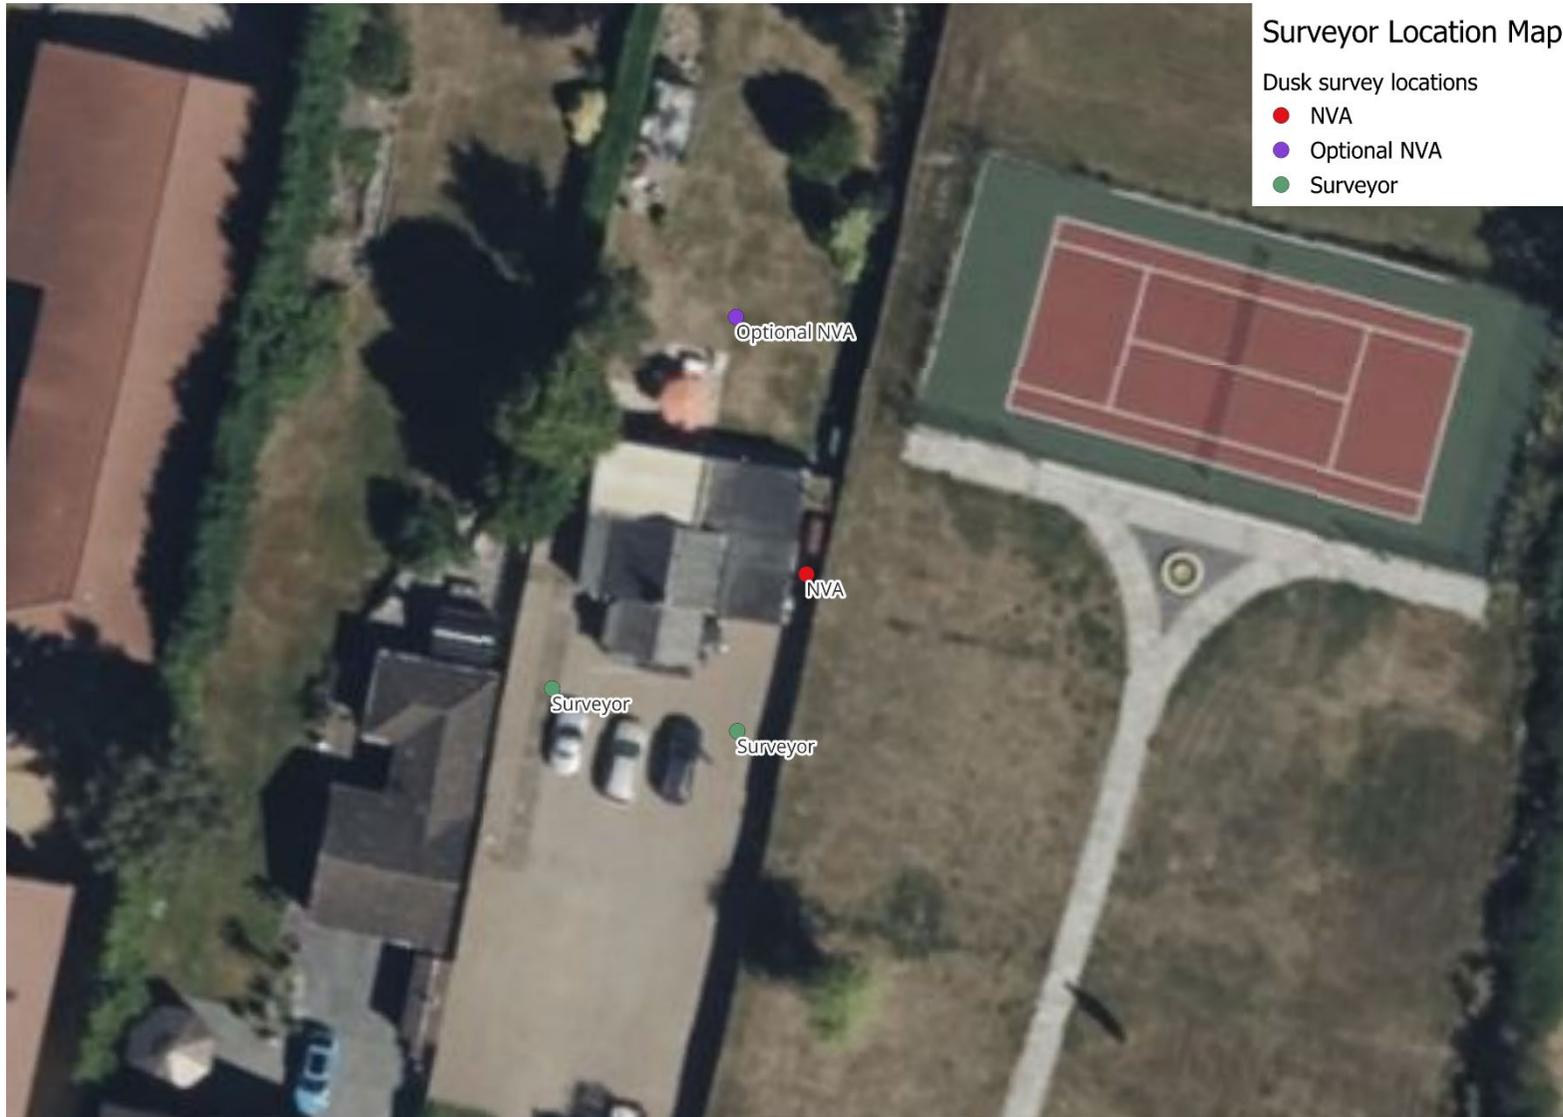
Figure 16: Potential surveyor locations for presence/likely absence surveys.

Surveyors would observe the PRF's using Night Vision Aids (NVA) and recording bat detectors to identify any roosting bats within the building.

To cover all PRF's of the building it is propped that a minimum of two surveyors and standalone NVA with detector be used. Although no PRF's were identified on the north aspect, an optional NVA could be utilised to cover bat activity and any PRF's that may have not been visible from the ground level.
