# Phase II Geo-Environmental Assessment

Jelson Homes

Sapcote Road, Burbage

PJS24-0117-DOC-0001

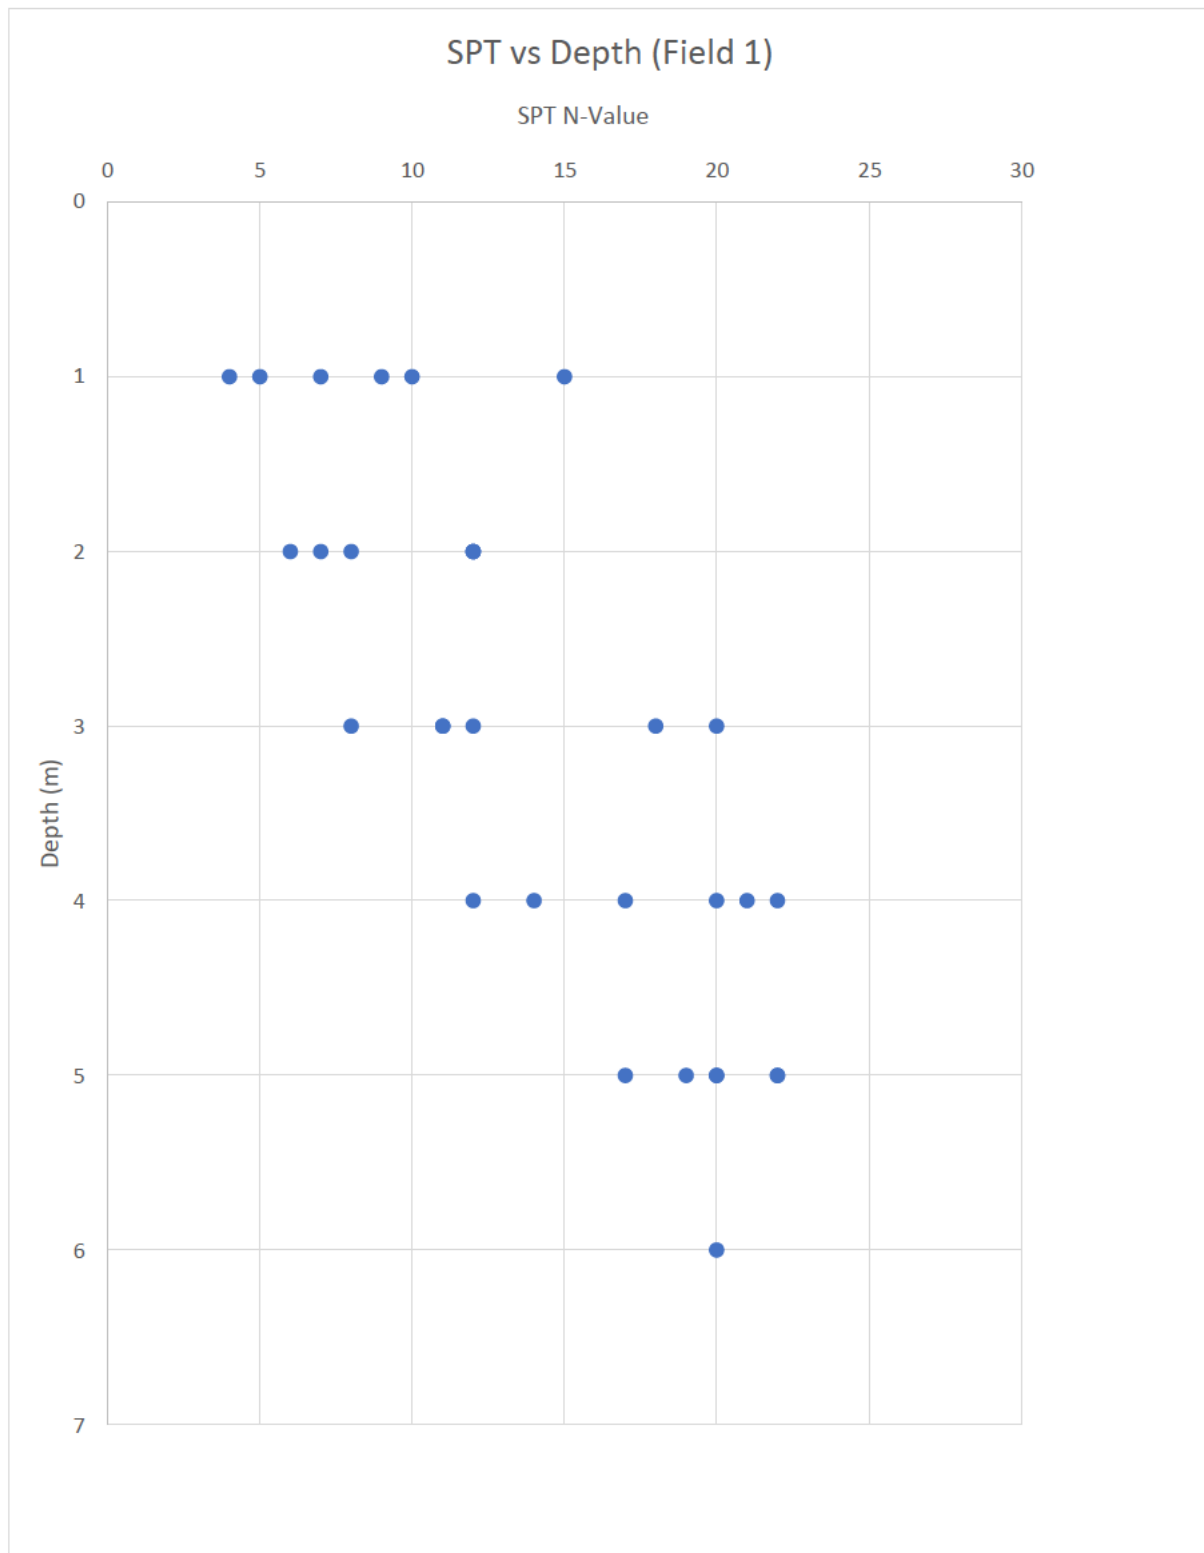
**Figure 1 - Corrected SPT N60 Value with Depth – Field 1**

The results of the in-situ testing generally show an increase in strength with depth of the Bosworth Clay Member deposits with some soft deposits encountered between 1m and 3m depth.

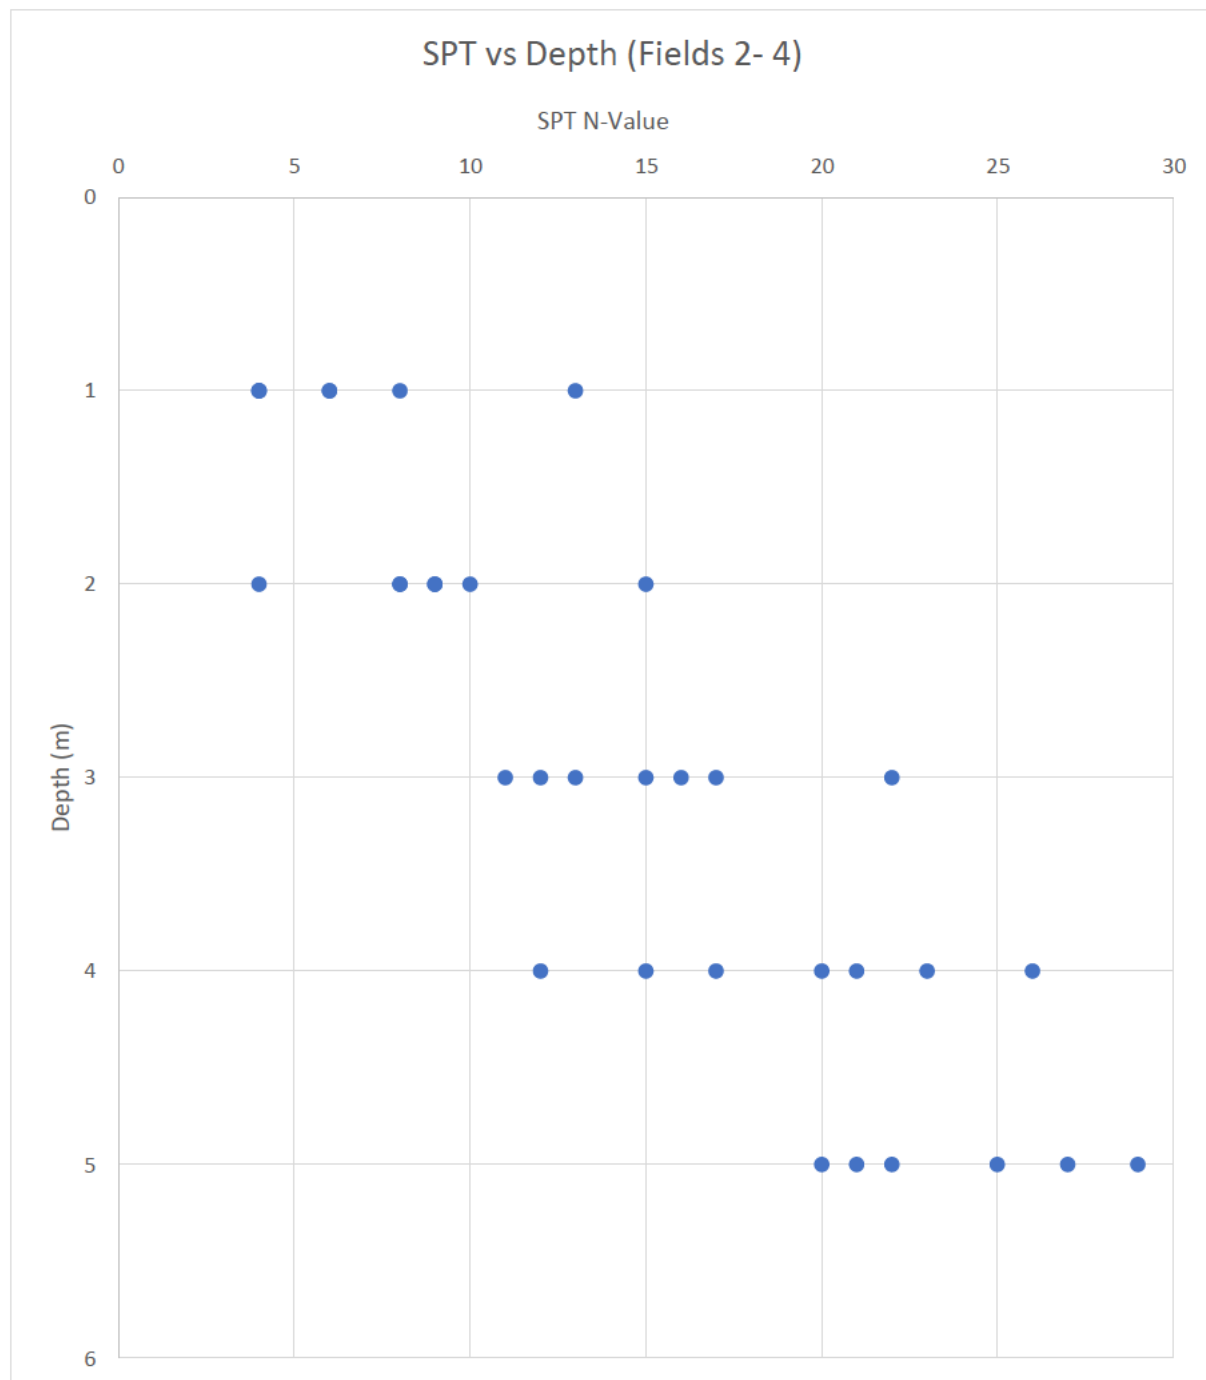
**Figure 2 - Corrected SPT N60 Value with Depth – Field 2 to 4.**

A plot of the corrected SPT N60 value vs depth in relation to the Bosworth Clay Member deposits encountered below Fields 2 to 4 is presented as Figures 2 below.

The results of the in-situ testing generally show an increase in strength with depth of the Bosworth Clay Member deposits with some soft deposits encountered between 1m and 2m depth most notably at the northern end of Field 1.

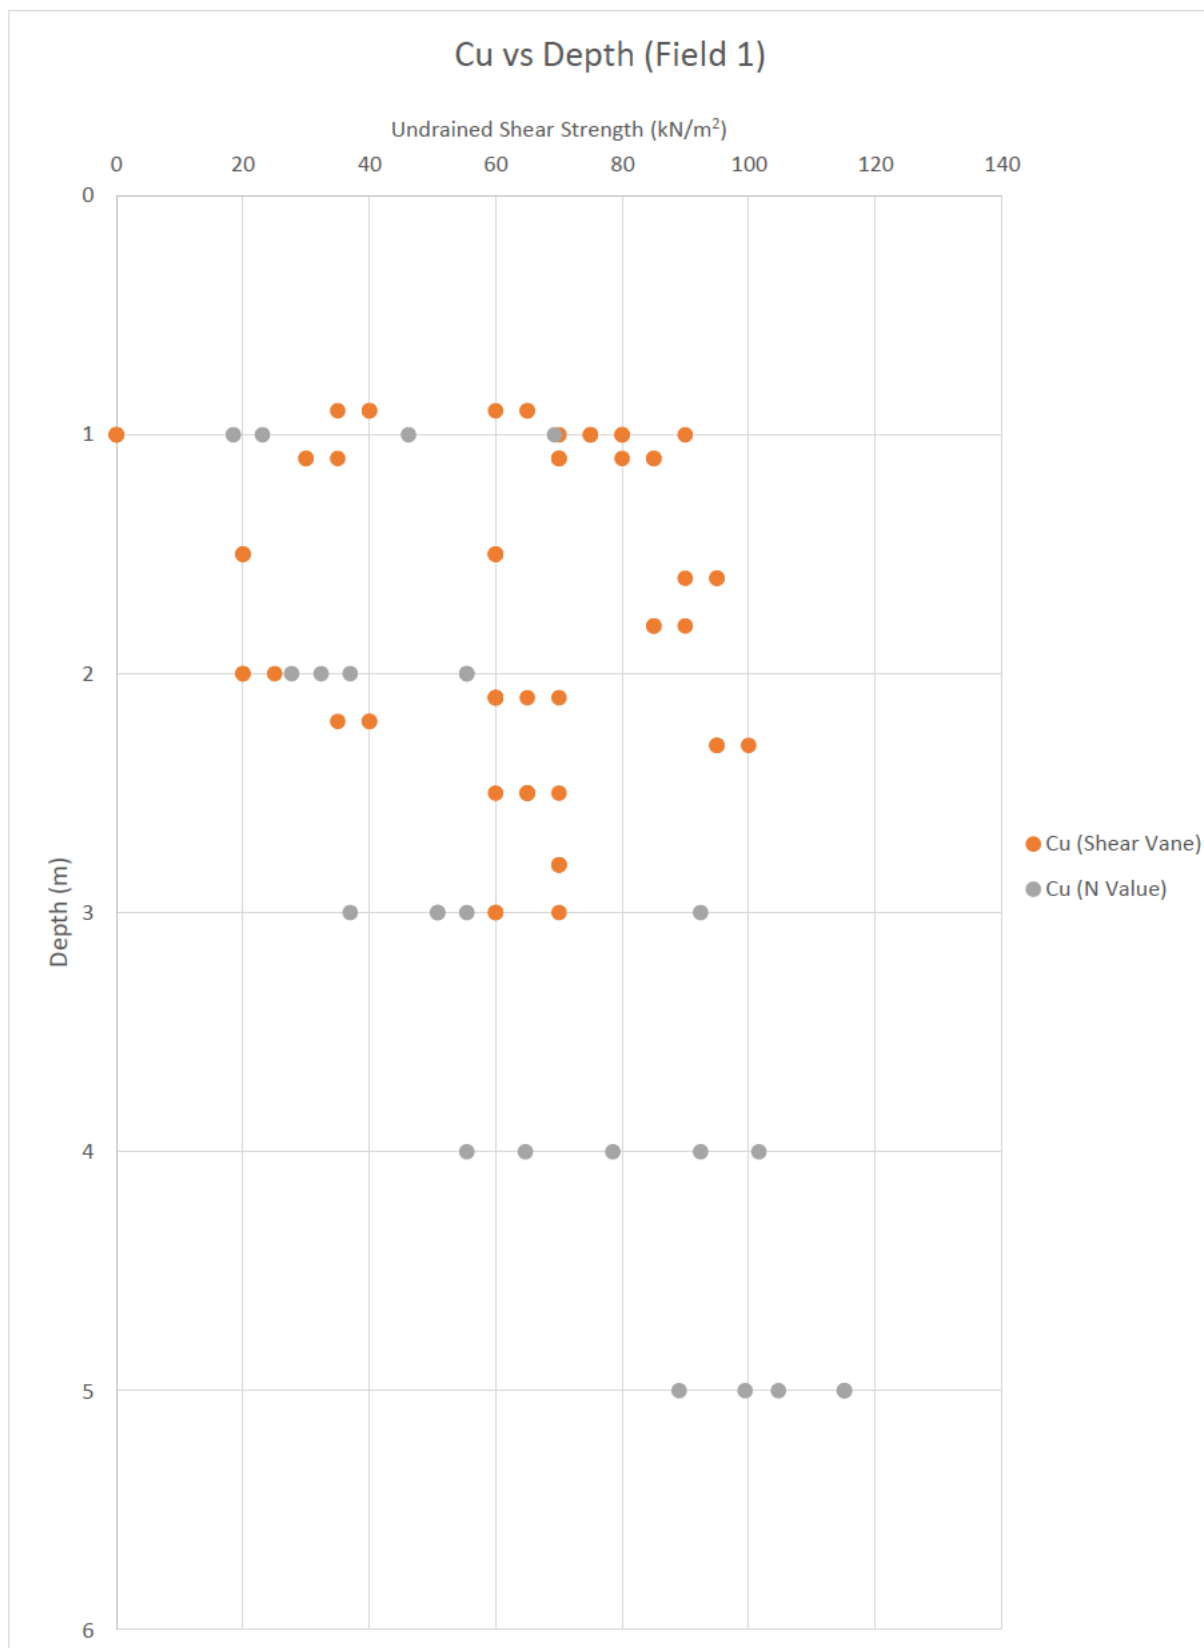
**Figure 3 - Estimated Shear Strength with Depth – Field 1**

The results show a clear trend of increasing shear strength with depth but with variable very soft and soft low strength deposits noted between 1m and 3m depth.

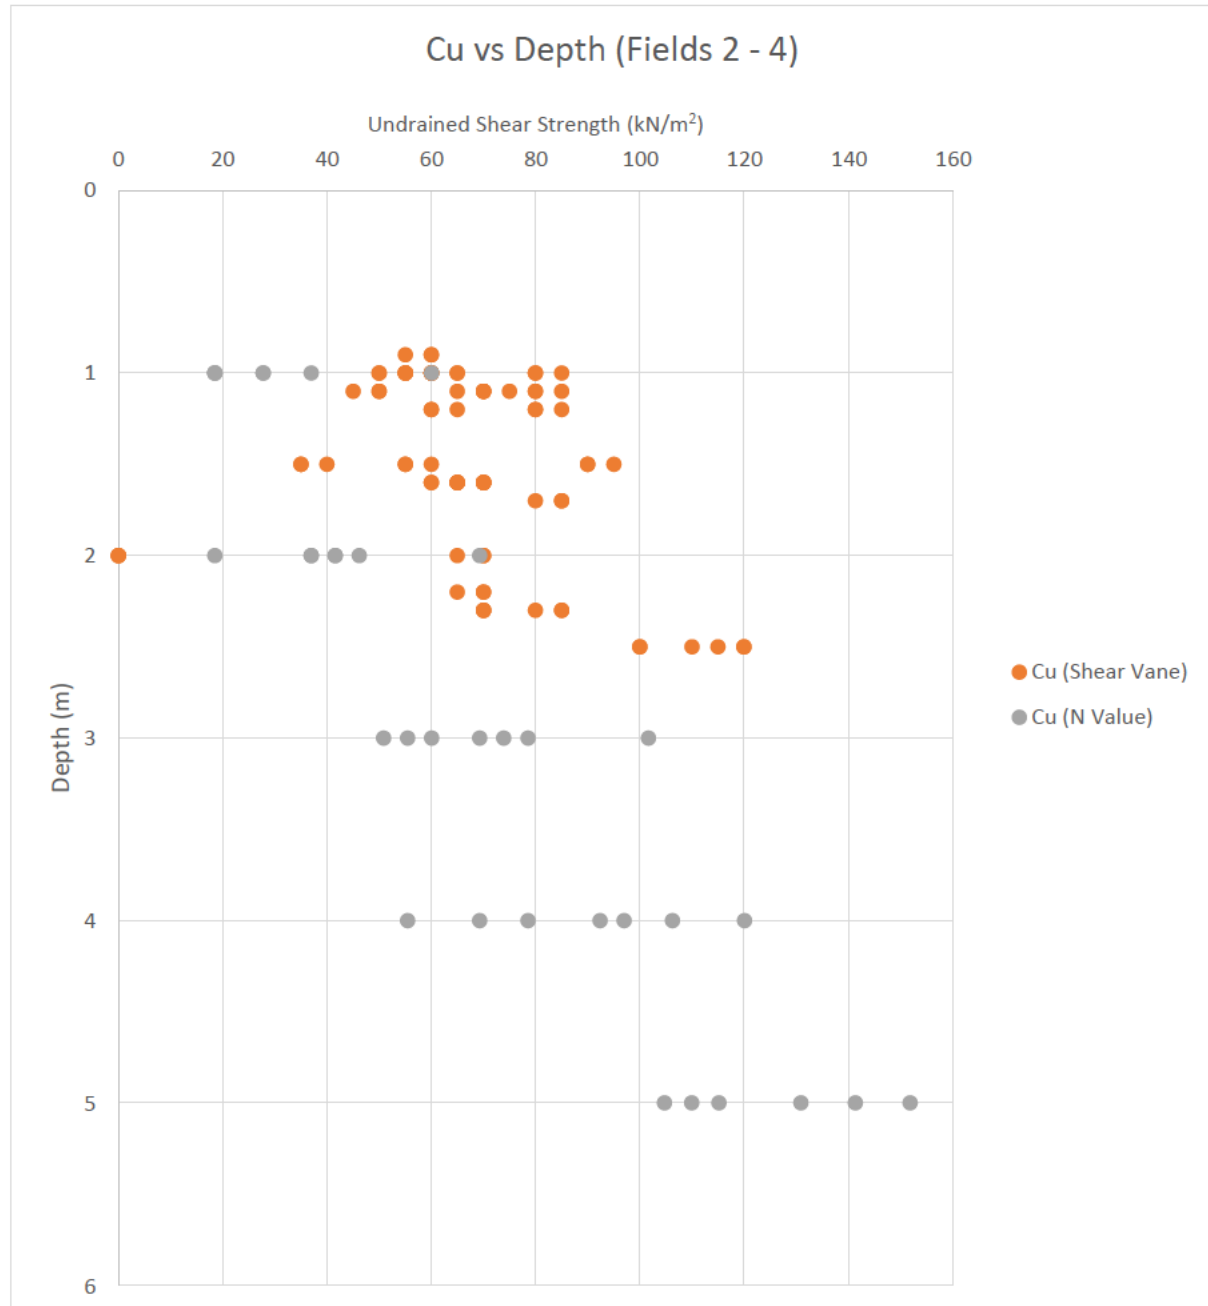
**Figure 4 - Estimated Sheer Strength with Depth – Fields 2 to 4**

Figure 4 presents plots of the estimated undrained shear strength with depth beneath Fields 2 to 4 of the natural deposits based on the soil plasticity testing, F1 values, SPT N values and in-situ shear strength of the deposits recorded using an HSV.

The results show a clear trend of increasing shear strength with depth but with some variable very soft and soft low strength deposits noted between 1m and 2m depth encountered in a few locations.

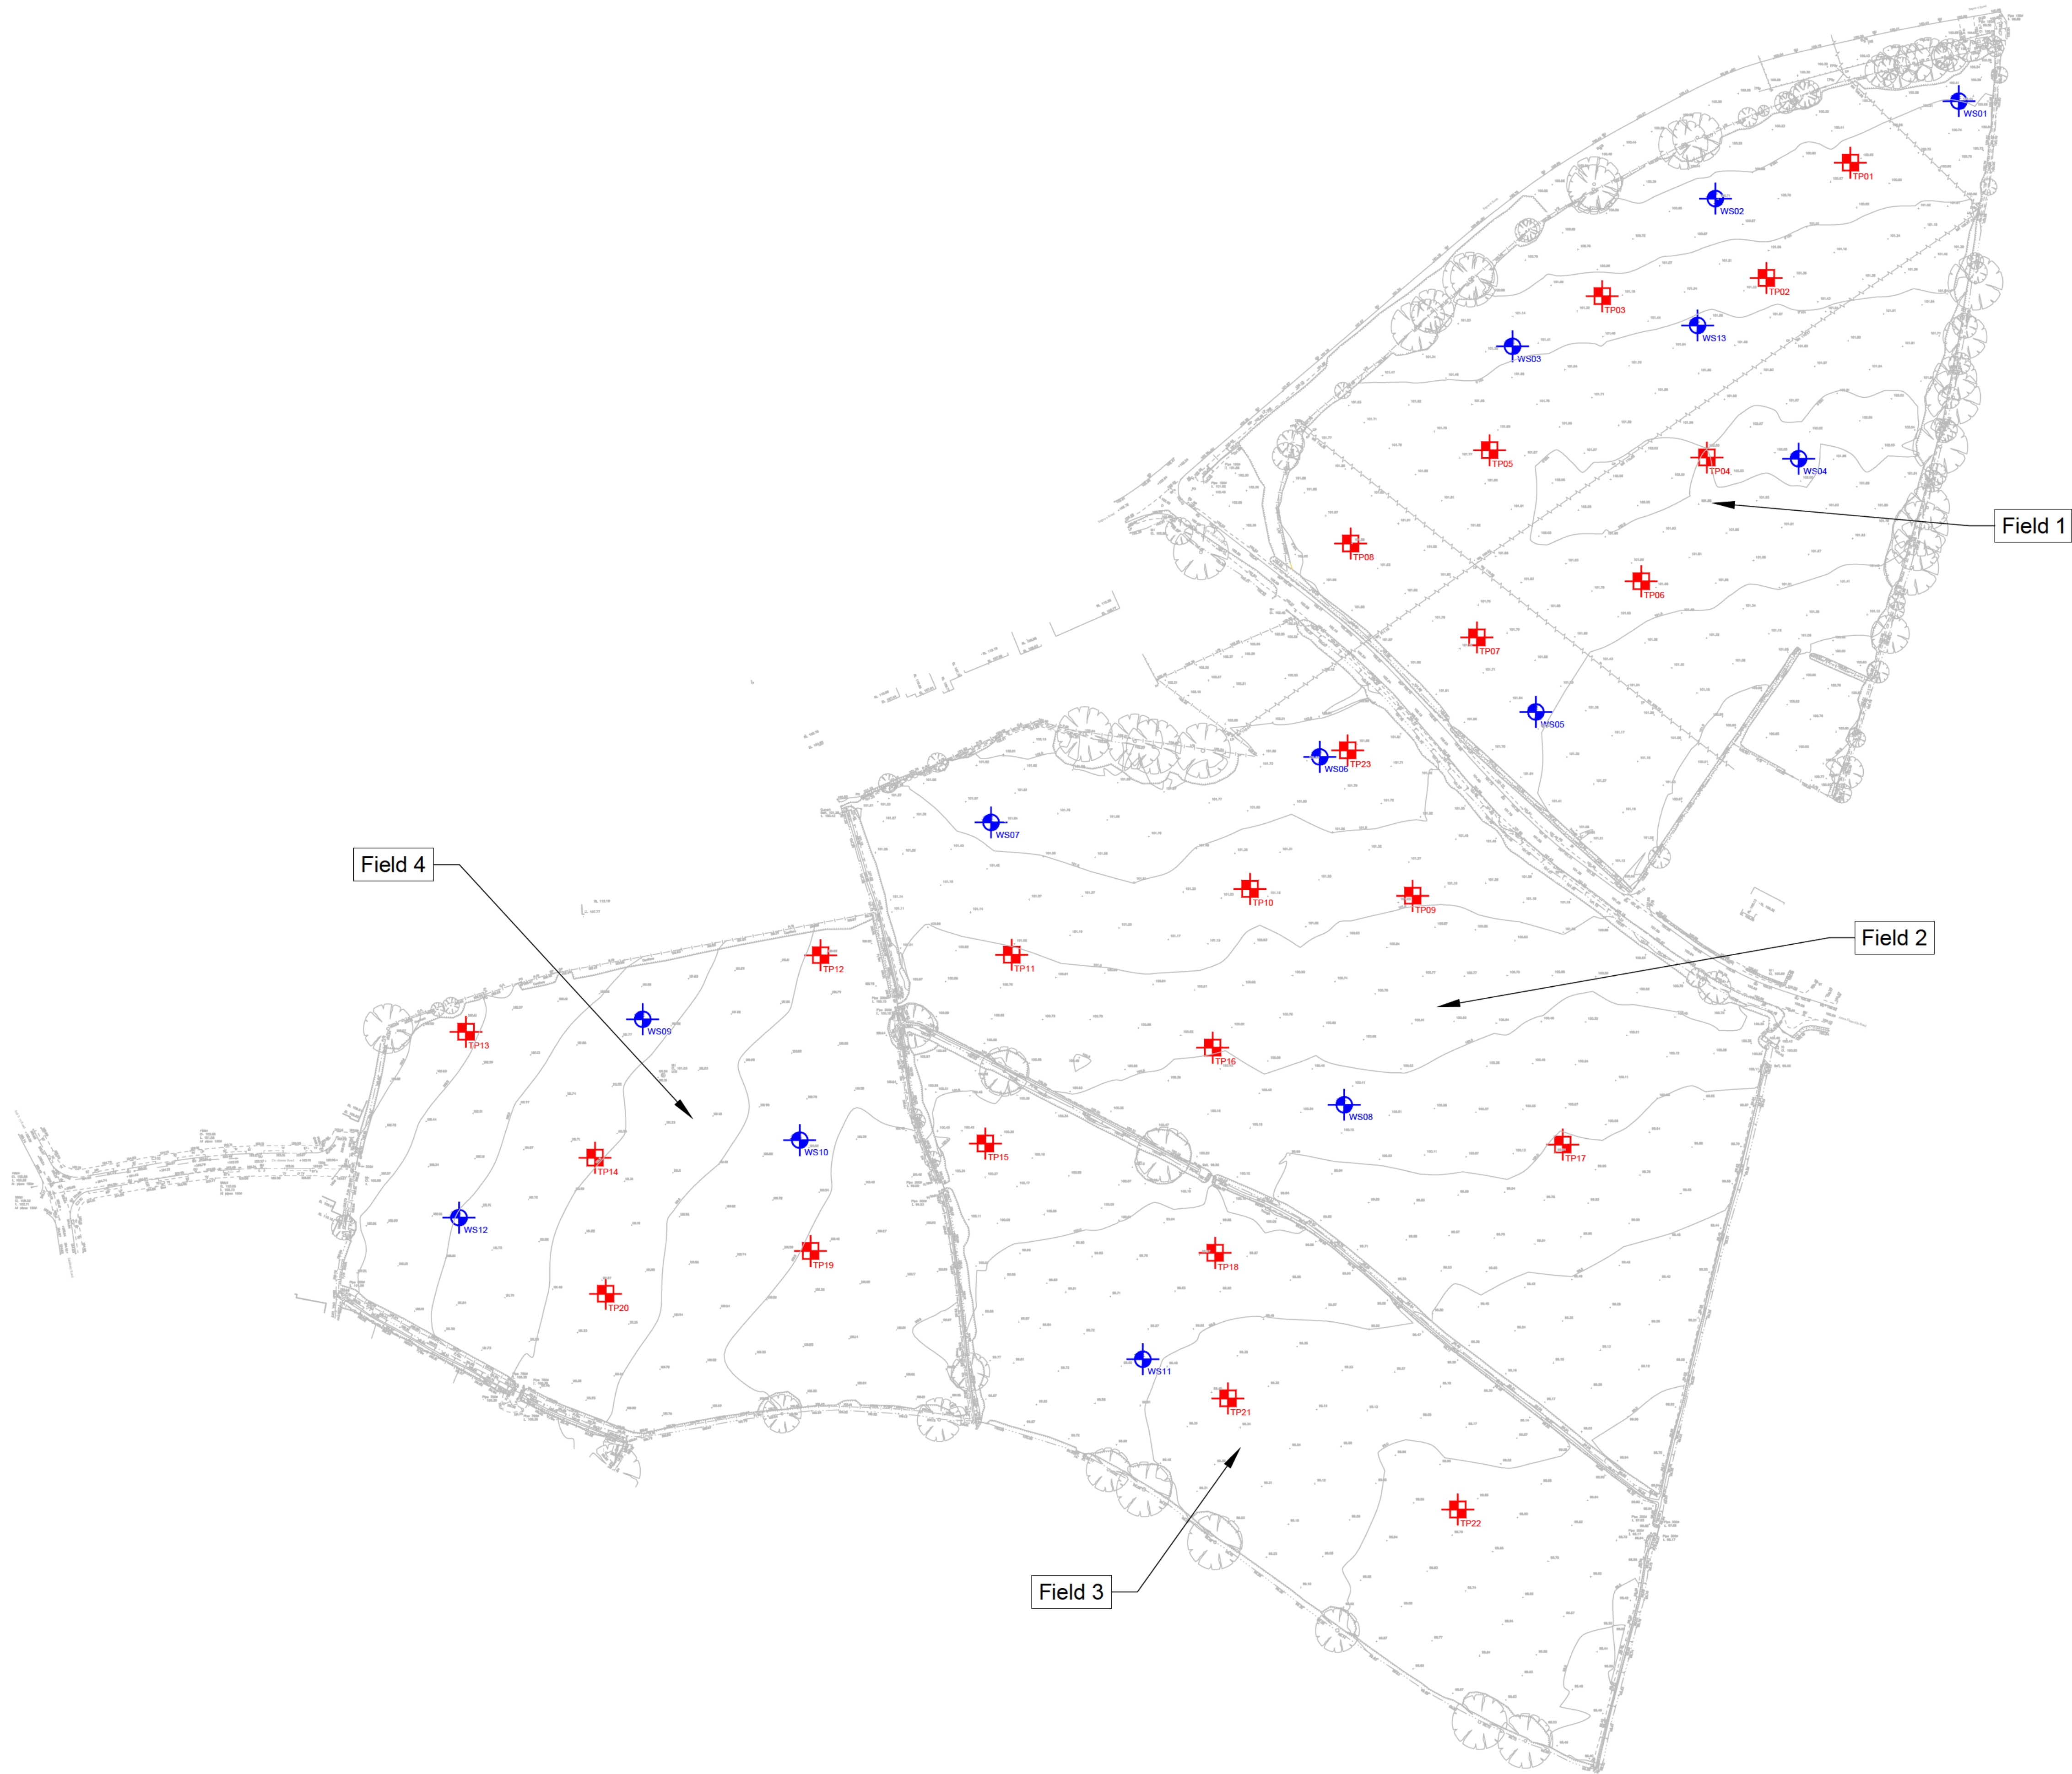
**Key - Exploratory Investigation**

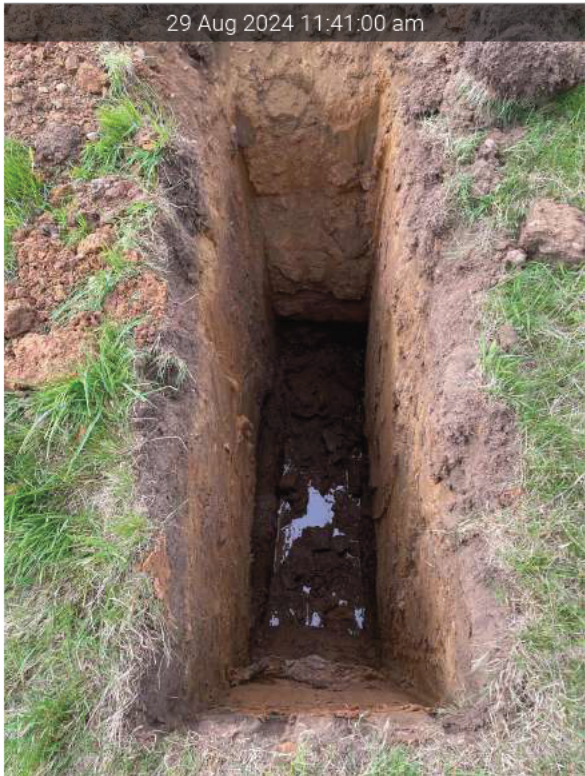
29 Aug 2024  
TP01 after 5mins

| Site Area | Location | Observation | Depth Range (m) |
|---|---|---|---|
| <b>Field 1</b> | TP01 | Slow groundwater seepage within side of excavation at 2.40m with a layer of silty sand. Fast groundwater ingress noted at 1.80m after excavation left open for 10 minutes. | 1.80 |

| Site Area | Location | Observation | Depth Range (m) |
|---|---|---|---|
| <b>Field 1</b> | TP01 | Major instability and collapse of side walls noted from 1.80m after excavation left open for 5 minutes. | 1.80 |
