DESFORD LANE, RATBY, LEICESTERSHIRE

PHASE II SITE APPRAISAL  
FOR  
GLADMAN DEVELOPMENTS LTD

**Project Ref:**  
P10567/PIISAR.2

**Date:**  
May 2024

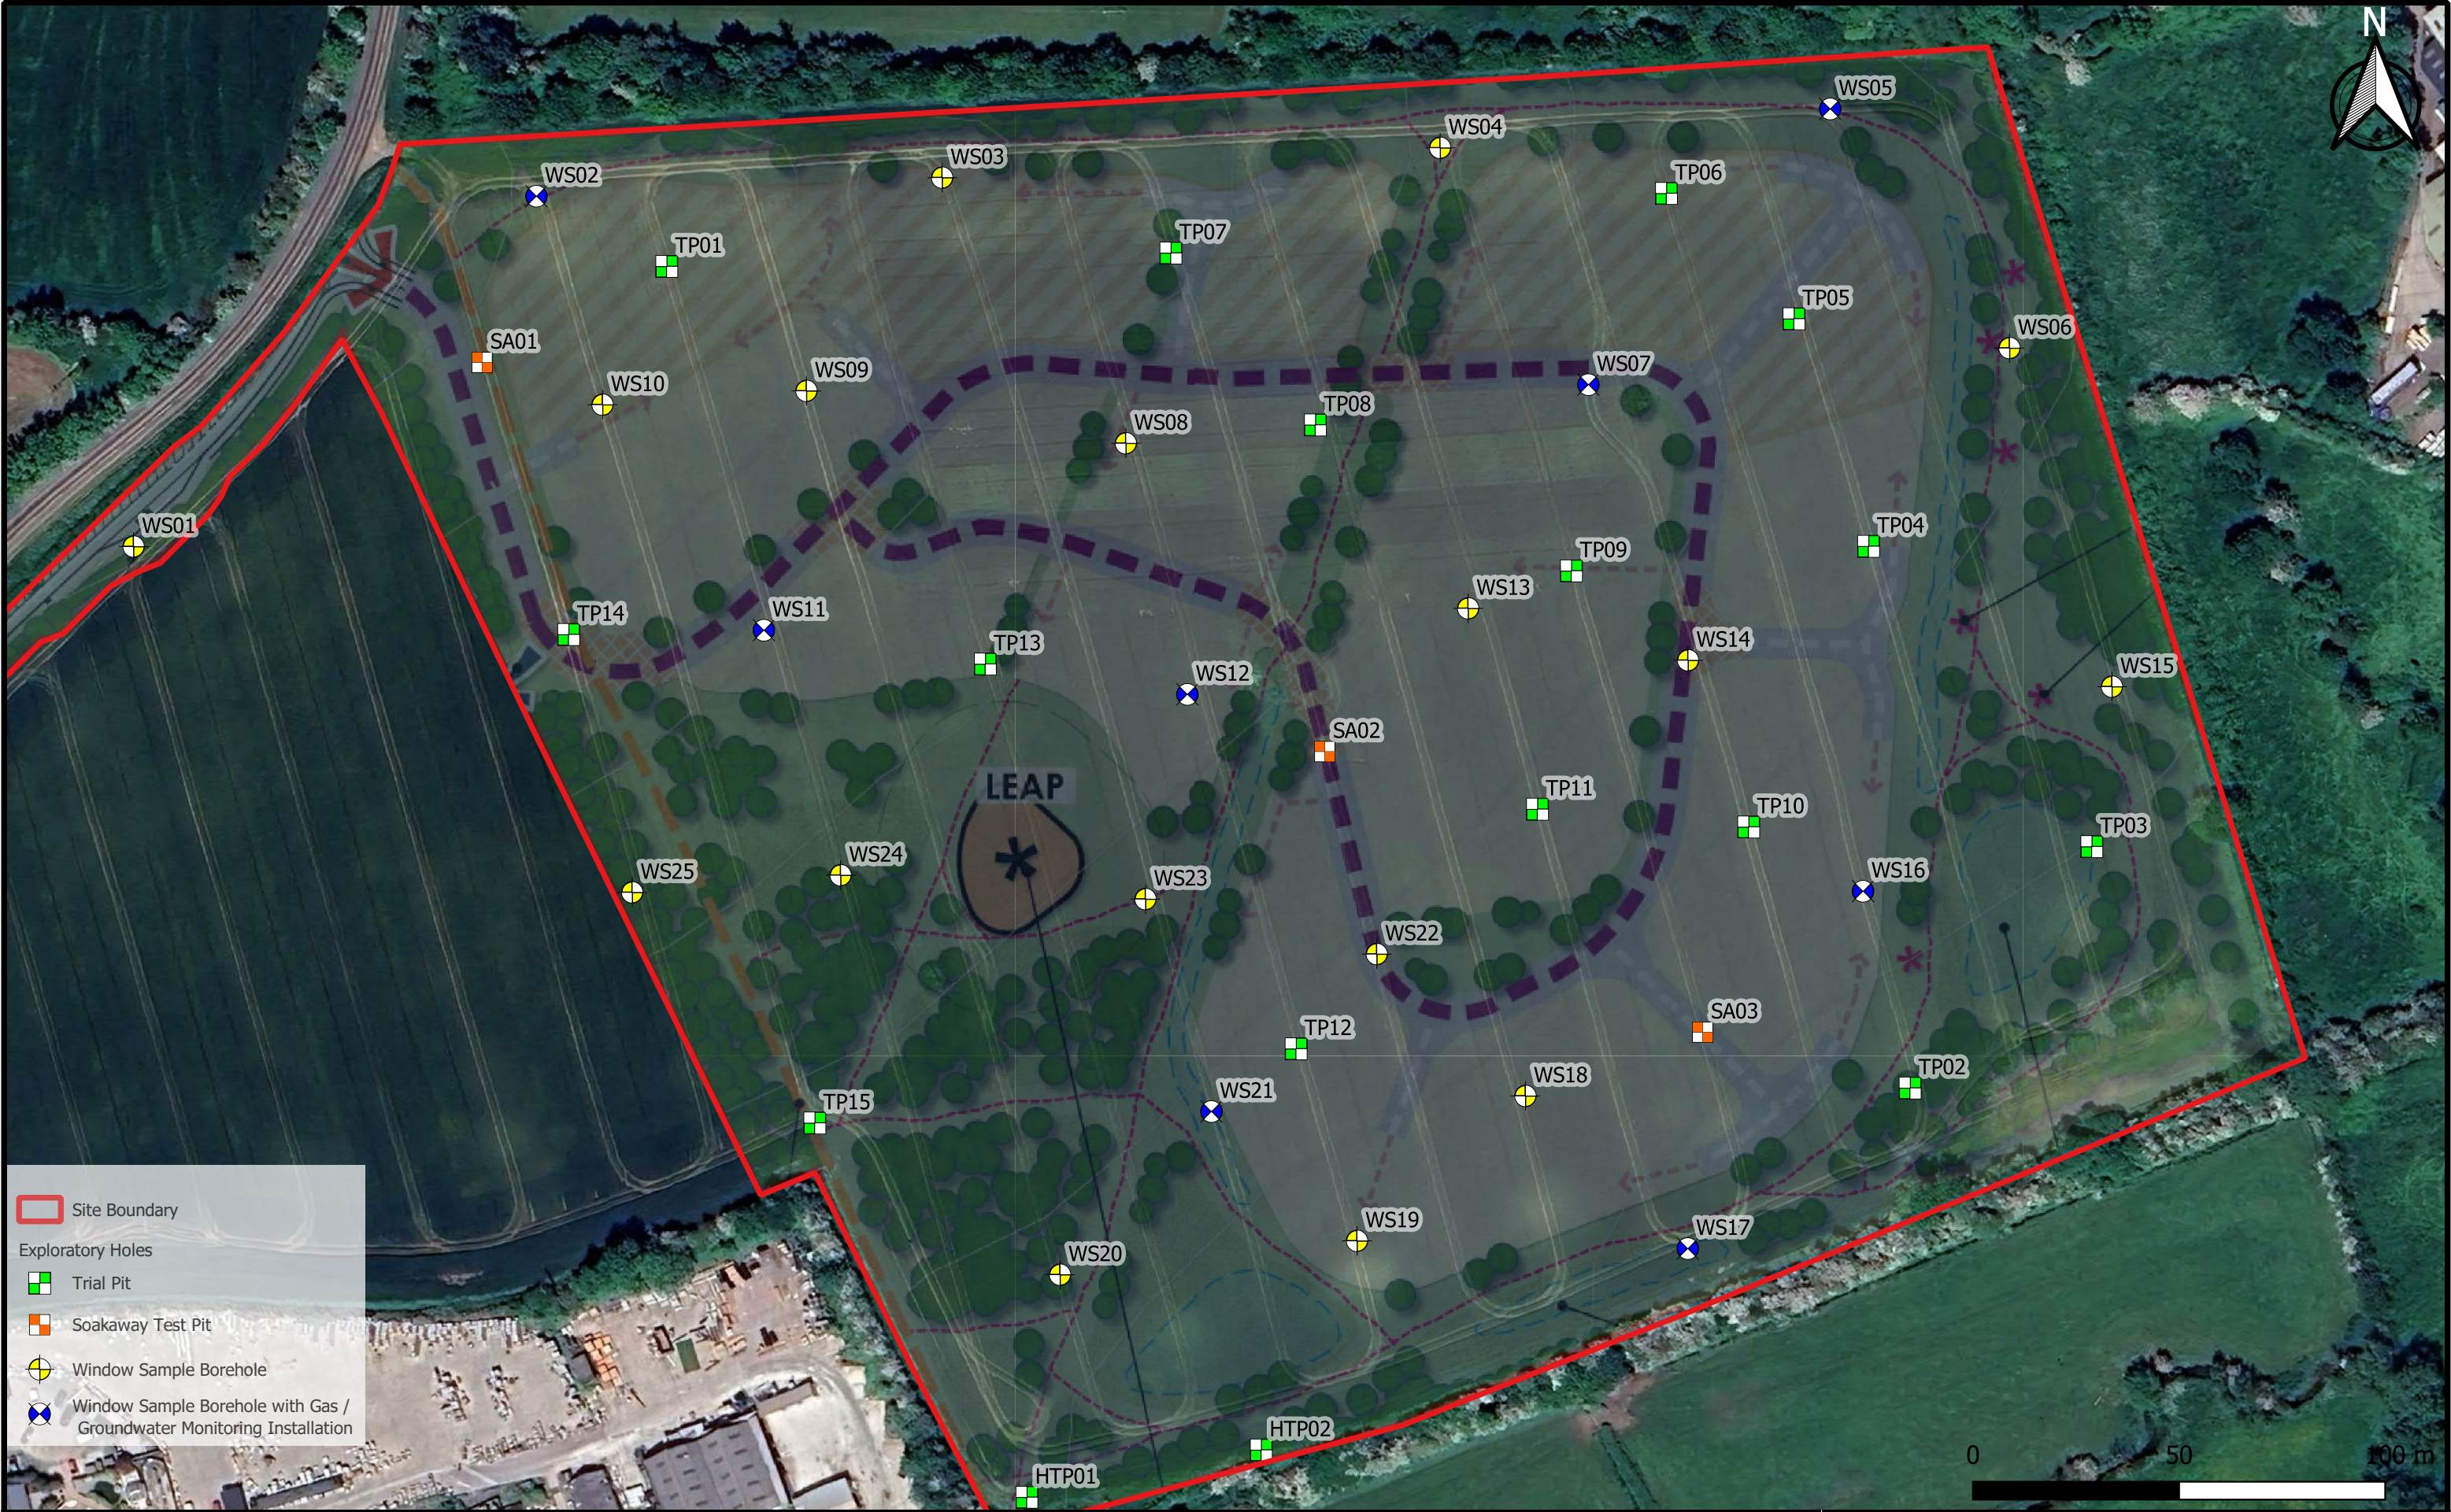
NOTES:  
- Approximate 60m investigation grid

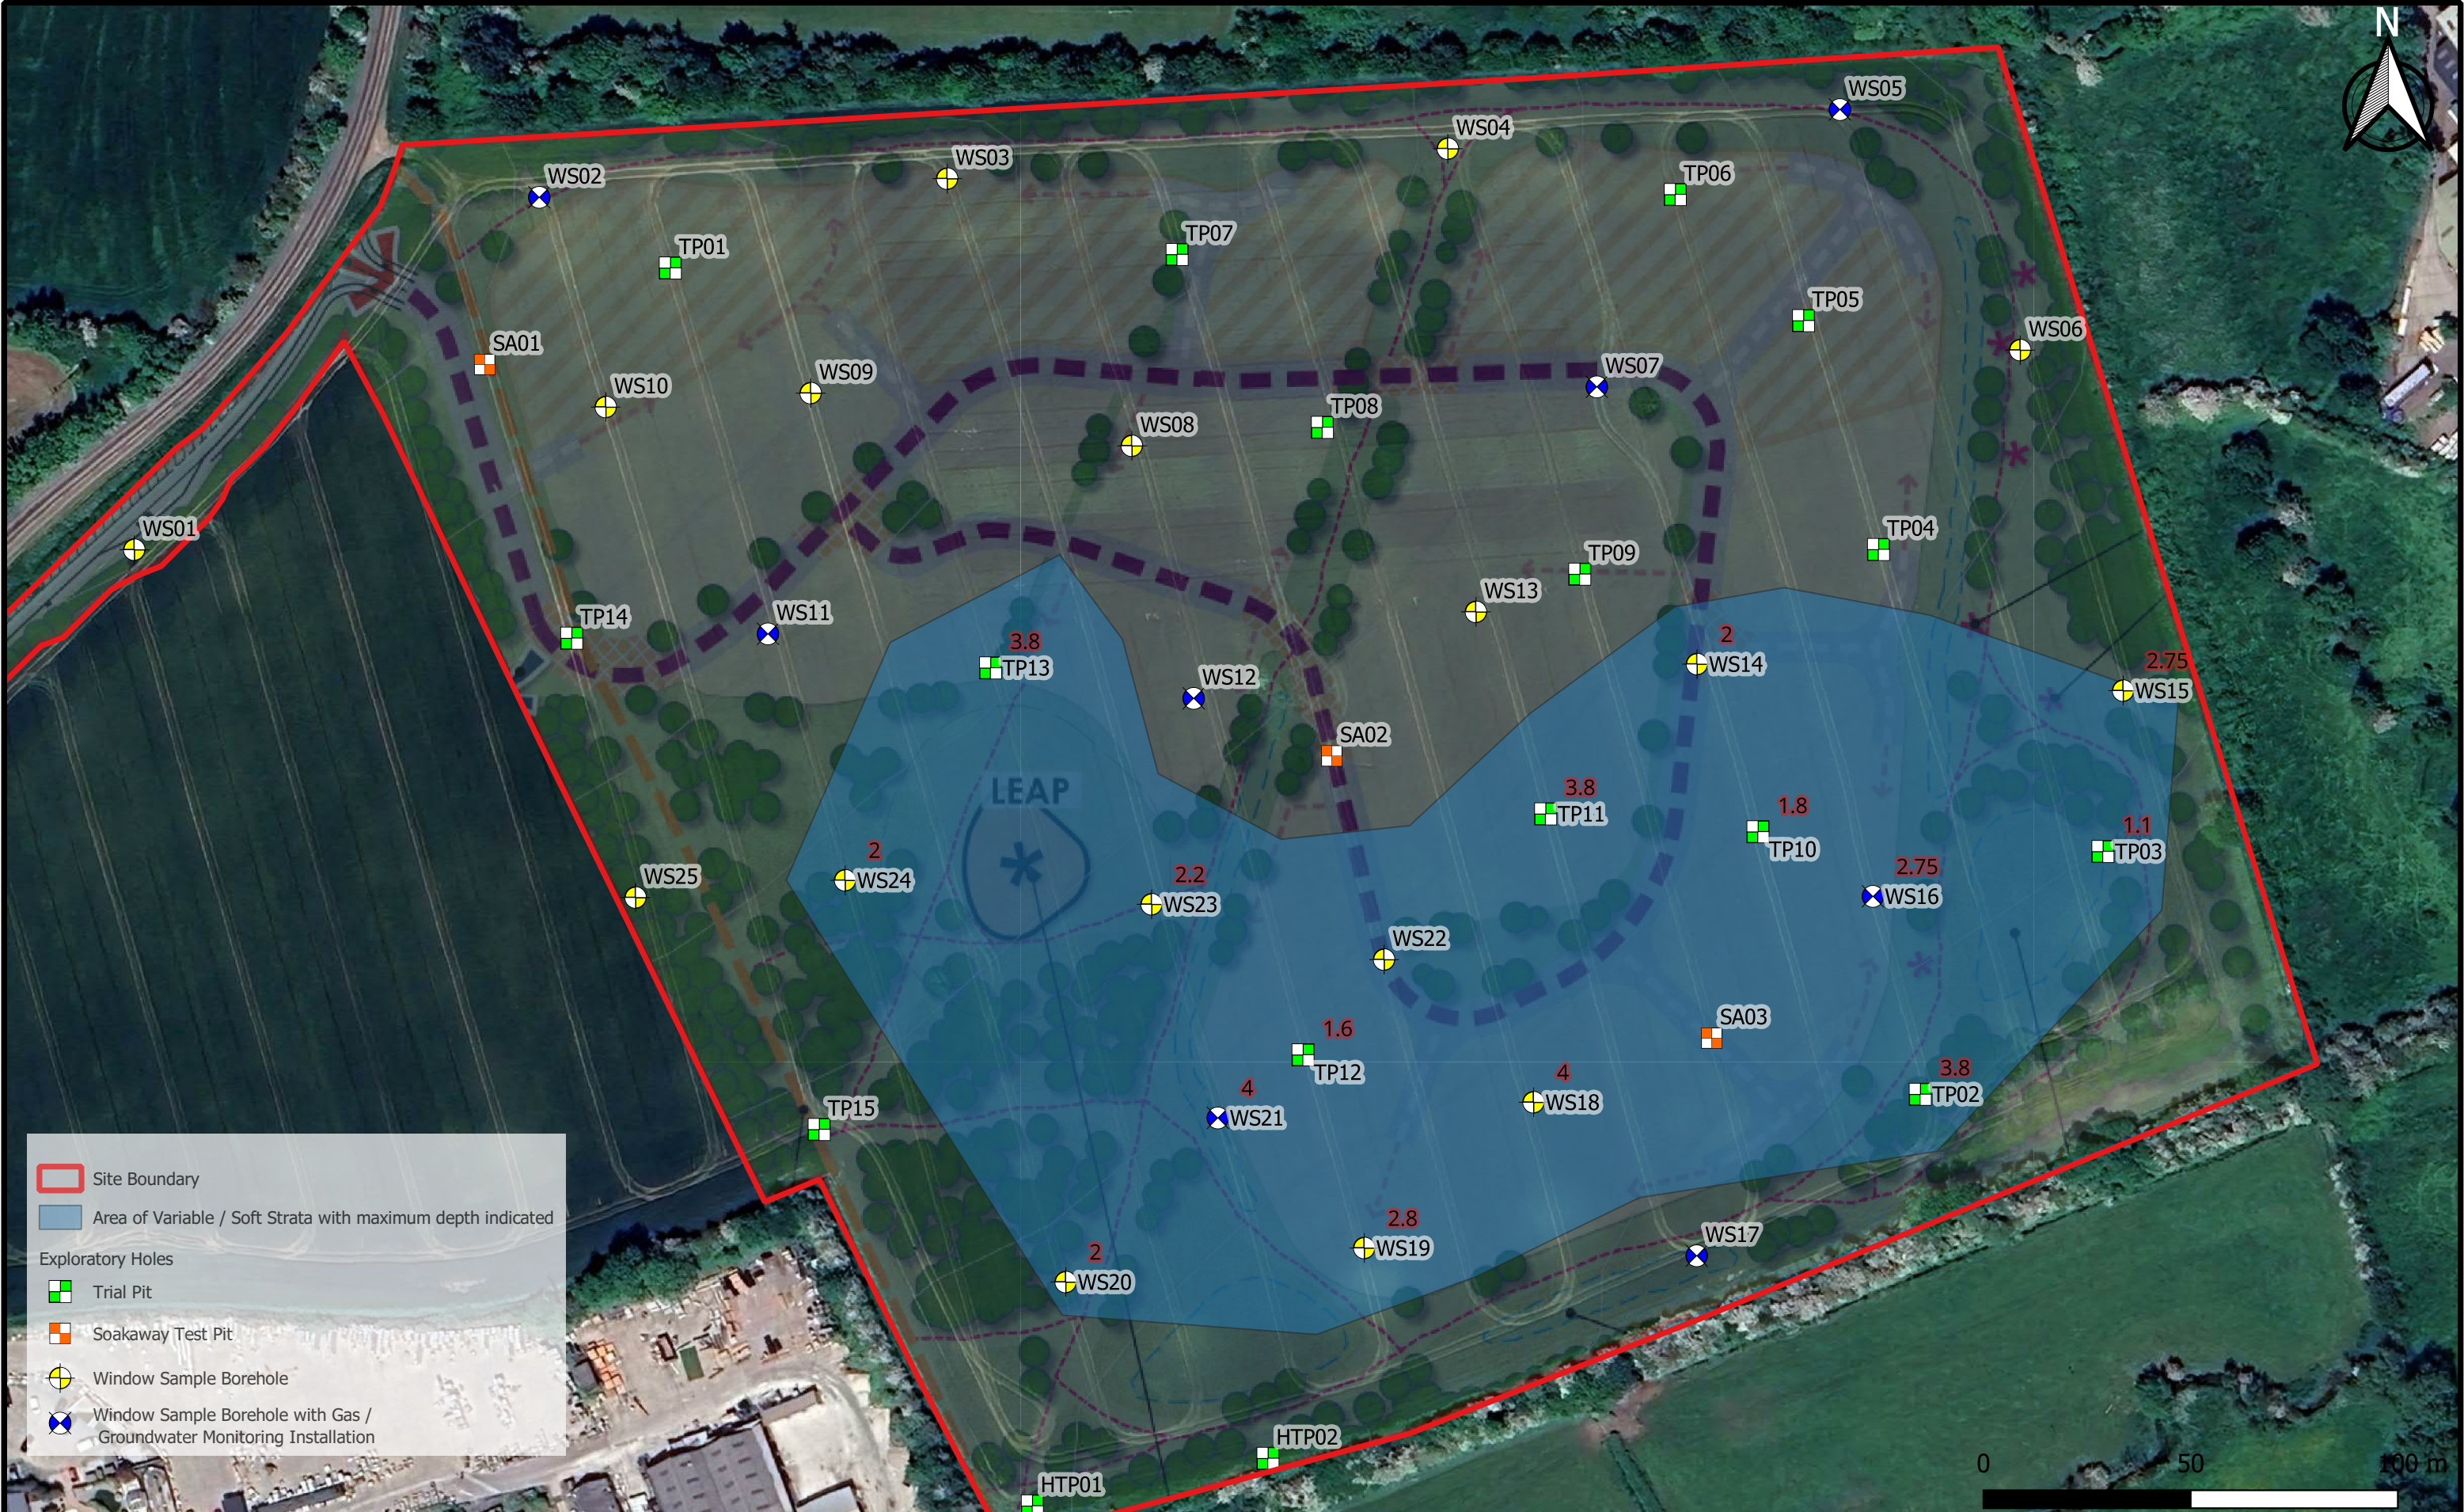
**NOTES:**  
Minimum foundation depth of 0.9m begl  
for cohesive strata (with ABP of  
110kN/m<sup>2</sup>) will be applicable for the  
northern half of the development area.  
Shaded area confirms presence of shallow  
granular strata or soft strata within the  
southern half of development area.

A foundation zoning plan is presented in Appendix N. A minimum foundation depth of 0.9m begl for cohesive strata (with an ABP of 110kN/m<sup>2</sup>) will be applicable for the northern half of the development area. However, the shaded area indicated on the foundation zoning plan within the southern half of the development area confirms the presence of shallow granular strata or soft strata that would need to be deepened through to achieve consistent and competent cohesive founding strata.
